WEST ERREGULLA PROCESSING PLANT AND PIPELINE

REHABILITATION MANAGEMENT PLAN

E-PLN-036

West Erregulla Rehabilitation Management Plan

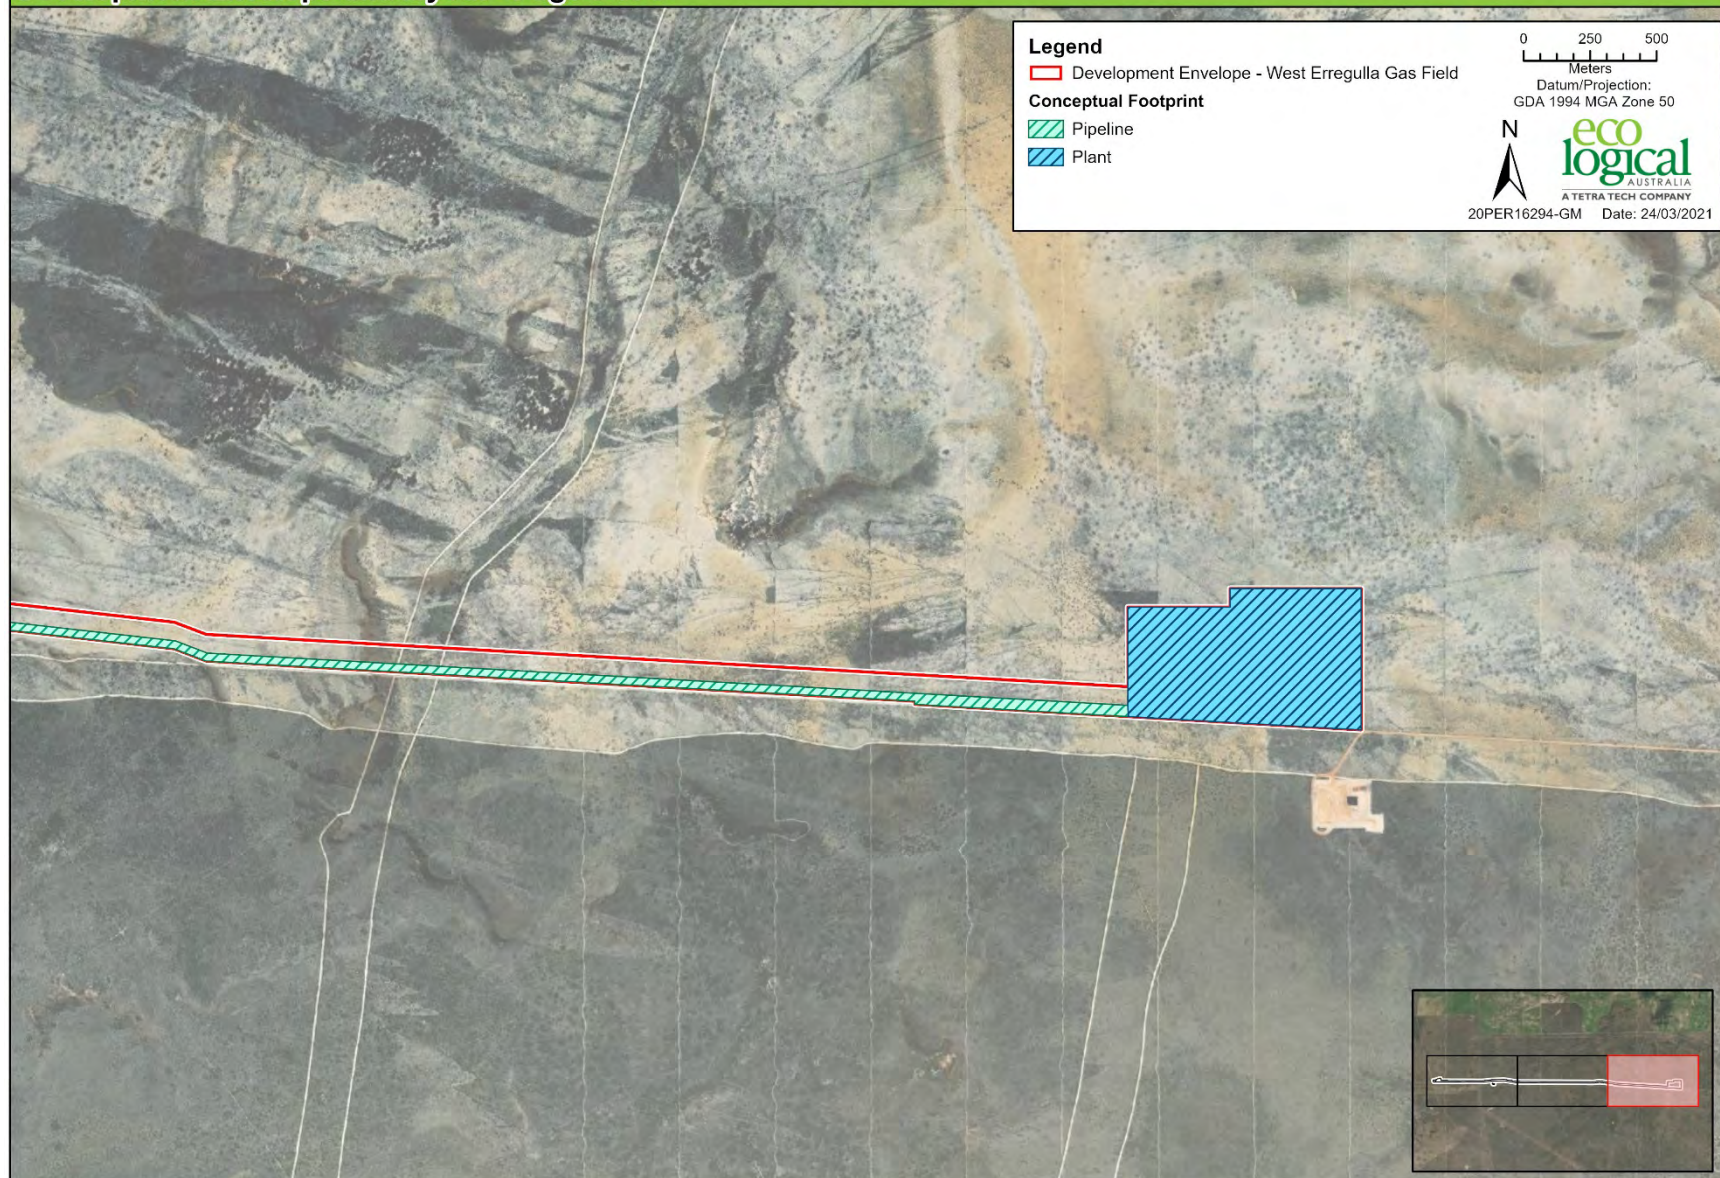
Figure 1-2 Development Envelope and layout

A Development Envelope of 213 ha was surveyed to ensure siting to minimise environmental impacts. Total proposed disturbance is 90 hectares (ha). A breakdown of the disturbance footprint is outlined in Table 1-1. It is noted that approximately 41.5 ha (46%) of the Disturbance Footprint is intended to be rehabilitated upon completion of construction.

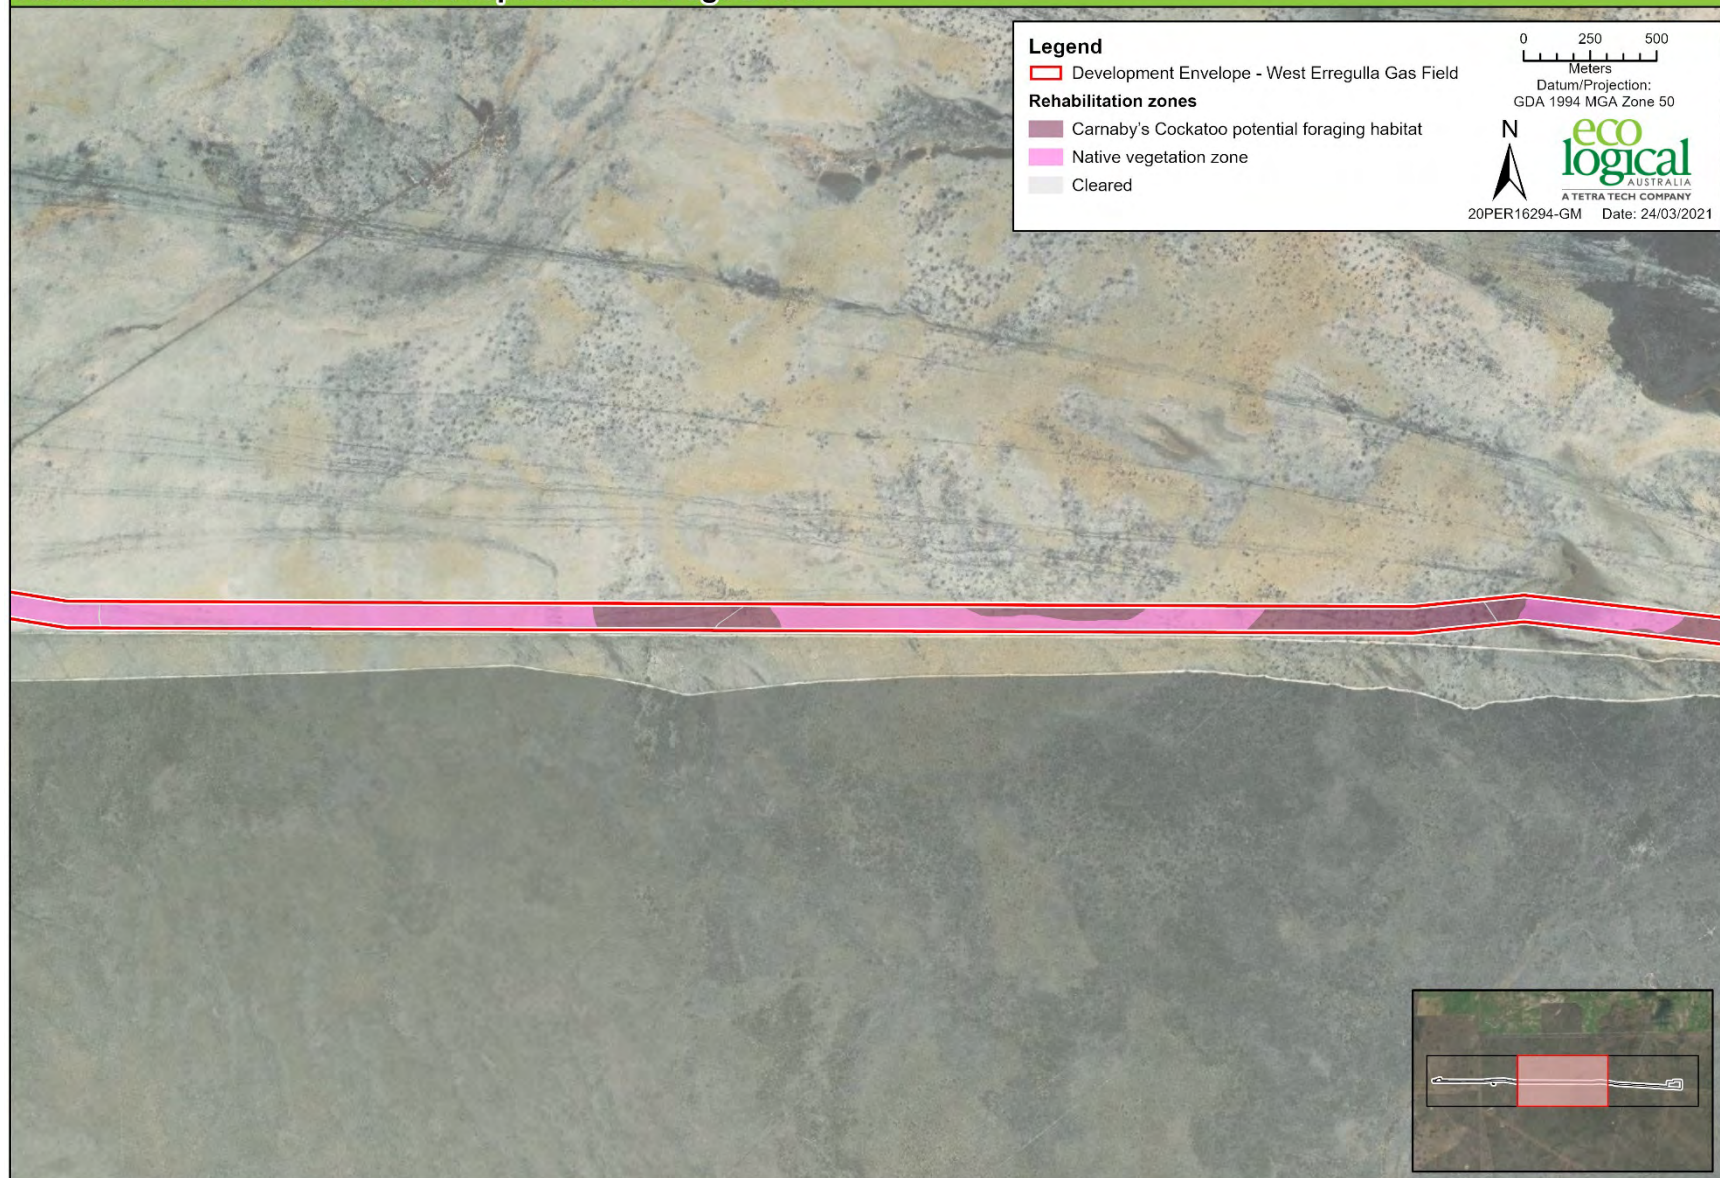
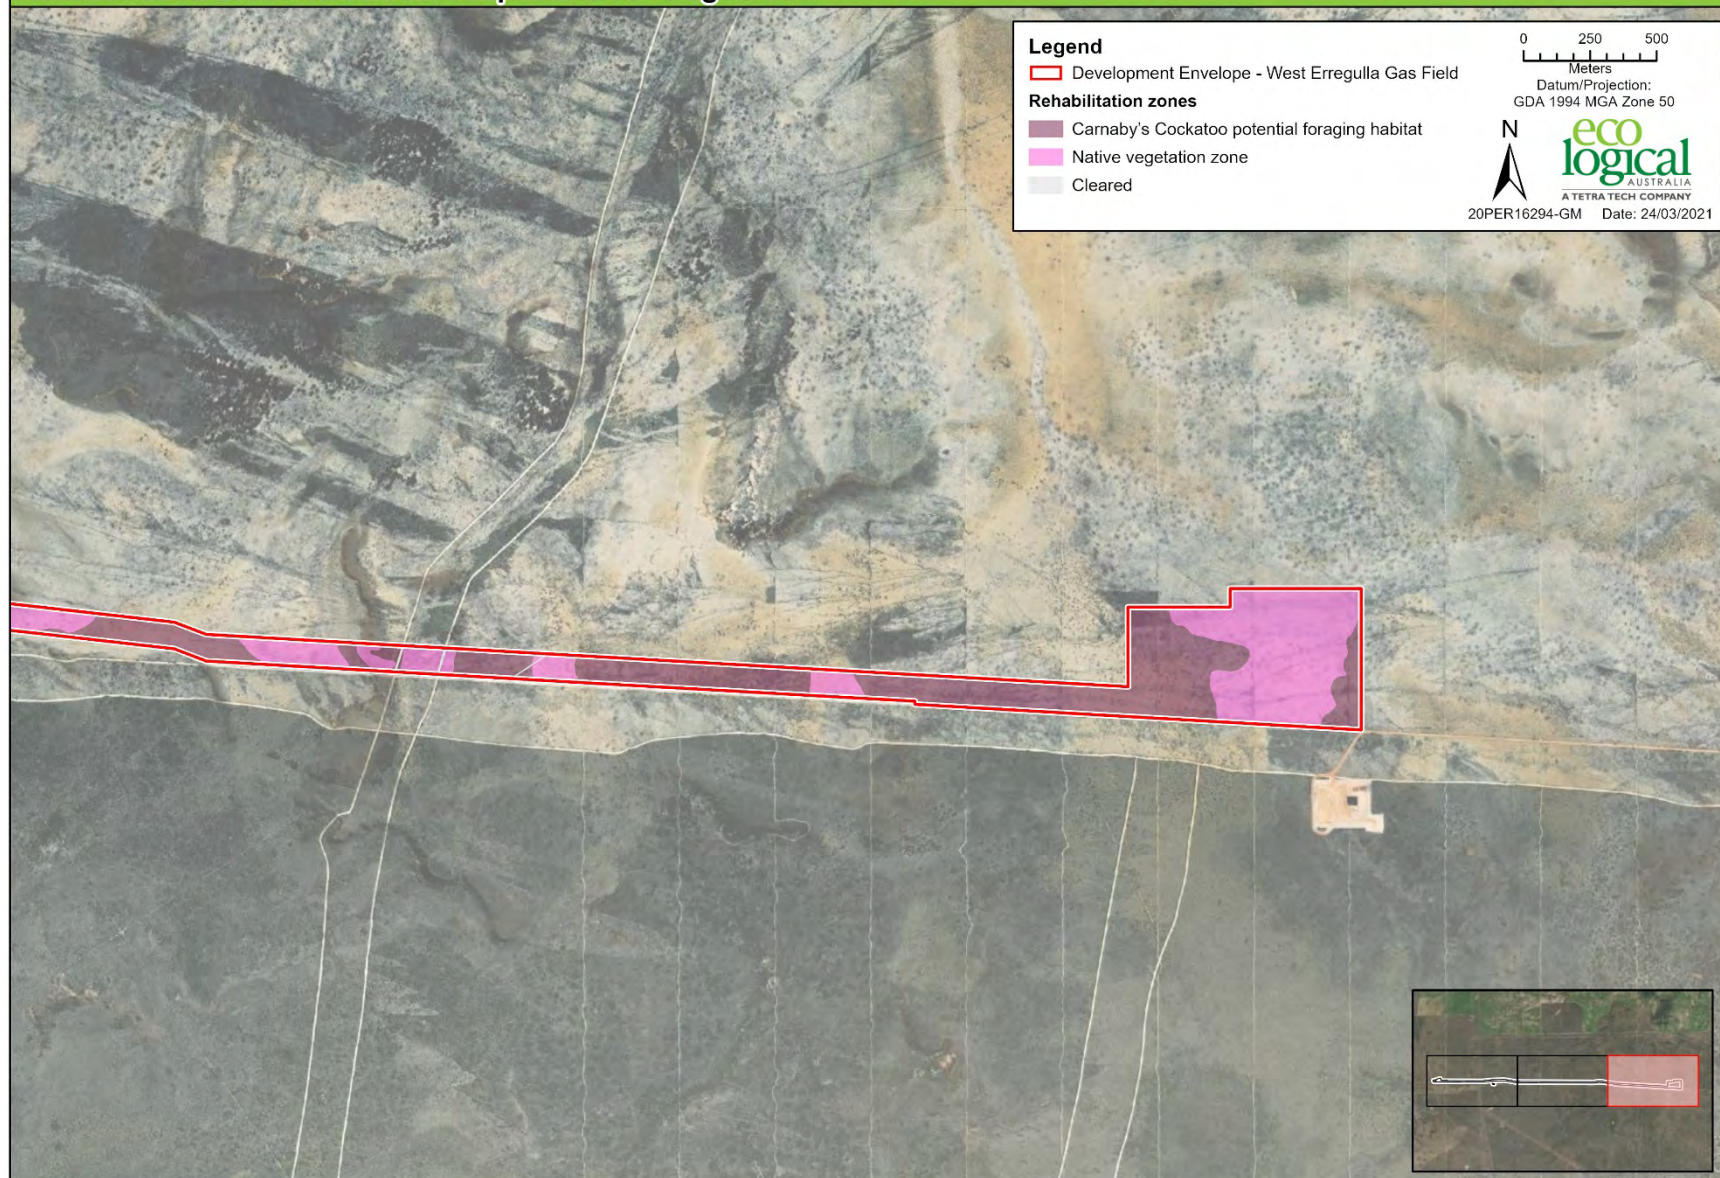
Figure 2-1 Rehabilitation zones within the Development Envelope

For the purposes of this RMP, two distinct rehabilitation zones have been defined based on ecological survey work undertaken to date and the presence of MNES habitat. They include the following:

- Native vegetation (native vegetation without additional values required to support MNES)
- Carnaby's cockatoo potential foraging habitat.

These zones are shown on Figure 2-1 and fully described in Table 2-2.

Rehabilitation zone	Zone description	Extent within the Disturbance Footprint (ha)	Proportion of the Development Envelope (%)
Native vegetation	Defined as all native vegetation within the Disturbance Footprint Envelope, excluding areas mapped as MNES habitat below. Native vegetation has been defined and mapped as vegetation communities by ELA (2020a).	52	58
Carnaby's Cockatoo potential foraging habitat	Preliminary mapping includes <i>Banksia</i> spp. and occasional <i>Eucalyptus tottiana</i> mid open woodland over shrubs and sedgeland on sandy plains (Appendix A).	38	42

Initial habitat mapping has been completed based on reconnaissance field surveys conducted in late 2020 (see Appendix A). Rehabilitation zones may also be updated during trenching, for example if direct evidence of conservation significant species presence is detected in an area previously not considered potential conservation significant species habitat.

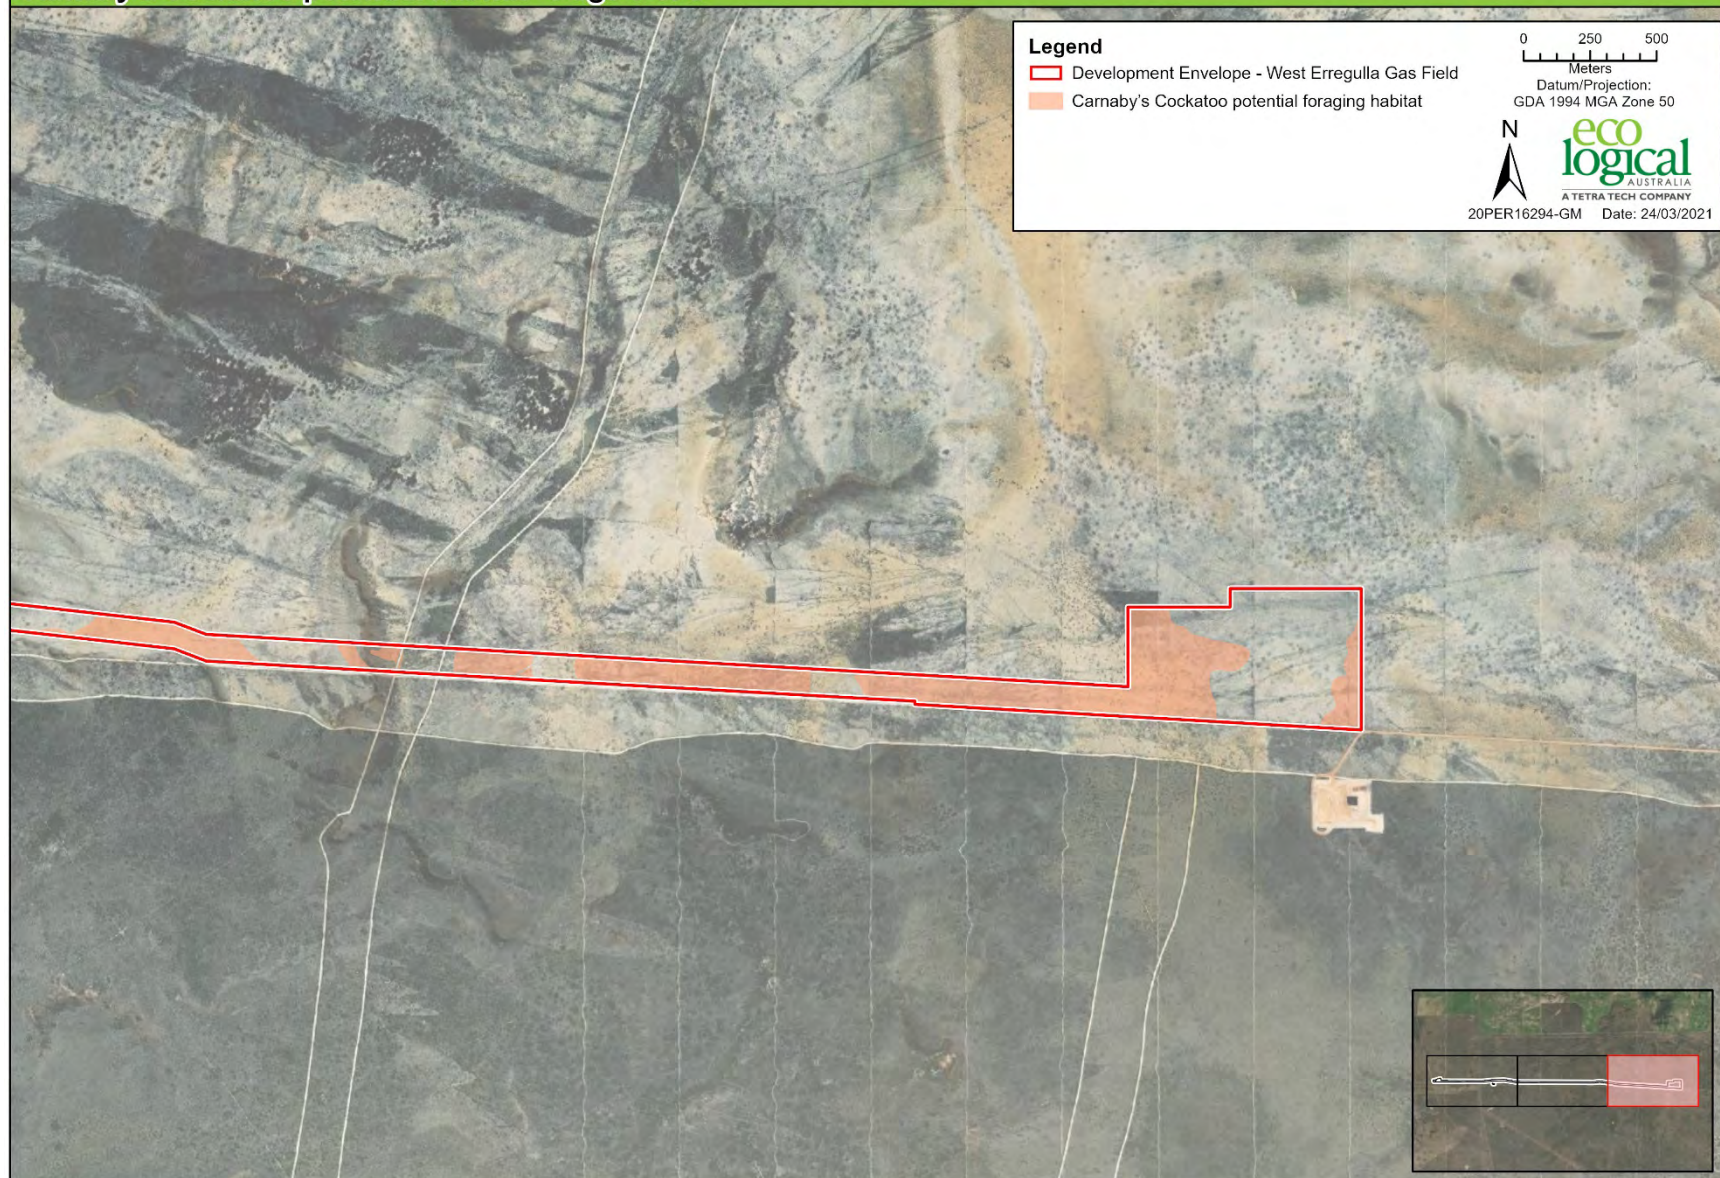
Appendix A Potential Carnaby's Cockatoo foraging habitat mapping

No individuals of *Paracaleana dixonii* were recorded in the recent survey, while approximately 95.2 ha of low quality Carnaby's Cockatoo foraging habitat was mapped (ELA 2020a) within the Development Envelope including approximately 38 ha within the proposed disturbance footprint.

A summary of the habitat requirements and expected residual impacts to potential habitat for *Paracaleana dixonii* and Carnaby's Cockatoo is presented in Table 1-4. Habitat mapping for Carnaby's Cockatoo only is provided in Appendix A, as recent fire activity within the Development Envelope burnt all suitable habitat for *Paracaleana dixonii* (Table 1-4).

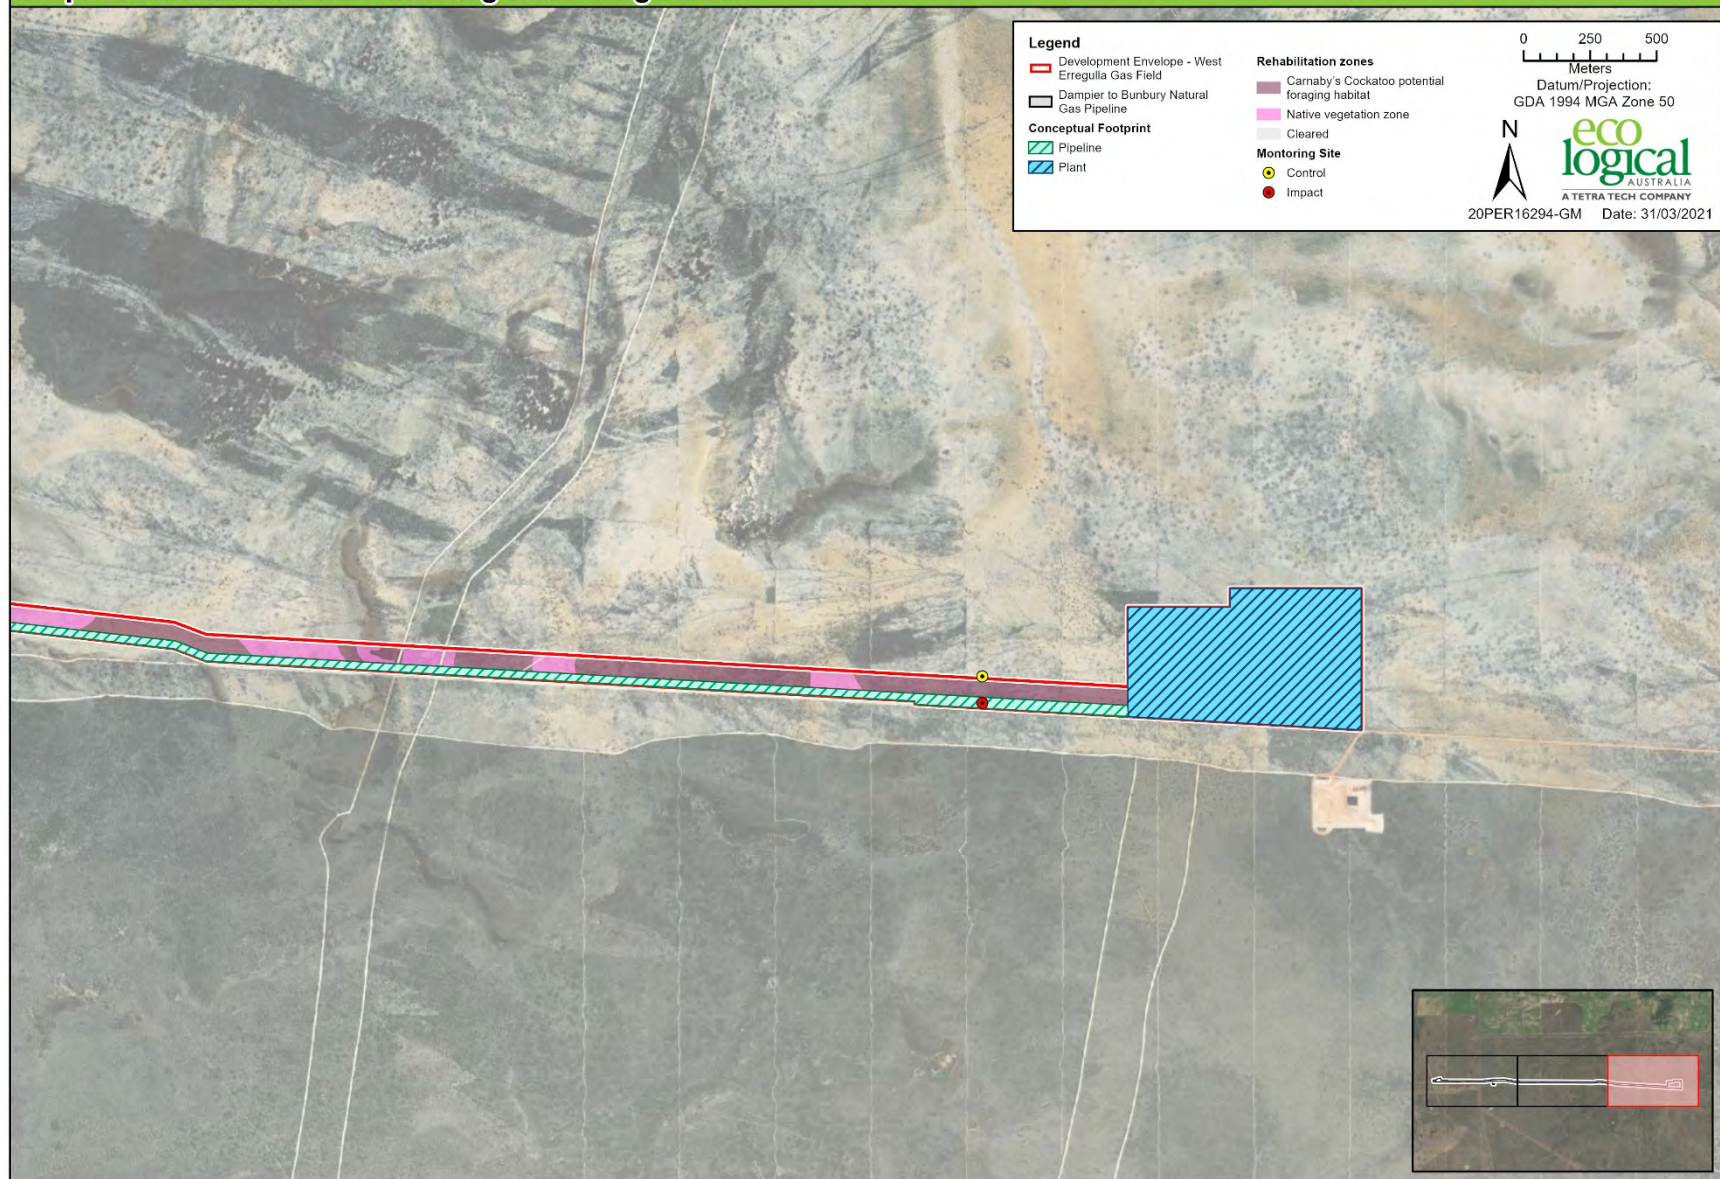
Appendix B Rehabilitation Monitoring Sites

Based on the existing information available for vegetation and fauna habitats, preliminary monitoring sites for each rehabilitation zone will be selected from which an assessment against the management targets can occur. Each monitoring site will comprise one rehabilitation site and one corresponding control site. Six monitoring sites will be selected, including three for each rehabilitation zone to ensure appropriate replication of monitoring across the length of the Disturbance Footprint (Appendix B).

Monitoring sites will be located within the 'core' of rehabilitation zones to minimise the impacts of edge effects and to avoid transitional vegetation/habitats. Paired control sites will be located on undisturbed land within 300 m of the pipeline corridor but outside of the disturbance area. They will be established in the same native vegetation communities as the rehabilitation sites, to assist comparisons between rehabilitation and control area sites.

Following the completion of construction, appropriately sized quadrats will be established at each of the pre-determined monitoring (rehabilitation and control) sites (Appendix B). Each quadrat will be permanently demarcated with fixed markers (e.g. fence dropper) and GPS coordinate locations of each quadrat corner will be recorded.
