# Visual Impact Assessment

## Turner River Solar Hub

### Fortescue Ltd

10 January 2025

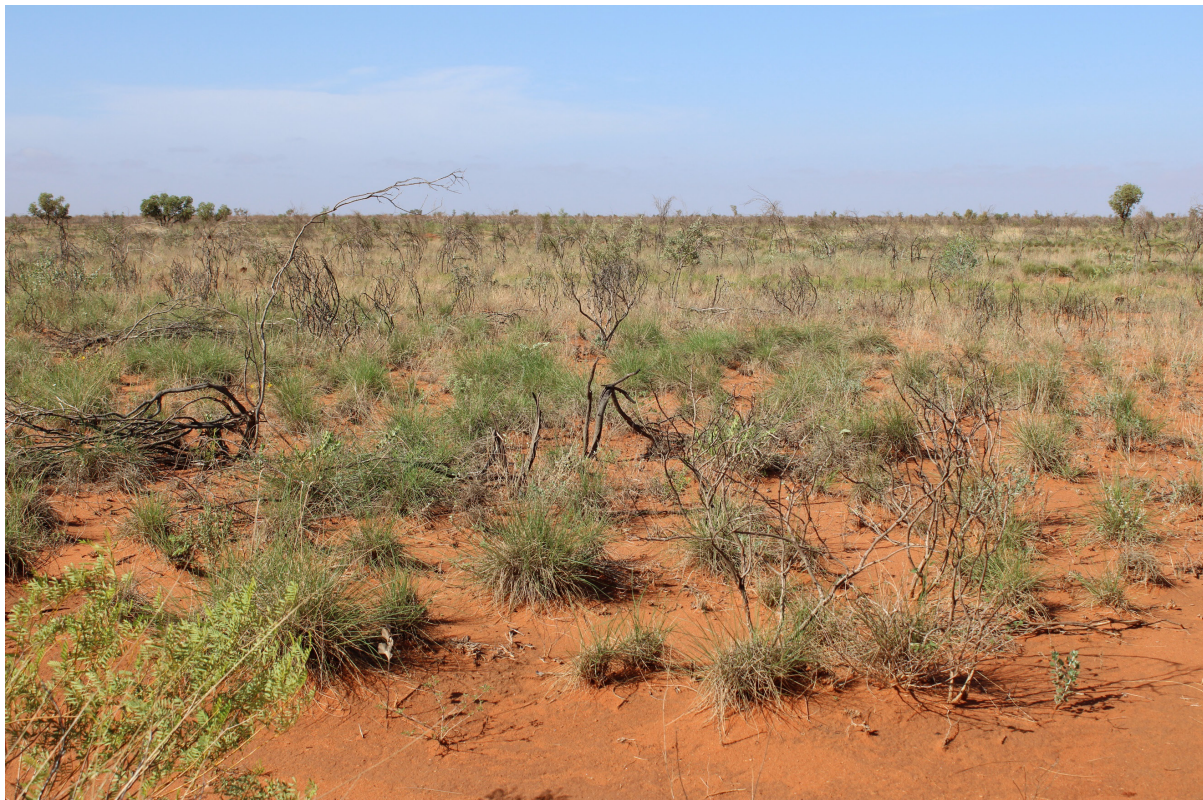
**Plate 1: Typical view of the Plains LCU**

Criteria	Characteristics
Extent in Study Area	131,960 ha (48%)
Direct Impact of Project Footprint	831.6 ha (0.63%)
<b>Environmental Aspects</b>	
Vegetation	Spinifex grasslands with or without scattered shrubs or shrublands
Landforms	Plains
Related Land Systems	Boolgeeda, Macroy, Platform and Satirist
Local Rarity	Not Rare (>20 % of Study Area)
<b>Aesthetic Values</b>	
Visual Elements	Stony to clayey plains with mix of blue sky, various hues of green / brown vegetation, and ochre to pale earth.
<b>Socio-Cultural Values</b>	
Land Uses	Mineral exploration, pastoralism, and transportation
Heritage Places	Based on desktop research Native Title determinations recognise the Nyamal People and Kariyarra People across the Plains LCU in the Study Area. Aboriginal Heritage Places are widespread across the Plains LCU.
Landscape Value and Impact	Not Rare x High Landscape Preference = Medium Value Medium Value x Low Magnitude of Change = Minor-moderate Impact

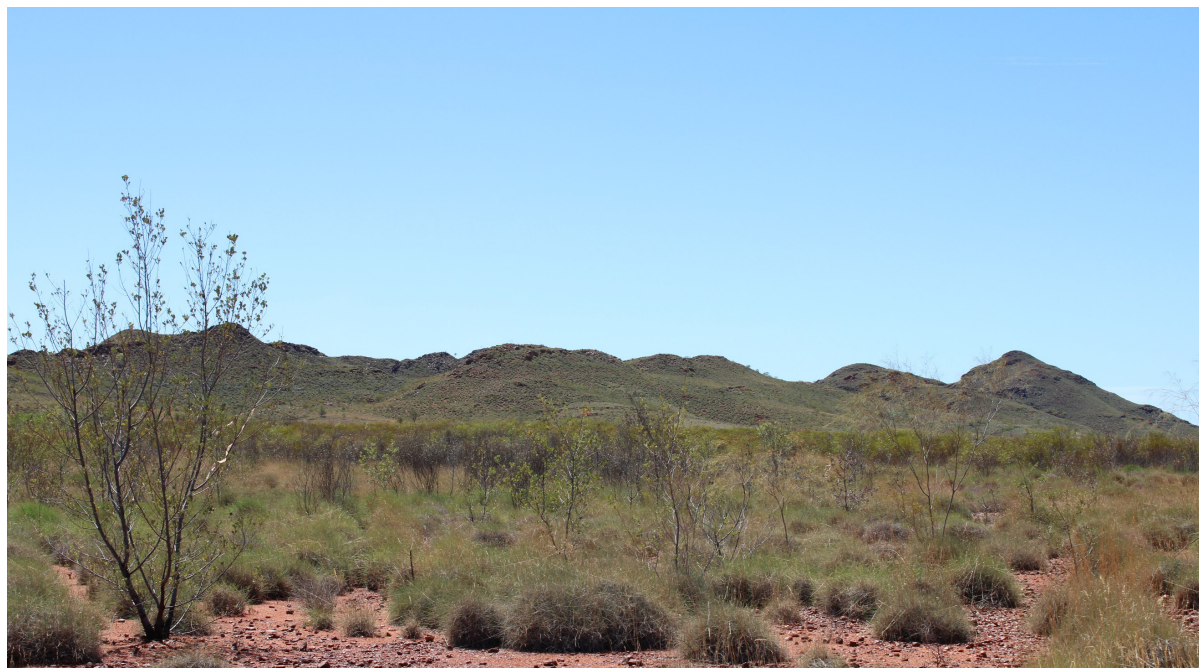
**Plate 3: Typical view of the Ranges, Hills and Low Rises LCU**

Criteria	Characteristics
Extent in Study Area	91,691 ha (33%)
Direct Impact of Project Footprint	2.10 ha (<0.01%)
<b>Environmental Aspects</b>	
Vegetation	Spinifex grasslands with or without scattered shrubs
Landforms	Ranges, hills, ridges, low rises, plateaux
Related Land Systems	Boolaloo, Capricorn, Robe, Rocklea, and Talga
Local Rarity	Not Rare (>20 % of Study Area)
<b>Aesthetic Values</b>	
Visual Elements	Mostly rounded hills or slopes, ochre earth, contrasting mix of blue sky, various hues of green/ brown vegetation.
<b>Socio-Cultural Values</b>	
Land Uses	Mineral exploration, pastoralism, and transportation
Heritage Places	Based on desktop research Native Title determinations recognise the Nyamal People and Kariyarra People across the Ranges, Hills, and Low Rises LCU in the Study Area. Aboriginal Heritage Places are widespread across the Ranges, Hills, and Low Rises LCU.
Landscape Value and Impact	Not Rare x High Landscape Preference = Medium Value Medium Value x Low Magnitude of Change = Minor-Moderate Impact

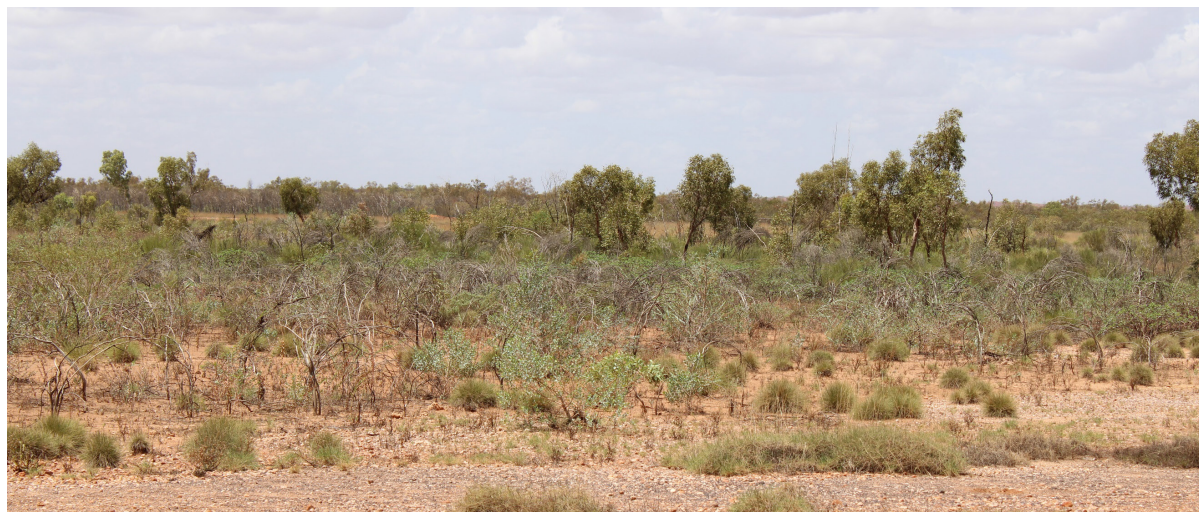
**Plate 4: Typical view of the River Plains LCU (midground)**

Criteria	Characteristics
Extent in Study Area	10,148 ha (4%)
Direct Impact of Project Footprint	0 ha (0%)
<b>Environmental Aspects</b>	
Vegetation	Tall shrublands or woodlands of acacias, fringing eucalypts
Landforms	Floodplains, major river channels
Related Land Systems	River
Local Rarity	Rare (<5% of Study Area)
<b>Aesthetic Values</b>	
Visual Elements	Plains or hills surrounding pools (or sandy riverbeds), flood plains, tall trees and a contrasting mix of blue sky and various hues of green, brown, and sometimes white vegetation.
<b>Socio-Cultural Values</b>	
Land Uses	Mineral exploration, pastoralism, and transportation
Heritage Places	Based on desktop research Native Title determinations recognise the Nyamal People and Kariyarra People across the River Plains LCU in the Study Area. Aboriginal Heritage Places cover much of the River Plains LCU. Water is also a resource (when present).
Landscape Value and Impact	Rare x High Landscape Preference = High Value High Value x Negligible Magnitude of Change = Minor-Moderate Impact

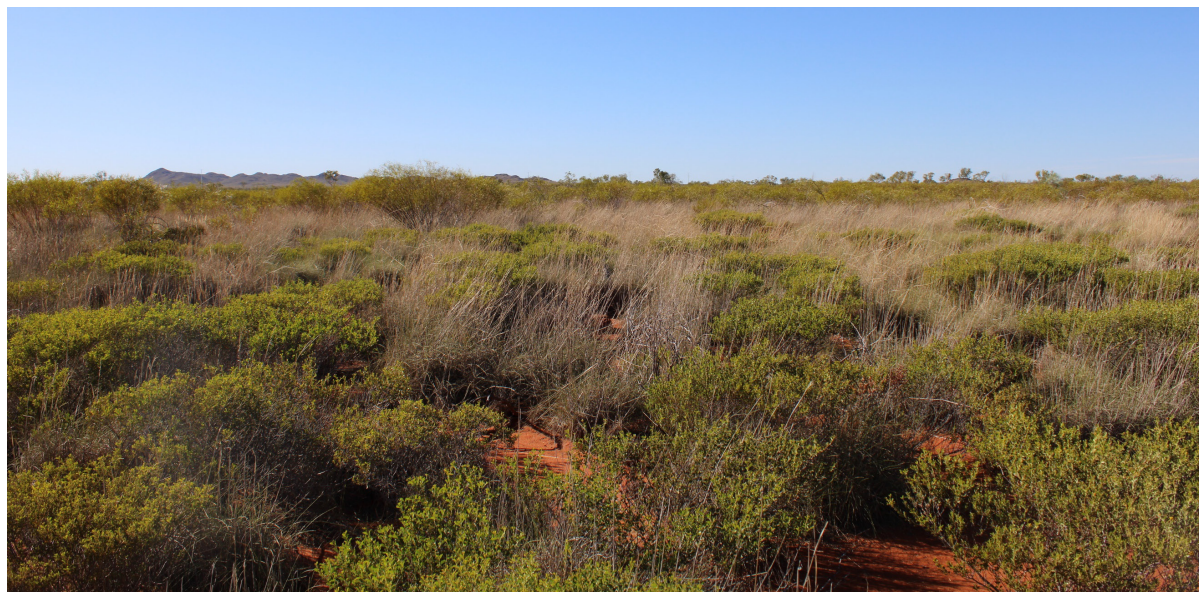
**Plate 5: Typical view of the Sandplains LCU**

Criteria	Characteristics
Extent in Study Area	35,549 ha (13%)
Direct Impact of Project Footprint	261.5 ha (0.74%)
<b>Environmental Aspects</b>	
Vegetation	Spinifex and / or hummock grasslands with shrublands or scattered shrubs
Landforms	Broad or restricted sandplains, linear dunes
Related Land Systems	Gregory and Uaroo
Local Rarity	Somewhat Rare (>5% but <20% of Study Area)
<b>Aesthetic Values</b>	
Visual Elements	Linear red sand dunes and restricted sandplains supporting shrubby hard spinifex (and occasionally soft spinifex) grassland Linear red dunes or red sandy plains, low vegetation forming a contrasting mix of blue sky and various hues of green, brown and red.
<b>Socio-Cultural Values</b>	
Land Uses	Mineral exploration, pastoralism, and transportation
Heritage Places	Native Title determinations recognise the Kariyarra People across the Sandplains LCU in the Study Area. Aboriginal Heritage Places are widespread across the Sandplains LCU. Aboriginal Heritage Places are widespread across the Sandplains LCU.

Landscape Value and Impact	Somewhat Rare x High Landscape Preference = High Value High Value x Low Magnitude of Change = Moderate Impact

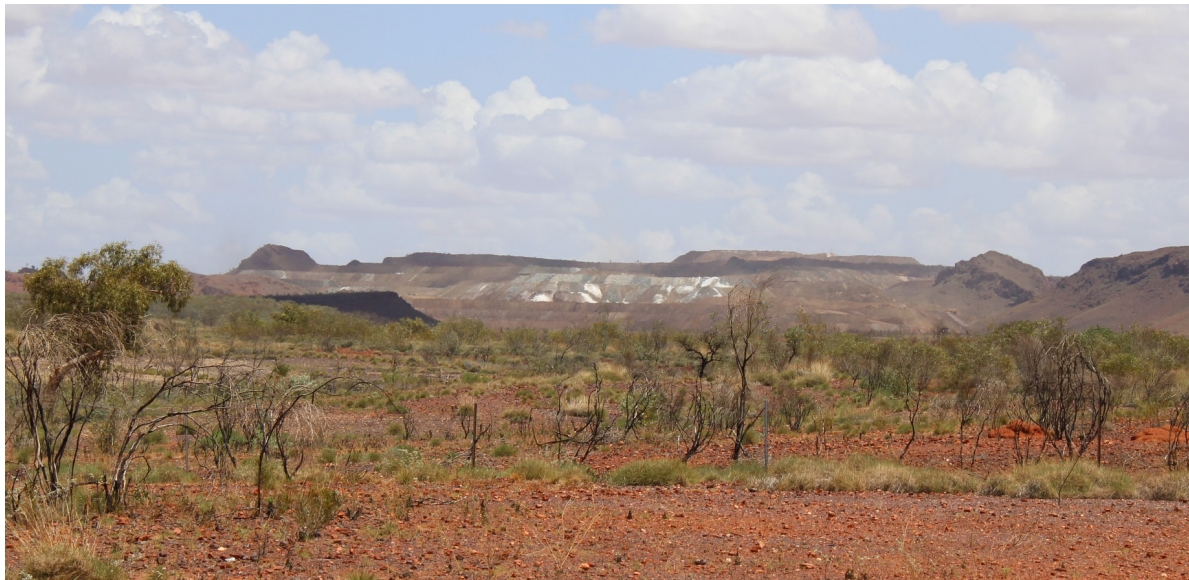
**Plate 6: View of the Modified LCU (background)**

The following plates and Table 12 provide a summary description of the Modified LCU. Plate 6 to Plate 8 are representative of views of the Modified LCU however the modified elements shown in these photographs have not been mapped due to the scale of the element being too small or it not being present on the aerial imagery used to map the Modified LCU.

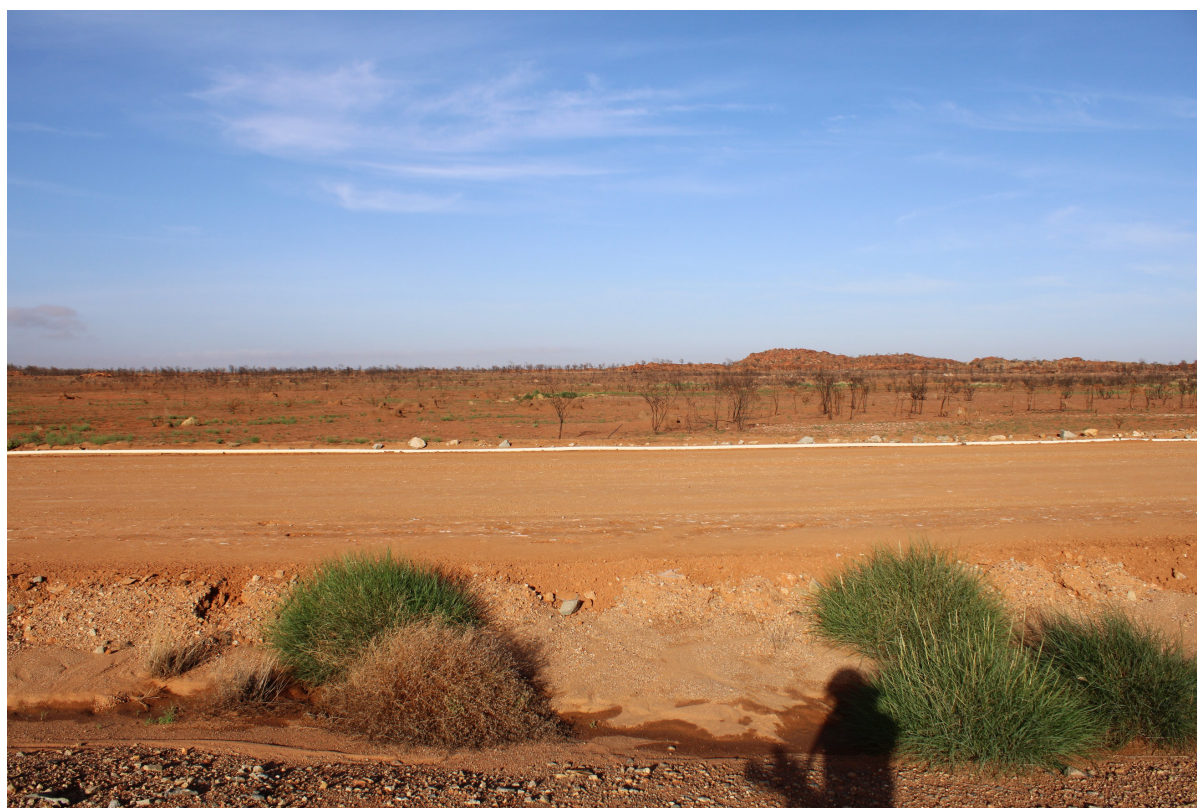
**Plate 10: VIA2, facing west**

Criteria	Characteristic
Foreground Elements	Access (unsealed) road, transmission line, water pipe, mine vehicles, spinifex, burnt area
Mid-Ground Elements	Transmission line, spinifex, shrubs, rockpiles, burnt area
Background Elements	Transmission line, spinifex, shrubs, rockpiles, communication tower, built form, burnt area
Viewer Motion	Up to 80 km/h
Accessibility	Low (private road)
Usage Type	Low (private road)
Photography	Automatic exposure settings Canon SLR Camera (DS126741) Canon EFS lens (18 to 55mm) Shots taken on lowest zoom setting (18mm) Facing: 360-degree view
After the field visit and in consideration of desktop assessment, VIA2 was rated as <b>low sensitivity</b> due to viewers predominantly being commuters or workers and the reduced scenic quality. The magnitude of change to the existing landscape was determined to be <b>negligible</b> as the Project is not visible. It therefore has an impact rating (Table 7) of <b>minor-negligible</b> . Further assessment of VIA2 is presented in Appendix A.

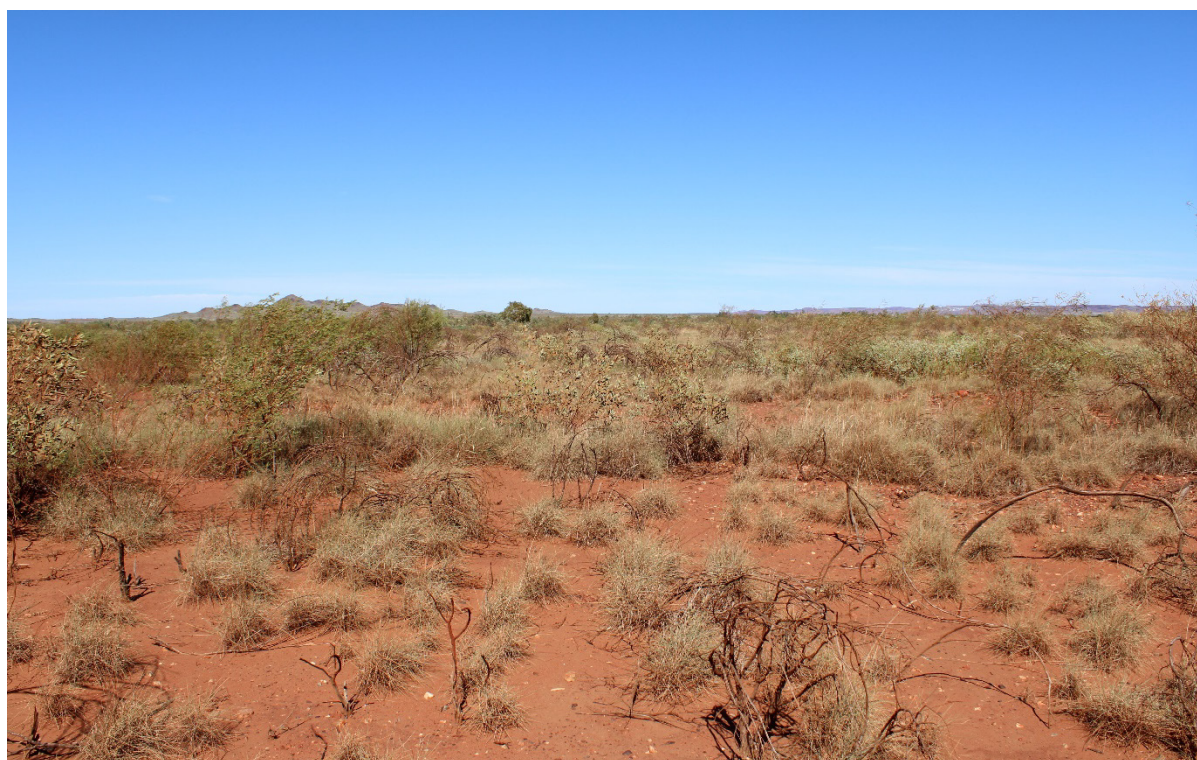
**Plate 19: VIA11, facing southwest**

Criteria	Characteristic
Location	Easting / Northing: 0687445/7661992
Date	19/04/2024
Site Code	VIA11
POI Setting	Plain
Local Vegetation Type	Spinifex, scattered shrubs, stands of shrubs
Vegetation/Topography Screening Potential	80%
Foreground Elements	Access (unsealed) road, bare ground, scattered shrubs, spinifex, burnt area
Mid-Ground Elements	Helicopter, stands of shrubs, spinifex, scattered shrubs, and trees, burnt area

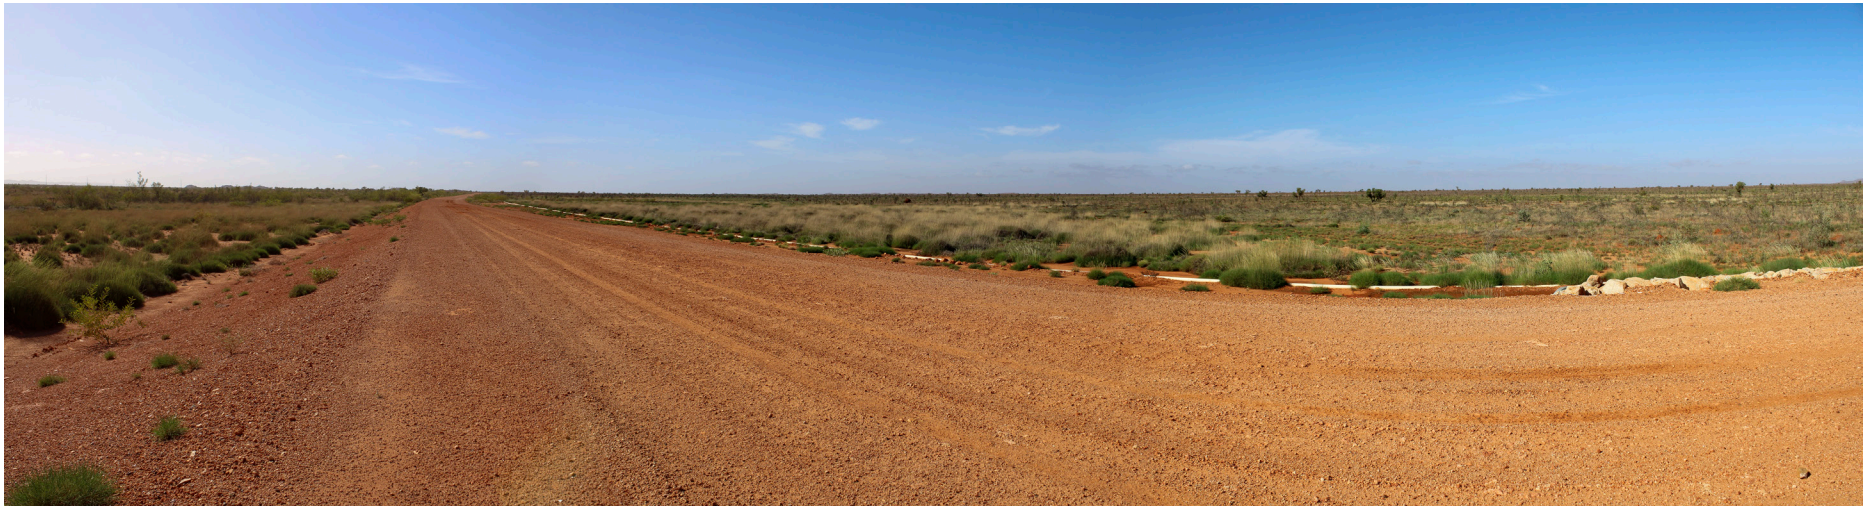
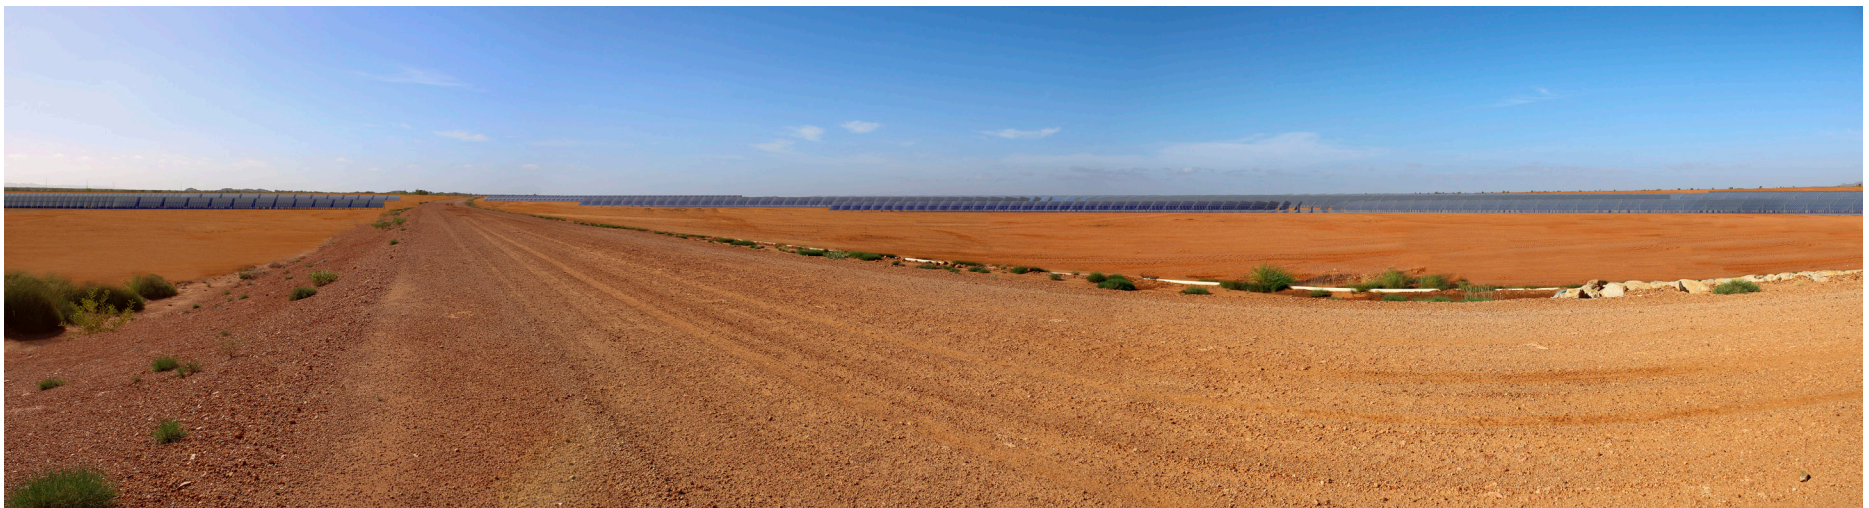
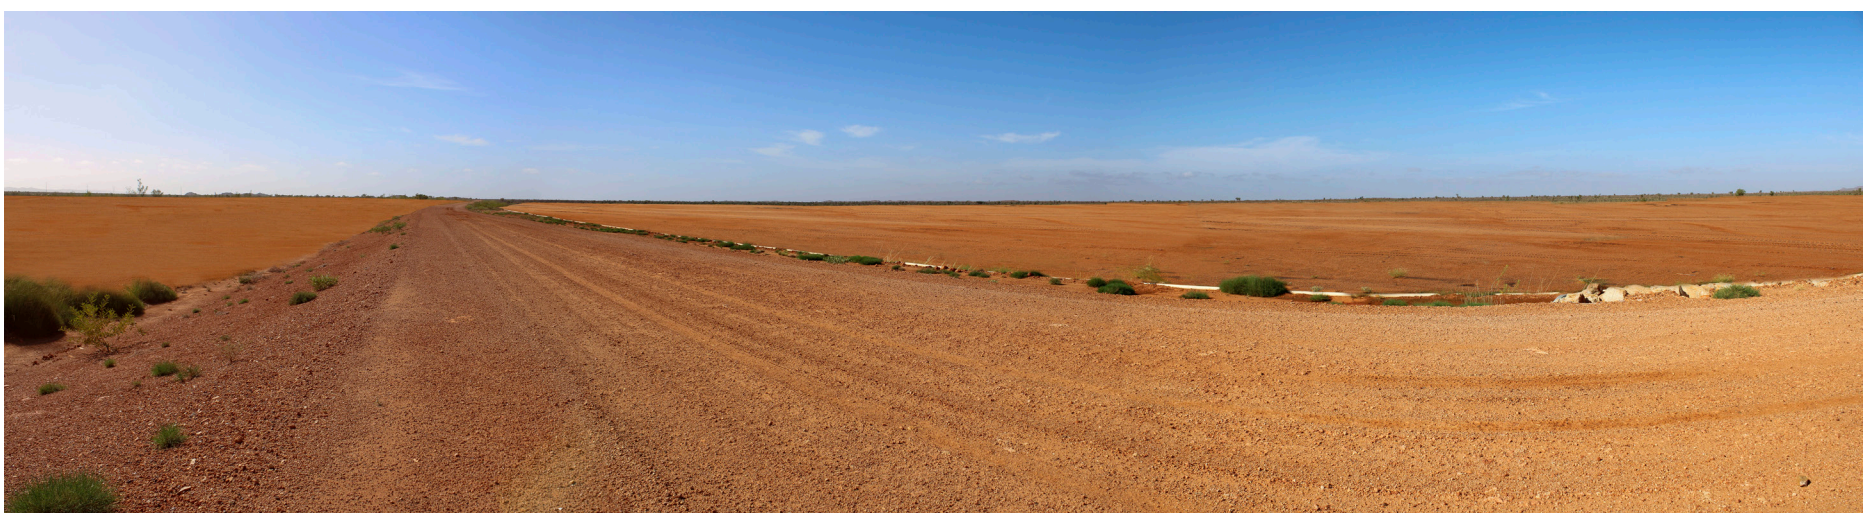
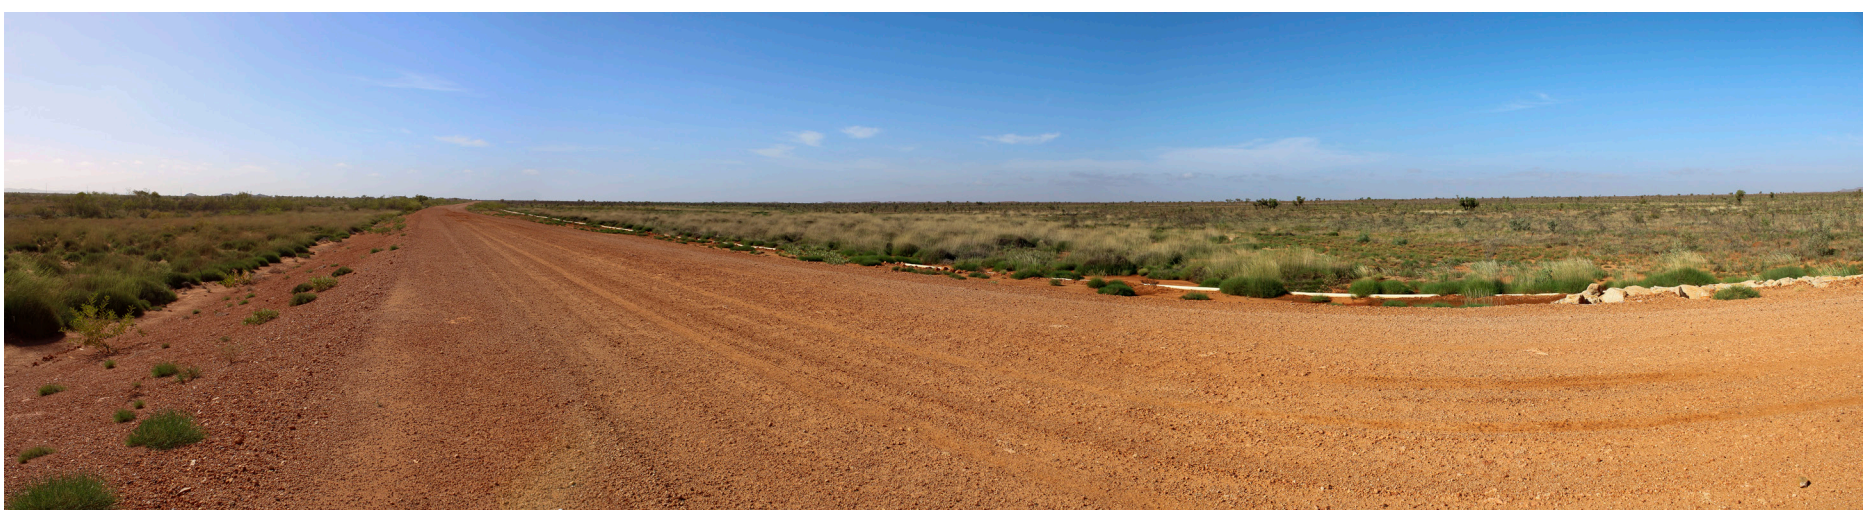
**Plate 27: VIA8 – Current view, looking southeast toward the southern area**

**Plate 28: VIA8 – Operational view, looking southeast toward the southern area**

**Plate 29: VIA8 – Closure view, looking southeast toward the southern area**

**Plate 30: VIA8 – Post-50 years view, looking southeast toward the southern area**

VIA8 captures a view from an existing unsealed private road within the southern area. The current view from VIA8 is partly a natural view and partly a modified view, with modified elements including an access and small pipeline. The predicted view is a modified view of cleared bare ground and the solar arrays. Due to the viewpoint's location within the southern area project area and the required clearing, the southern area is highly visible from VIA8 and the change in view is stark. The northern area will not be visible from VIA8. Immediately following closure of the

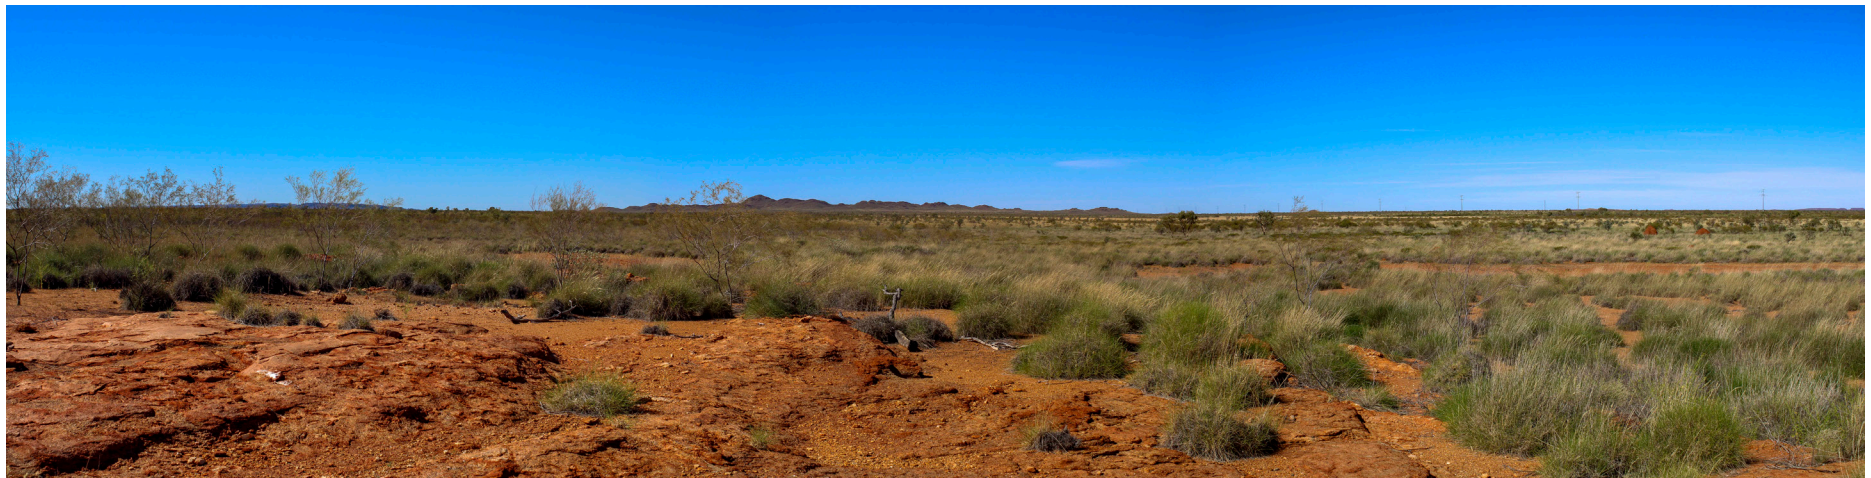
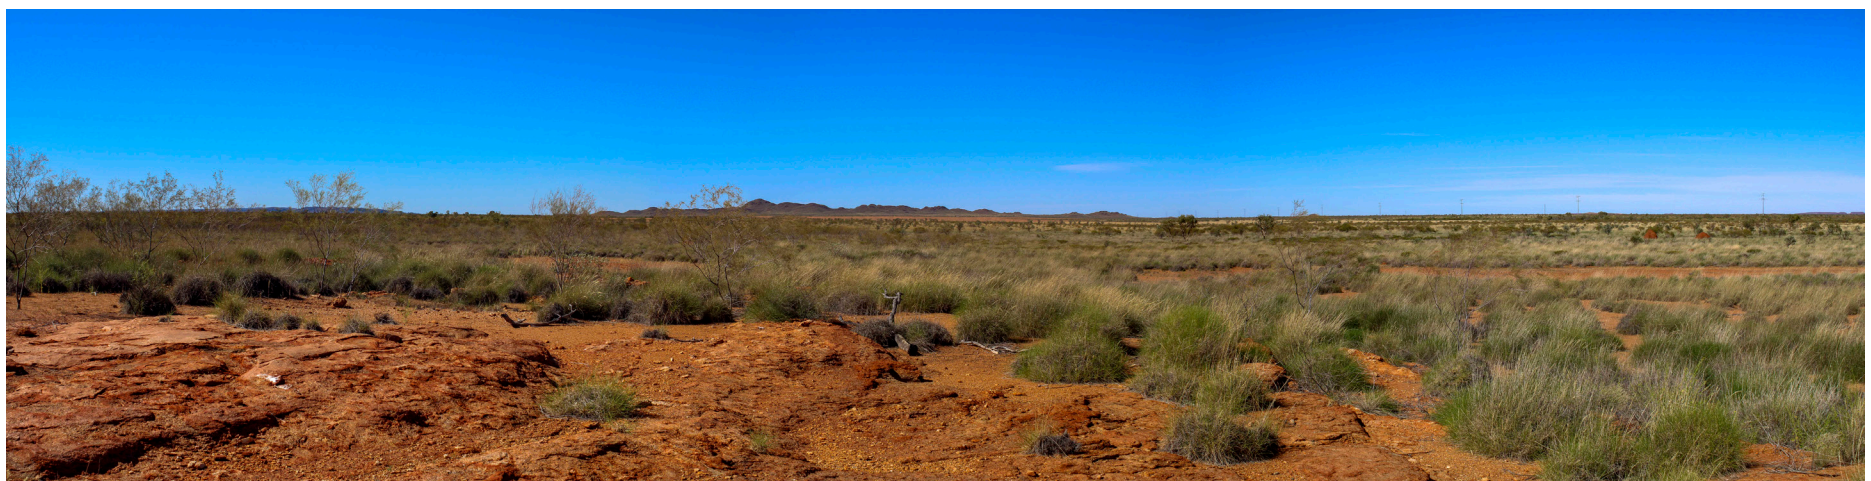
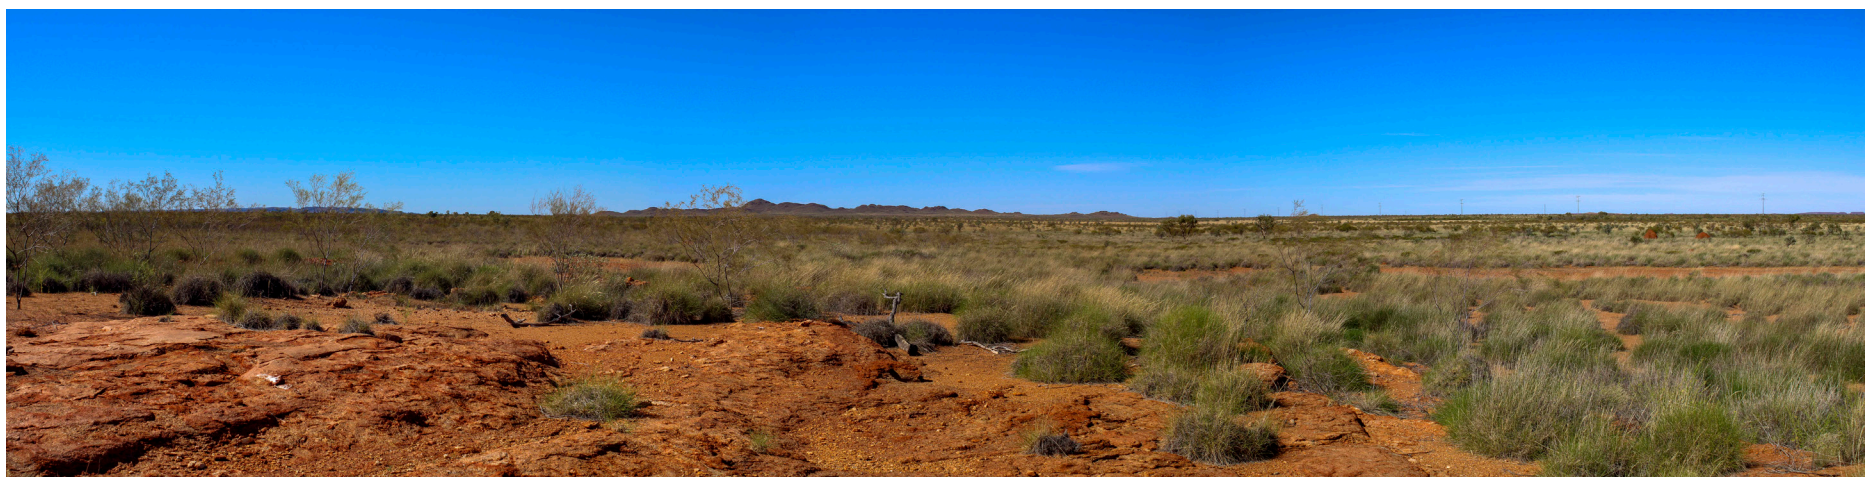
**Plate 32: VIA10 – Current view, looking south toward the northern area**

**Plate 33: VIA10 – Operational view, looking south toward the northern area**

**Plate 34: VIA10 – Closure view, looking south toward the northern area**

**Plate 35: VIA10 – Post-50 years view, looking south toward the northern area**

VIA10 captures a view 1.3 km north of the northern area. The current view from VIA10 is predominantly natural view, with modified elements in the background including a transmission line and mine. The predicted view remains a predominantly natural view, with modified elements including the northern area in the midground and a transmission line and mine in the background. Although the northern area is partly screened by vegetation, the solar panels are more apparent in the landscape than the existing modified elements resulting in a change in the character of the view from VIA10. The southern area will not be visible from VIA10. Immediately following closure of the northern area, an area of bare ground will be visible. Due to the bare ground present in the midground and foreground and the distance, the northern area blends with the surrounding natural landscape. Assuming revegetation of the northern area is successful, over time the view will return to one similar to that of the current view – one that is predominantly natural.

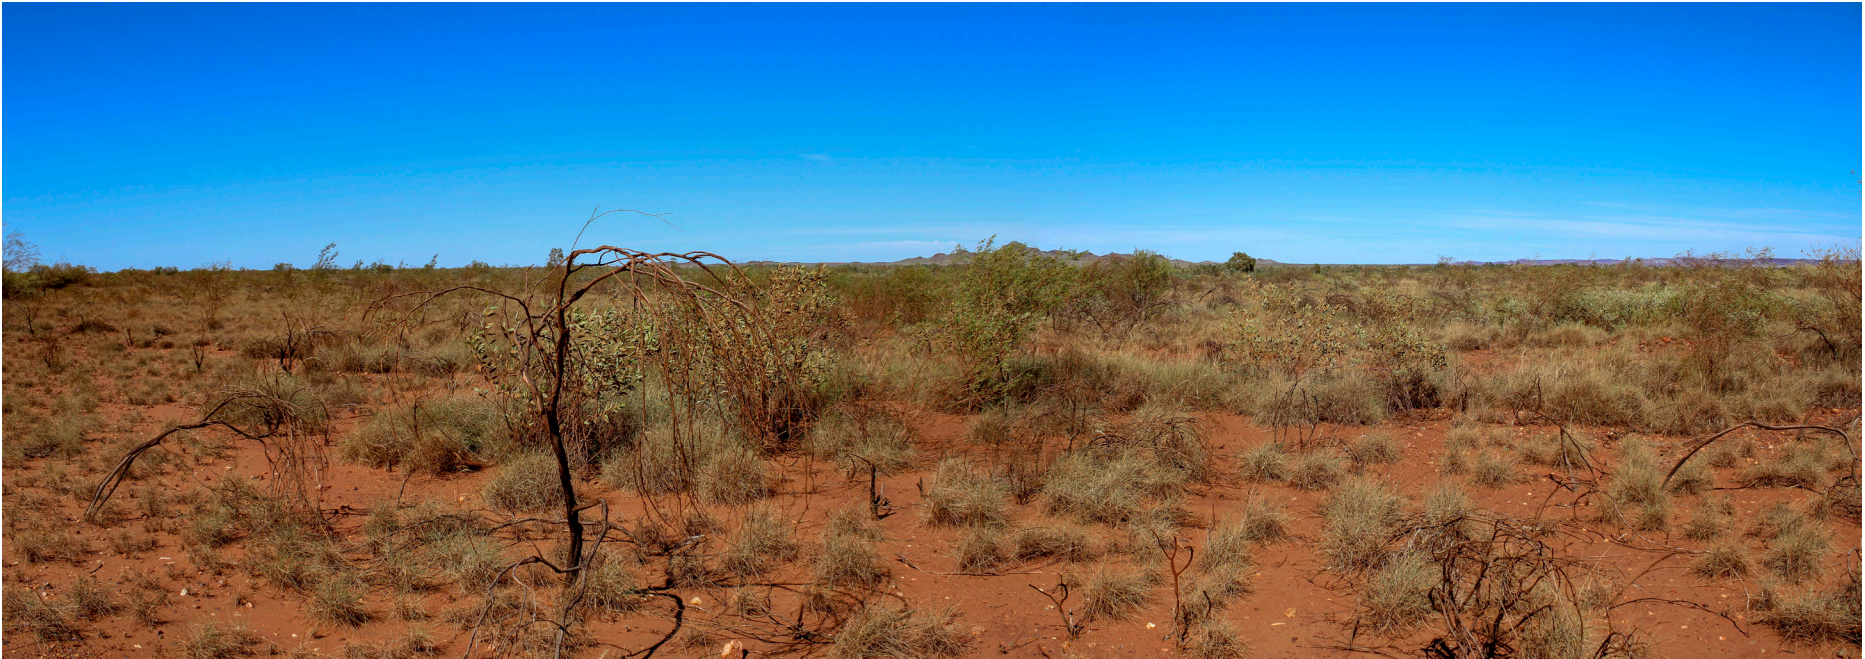
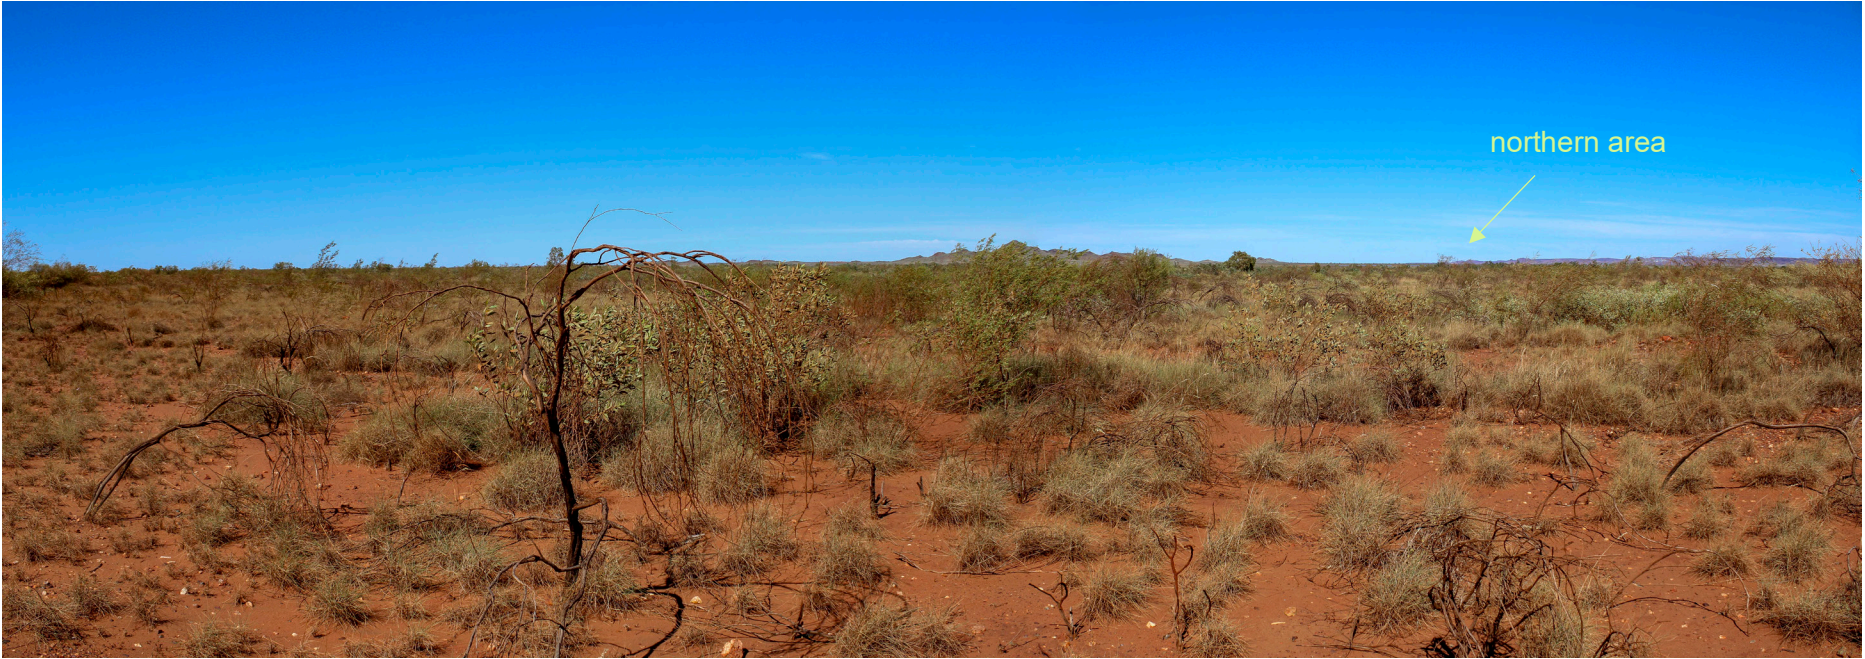
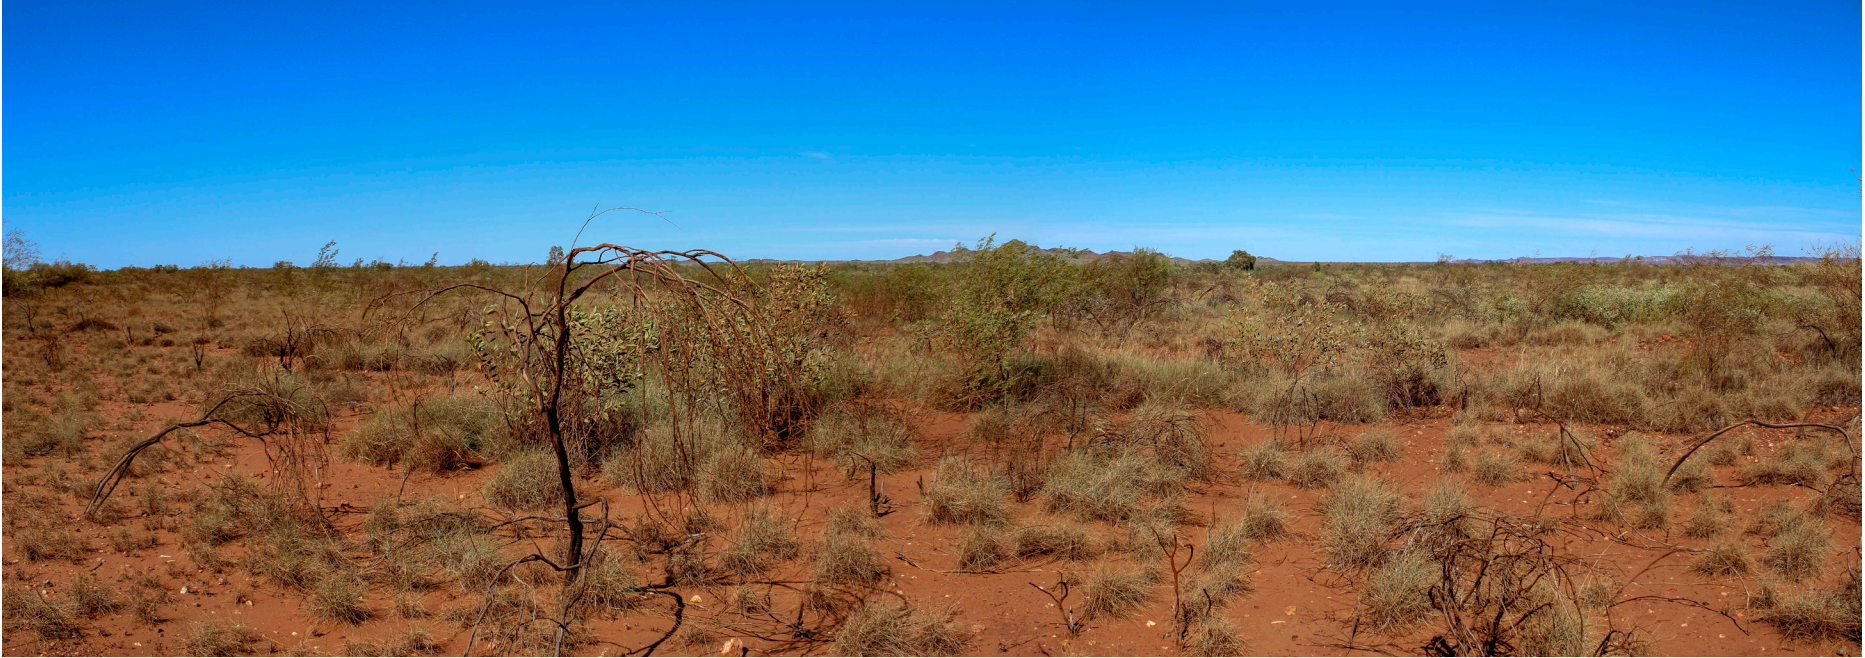
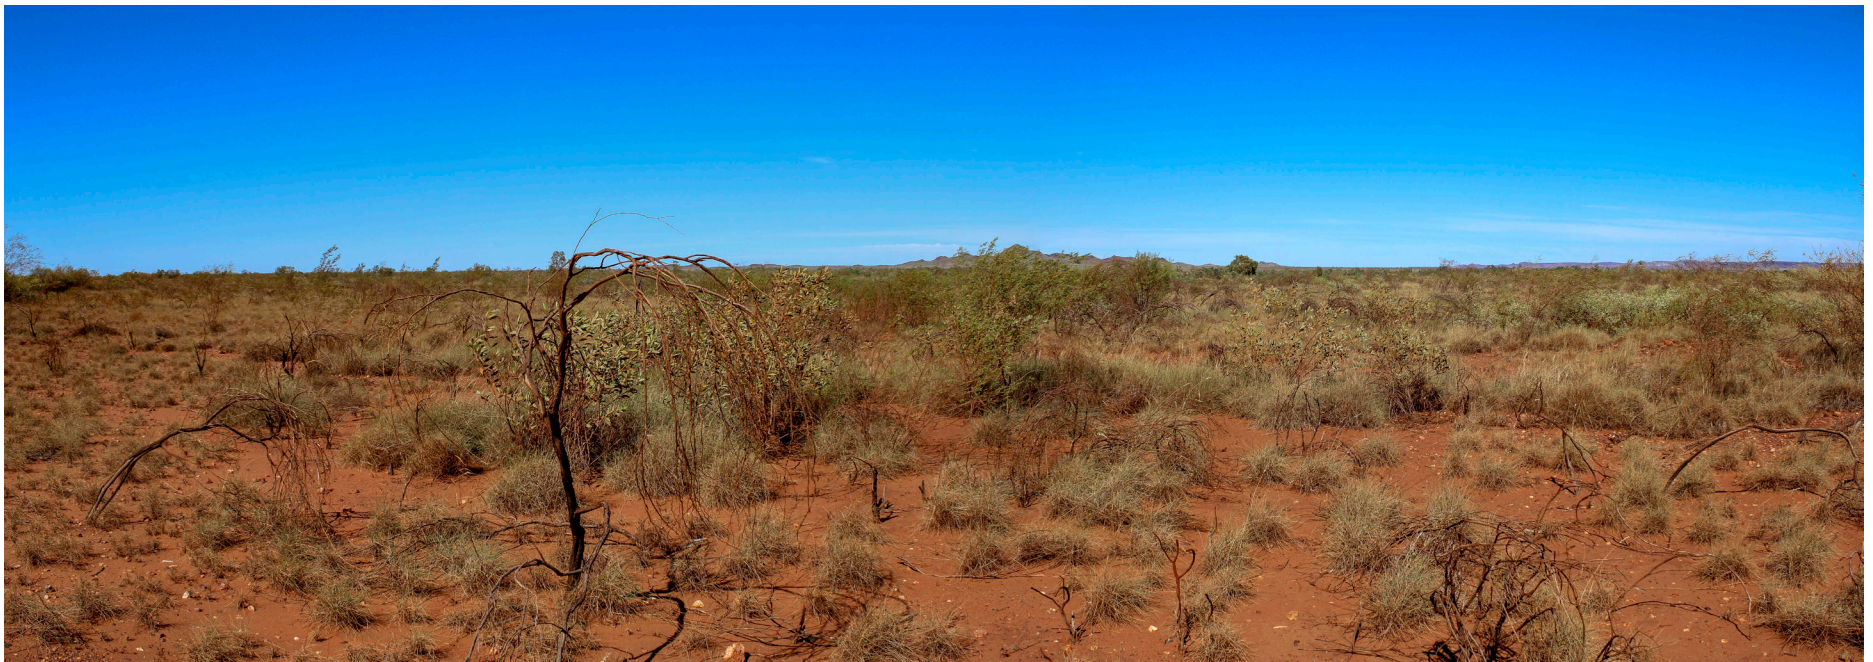
Plate 37: VIA11 – Current view, looking southwest toward the northern area

Plate 38: VIA11 – Operational view, looking southwest toward the northern area

**Plate 39: VIA11 – Closure view, looking southwest toward the northern area**

**Plate 40: VIA11 – Post-50 years view, looking southwest toward the northern area**

VIA11 captures a view 2.5 km northeast of the northern area. The current view from VIA11 is a predominantly natural view, with modified elements in the background including a transmission line and mine. The predicted view remains a predominantly natural view, with modified elements including the northern area, a transmission line and mine in the background. The northern area is predominantly screened by vegetation and due to the view distance are barely visible just below the horizon. Existing modified elements are more apparent than in the landscape than the northern area therefore there is no change in the existing character of the view from VIA11. The southern area will not be visible from VIA11. Immediately following closure of the northern area, an area of bare ground will be barely visible on the horizon, blending with the surrounding natural landscape. Assuming revegetation of the northern area is successful, over time the view will return to the current view – one that is predominantly natural.
