# Visual Impact Assessment

## Turner River Solar Hub

### Fortescue Ltd

10 January 2025

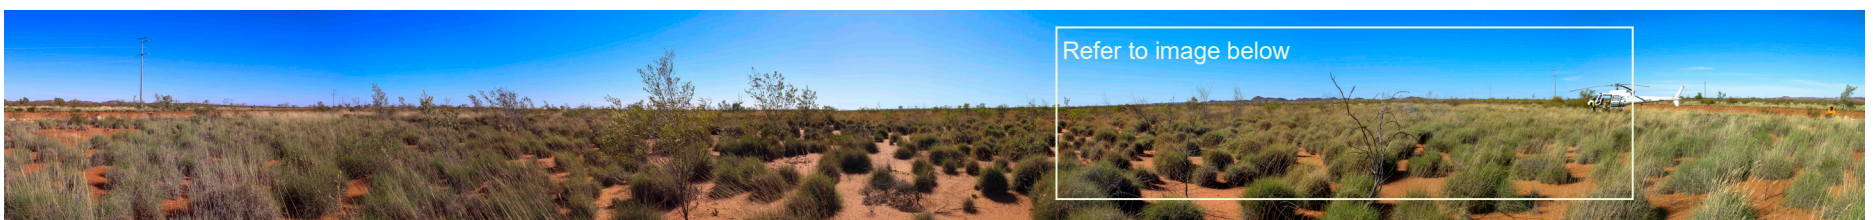
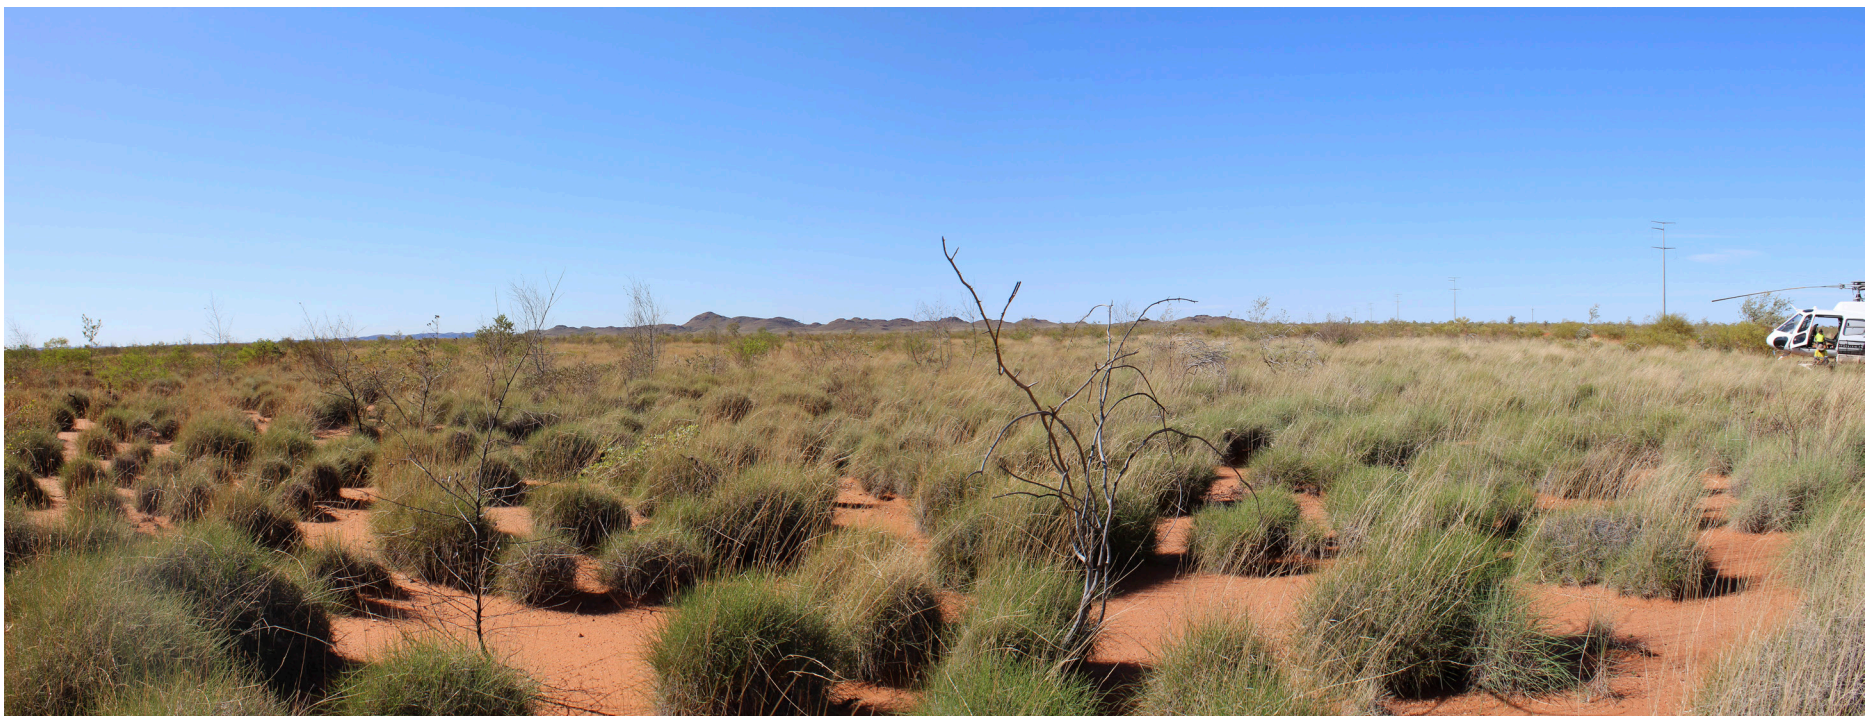
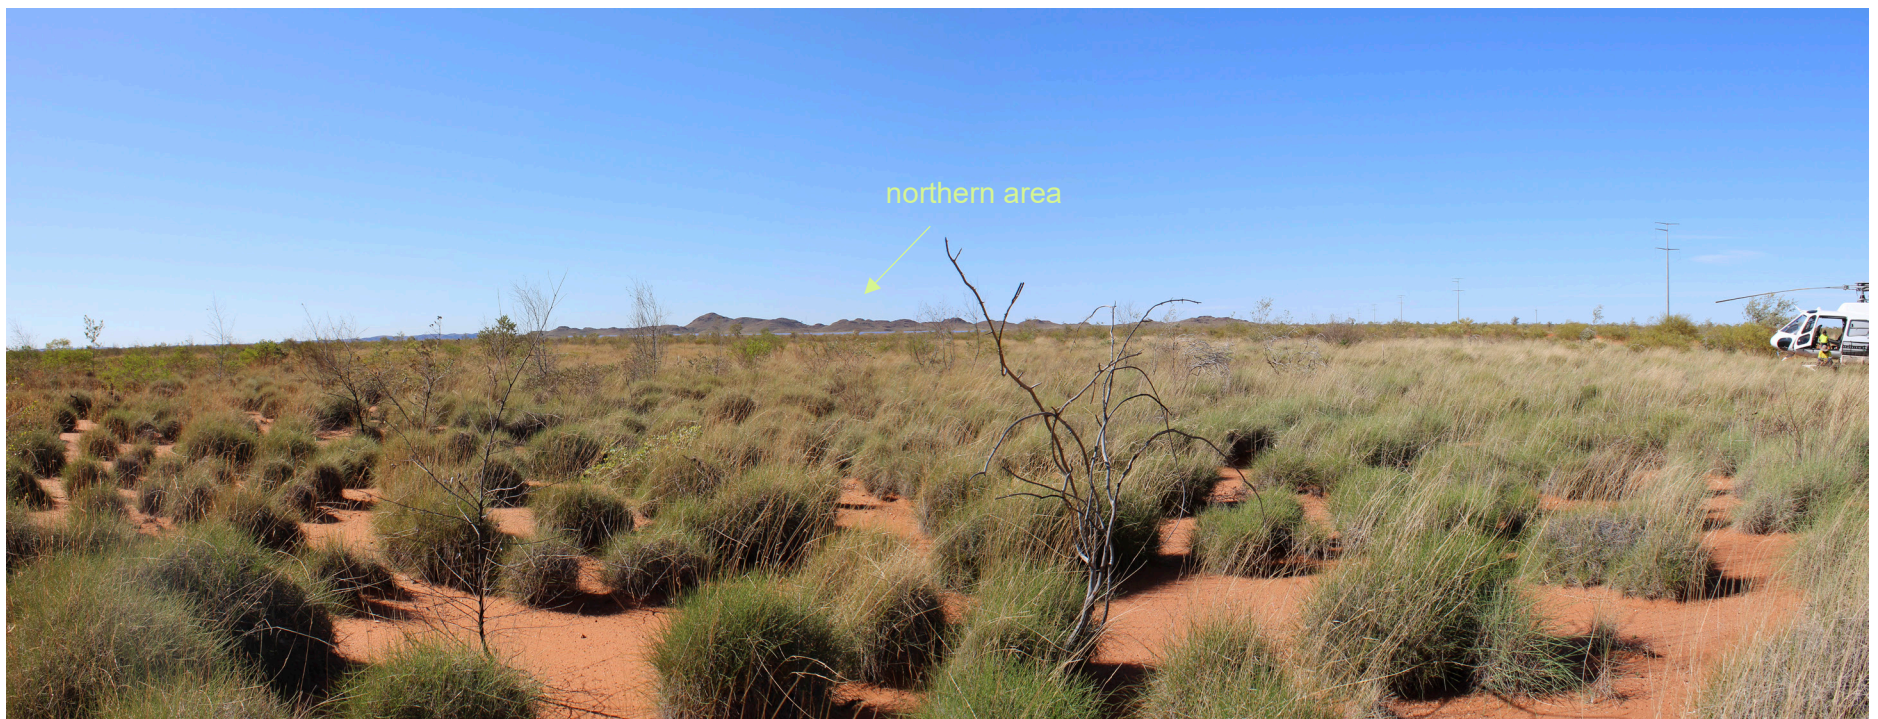
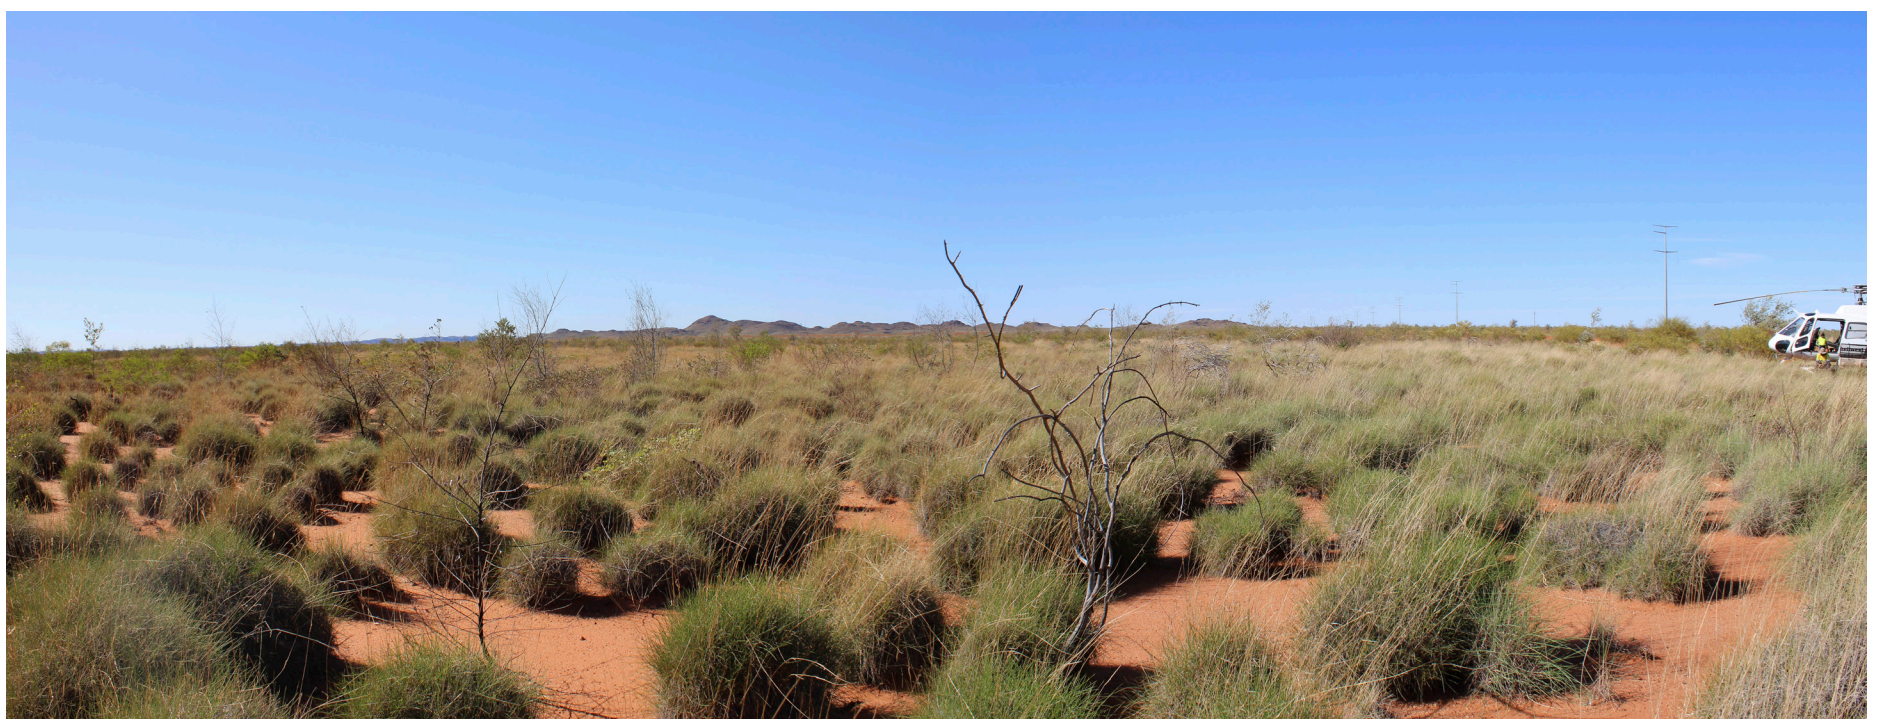
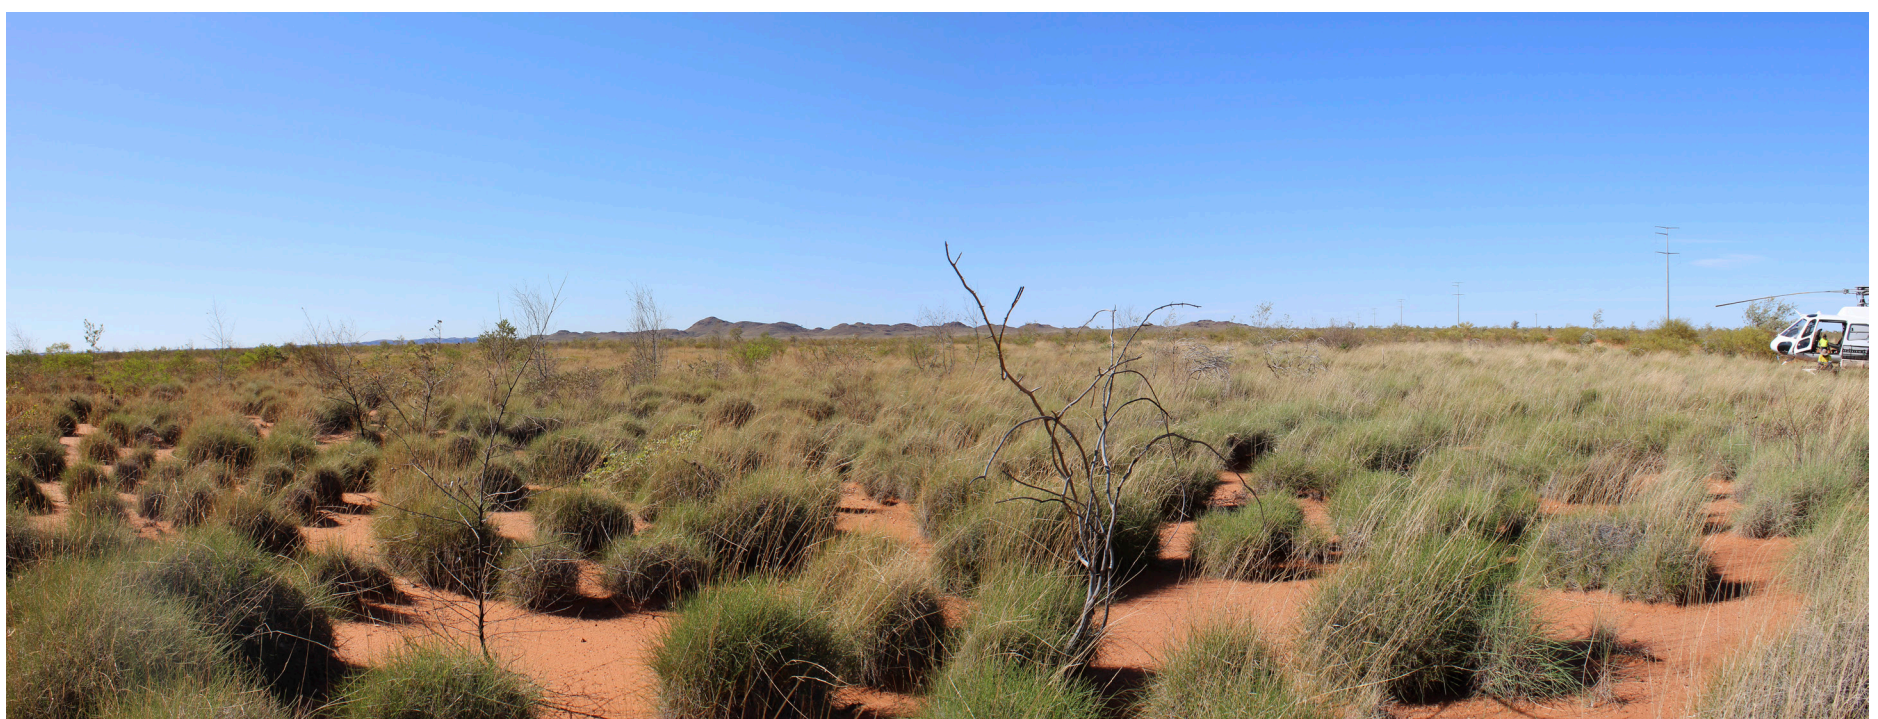
**Plate 41: VIA13 – Current view (360-degree)**

**Plate 42: VIA13 – Current view, looking southeast toward the northern area**

**Plate 43: VIA13 – Operational view, looking southeast toward the northern area**

**Plate 44: VIA13 – Closure view, looking southeast toward the northern area**

**Plate 45: VIA13 – Post-50 years view, looking southeast toward the northern area**

VIA13 captures a view 0.2 km west of the northern area and 1.5 km northwest from the main area of infrastructure. The current view from VIA13 is a predominantly natural view, with modified elements in the background including a transmission line. The predicted view remains a predominantly natural view, with modified elements including the northern area and a transmission line in the background. The northern area is partly screened by vegetation. Existing modified elements are more apparent in the landscape than the Wodgina area and although the northern area increases the modified characteristics of the view it does not significantly change the existing character, remaining a predominantly natural view from VIA13. The southern area will not be visible from VIA13. Immediately following closure of the northern area, an area of bare ground may be visible in the background, blending with the surrounding natural landscape. Assuming revegetation of the northern area is successful, over time the view will return to the current view – one that is predominantly natural.

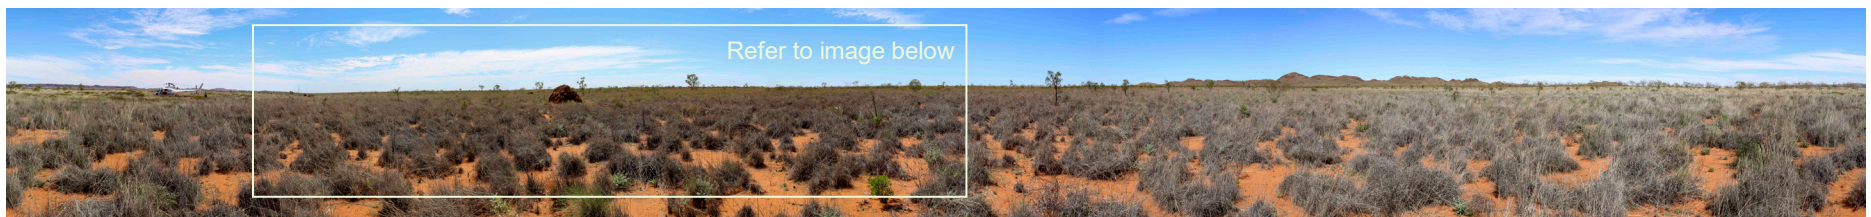
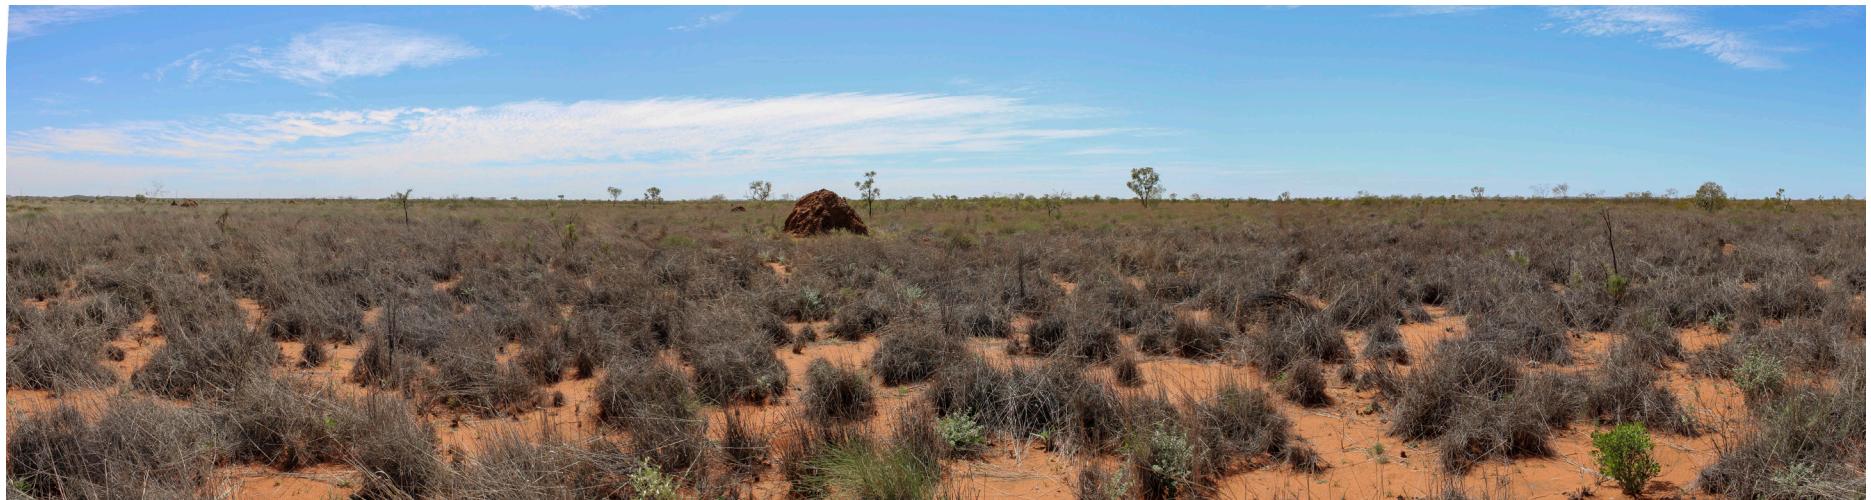
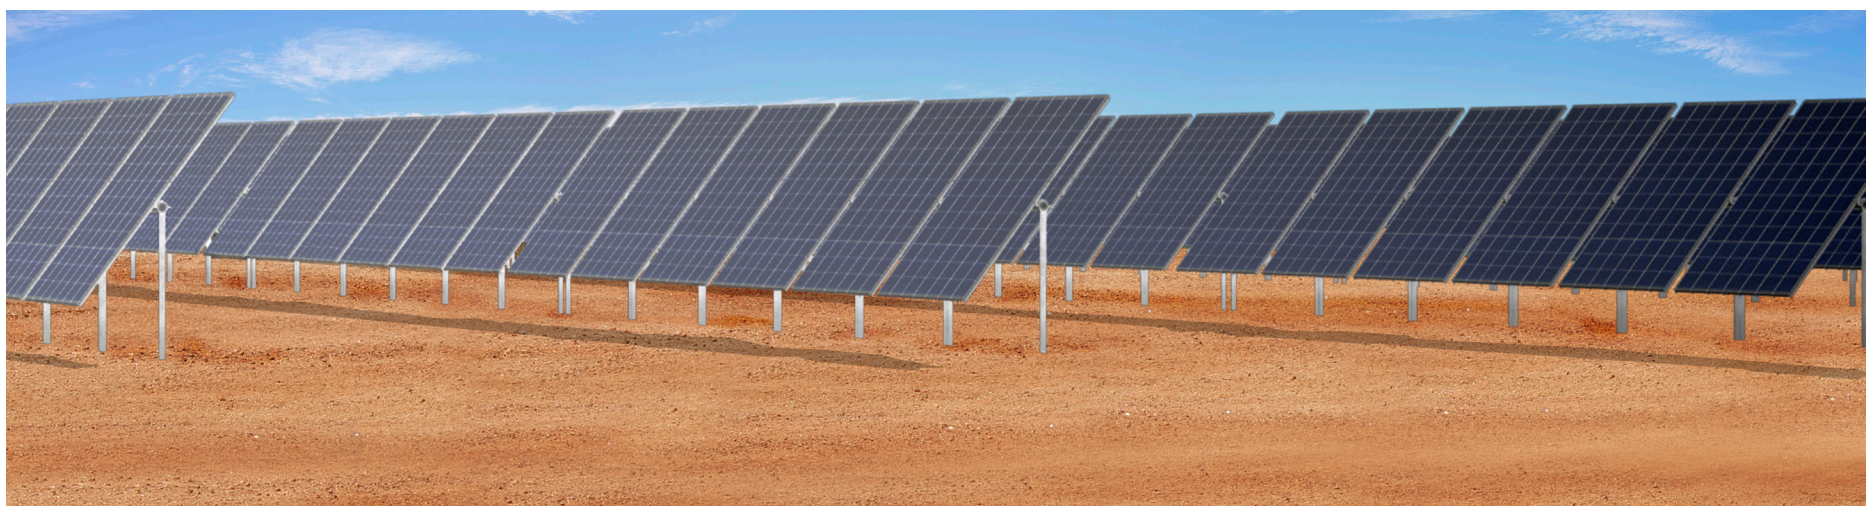
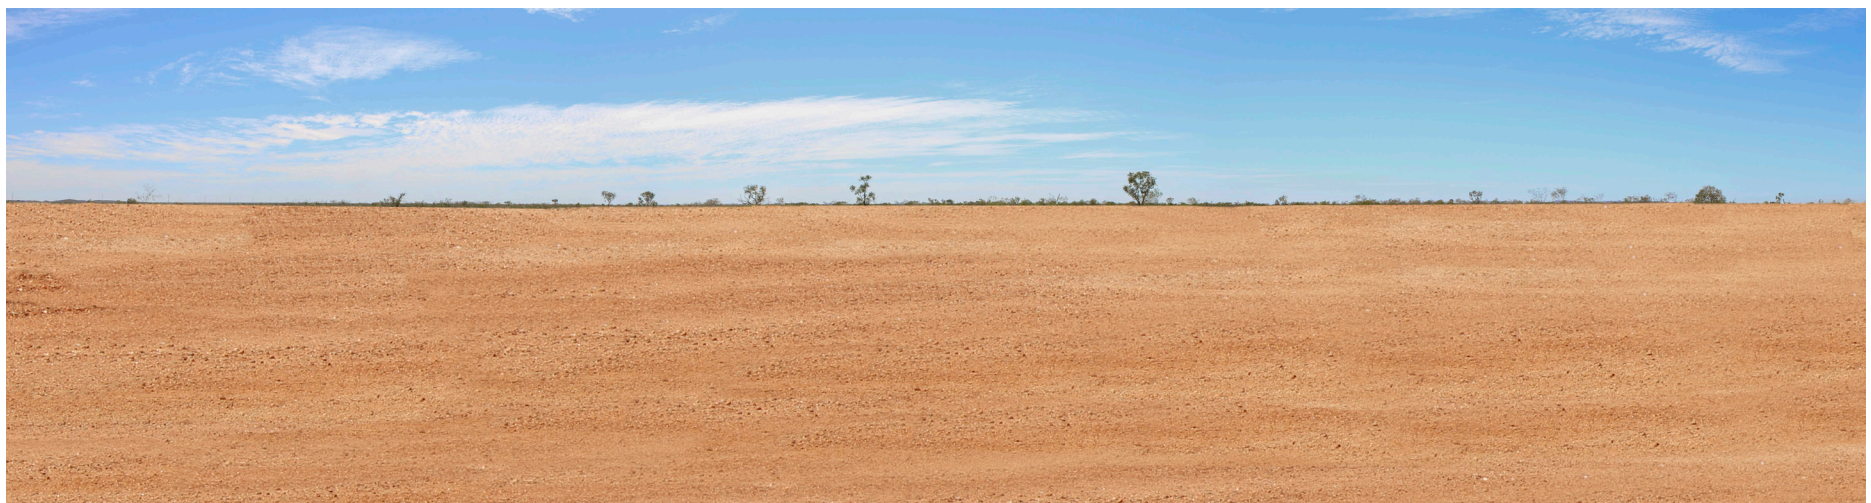
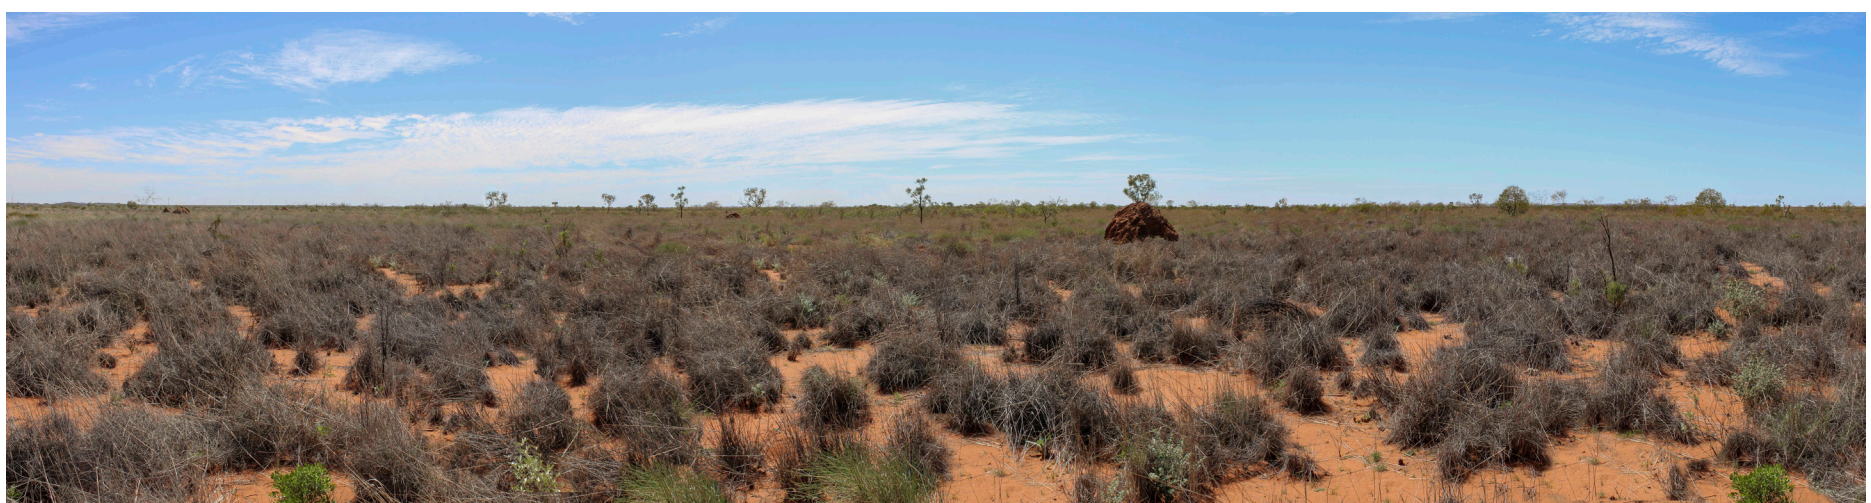
**Plate 46: VIA14 – Current view (360-degree)**

**Plate 47: VIA14 – Current view, looking north toward the northern area**

**Plate 48: VIA14 – Operational view, looking north toward the northern area**

**Plate 49: VIA14 – Closure view, looking north toward the northern area**

**Plate 50: VIA14 – Post-50 years view, looking north toward the northern area**

VIA14 captures a view within the northern area. The current view from VIA14 is predominantly natural view, with modified elements in the background including a transmission line. The predicted view is a highly modified view of cleared bare ground and the solar arrays. Due to the viewpoint's location within the northern area, the northern area is highly visible from VIA14 and the change in view is stark. The southern area will not be visible from VIA14. Immediately following closure of the northern area, a large area of bare ground will be visible. Assuming revegetation of the northern area is successful, over time the view will return to one similar to that of the current view – one that is predominantly natural.

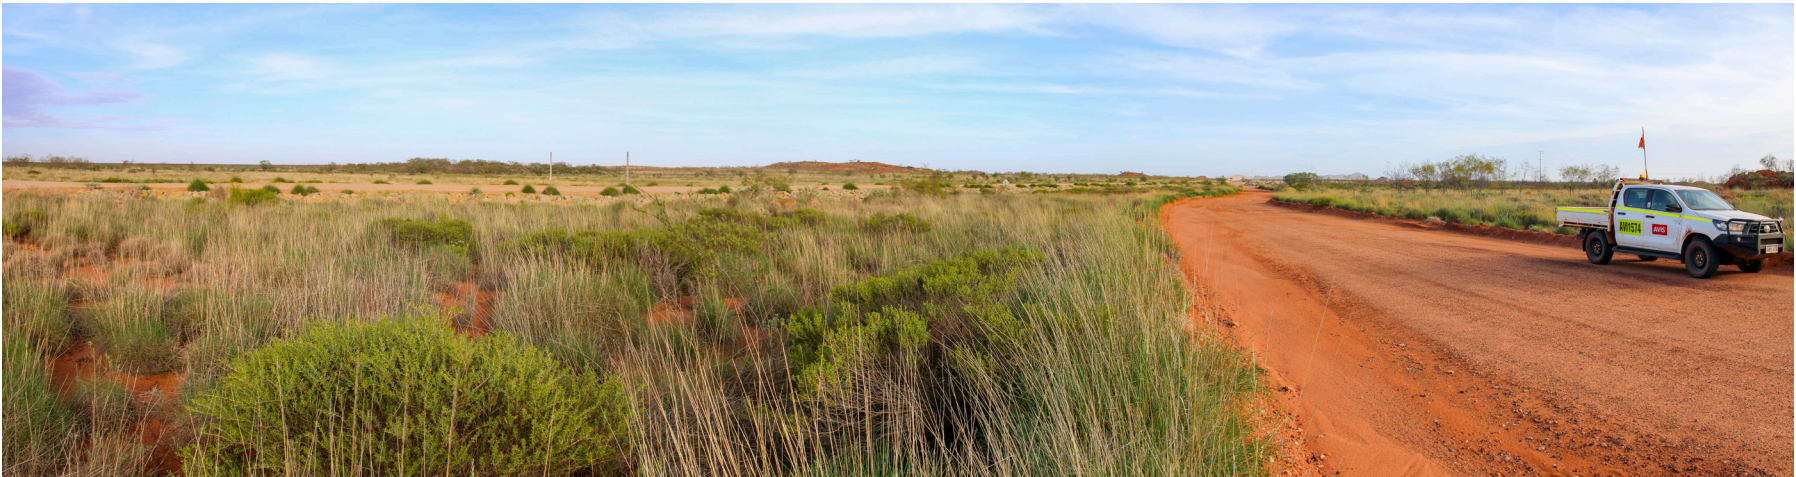
Plate 2: VIA1 – Current and predicted view, looking northwest toward the southern area

VIA1 captures a view from the Junction Camp Access Road, 2.6 km southeast from the southern area. Junction Camp Access Road is an unsealed private road that runs generally to the east and parallel to Great Northern Highway and provides access to Fortescue’s North Star Project. The current view from VIA1 is partly a natural view and partly a modified view, with modified elements including two access roads, a camp and a transmission line. Neither the southern area nor the northern area is expected to be visible from VIA1 due to the view distance and the screening from topography and vegetation.

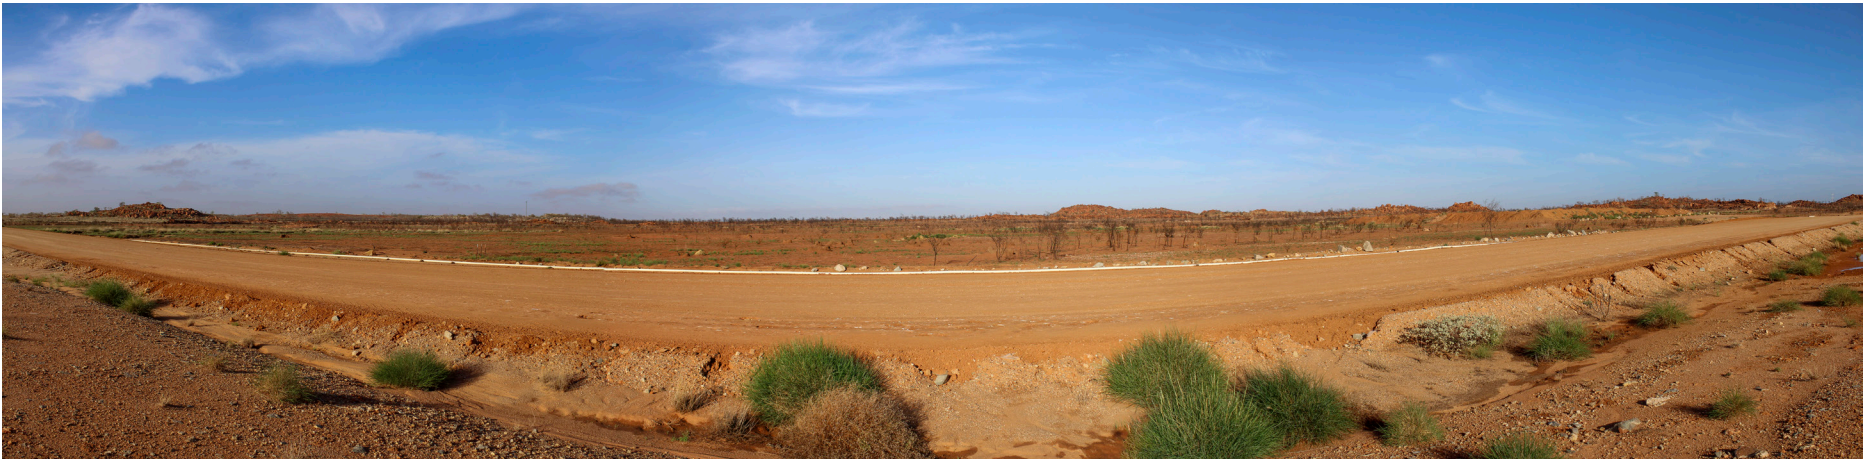
Plate 4: VIA2 – Current and predicted view, looking west toward the southern area

VIA2 captures a view from the Junction Camp Access Road, 2.6 km southeast from the southern area. Junction Camp Access Road is an unsealed private road that runs generally to the east and parallel to Great Northern Highway and provides access to Fortescue’s North Star Project. The current view from VIA2 is partly a natural view and partly a modified view, with modified elements including two access roads, a camp and a transmission line. Neither the southern area nor the northern area is expected to be visible from VIA2 due to the view distance and the screening from topography and vegetation.

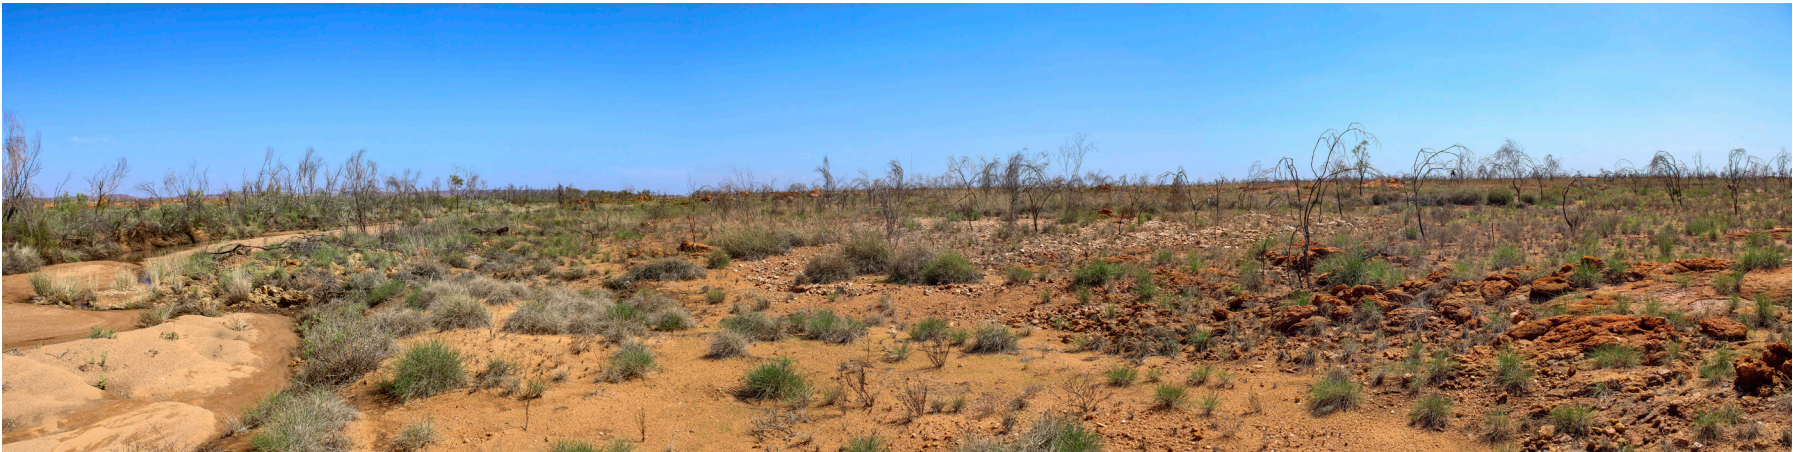
Plate 6: VIA3 – Current and predicted view, looking north toward the southern area

VIA3 captures a view from a creek, 0.7 km south from the southern area. The view from VIA3 is a natural view. The southern area is expected to be largely not visible from VIA3 due to the screening effects of topography and vegetation, distant glimpses of the southern area may occur in gaps in the rocky outcrops and vegetation. The northern area will not be visible from VIA3.

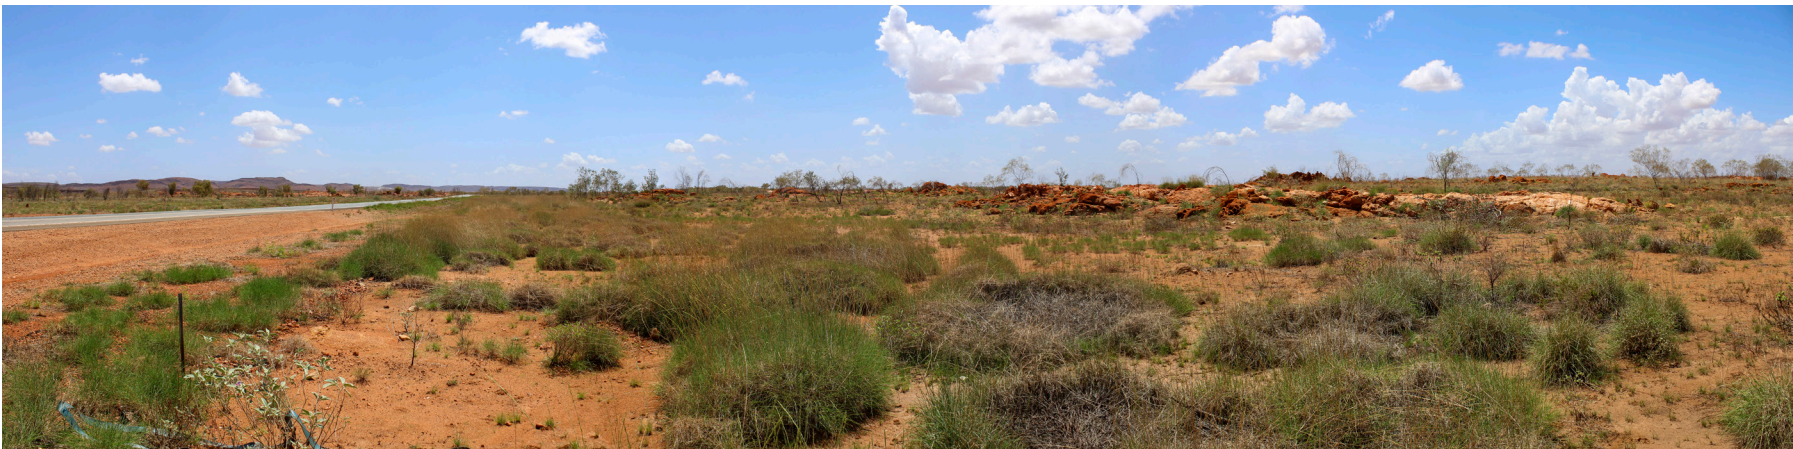
Plate 7: VIA4 – Current and predicted view, looking northeast toward the southern area

VIA4 captures a view from the Great Northern Highway, 6.8 km southwest from the southern area. The view from VIA4 is partly a natural view and partly a modified view, with modified elements including the highway. Neither the southern area nor the northern area is expected to be visible from VIA4 due to the view distance.

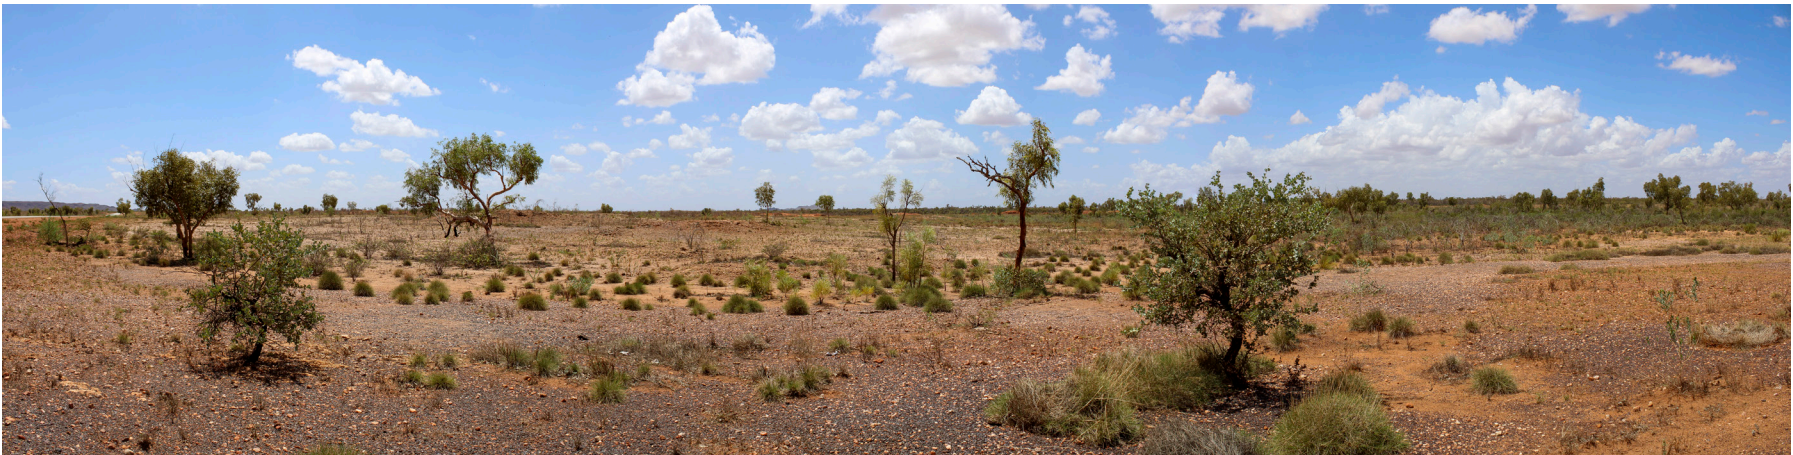
Plate 8: VIA5 – Current and predicted view, looking northeast toward the southern area

VIA5 captures a view from the Great Northern Highway, 3.0 km southwest from the southern area. The view from VIA5 is predominantly a natural view with modified elements including the highway. Neither the southern area nor the northern area is expected to be visible from VIA5 due to the view distance and the screening from topography and vegetation.

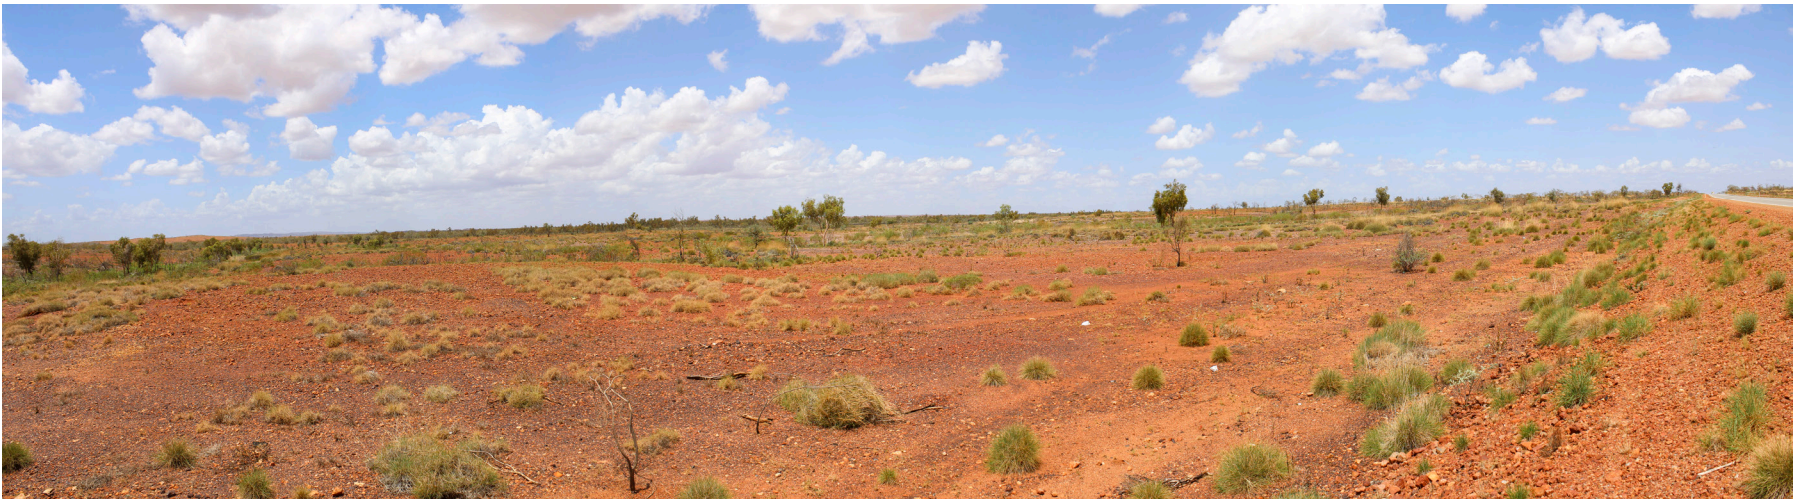
**Plate 9: VIA6 – Current and predicted view, looking southeast toward the southern area**

VIA6 captures a view from the Great Northern Highway, 1.8 km northwest from the southern area. The view from VIA6 is predominantly a natural view with modified elements including the highway. Neither the southern area nor the northern area is expected to be visible from VIA6 due to the view distance and the screening from topography and vegetation.

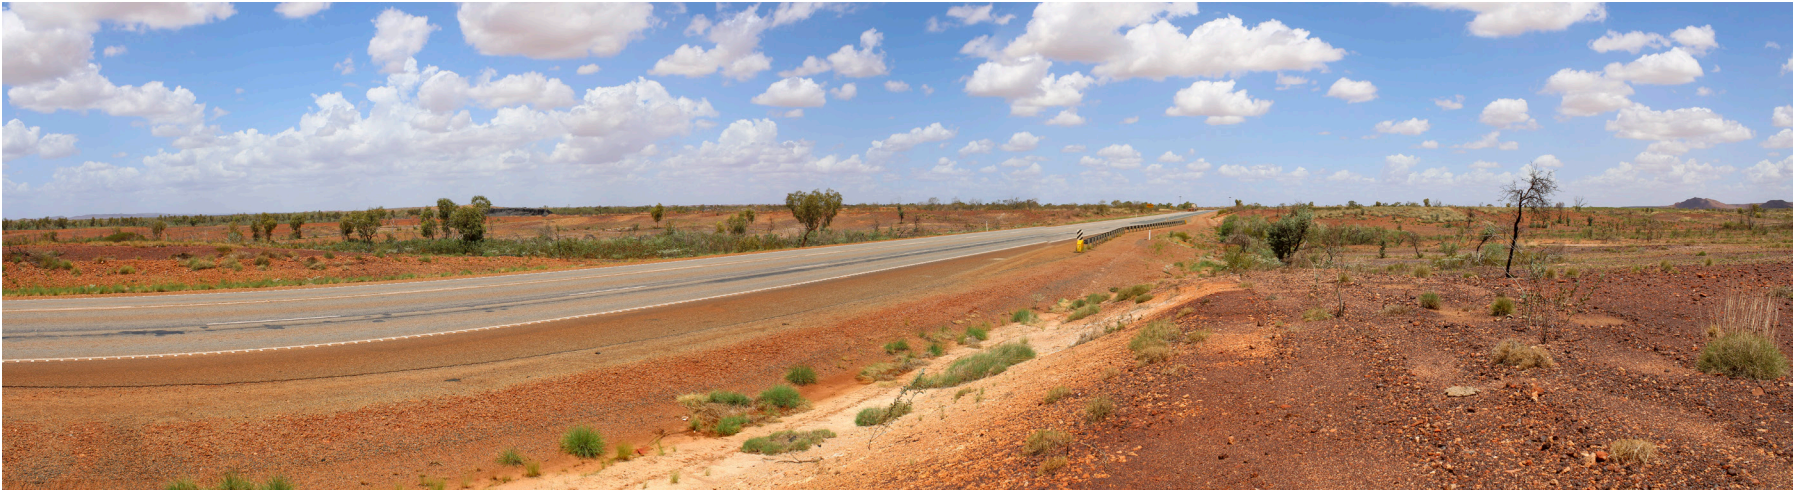
**Plate 10: VIA7 – Current and predicted view, looking southeast toward the southern area**

VIA7 captures a view from the Great Northern Highway, 2.4 km northwest from the southern area. The current view from VIA7 is partly a natural view and partly a modified view, with modified elements including a highway and soil stockpile. Neither the southern area nor the northern area is expected to be visible from VIA7 due to the view distance and the screening from topography and vegetation.

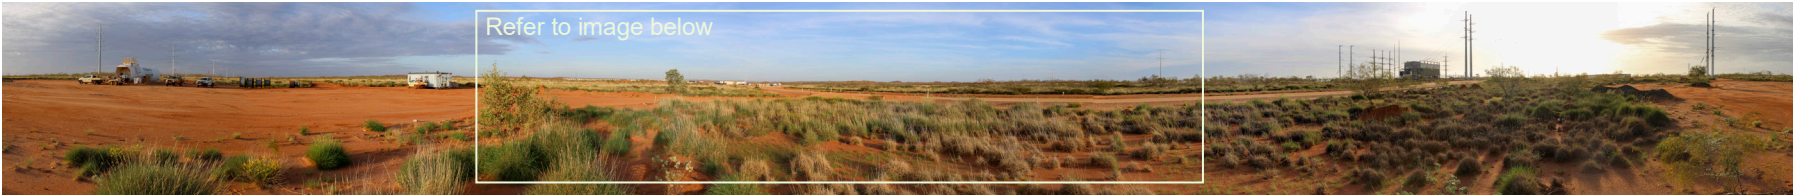
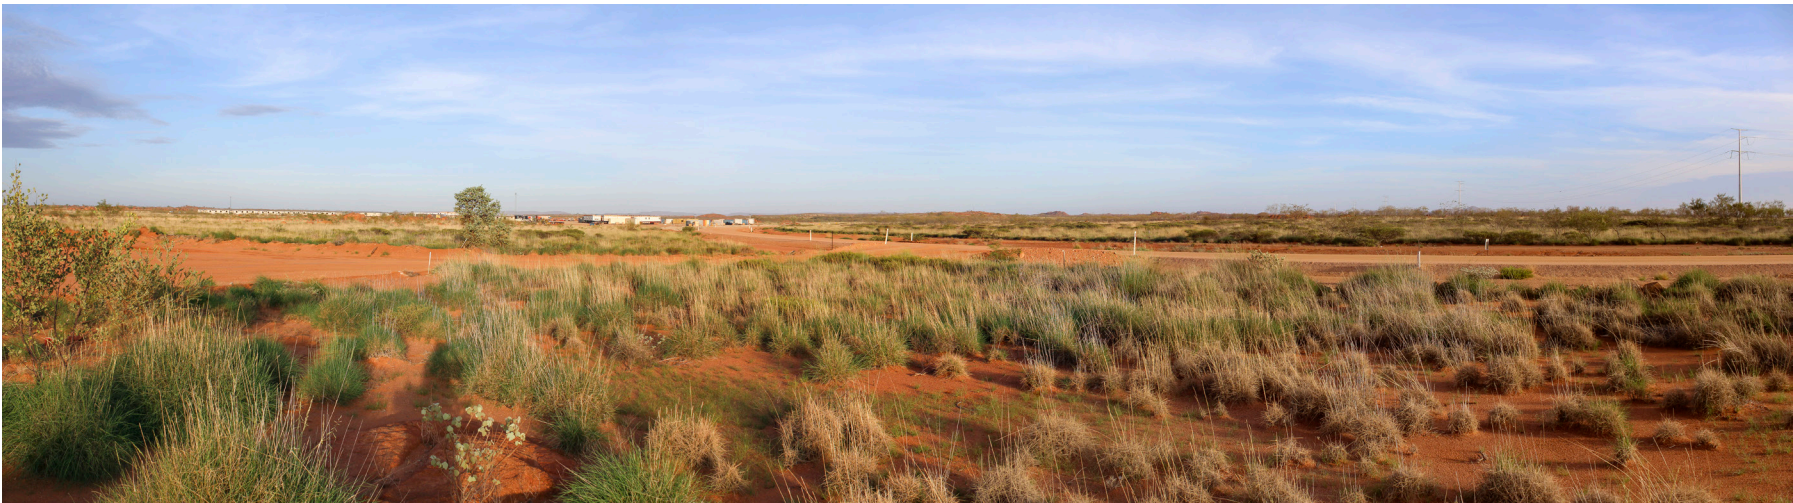
**Plate 12: VIA9 – Current and predicted view, looking northwest toward the southern area**

VIA9 captures a view from the Junction Camp Access Road, 3.8 km southeast from the southern area. Junction Camp Access Road is an unsealed private road that runs generally to the east and parallel to Great Northern Highway and provides access to Fortescue’s North Star Project. The view from VIA9 is partly a natural view and partly a modified view, with modified elements including an access road, camp, transmission line, substation and refuelling station. Neither the southern area nor the northern area is expected to be visible from VIA9 due to the view distance and the screening from topography and vegetation.

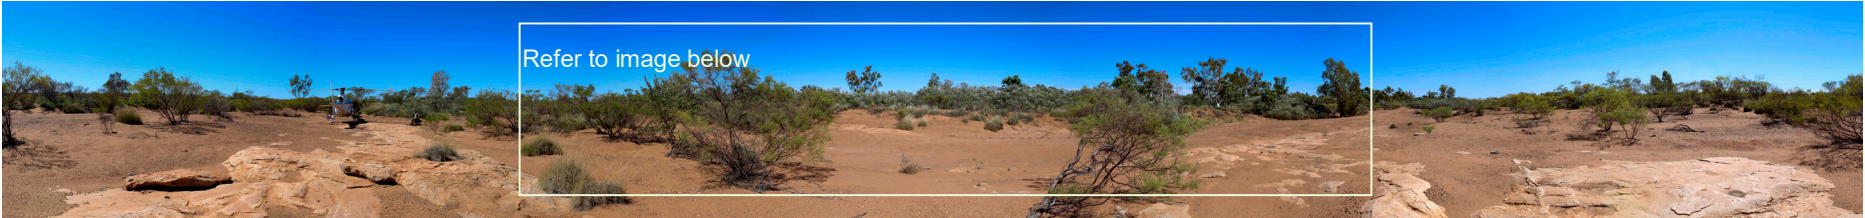
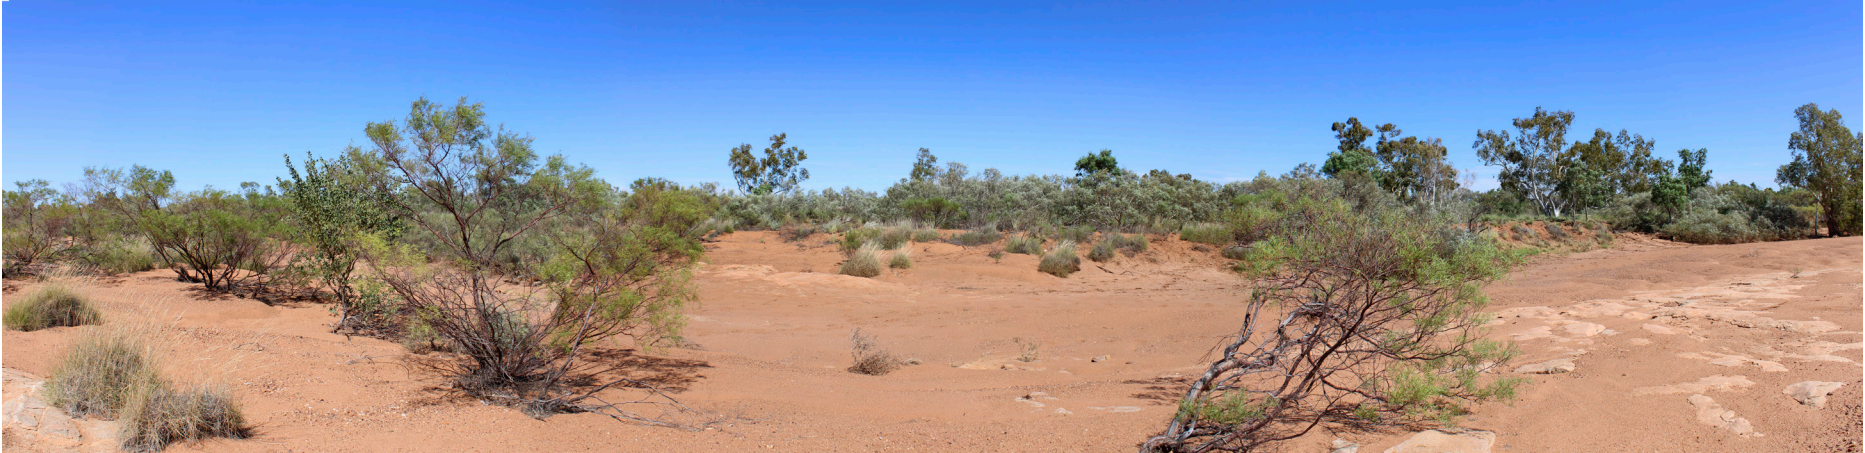
**Plate 18: VIA12 – Current and predicted view, looking southwest toward the northern area**

VIA12 captures a view from the Turner River, 2 km northeast from the northern area. The view from VIA12 is a natural view. Neither the southern area nor the northern area is expected to be visible from VIA12 due to the screening effects of topography and vegetation.

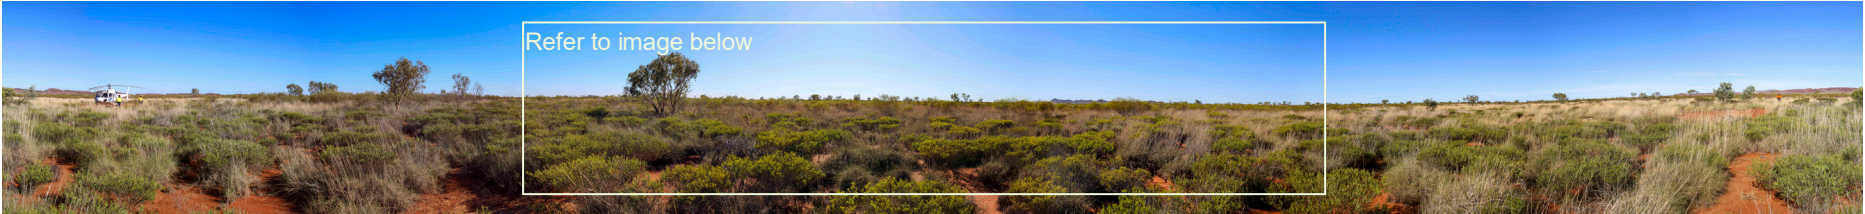
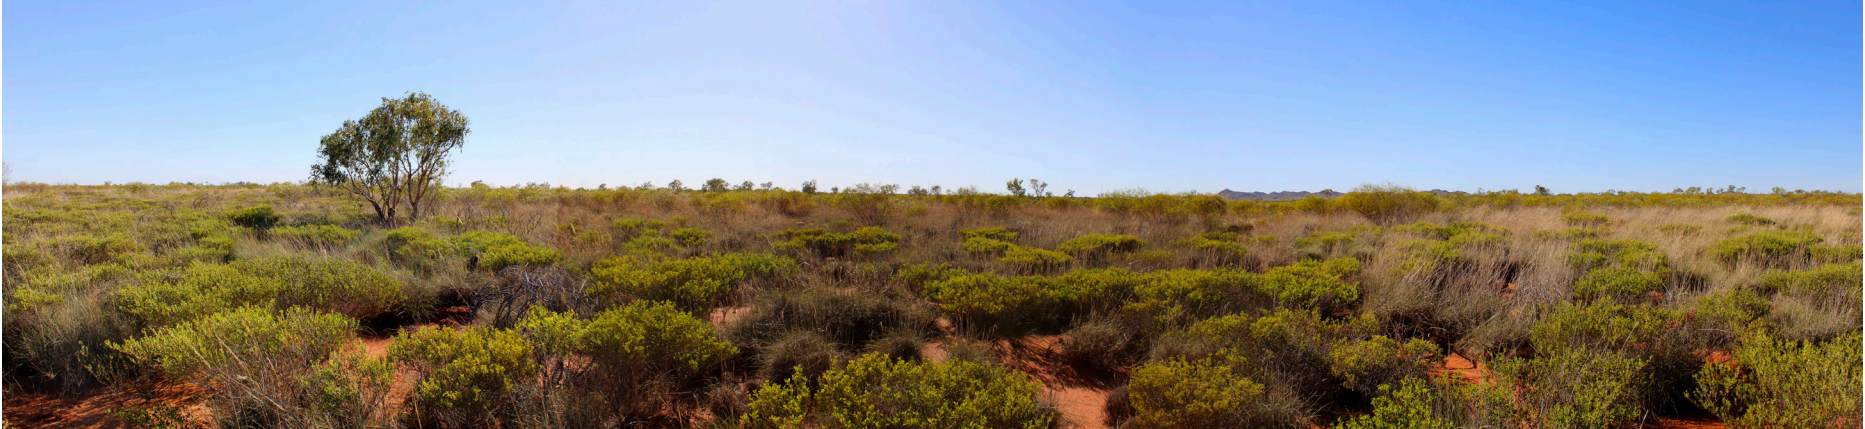
**Plate 18: VIA15 – Current and predicted view, looking east toward the northern area**

VIA15 captures a view 2.7 km west from the northern area. The view from VIA15 is a predominantly natural view with a transmission line partly visible in the background. Neither the southern area nor the northern area is expected to be visible from VIA15 due to the screening effects of topography and vegetation.

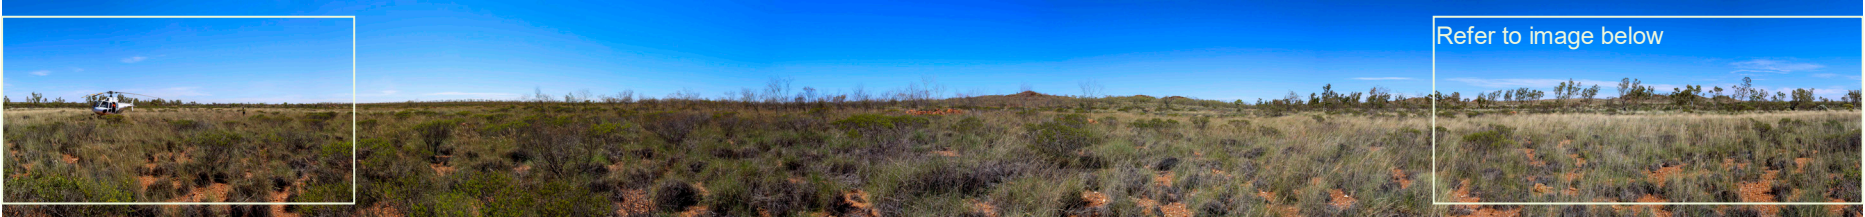
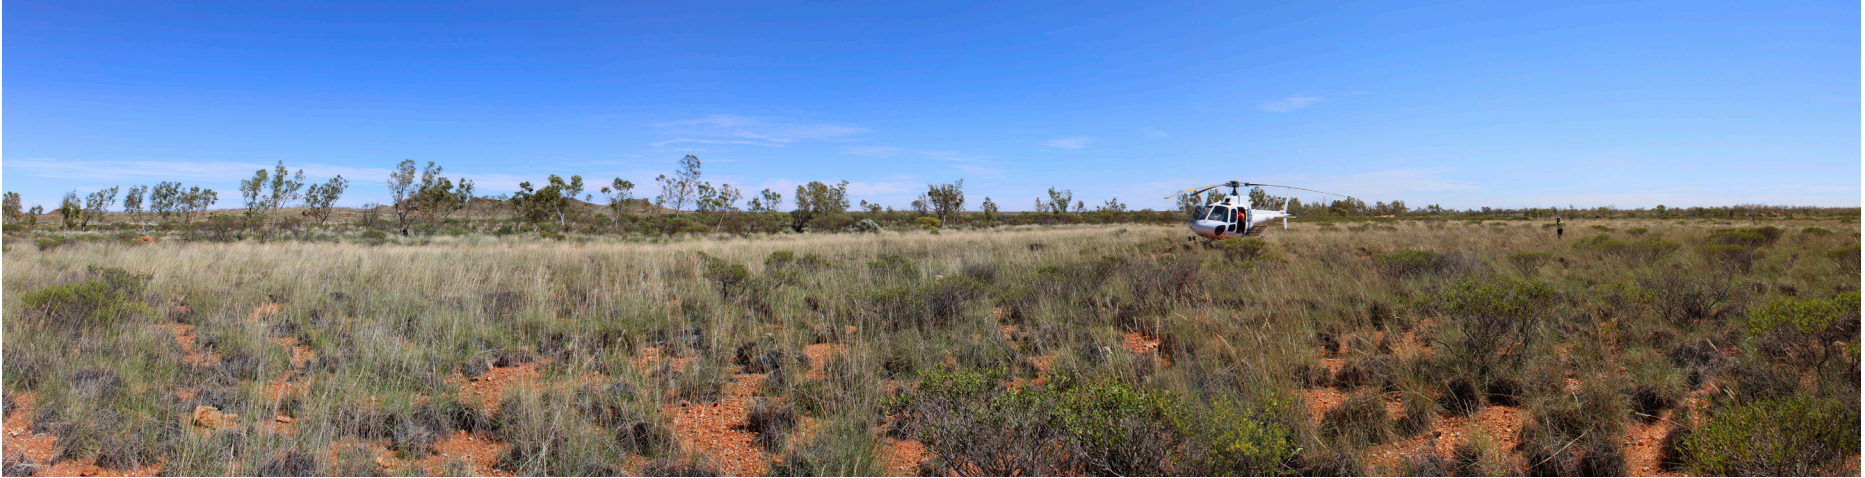
**Plate 18: VIA16 – Current and predicted view, looking northwest toward the northern area**

VIA16 captures a view 2.5 km east from the northern area. The view from VIA16 is a natural view. Neither the southern area nor the northern area is expected to be visible from VIA16 due to the screening effects of topography and vegetation.
