# Visual Impact Assessment

## Turner River Solar Hub

### Fortescue Ltd

10 January 2025

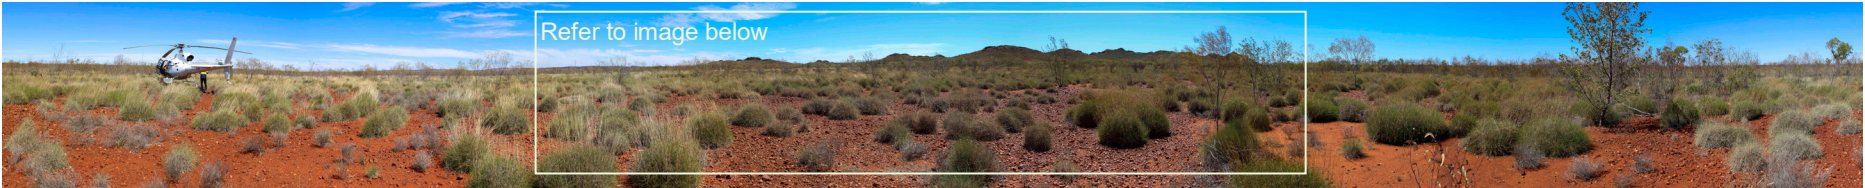
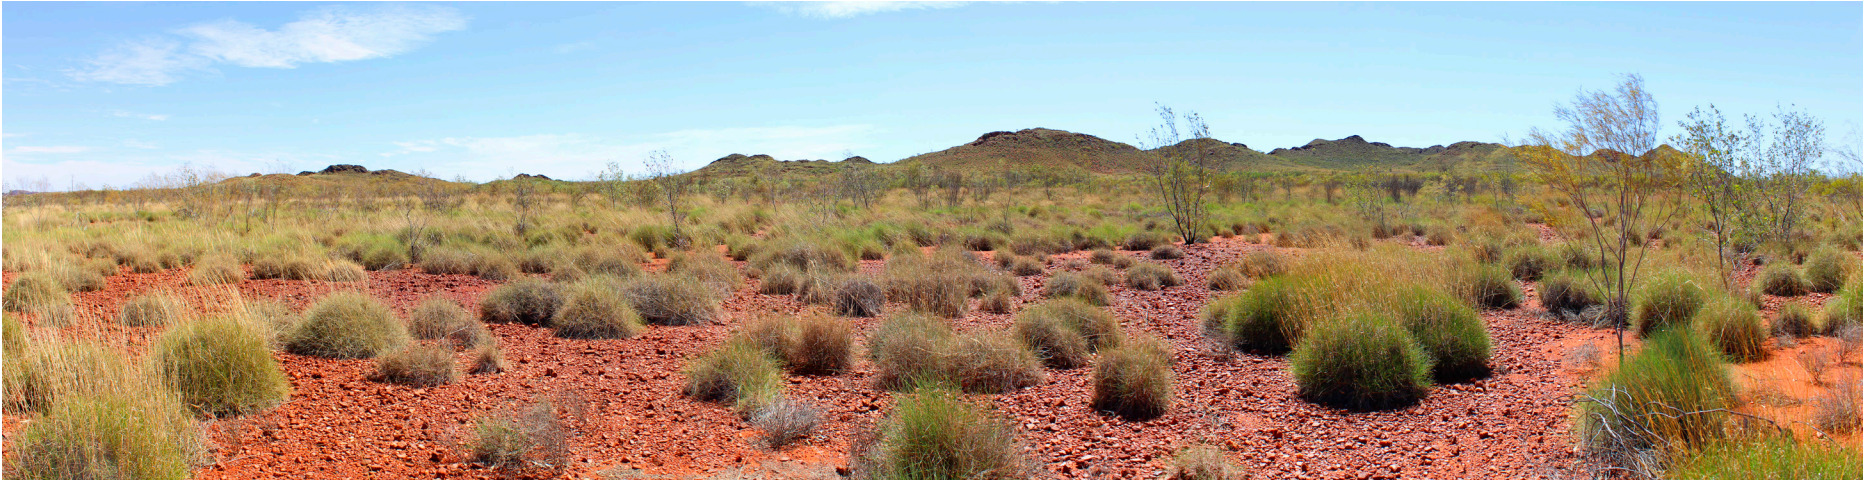
**Plate 17: VIA17 – Current and predicted view (360-degree)**

**Plate 18: VIA17 – Current and predicted view, looking north toward the northern area**

VIA17 captures a view 2 km south from the northern area. The view from VIA17 is a predominantly natural view, with a transmission line partly visible in the background. Neither the southern area nor the northern area is expected to be visible from VIA17 due to the screening effects of topography.
