**PTA 250302 Swan River Ferry Expansion Project – Perth to Applecross
Coastal Engineering Support – Preliminary Coastal Process Impact Assessment**

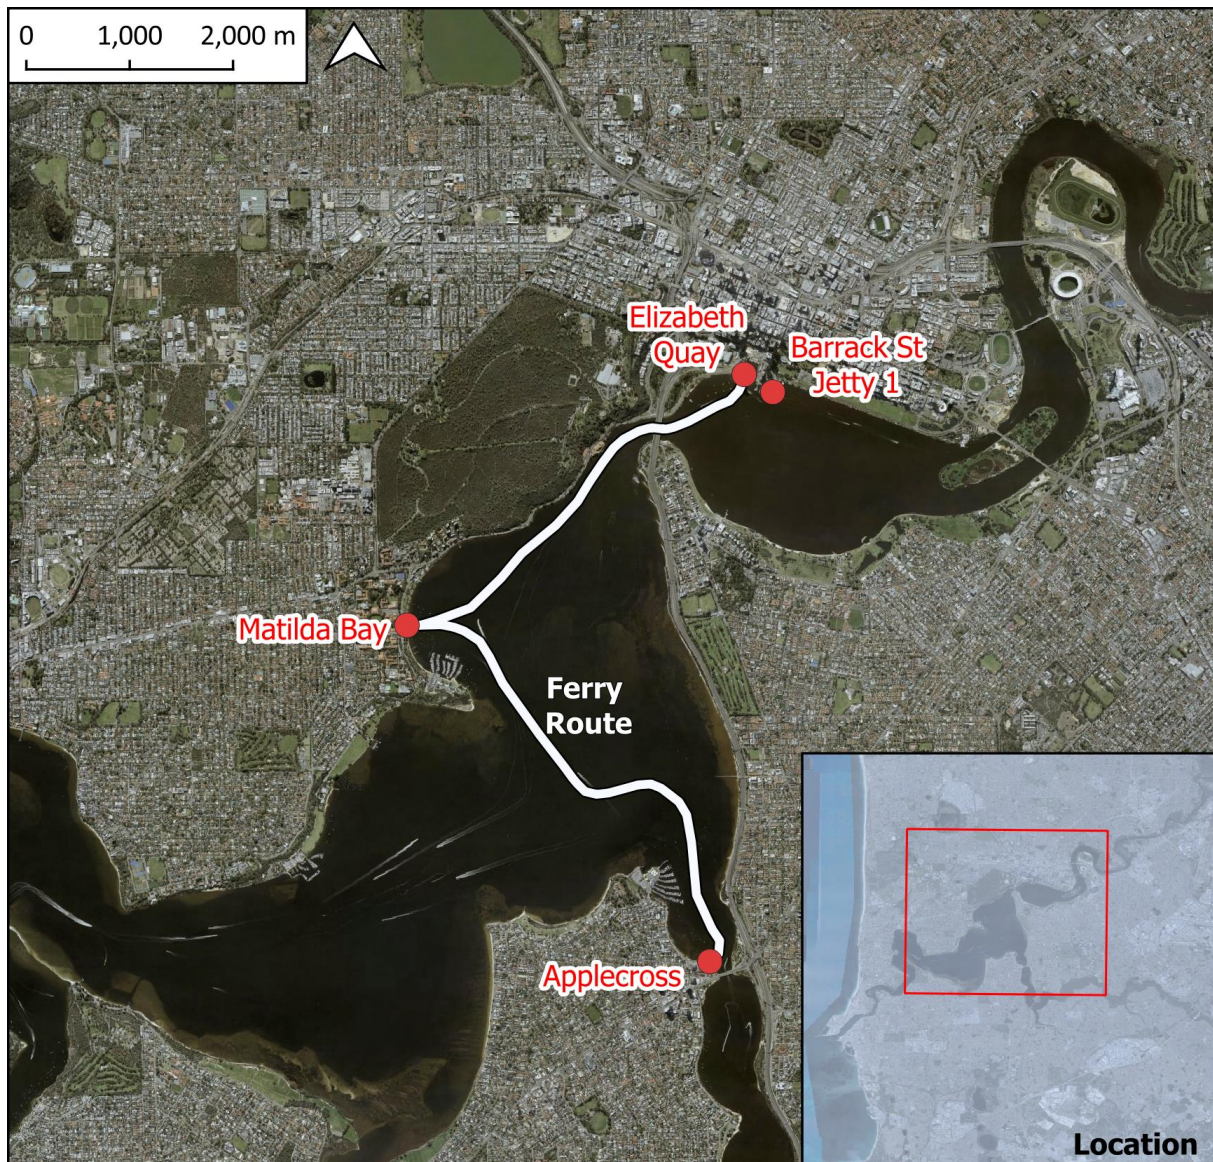
Figure 1: Site Figure

The Swan River Ferry Expansion Project, led by the Public Transport Authority (PTA) in collaboration with the Department of Transport, involves the expansion of Transperth ferry operations on the Swan River (Figure 1). The project is initially proposed to deliver five new electric ferry vessels, new ferry terminals at Applecross and Matilda Bay, and modifications to the existing terminal at Elizabeth Quay. Associated electrical infrastructure will also be installed to support overnight charging at the DTMI-managed Barrack Street Jetty (No. 1 or 2), and to enable rapid high-capacity charging at Matilda Bay and 'back-up' charging facilities at Applecross and Elizabeth Quay. The service is planned to operate at approximately 20-minute intervals, enabling a one-hour round trip between Applecross, Matilda Bay, and Elizabeth Quay.

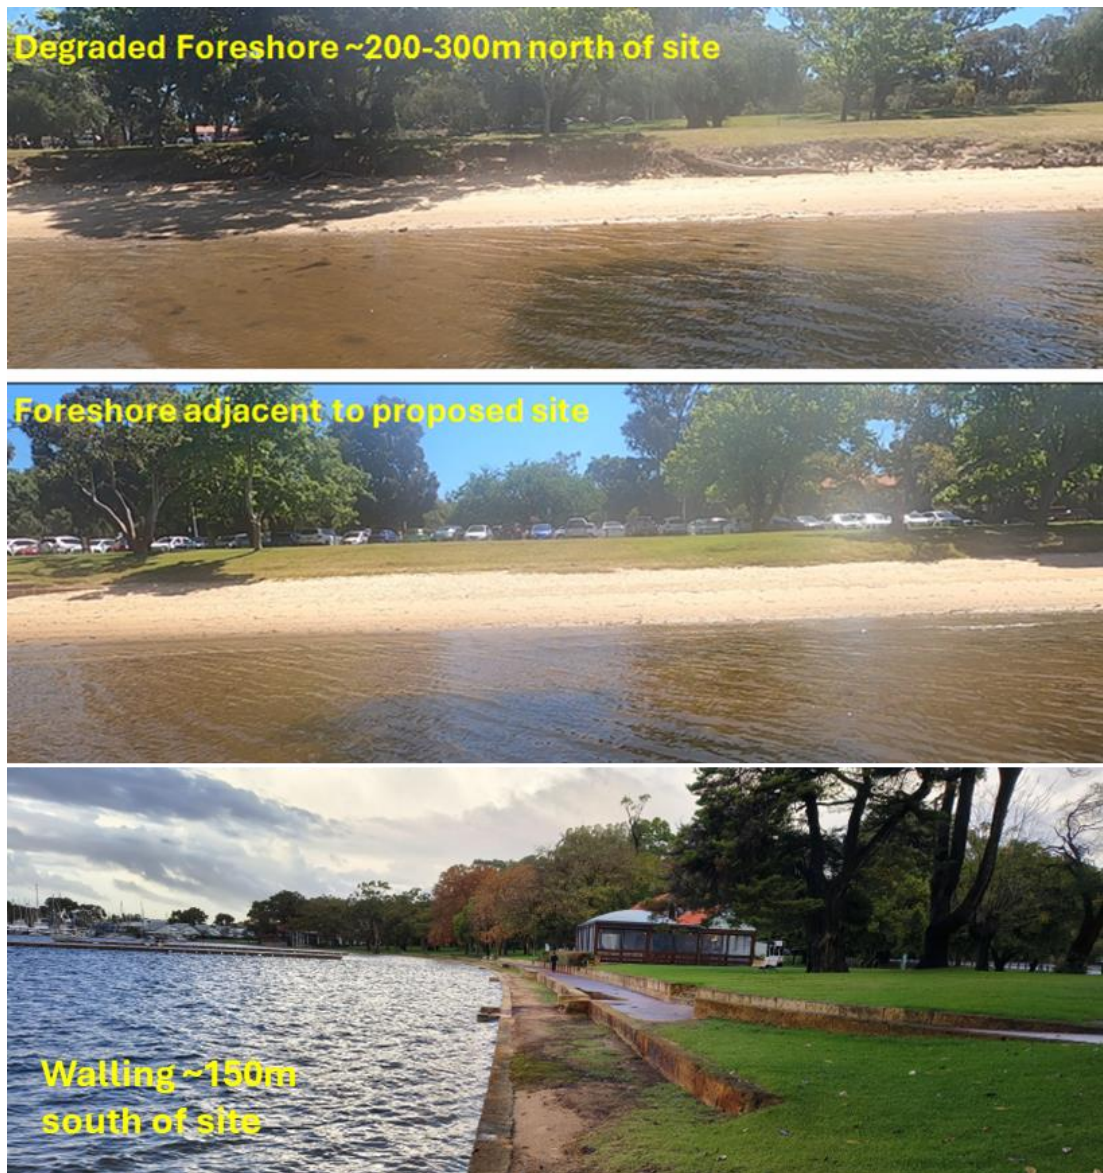
Figure 5: Photographs Illustrating Foreshore Condition Adjacent to Matilda Bay Site

The beach structure consists of a relatively narrow strip, with the bank typically rising above 2.0 m AHD and comprising grassed areas interspersed with mature trees. The steepness of the bank varies due to topographic differences (including due to historic fill), and patterns of erosion and accretion around the bay.

Where erosion has encroached upon the bank, scarp development and tree root exposure have occurred, which has prompted installation of limestone block walls along parts of the foreshore (Figure 5). The proposed terminal site is located along a gentler sloping section of the foreshore without trees, resulting in lower potential for scarp development and slightly greater capacity to retain beach amenity and recreational value compared to other parts.

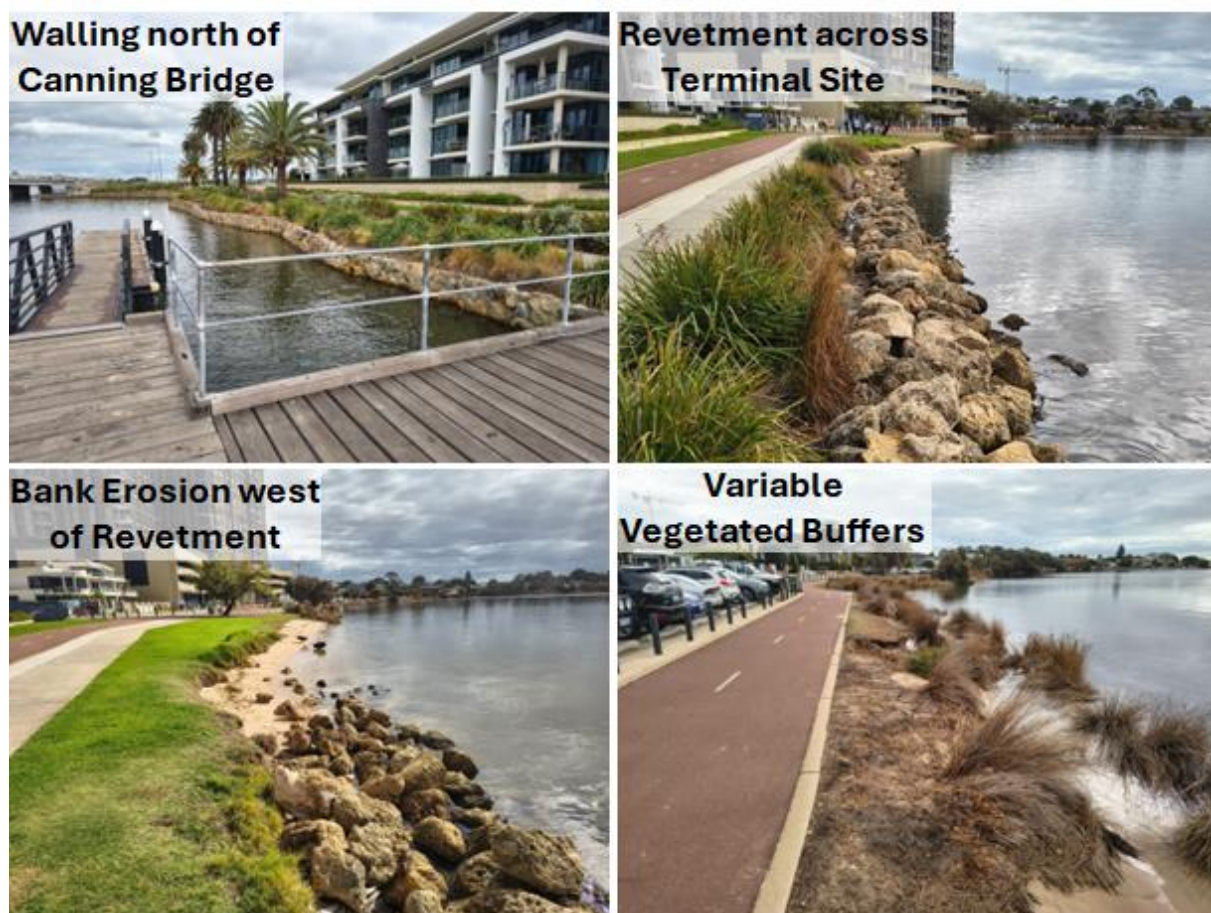
Figure 7: Photographs Illustrating Foreshore Condition Adjacent to Applecross Site

The foreshore is relatively low-lying, with the adjacent shared path and lowest road levels on Canning Beach Road currently set at approximately +1.1 m AHD. At this elevation, the path is already susceptible to overtopping during elevated water level and northerly wave events, with inundation frequency to increase under projected sea level rise scenarios over the 50-year design life. Design of the jetty's landward connection will subsequently need to accommodate future conditions and allow for integration with both present and future path levels if raised.

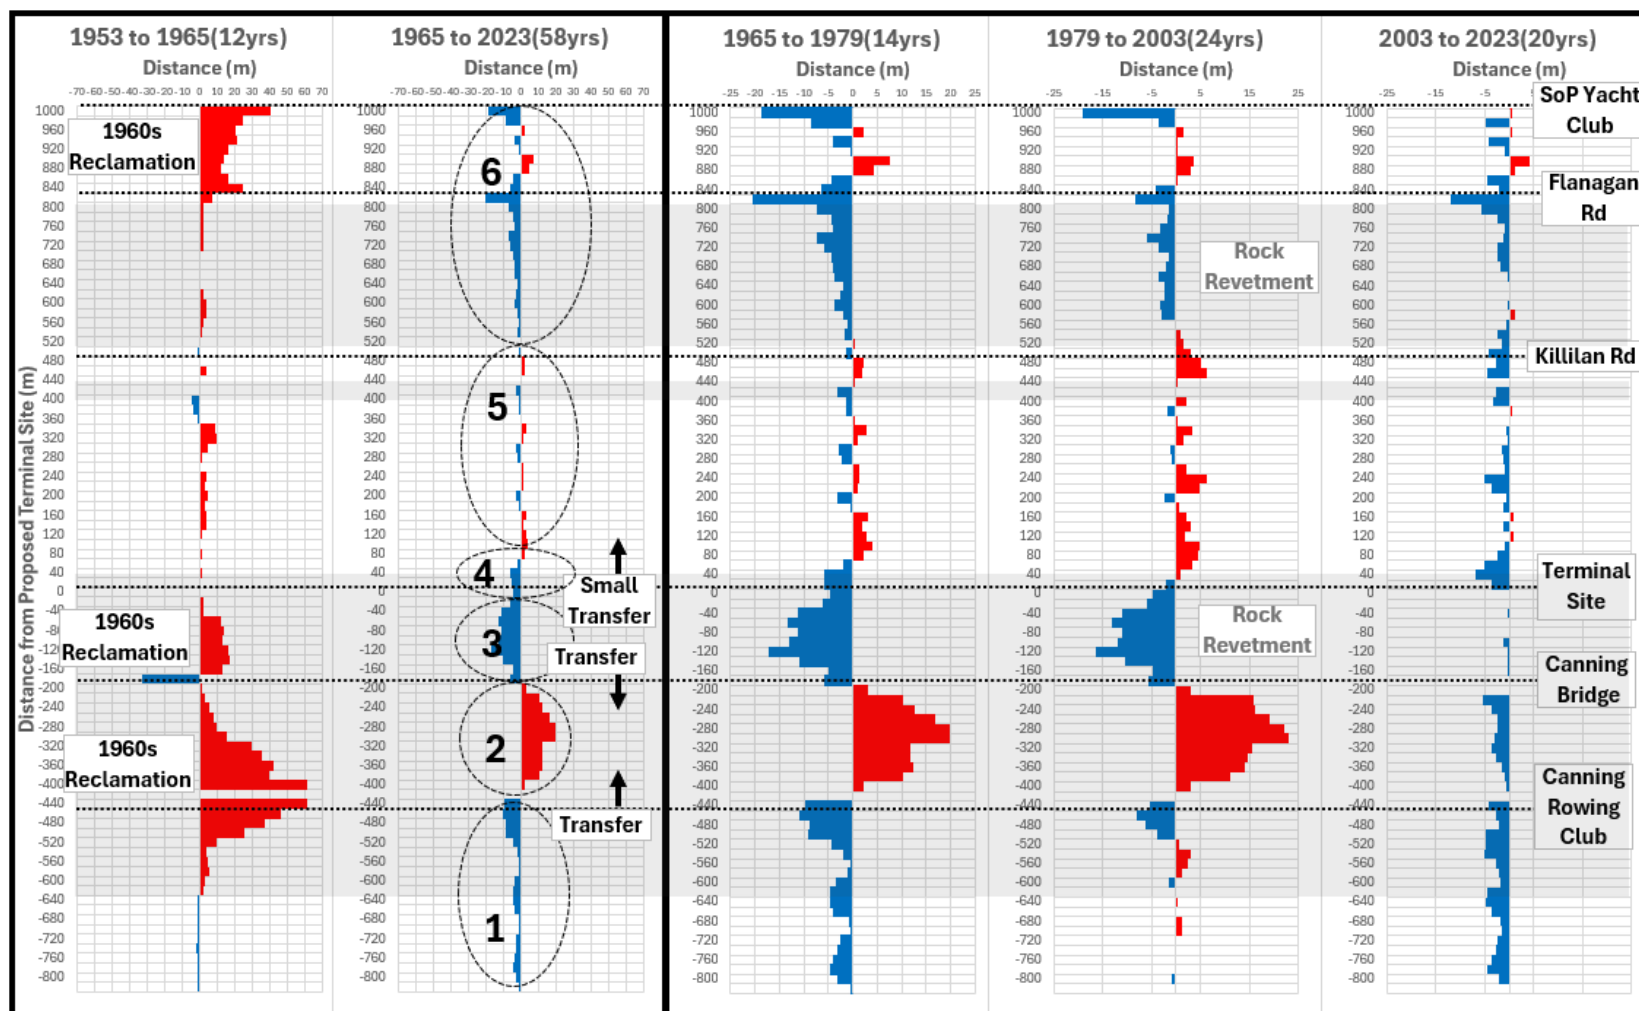
Applecross – Measured Shoreline Change for Selected Periods Between 1953 and 2023

Key changes observed across the Applecross shoreline between 1953 and 2023 include:

Zone 1	Erosion of the shoreline south of the Canning Rowing Club following 1960s reclamation works, with a high rate of loss observed during the first 14 years to 1979. This eroded material was predominantly transported northward, contributing to accretion in Zone 2.
Zone 2	Progressive accretion on the southern side of Canning Bridge between 1965 and 2003, advancing this shoreline beyond the original reclaimed extent of the 1960s. This accretion is associated with the capture and storage of material adjacent to the bridge abutment, sourced primarily from the northward transport of reclaimed material from Zone 1 (south of the Canning Rowing Club). Since 2003, a switch to erosion has occurred, indicating that supply has been exhausted, with material loss potentially occurring offshore, including in response to a period of elevated mean sea level.
Zone 3	Erosion of the reclaimed east-facing shoreline fronting the Raffles Hotel, north of Canning Bridge, commenced in the 1960s and led to the installation of a mortared rock walling along this section (evident in 1970s aerial imagery). Erosion continued until around 2003, at which point the beach in front of the wall had been completely lost, although further erosion may have persisted as bed lowering riverward of the wall. Most of the eroded material was likely transported to the bridge and into the river channel, with a smaller proportion moving northward to Zone 4.

Zone 5	<p>Overall stability of the shoreline extending northward to Killian Road between 1953 and 2003, likely supported by a relatively wide terrace and sections of stabilising vegetation. Changes during this period were primarily due to local sediment redistribution following the loss of sections of vegetation. Since 2003, this section has experienced increased erosion stress, although revegetation efforts during this time have now established wider vegetation buffers to help control erosion. The erosion is likely driven by a combination of:</p> <ul style="list-style-type: none"> • Disturbance from stormwater systems releasing focused flows. • Reduced sediment supply from Zone 3 and across Zone 4; • Increased potential for sediment mobility following earlier vegetation loss; • Influence of higher mean sea levels, which increases the height of wave impact on the shore and enables greater wave energy to propagate across the shallow terrace.

Zone 6	<p>Tendency for erosion along the north- and east-facing foreshores on either side of Flanagan Road. This is influenced by the relative absence of a terrace margin in this stretch, with offshore depths rapidly dropping below –4 m AHD, including to dredged areas within the South of Perth Yacht Club. These conditions have promoted offshore sediment transfer, with rock revetment subsequently built where limited buffer remains near the shared path south of Flanagan Road. Local alongshore sediment transport patterns are evident, including a small accumulation of material in the lee of the South of Perth Yacht Club, sourced from sediment transported northward from south of Flanagan Road and deposited in the sheltered area behind the yacht club.</p>

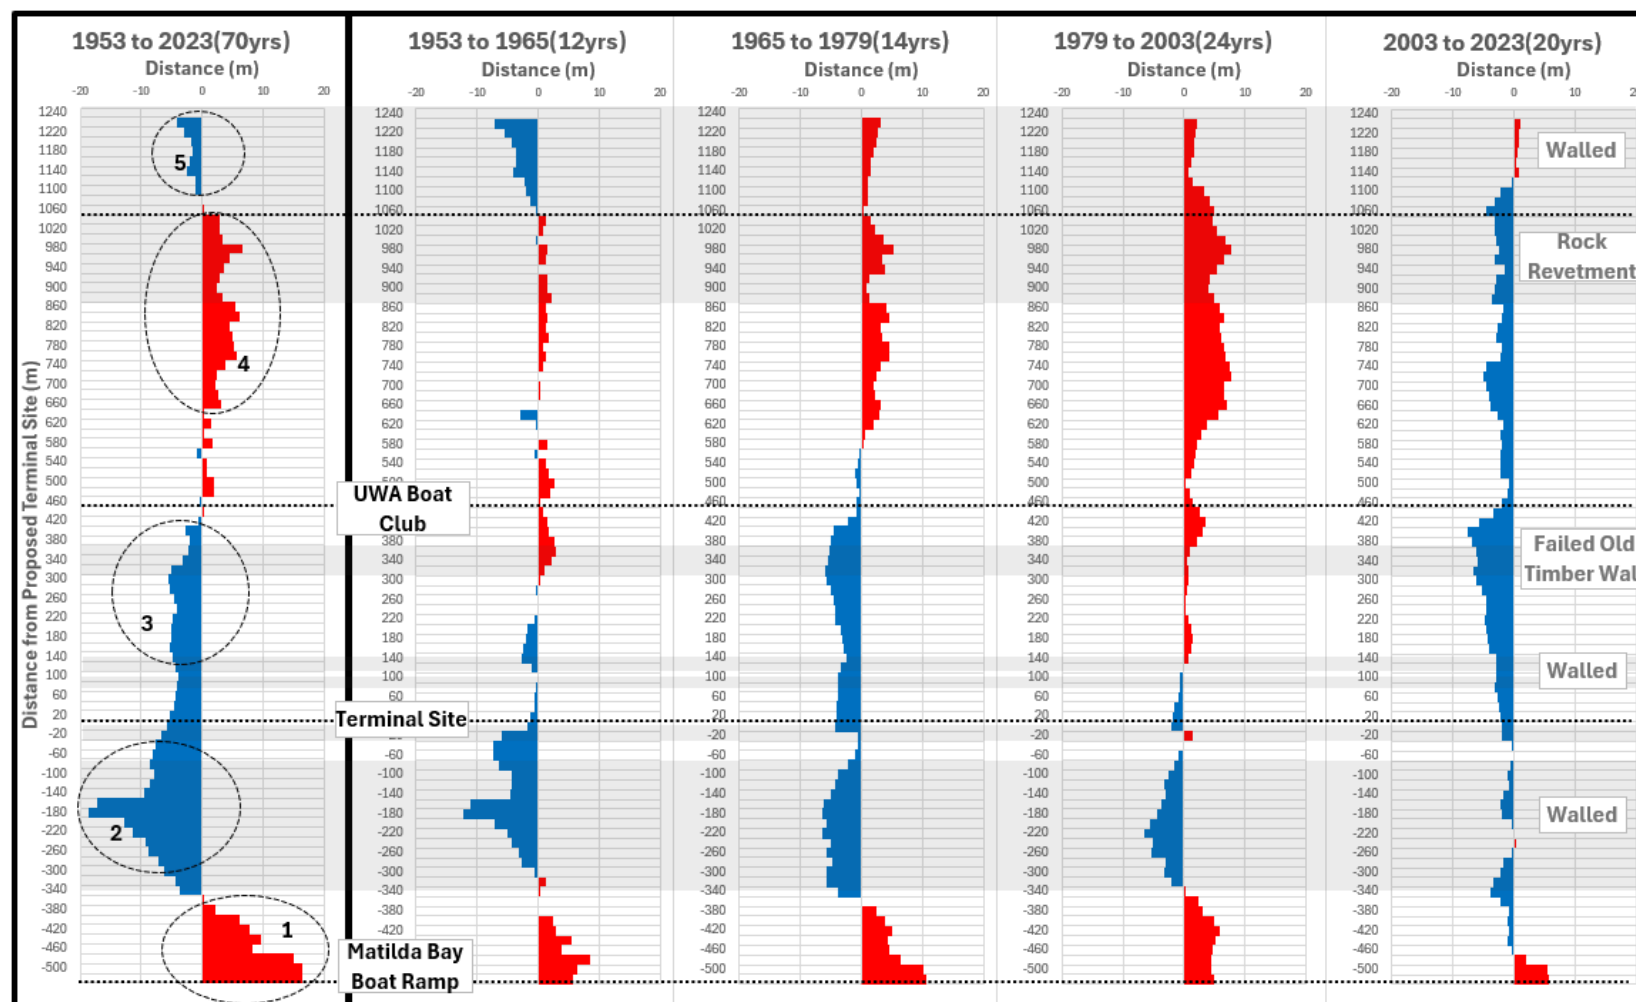
Matilda Bay – Measured Shoreline Change for Selected Periods Between 1953 and 2023

Overall, the Matilda Bay shoreline exhibits a general tendency toward erosion, particularly on either side of the proposed terminal site. This pattern suggests a net loss of sediment to offshore areas, with the increased erosion observed since 2003 likely influenced by elevated mean sea levels during this period.

Key changes observed across the Matilda Bay shoreline between 1953 and 2023 include:

Zone 1	Progressive accumulation on the northeast side of the Matilda Bay boat ramp due to the capture of sediments transferred from the north (up to 15m). This process has been enhanced by the sheltering effect of the Yacht Club, which limits the potential for sediment to move back northward.
Zone 2	Erosion to the south of the proposed terminal site (typically ranging 5-10m), resulting from a combination of southward sediment transport toward the Matilda Bay boat ramp (Zone 1), release of sediment previously stored following removal of the jetty facility between 1965 and 1974, and infilling of dredged areas for swimming jetties in 1972. The majority of this shoreline section is now protected by limestone block walling, installed in response to ongoing erosion.
Zone 3	Erosion north of the proposed terminal site (typically 5m), extending to the UWA Boat Shed, which includes a section of failed timber walling installed in 1957. Continued shoreline retreat onto the adjacent steep banks has led to the formation of scarps across this section. Most of this erosion occurred during two periods—1965–1979 and 2003–2023—highlighting the zone’s sensitivity to variable conditions and shifts in prevailing sediment transport direction.

Zone 4	Accretion north of the UWA Boat Club primarily between 1965 and 2003 (ranging 3-7m), likely due to sediment input from Zones 3 and 5. A transition to erosion after 2003 reflects the depletion of supply from Zone 5 and a lack of recent northward transport from Zone 4. This shift has prompted revetment extensions at the northern end of the site to protect Mounts Bay Road and the adjacent shared path.
Zone 5	Erosion occurred following the initial release of sediments that had accumulated on the south side of Crawley Baths, following their removal between 1953 and 1965. Walling was subsequently installed by 1974 across this section.
