**Talison Lithium Limited**  
Rehabilitation of Historical Mining Areas  
Preliminary Contaminated Sites Assessment,  
Greenbushes, Western Australia

December 2018

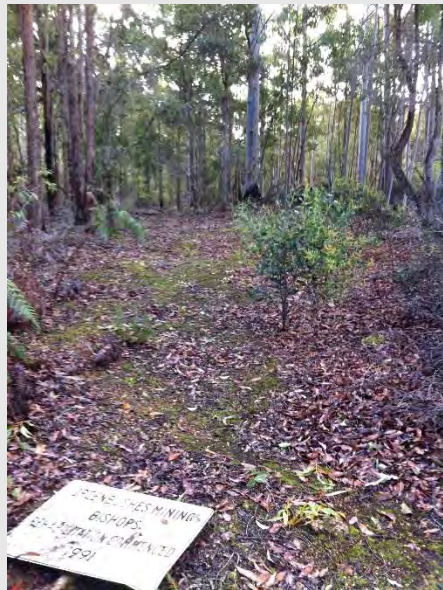
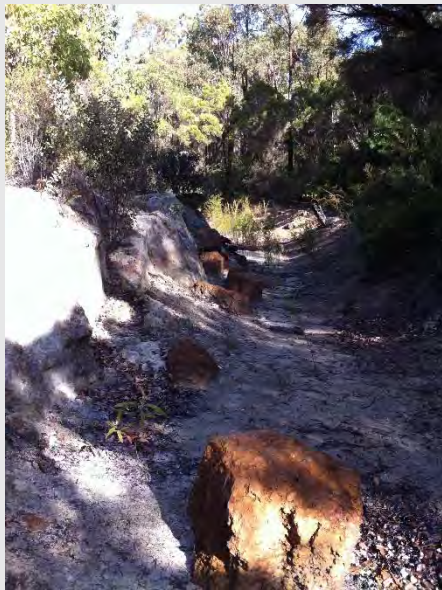
Site Inspection Date: 5 July 2018	Waterbody onsite? <input type="checkbox"/> Yes / <input checked="" type="checkbox"/> No	Sample ID (if applicable): -	
Criteria	Comments	Site Photos	
Site Access (i.e. tracks, fencing)  Evidence of access?  Frequency?	<ul style="list-style-type: none"><li>This area is located approximately 800 m south of the South Western Highway. It can be accessed from dirt 4WD tracks, which are located off Spring Gully road. This site does not appear to be frequently accessed</li></ul>

Topography and other site features	<ul style="list-style-type: none"><li>Bishops has a predominantly flat topography situated at an elevation of around 270 m AHD.</li></ul>		
Flood potential, surface drainage, water bodies	<ul style="list-style-type: none"><li>There are no waterbodies observed onsite, but shallow excavation trenches (1.5 m deep x 30 m long) likely store accumulated rainfall</li></ul>

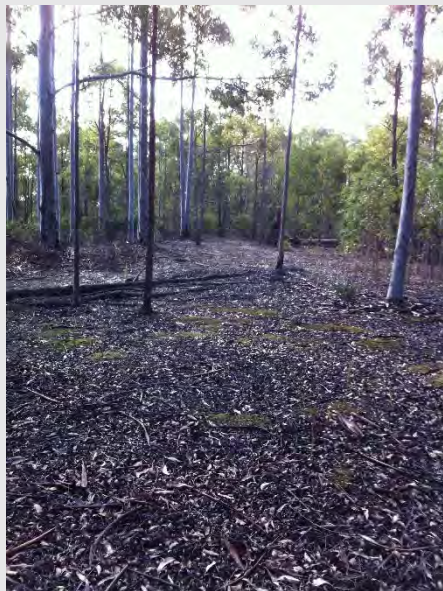
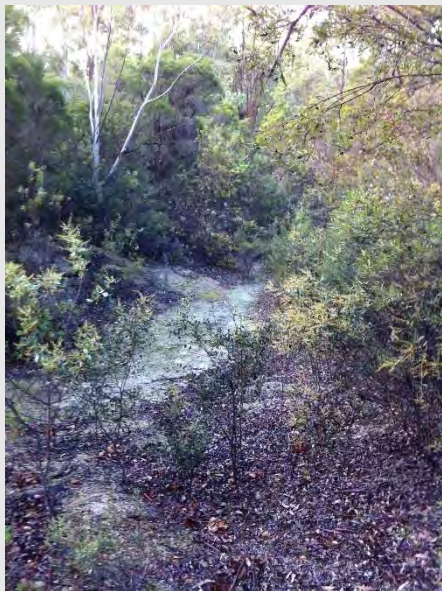
Photo 3: Bishops	Photo 4: Bishops

Presence and condition of water bodies/groundwater bores	<ul style="list-style-type: none"><li>There were no groundwater bores identified during the site inspection.</li><li>There were no surface water sources identified during the site inspection.</li></ul>		
Surrounding land uses	<ul style="list-style-type: none"><li>The land surrounding the site is State Forest.</li></ul>		
Location of receptors on and within 500 m of site boundary including sensitive receptors	<ul style="list-style-type: none"><li>There is a surface water body present in Charnley West (to the north of the site), apart from this there does not appear to be any other receptors within 500 m of the site boundary.</li></ul>		
		Photo 1: Bishops	Photo 2: Bishops

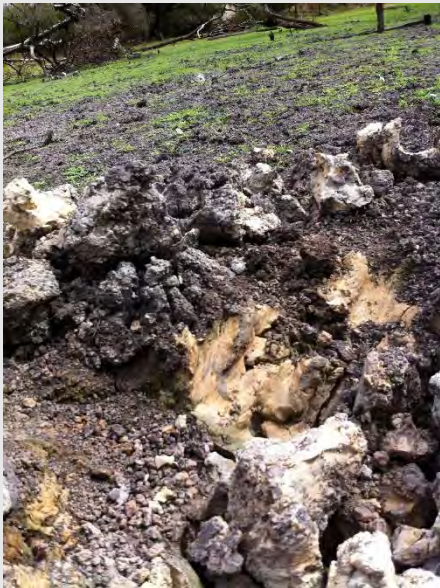
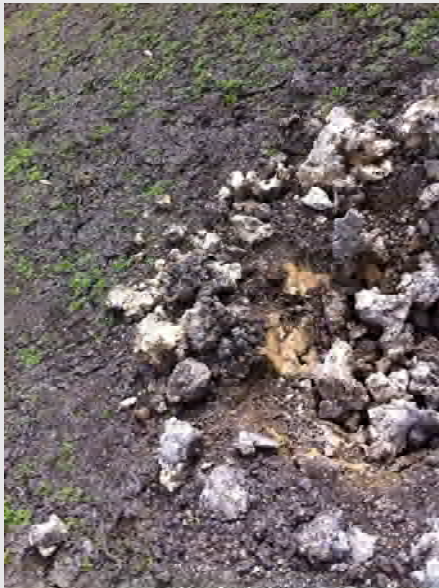
Site Inspection Date: 20 March 2018	Waterbody onsite? <input type="checkbox"/> Yes / <input checked="" type="checkbox"/> No	Sample ID (if applicable): -	
Criteria	Comments	Site Photos	
Site Access (i.e. tracks, fencing)  Evidence of access?  Frequency?	<ul style="list-style-type: none"><li>Site accessible by foot, with four wheel drive tracks and walking trails present throughout some areas of the site. The nearest dirt 4WD track to access the site connects to Spring Gully Road. The south western highway is located approximately 1.5 km north of the site.</li><li>Thick shrub land and native bushland comprising of most of the site. The gully area was dry at the time of inspection as presented in Photo 8, but is noted by the site contact to have a seasonal waterbody present</li><li>This site does not appear to be frequently accessed.</li></ul>

Topography and other site features	<ul style="list-style-type: none"><li>The area is relatively flat, with a narrow gully present throughout the centre of the site and dense shrubbery surrounding the banks. The site is predominantly comprised of established bushland.</li><li>The sandy gravel flanks were identified at the southern section of the gully.</li></ul>

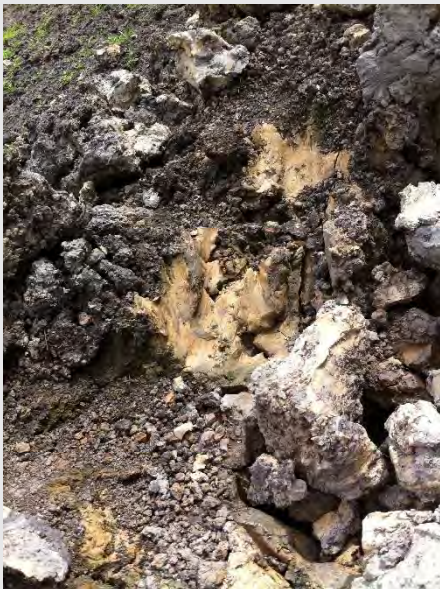
Flood potential, surface drainage, water bodies	<ul style="list-style-type: none"><li>None observed. Flooding into neighbouring properties was considered unlikely.</li></ul>		
Current site activities	<ul style="list-style-type: none"><li>Walking trails</li><li>This area is also classified as an Aboriginal Heritage Site based on mythological purposes.</li></ul>		
Visible signs of contamination	<ul style="list-style-type: none"><li>No visible signs of contamination.</li></ul>

Historical mining activity and visible signs of historical mining activities	<ul style="list-style-type: none"><li>Evidence relating to past mining activities comprises depositional evidence of workings within base of gully (see Photo 5)</li></ul>		
Visible signs of vegetation stress	<ul style="list-style-type: none"><li>No signs of vegetation stress. Some patches of cleared land present onsite throughout the gully area.</li></ul>

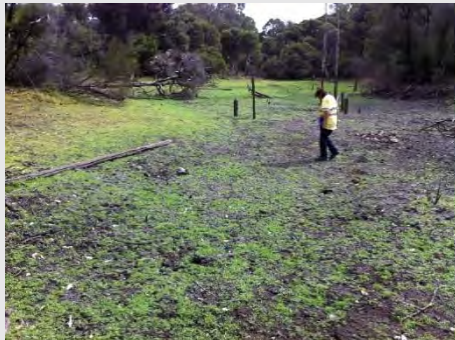
Presence of drums, waste and/or fill material	<ul style="list-style-type: none"><li>No drums, waste or fill material identified onsite, with the exception of exposed workings (Photo 5). No visual or olfactory evidence of impacts within workings.</li></ul>		
Presence, type and conditions of buildings, road or site infrastructure	<ul style="list-style-type: none"><li>No buildings present onsite. There are unsealed tracks present – with larger 4WD tracks providing access to the southern section of the site and walking trails present throughout.</li></ul>

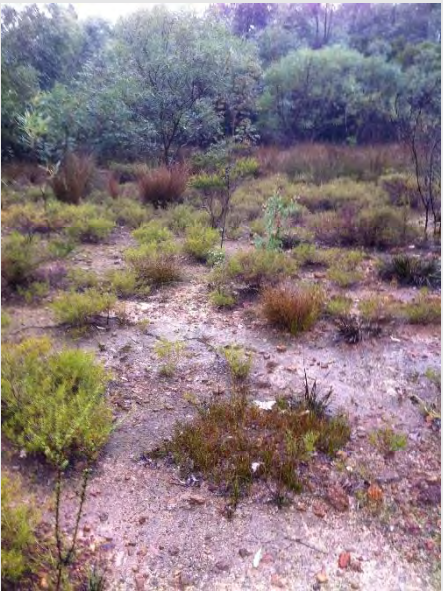
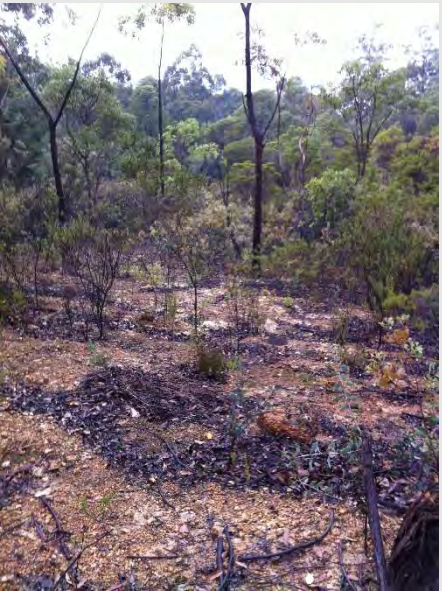
Site Inspection Date: 5 July 2018	Waterbody onsite? <input type="checkbox"/> Yes / <input checked="" type="checkbox"/> No	Sample ID (if applicable): -	
Criteria	Criteria	Site Photos	
Site Access (i.e. tracks, fencing) Evidence of access? Frequency?	<ul style="list-style-type: none"><li>Carters Farm is located to the north of the South Western Highway and is accessible via a dirt 4WD track positioned off this main highway.</li></ul>

Topography and other site features	<ul style="list-style-type: none"><li>The site slopes slightly to the north east but is predominantly flat.</li></ul>		
Flood potential, surface drainage, water bodies	<ul style="list-style-type: none"><li>There are no water bodies located on the site, based on the slope of the site it is likely that water will drain to the south east.</li></ul>		
Current site activities	<ul style="list-style-type: none"><li>There are no current site activities noted for this site</li></ul>

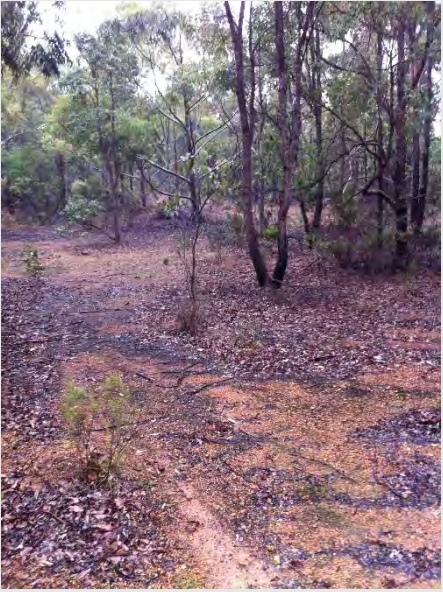
Aesthetic Issues (e.g. presence/intensity of odours)	<ul style="list-style-type: none"><li>There were no aesthetic issues identified onsite.</li></ul>		
Nature of site surface (sealed, unsealed, integrity of the seal)	<ul style="list-style-type: none"><li>Unsealed surface – mostly scrubland consisting mostly of natural sand and gravels with sparse to no vegetation. .</li></ul>

Presence, location and types of stockpiles materials	<ul style="list-style-type: none"><li>There were no stockpiled materials identified onsite.</li></ul>		
Illegal occupation and illegal dumping potential	<ul style="list-style-type: none"><li>There was no illegal occupation or dumping identified onsite.</li></ul>		
Local use of ground/surface waters and evidence of groundwater bores/surface water abstraction	<ul style="list-style-type: none"><li>There were no groundwater or surface water abstraction points identified onsite. Two groundwater abstraction bores onsite, three located north to north east of the site – see Section 4.5.3.</li></ul>

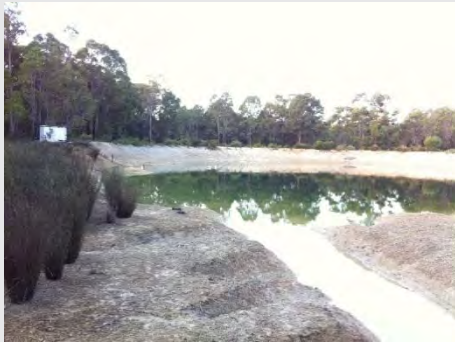
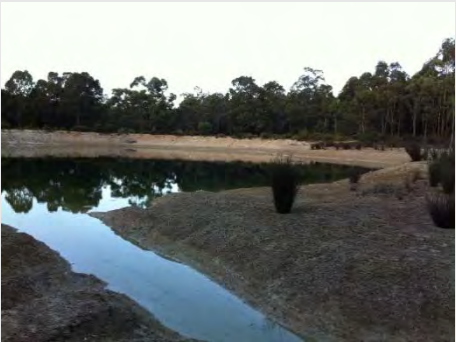
Site Inspection Date: 8 May 2018	Waterbody onsite? <input checked="" type="checkbox"/> Yes / <input type="checkbox"/> No	Sample ID (if applicable): CFN14	
Criteria	Criteria	Site Photos	
Site Access (i.e. tracks, fencing)	<ul style="list-style-type: none"><li>Site accessible by foot.</li></ul>

Evidence of access?	<ul style="list-style-type: none"><li>Thick shrub land surrounding the man-made banks of the water body.</li></ul>		
Frequency?	<ul style="list-style-type: none"><li>Likely that this site is occasionally accessed by the Golf Club, which use this water body as a water source for irrigation of the course. The site does not appear to be frequently accessed.</li><li>The southwest freeway is located to the south of this area.</li></ul>		
Topography and other site features	<ul style="list-style-type: none"><li>The area is relatively flat with a slight increase in elevation apparent on the northern side of the water body onsite.</li></ul>

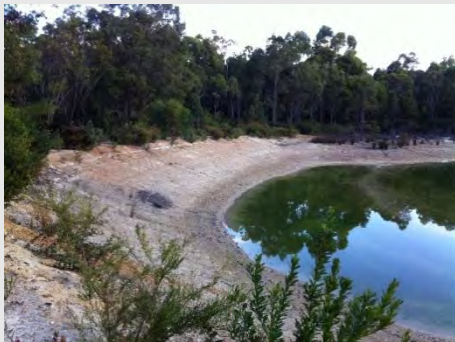
Flood potential, surface drainage, water bodies	<ul style="list-style-type: none"><li>One man-made waterbody/dam was apparent onsite during the inspection.</li></ul>		
Current site activities	<ul style="list-style-type: none"><li>Waterbody onsite is used to irrigate Greenbushes Golf course.</li></ul>		
Visible signs of contamination	<ul style="list-style-type: none"><li>No visible signs of contamination.</li></ul>	Photo 12: Carters Farm North	Photo 13: Carters Farm North
Historical mining activity and visible signs of historical mining activities	<ul style="list-style-type: none"><li>The water bodies reflect mining excavations which are now are water bodies likely indicating groundwater levels and/or surface water accumulation.</li></ul>

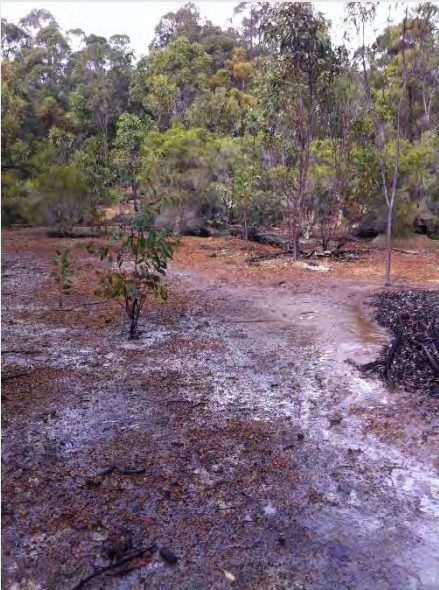
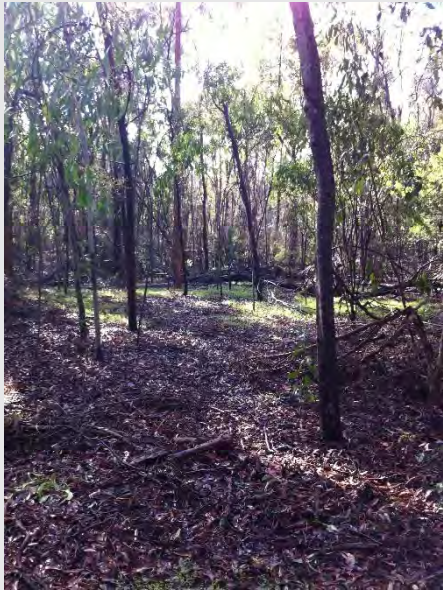
Site Inspection Date: 5 July 2018	Waterbody onsite? <input checked="" type="checkbox"/> Yes / <input type="checkbox"/> No	Sample ID (if applicable): CH21	
Criteria	Comments	Site Photos	
Site Access (i.e. tracks, fencing)	<ul style="list-style-type: none"><li>Accessed via unsealed 4WD tracks located off of Charnley Road.</li></ul>

Evidence of access? Frequency?	<ul style="list-style-type: none"><li>The site does not appear to be frequently accessed.</li></ul>		
Topography and other site features	<ul style="list-style-type: none"><li>The site is generally flat, situated at an elevation of approximately 270 m AHD, with a slight slope towards the north east (where the water bodies are located).</li></ul>		
Flood potential, surface drainage, water bodies	<ul style="list-style-type: none"><li>Two small waterbodies exist onsite which probably reflect groundwater levels (water levels 2 meters below ground level)</li></ul>

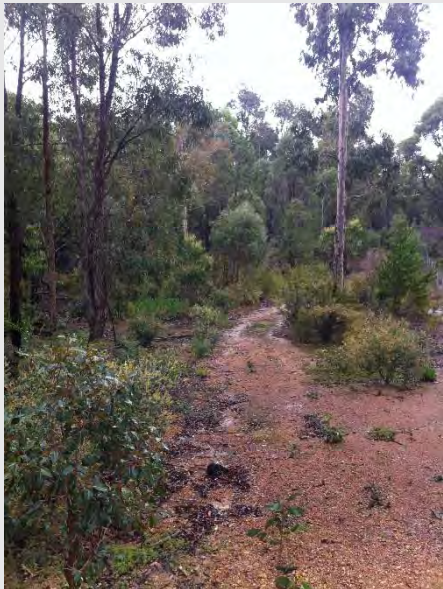
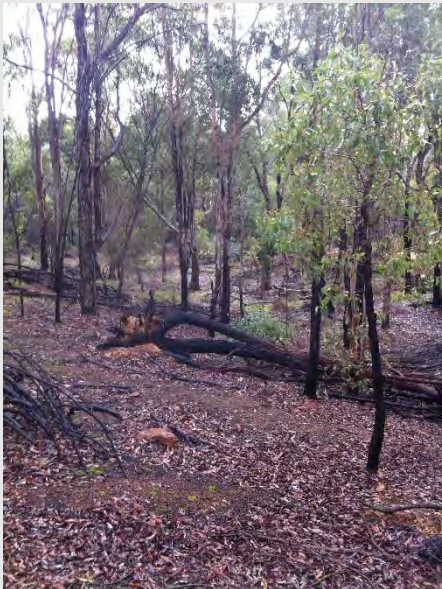
Site Inspection Date: 5 July 2018	Waterbody onsite? <input type="checkbox"/> Yes / <input checked="" type="checkbox"/> No	Sample ID (if applicable): -	
Criteria	Comments	Site Photos	
Site Access (i.e. tracks, fencing)	<ul style="list-style-type: none"><li>Accessed via unsealed 4WD tracks located south off the South Western Highway.</li></ul>

Evidence of access?	<ul style="list-style-type: none"><li>The site does not appear to be very frequently accessed, however is located proximally to residential housing.</li></ul>		
Frequency?			
Topography and other site features	<ul style="list-style-type: none"><li>The site is predominantly flat situated at an elevation of approximately 270 m AHD and slopes slightly to the north west. Common site undulations/shallow excavations are likely derived from mining/rehabilitation actives (e.g.: Photo 21)</li></ul>		
Flood potential, surface drainage, water bodies	<ul style="list-style-type: none"><li>There were no water bodies onsite during the inspection.</li></ul>

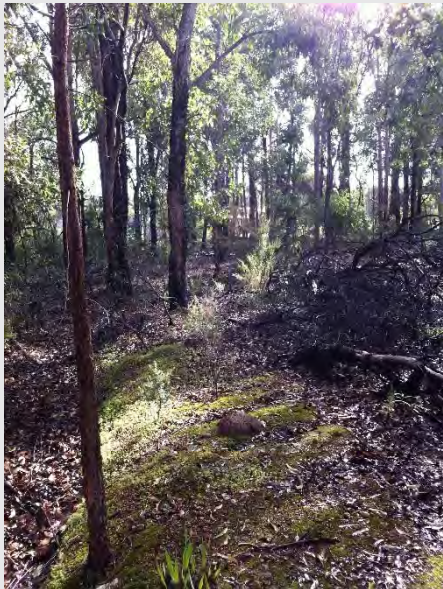
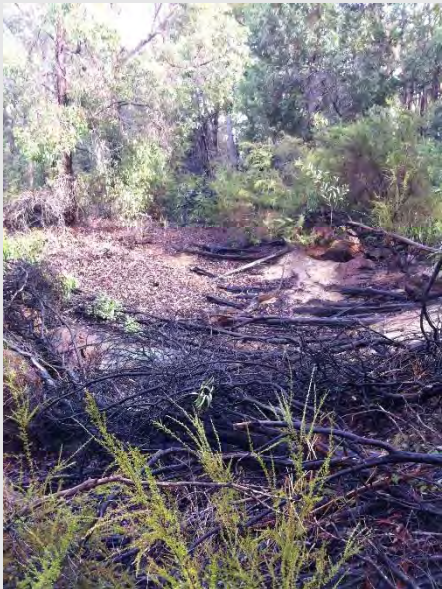
Presence, type and conditions of buildings, road or site infrastructure	<ul style="list-style-type: none"><li>There were no buildings, infrastructure or roads identified onsite. The road leading to the site is an unsealed 4WD track.</li></ul>

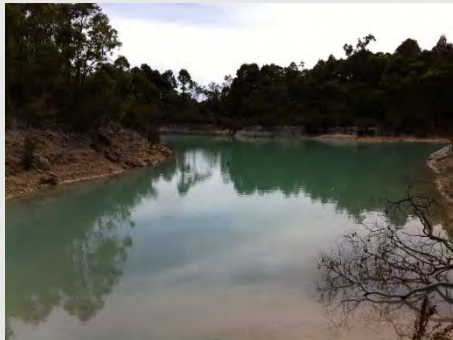
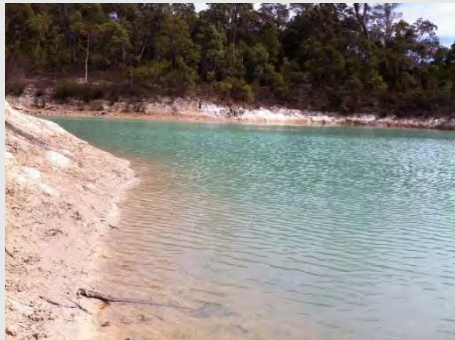
Site Inspection Date: 20 March 2018	Waterbody onsite? <input checked="" type="checkbox"/> Yes / <input type="checkbox"/> No	Sample ID (if applicable): CW09	
Criteria	Criteria	Site Photos	
Site Access (i.e. tracks, fencing)  Evidence of access?  Frequency?	<ul style="list-style-type: none"><li>Site accessible by foot, with four wheel drive tracks and walking trails present throughout some areas of the site.</li><li>Thick shrub land and native bushland comprising of most of the site and bound the bank of the waterbody onsite.</li><li>This site does not appear to be frequently accessed.</li></ul>

Topography and other site features	<ul style="list-style-type: none"><li>The area is relatively flat with relatively steep banks separating the water body and the surrounding vegetation (between ~0.5-2 m difference in elevation between the water level and the vegetation).</li></ul>		
Flood potential, surface drainage, water bodies	<ul style="list-style-type: none"><li>There was one waterbody apparent onsite during the inspection.</li><li>Flooding into neighbouring properties was considered unlikely onsite.</li></ul>

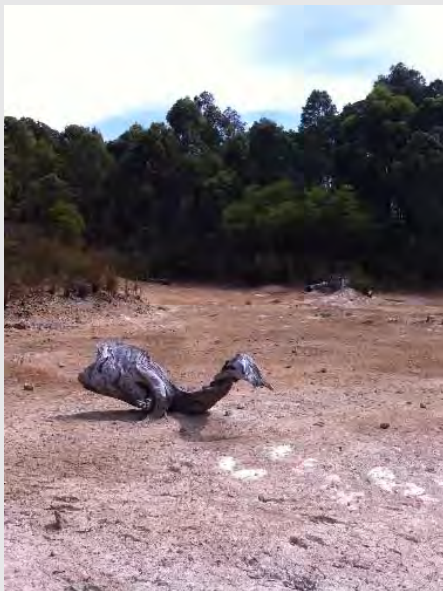
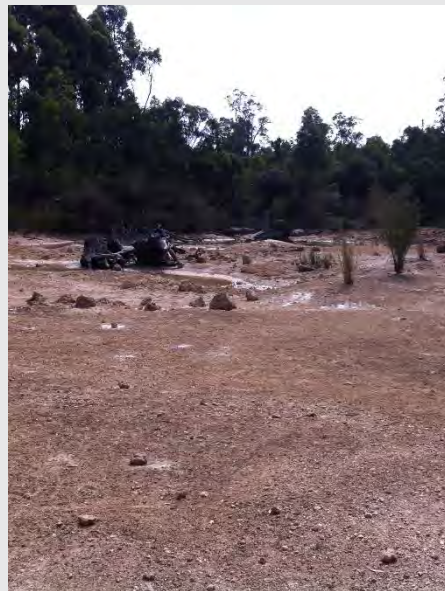
Current site activities	<ul style="list-style-type: none"><li>Waterbody identified onsite and dirt trails likely used for hiking and motorbike activities.</li></ul>		
Visible signs of contamination	<ul style="list-style-type: none"><li>No visible signs of contamination.</li></ul>		
Historical mining activity and visible signs of historical mining activities	<ul style="list-style-type: none"><li>The water bodies reflect mining excavations which are now water bodies likely indicating groundwater levels and/or surface water accumulation.</li></ul>	Photo 22: Charnley West	Photo 23: Charnley West
Visible signs of vegetation stress	<ul style="list-style-type: none"><li>No signs of vegetation stress. Some patches of cleared land present onsite though.</li></ul>

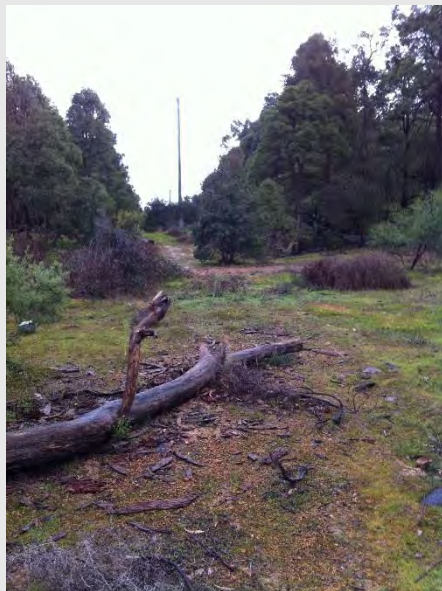
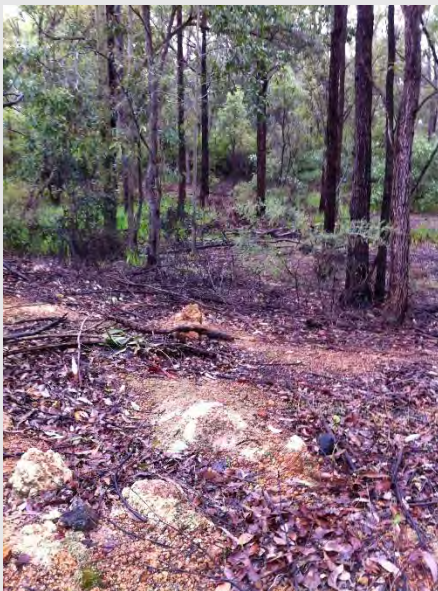
Site Inspection Date: 5 July 2018	Waterbody onsite? <input type="checkbox"/> Yes / <input checked="" type="checkbox"/> No	Sample ID (if applicable): -	
Criteria	Comments	Site Photos	
Site Access (i.e. tracks, fencing)  Evidence of access?  Frequency?	<ul style="list-style-type: none"><li>There are a few unsealed walking trails present throughout the site. The site access is via an unsealed 4WD track, south of the South Western Highway.</li><li>The site does not appear to be frequently accessed but is positioned between the active mine site (to the south) and the residential developments (to the north).</li></ul>

Topography and other site features	<ul style="list-style-type: none"><li>The site is situated on a predominantly flat section of land, which is at an elevation of approximately 320 m AHD. The site appears to slope downwards to the north slightly.</li></ul>		
Flood potential, surface drainage, water bodies	<ul style="list-style-type: none"><li>There were no surface water bodies onsite during the site inspection.</li></ul>

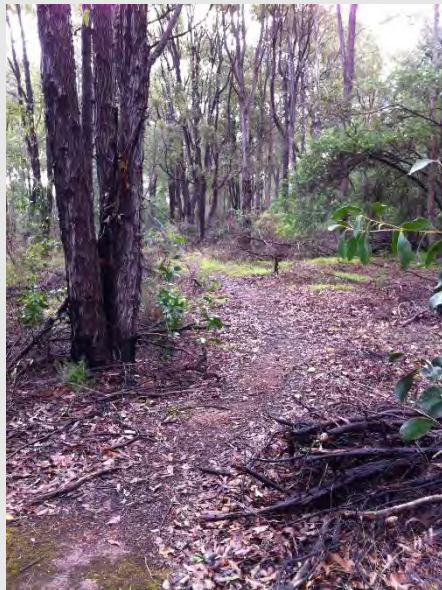
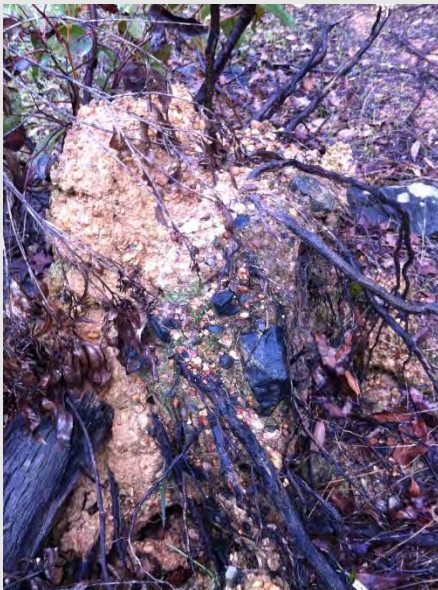
Current site activities	<ul style="list-style-type: none"><li>There appear to be a few walking trails present throughout the site, however there were no other obvious site uses.</li></ul>		
Visible signs of contamination	<ul style="list-style-type: none"><li>There were no visible signs of contamination.</li></ul>		
Historical mining activity and visible signs of historical mining activities	<ul style="list-style-type: none"><li>Disturbed/ reworked clayey soils caused by historical mining practices (Photo 27),</li></ul>		
Visible signs of vegetation stress	<ul style="list-style-type: none"><li>There was no visible signs of vegetation stress, apart from the minor felled tree and the sparsity of the vegetation onsite.</li></ul>		
Presence of drums, waste and/or fill material	<ul style="list-style-type: none"><li>There were no drums, waste or fill materials identified onsite.</li></ul>		
Presence, type and conditions of buildings, road or site infrastructure	<ul style="list-style-type: none"><li>There were no buildings or roads onsite. Overhead power infrastructure crosses the southern site boundary (Photo 26)</li></ul>

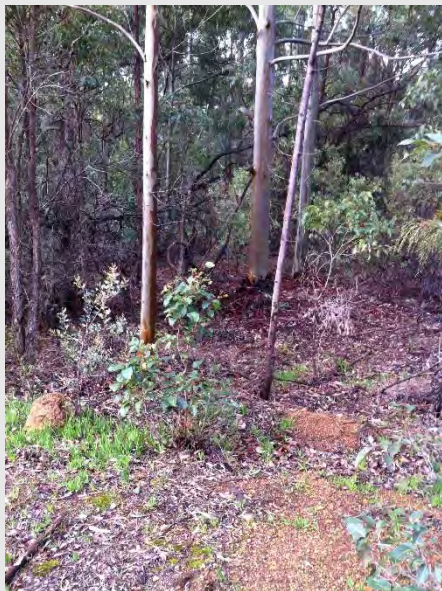
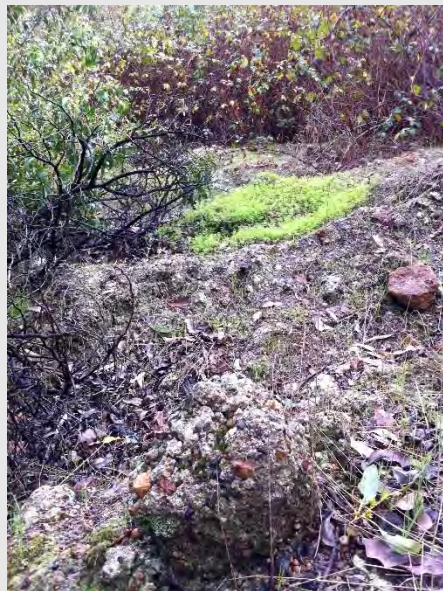
Site Inspection Date: 5 July 2018	Waterbody onsite? <input type="checkbox"/> Yes / <input checked="" type="checkbox"/> No	Sample ID (if applicable): -	
Criteria	Comments	Site Photos	
Site Access (i.e. tracks, fencing)  Evidence of access?  Frequency?	<ul style="list-style-type: none"><li>Accessible via 4WD track located of Stanifer Street, south of the South Western Highway. This site is not fenced off and appears to have small dirt tracks present throughout. However, this area does not appear to be frequently accessed.</li></ul>

Topography and other site features	<ul style="list-style-type: none"><li>The site slopes to the south-west and is located at an elevation of between 280 – 300 m AHD, with drainage towards the north.</li></ul>		
Flood potential, surface drainage, water bodies	<ul style="list-style-type: none"><li>There are no surface water bodies present onsite.</li></ul>		
Current site activities	<ul style="list-style-type: none"><li>There were no current site activities identified for this site.</li></ul>

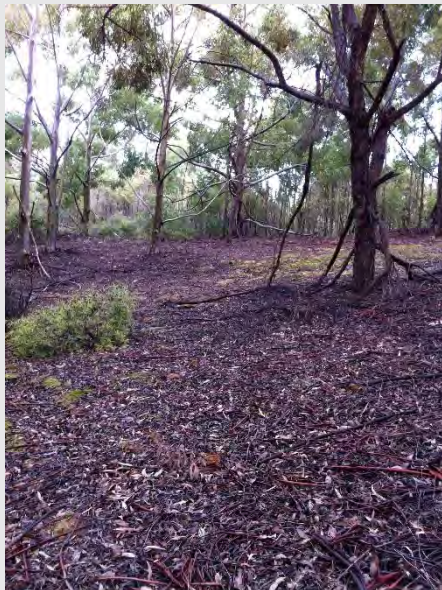
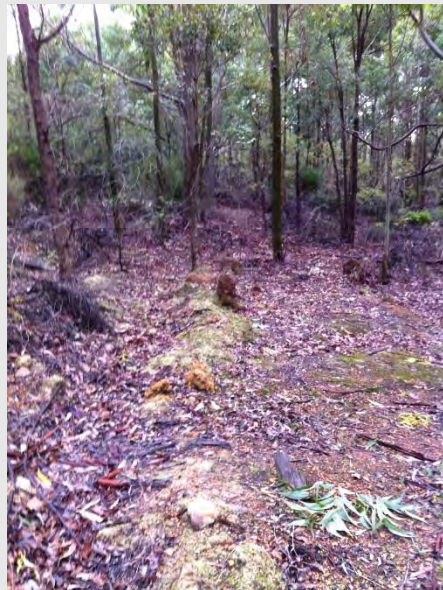
Visible signs of contamination	<ul style="list-style-type: none"><li>There were no visible signs of contamination onsite.</li></ul>		
Historical mining activity and visible signs of historical mining activities	<ul style="list-style-type: none"><li>Reworked clayey soils related to historical mining activities (Photo 31 and Photo 34). There was no other evidence of historical mining activities onsite.</li></ul>		
Visible signs of vegetation stress	<ul style="list-style-type: none"><li>There were no visible signs of vegetation stress.</li></ul>		
Presence of drums, waste and/or fill material	<ul style="list-style-type: none"><li>There were no drums, waste or fill materials present onsite.</li></ul>	Photo 30: Cornwall Alluvial North	
Presence, type and conditions of buildings, road or site infrastructure	<ul style="list-style-type: none"><li>There were no buildings, roads or infrastructure present onsite. The road to access the site is an unsealed 4WD track.</li></ul>

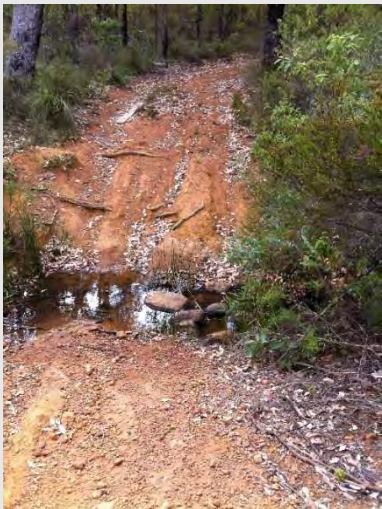
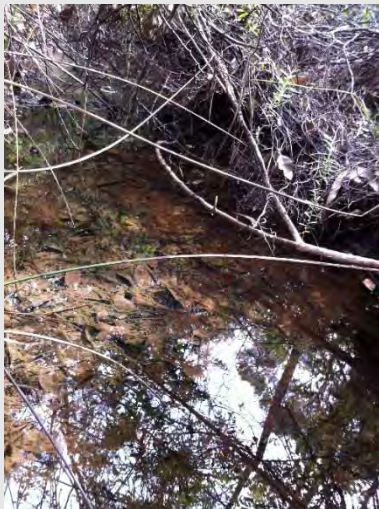
Site Inspection Date: 20 March 2018	Waterbody onsite? <input checked="" type="checkbox"/> Yes / <input type="checkbox"/> No	Sample ID (if applicable): CB13		
Criteria	Comments			
Site Access (i.e. tracks, fencing)  Evidence of access?  Frequency?	<ul style="list-style-type: none"><li>Site access via Ashcroft Road, which is located to the south of the brook. This is an unsealed 4WD trail, the dam itself is accessed via foot.</li><li>Thick shrub land and native bushland comprising of most of the site and bound the bank of the waterbody onsite.</li><li>The site does not appear to be frequently accessed.</li></ul>

Topography and other site features	<ul style="list-style-type: none"><li>The site is situated within a gully and appears to have predominantly flat topography.</li></ul>			
Flood potential, surface drainage, water bodies	<ul style="list-style-type: none"><li>It is unlikely that this site will flood due to the topography of the site (situated within a gully area) and based on the interconnectivity of this brook to both Norilup Brook to the north east</li></ul>

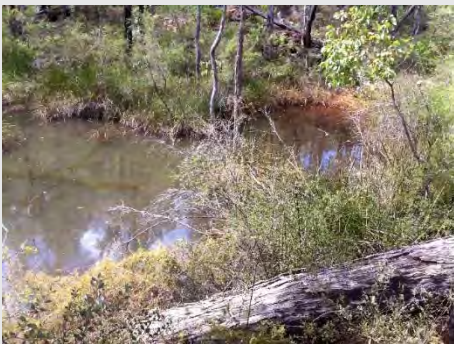
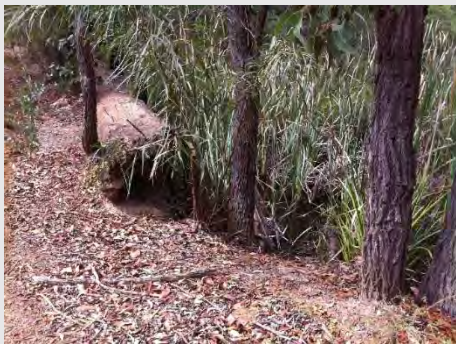
Current site activities	<ul style="list-style-type: none"><li>There were no current site activities identified throughout the site inspection – this site does not appear to be frequently accessed.</li></ul>			
Visible signs of contamination	<ul style="list-style-type: none"><li>There is evidence of iron staining within the surface water, at the south east section of the site.</li><li>There were no other signs of contamination onsite.</li></ul>	Photo 34: Cowan Brook		
Historical mining activity and visible signs of historical mining activities	<ul style="list-style-type: none"><li>Increases the depth and width of the brook channel. Iron staining was also observed within the surface water towards the southern end.</li></ul>	Photo 35: Cowan Brook		
Visible signs of vegetation stress	<ul style="list-style-type: none"><li>There was no visible signs of vegetation stress.</li></ul>

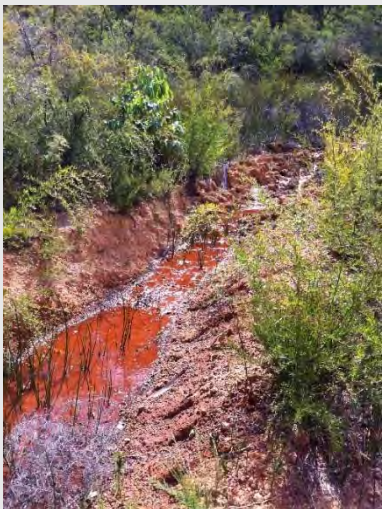
Presence, type and conditions of buildings, road or site infrastructure	<ul style="list-style-type: none"><li>There were no buildings or infrastructure identified onsite. The road to access the site is an unsealed 4WD track.</li></ul>	Photo 36: Cowan Brook		
Aesthetic Issues (e.g. presence/intensity of odours)	<ul style="list-style-type: none"><li>There were no odours or aesthetic issues identified onsite.</li></ul>

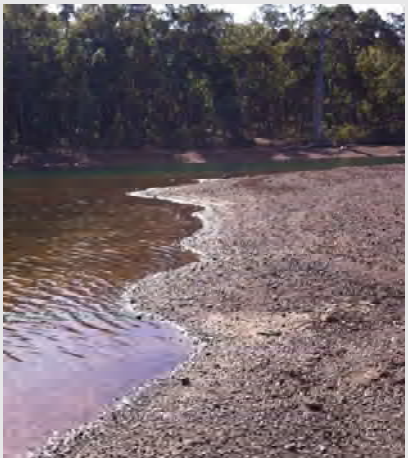
Site Inspection Date: 7 May 2018	Waterbody onsite? <input checked="" type="checkbox"/> Yes / <input type="checkbox"/> No	Sample ID (if applicable): DG08	
Criteria	Criteria	Site Photos	
Site Access (i.e. tracks, fencing)  Evidence of access?  Frequency?	<ul style="list-style-type: none"> <li>Site accessible by foot, with 4WD tracks present throughout some areas of the site.</li> <li>Thick shrub land and native bushland comprising of most of the site. There is a boarder of cleared land surrounding the waterbody onsite (ranging between ~ 2 -10 m wide).</li> <li>Some Water Authority Catchment fencing installed around the water body onsite. The Site does not appear to be frequently accessed.</li> <li>The southwest freeway is located to the north of this area.</li> </ul>

Topography and other site features	<ul style="list-style-type: none"> <li>The area is flat with little variation in topography between the water level and the surrounding vegetation elevation.</li> </ul>

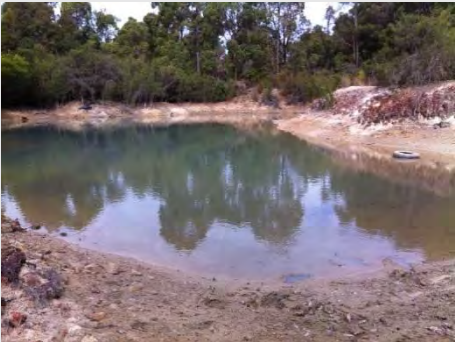
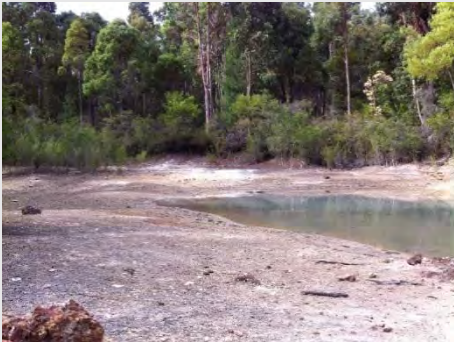
Topography and other site features	<ul style="list-style-type: none"><li>The site increases in height to the north west. There is one main waterbody situated in the mid-south section of the site. There are some cleared areas prevalent in the eastern section of the site.</li></ul>		
Flood potential, surface drainage, water bodies	<ul style="list-style-type: none"><li>There was one main waterbody identified onsite, this dam is surrounded by steep embankments which vary in height from ~0.2 to 2 m above the level of the surface water. Based on these steep banks, it is unlikely that this area will pose a risk to neighbouring properties.</li></ul>

Current site activities	<ul style="list-style-type: none"><li>Used by water authority to supplement Greenbushes water supply.</li></ul>		
Visible signs of contamination	<ul style="list-style-type: none"><li>No visible signs of contamination onsite.</li></ul>	Photo 49: Mount Jones	Photo 50: Mount Jones
Historical mining activity and visible signs of historical mining activities	<ul style="list-style-type: none"><li>Areas with sparse vegetation (Photo 55), evidence of sandy gravels on soils surface (Photo 53), water bodies (Photo 50 and Photo 51) are likely the result of historical mining activities</li></ul>

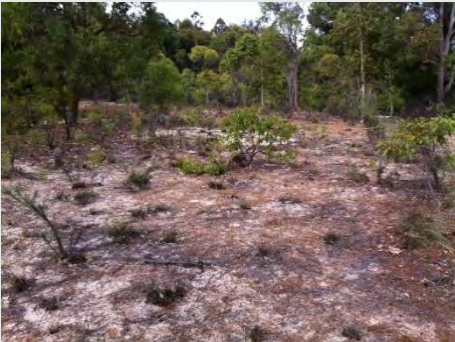
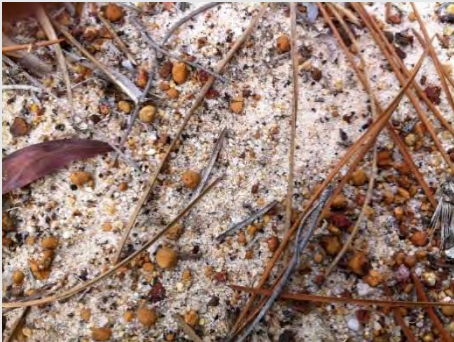
Visible signs of vegetation stress	<ul style="list-style-type: none"><li>No visible signs of vegetation stress, however there are sections to the east of the site, which are sparse to bare of vegetation and lacking established vegetation or bushland.</li></ul>		
Presence of drums, waste and/or fill material	<ul style="list-style-type: none"><li>No drums or fill material identified onsite, one dumped tyre noted within the water body.</li></ul>

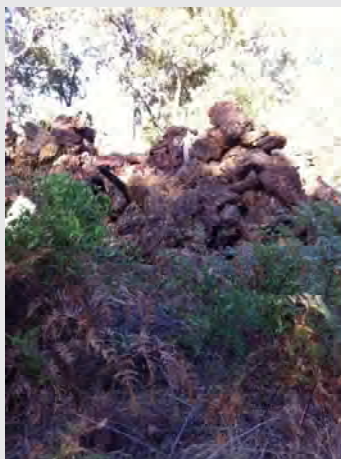
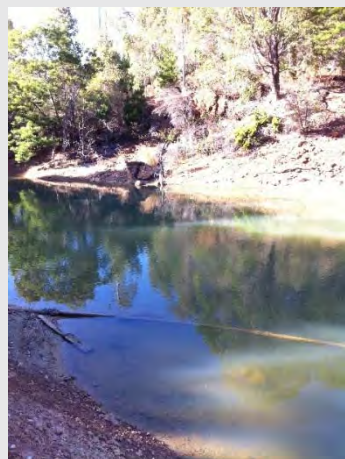
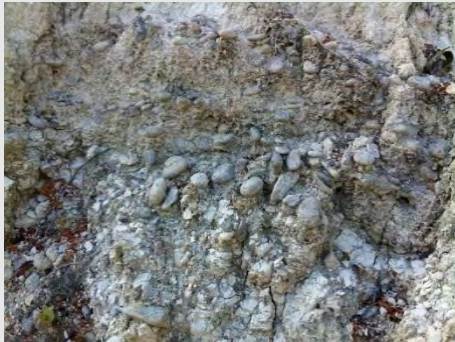
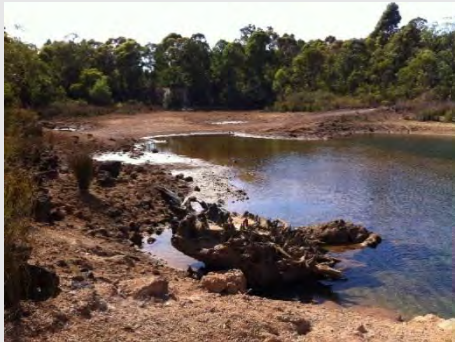
Historical mining activity and visible signs of historical mining activities	<ul style="list-style-type: none"><li>Historical mining activities comprise excavations and water bodies (Photo 56, Photo 57, Photo 59 and Photo 61), and stockpiles of overburden and clays (Photo 58 and Photo 60)</li></ul>		
Visible signs of vegetation stress	<ul style="list-style-type: none"><li>No signs of vegetation stress.</li></ul>		
Presence of drums, waste and/or fill material	<ul style="list-style-type: none"><li>No signs of drums, waste or fill material.</li></ul>

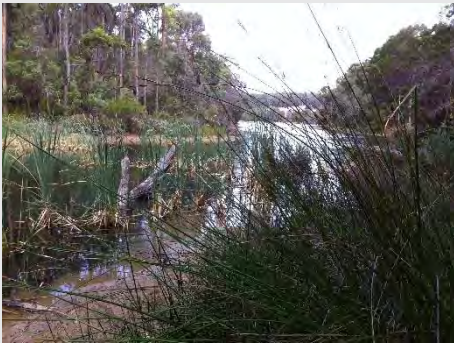
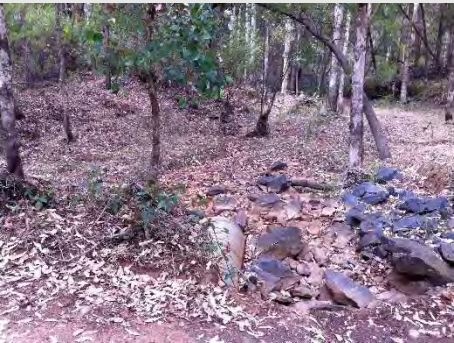
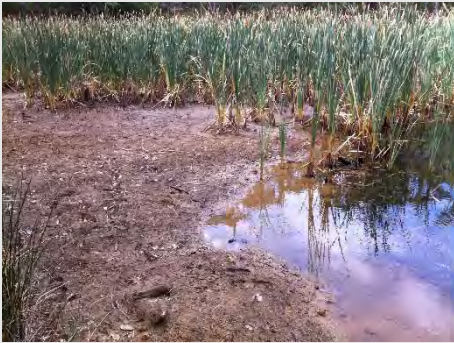
Current site activities	<ul style="list-style-type: none"><li>Walking trails pass through the site.</li></ul>		
Visible signs of contamination	<ul style="list-style-type: none"><li>Evidence of disturbances to soils surface (Photo 65 and Photo 66) and disturbance to current water bodies (Photo 62 and Photo 66) are likely the result of historical mining activities</li></ul>

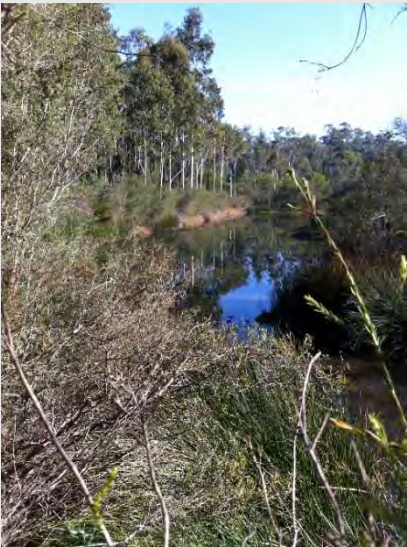
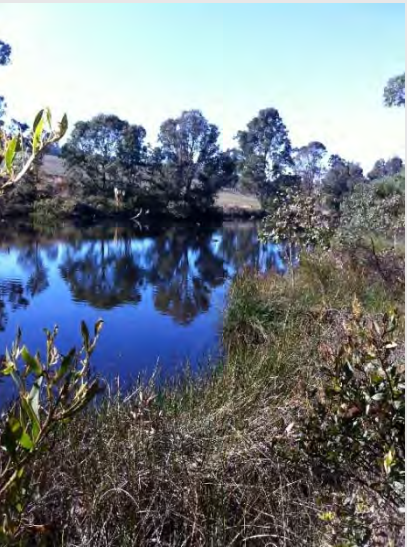
Historical mining activity and visible signs of historical mining activities	<ul style="list-style-type: none"><li>Evidence of sparse vegetation and artificial disturbance to current water bodies/channels (Photo 70 and Photo 75) are likely the result of historical mining activities</li></ul>

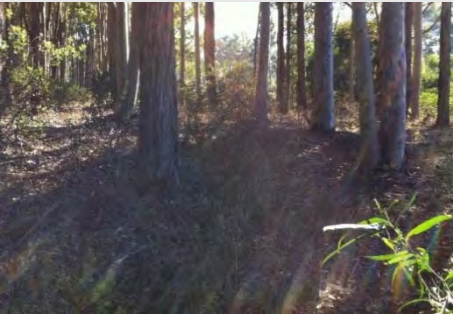
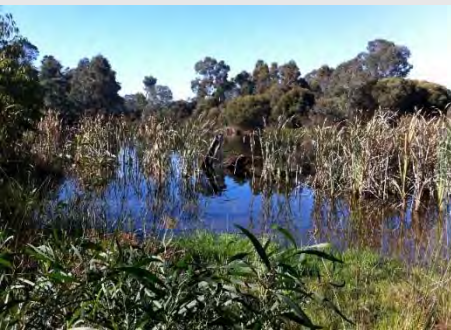
Visible signs of vegetation stress	<ul style="list-style-type: none"><li>No signs of vegetation stress.</li></ul>		
Presence of drums, waste and/or fill material	<ul style="list-style-type: none"><li>No signs of drums, waste or fill material.</li></ul>	Photo 71: Salt Water Gully	Photo 72: Salt Water Gully
Presence, type and conditions of buildings, road or site infrastructure	<ul style="list-style-type: none"><li>No onsite buildings</li><li>Access to the site is via Catterick road, which is located off the South Western Highway.</li></ul>		
Aesthetic Issues (e.g. presence/intensity of odours)	<ul style="list-style-type: none"><li>No signs of any aesthetic issues.</li></ul>		
Nature of site surface (sealed, unsealed, integrity of the seal)	<ul style="list-style-type: none"><li>Unsealed surface – mostly bushland with leaf litter covering over the floor.</li></ul>

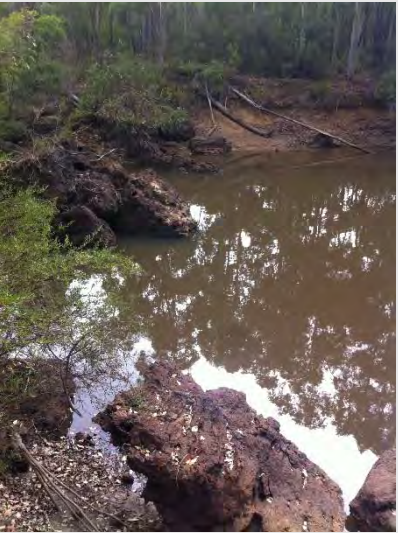
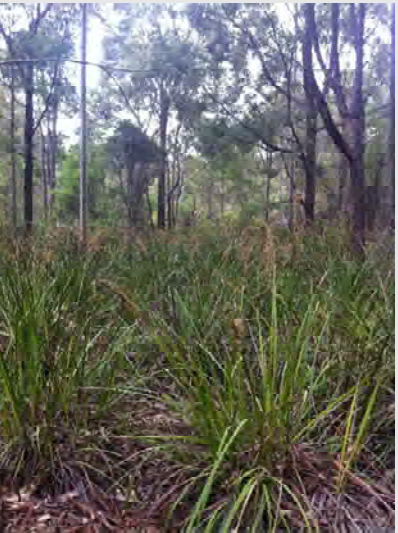
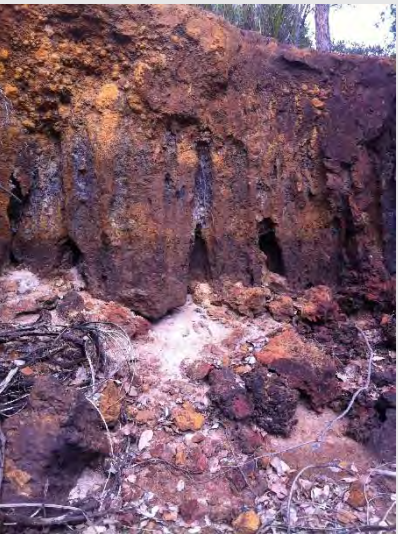
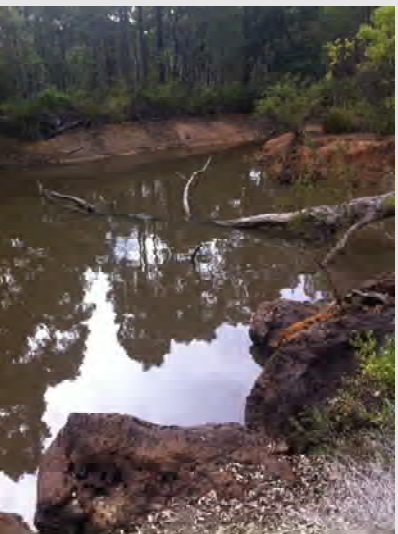
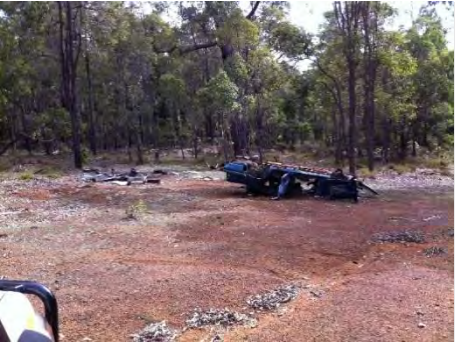
Table 7-19 Scandanavian Gully Site Inspection Notes

Site Inspection Date: 8 May 2018	Waterbody onsite? <input checked="" type="checkbox"/> Yes / <input type="checkbox"/> No	Sample ID (if applicable): SG19	
Criteria	Comments	Site Photos	
Site Access (i.e. tracks, fencing)  - Evidence of access?  Frequency?	<ul style="list-style-type: none"><li>This site is accessible by foot from an unsealed 4WD track, which extends from Stanifer Street. The southwest highway is located within 200 m north of the site.</li><li>This site does not appear to be frequently accessed, however has been noted to be positioned at a junction between the mine site and the town power supply.</li></ul>

Current site activities	<ul style="list-style-type: none"><li>There were no current site activities identified for this site.</li></ul>		
Visible signs of contamination	<ul style="list-style-type: none"><li>There were no visible signs of contamination onsite.</li></ul>		
Historical mining activity and visible signs of historical mining activities	<ul style="list-style-type: none"><li>Some signs of historical mining practices occurring onsite, particularly evidence of historical groundwork activities (e.g. excavations).</li></ul>	Photo 75: Scandanavian Gully	Photo 76: Scandanavian Gully
Visible signs of vegetation stress	<ul style="list-style-type: none"><li>No visible signs of vegetation stress.</li></ul>

Aesthetic Issues (e.g. presence/intensity of odours)	<ul style="list-style-type: none"><li>No aesthetic issues apart from some evidence of historical groundworks onsite.</li></ul>		
Nature of site surface (sealed, unsealed, integrity of the seal)	<ul style="list-style-type: none"><li>The site surface is unsealed and predominantly consisting of sandy soils.</li></ul>		
Presence, location and types of stockpiles materials	<ul style="list-style-type: none"><li>There were no stockpiled materials identified onsite.</li></ul>

Illegal occupation and illegal dumping potential	<ul style="list-style-type: none"><li>There was some illegal dumping of car parts identified to the south east of the site.</li></ul>		
Local use of ground/surface waters and evidence of groundwater bores/surface water abstraction	<ul style="list-style-type: none"><li>There was no evidence of local use of groundwater or surface water onsite.</li></ul>

Presence and condition of water bodies/groundwater bores	<ul style="list-style-type: none"><li>There was one water body identified onsite, no evidence of impacts were noted (visual/olfactory).</li></ul>		
Surrounding land uses	<ul style="list-style-type: none"><li>State forest.</li></ul>		
Location of receptors on and within 500 m of site boundary including sensitive receptors	<ul style="list-style-type: none"><li>With the exception of the State forest, there were no receptors identified within 500 m of the site boundary.</li></ul>	Photo 79: Scandanavian Gully

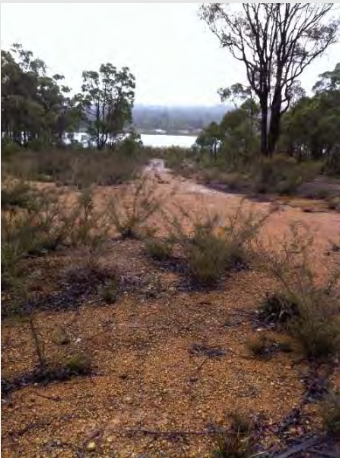
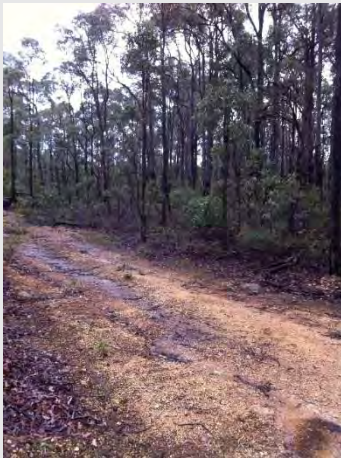
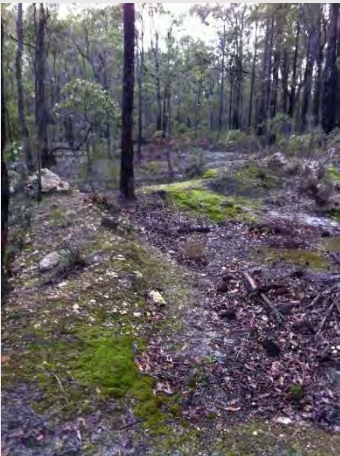
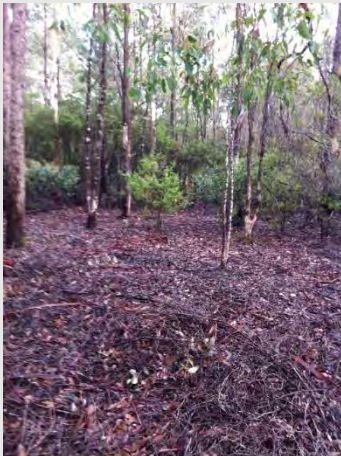
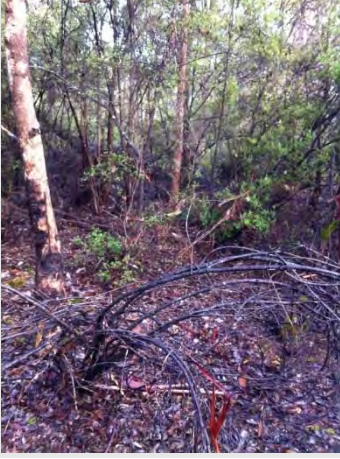
### Table 7-20 Southhampton West Site Inspection Notes

</div>	
Topography and other site features	<ul style="list-style-type: none"><li>The site slopes slightly to the north east and is situated at an elevation of between 260-270 m AHD.</li></ul>		
Flood potential, surface drainage, water bodies	<ul style="list-style-type: none"><li>Based on the topography of the site it is likely that surface drainage will flow to the north east of the site likely into the dam located in this location.</li></ul>

</div>	
Historical mining activity and visible signs of historical mining activities	<ul style="list-style-type: none"><li>Areas of sparse vegetation (Photo 81, Photo 82, Photo 83 and Photo 84) and disturbed surface soils were noted (Photo 81 and Photo 82)</li></ul>		
Visible signs of vegetation stress	<ul style="list-style-type: none"><li>There were no visible signs of vegetation stress during the site inspection.</li></ul>		
Presence of drums, waste and/or fill material	<ul style="list-style-type: none"><li>There were no drums, waste or fill material identified during the site inspection.</li></ul>

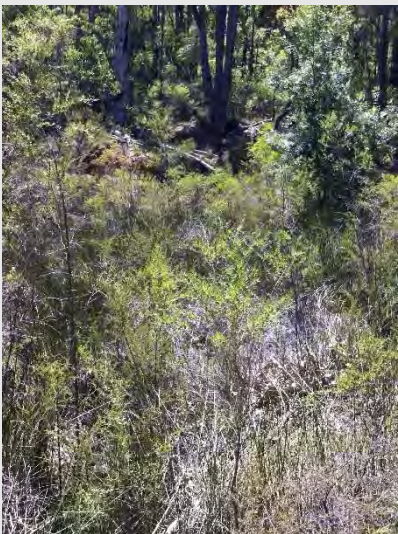
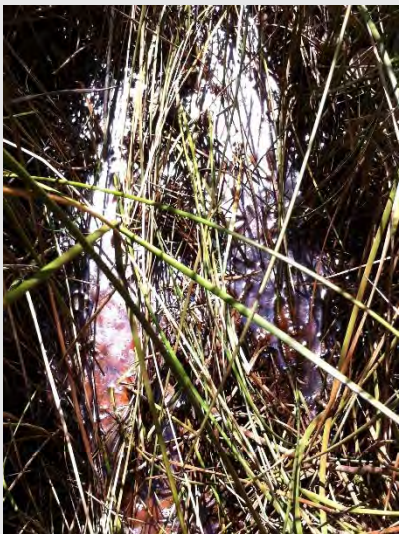
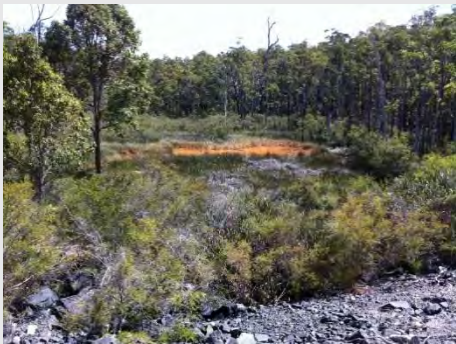
Table 7-21 Spring Gully Site Inspection Notes

Topography and other site features	<ul style="list-style-type: none"><li>This site appears to be relatively flat with the exception of the southern portion of the site, which appears to increase by up to approximately 10 m in elevation. This portion of the site extends out of Spring Gully. The elevation of the banks increases between approximately 0.5 - 2 m out of the gully area.</li></ul>

Flood potential, surface drainage, water bodies	<ul style="list-style-type: none"><li>Drainage onsite would likely flow into the gully region and nearby shallow water bodies. It is unlikely that flooding into neighbouring areas would occur.</li></ul>		
Current site activities	<ul style="list-style-type: none"><li>Greenbushes loop walking trail crosses through a portion of this site.</li><li>Old access roads to the site have been closed off.</li></ul>		
Visible signs of contamination	<ul style="list-style-type: none"><li>Iron staining was identified at the foot of Swenkies Dam (eastern areas of the Site). This area was not able to be accessed during the site inspection (see Photo 88).</li></ul>	Photo 85: Spring Gully	Photo 86: Spring Gully
Historical mining activity and visible signs of historical mining activities	<ul style="list-style-type: none"><li>Some ground disturbance was noted on the banks of the gully (sandy material/probably tailings)</li></ul>
