**Talison Lithium Limited**  
Rehabilitation of Historical Mining Areas  
Preliminary Contaminated Sites Assessment,  
Greenbushes, Western Australia

December 2018

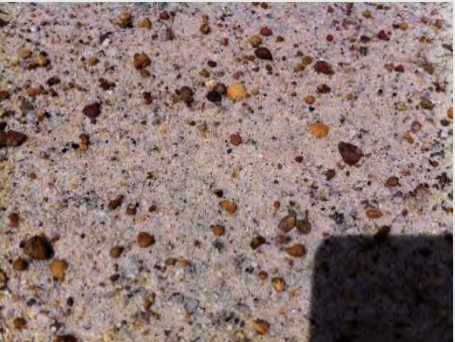
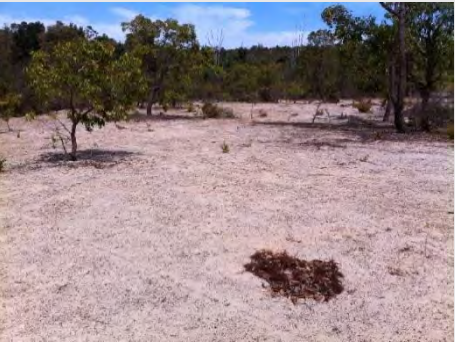
Table 7-22 Swenkies Site Inspection Notes

Current site activities	<ul style="list-style-type: none"><li>The Greenbushes loop (walking trail) passes through this area.</li><li>There were no other current site activities identified onsite.</li></ul>		
Visible signs of contamination	<ul style="list-style-type: none"><li>There were no visible signs of contamination; however, this area has historically used to house gravel and tailings stockpiles.</li></ul>		
Historical mining activity and visible signs of historical mining activities	<ul style="list-style-type: none"><li>Evidence of cleared land and baron soils (coarse sands or gravels, which are the remnant of mineral processing activities onsite) are signs of historical mining activities within this area (Photo 90 and Photo 91).</li></ul>		
Visible signs of vegetation stress	<ul style="list-style-type: none"><li>Evidence of clearing was prevalent with sparse vegetation coverage noted onsite.</li></ul>

Presence of drums, waste and/or fill material	<ul style="list-style-type: none"><li>There were no drums, waste of fill materials identified onsite.</li></ul>		
Presence, type and conditions of buildings, road or site infrastructure	<ul style="list-style-type: none"><li>There were no buildings or infrastructure identified onsite.</li></ul>		
Aesthetic Issues (e.g. presence/intensity of odours)	<ul style="list-style-type: none"><li>There were no odours or additional aesthetic issues identified onsite (apart from the cleared land detailed above).</li></ul>		
Nature of site surface (sealed, unsealed, integrity of the seal)	<ul style="list-style-type: none"><li>The site comprises of an unsealed surface, which is comprised of coarse sand and gravels.</li></ul>		
Presence, location and types of stockpiles materials	<ul style="list-style-type: none"><li>There were no stockpiles of materials identified during the site inspection, however tailings and gravels have historically been stockpiled onsite.</li></ul>

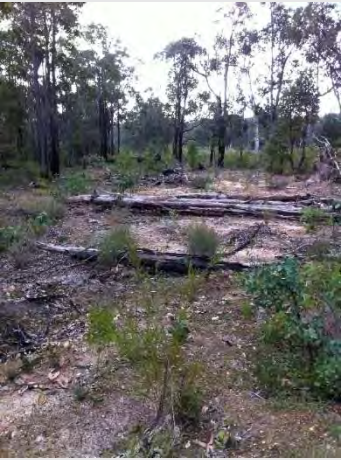
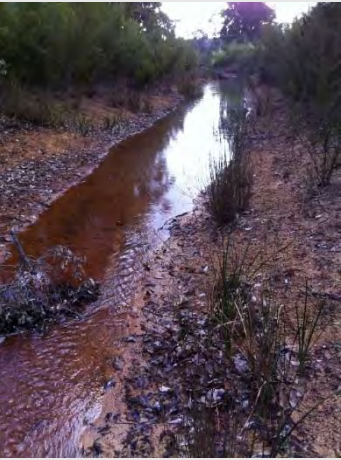
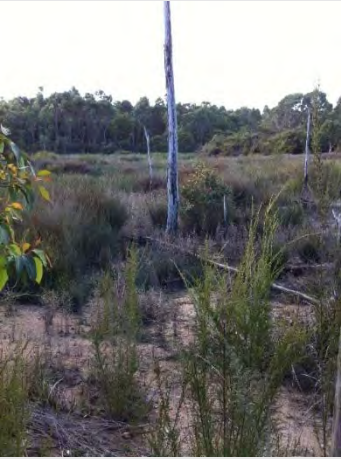
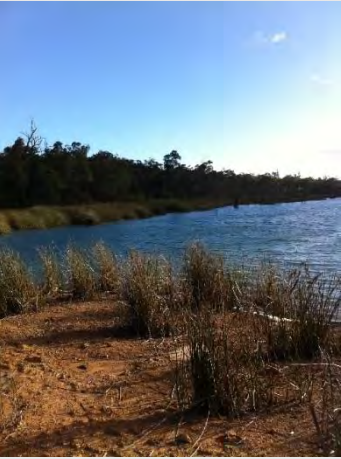
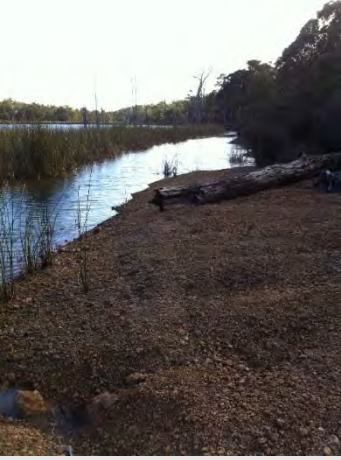
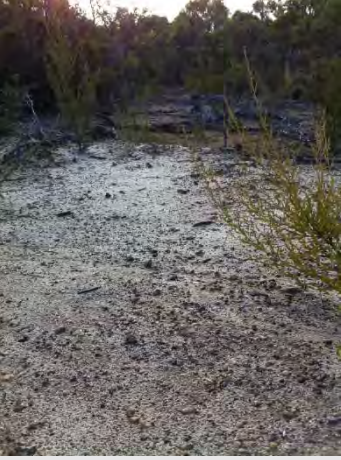
Table 7-23 Swenkies Dam Site Inspection Notes

Topography and other site features	<ul style="list-style-type: none"><li>The site is predominantly flat at an elevation of approximately 250 m AHD. The dam onsite is situated between two earth walls, the dam wall has been buttressed with hardrock.</li></ul>		
Flood potential, surface drainage, water bodies	<ul style="list-style-type: none"><li>The dam present onsite is likely to receive surrounding surface water run off from the north and south of the site based on the surrounding topography. The dam water levels are controlled via a pill way to limit the flooding potential.</li></ul>

Current site activities	<ul style="list-style-type: none"><li>The Greenbushes loop walking trail passes through this area. It is also known for recreational activities including fishing, motor biking, boating and camping.</li></ul>		
Visible signs of contamination	<ul style="list-style-type: none"><li>There was signs of iron staining within the surface water drainage.</li></ul>		
Historical mining activity and visible signs of historical mining activities	<ul style="list-style-type: none"><li>Some cleared vegetation and iron staining to the east of the site. The sand onsite is very coarse with gravels , which is indicative of historical mining practices. There were no other visible signs of historical mining activities onsite.</li></ul>

Presence of drums, waste and/or fill material	<ul style="list-style-type: none"><li>There were no drums, waste or fill materials identified onsite.</li></ul>		
Presence, type and conditions of buildings, road or site infrastructure	<ul style="list-style-type: none"><li>There were no buildings, roads or site infrastructure present onsite.</li></ul>		
Aesthetic Issues (e.g. presence/intensity of odours)	<ul style="list-style-type: none"><li>There were no aesthetic issues identified onsite.</li></ul>		
Nature of site surface (sealed, unsealed, integrity of the seal)	<ul style="list-style-type: none"><li>The site comprises of an unsealed surface, which is comprised of coarse sand and gravels. The portion of the site covered in bushland also has leaf litter covering the floor.</li></ul>

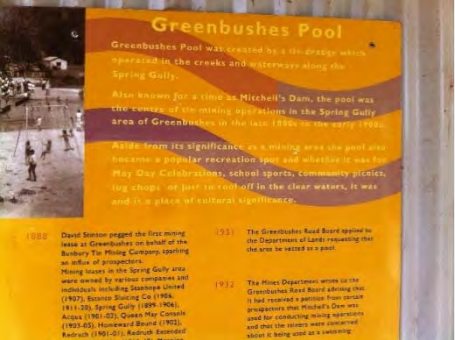
Table 7-24 Swimming Pool Site Inspection Notes

Site Inspection Date: 20 March 2018	Waterbody onsite? <input checked="" type="checkbox"/> Yes / <input type="checkbox"/> No	Sample ID (if applicable): SW09	
Criteria	Comments	Site Photos	
Site Access (i.e. tracks, fencing)  Evidence of access?  Frequency?	<ul style="list-style-type: none"><li>Site access via 4WD track located off Maranup Ford Road or Spring Gully Road.</li><li>This site appears to be accessed by the public quite frequently for swimming, fishing, camping, motorbike activities and boating.</li></ul>

Topography and other site features	<ul style="list-style-type: none"><li>The site slopes to the south and is situated at an elevation of approximately 270 m AHD. This site appears to have a central gully and possibly seasonal shallow water bodies, noted by Talison to be contoured and stable.</li></ul>

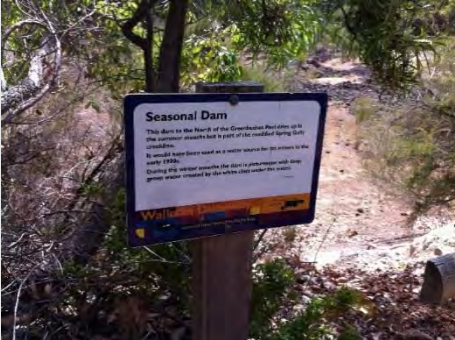
Flood potential, surface drainage, water bodies	<ul style="list-style-type: none"><li>The site is likely to drain down slope to the south, and discharge into Greenbushes Pool (recreational use).</li></ul>

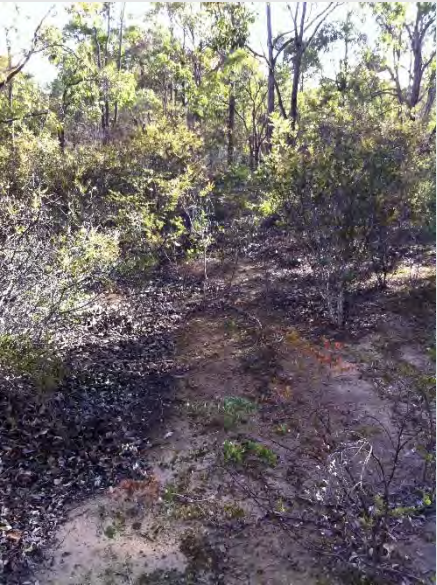
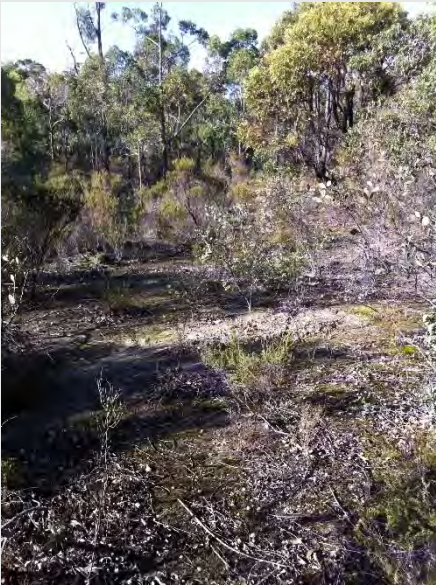
Table 7-25 Swimming Pool West Site Inspection Notes

Topography and other site features	<ul style="list-style-type: none"><li>The site is predominantly flat at an elevation of around 270 m AHD.</li></ul>		
Flood potential, surface drainage, water bodies	<ul style="list-style-type: none"><li>The site would likely drain into Swenkies dam which is located within 250 m south of the site. The topography to the south of the site slopes slightly to around 250 m AHD at the dam. There are no surface water bodies onsite.</li></ul>

Current site activities	<ul style="list-style-type: none"><li>This area is known as a recreational area with the old Greenbushes Swimming pool noted by Talison to be present at the south-eastern corner of this block. This has been used for swimming, fishing, camping and boating. However, there were no waterbodies present during the site inspection.</li></ul>		
Visible signs of contamination	<ul style="list-style-type: none"><li>There were no visible signs of contamination.</li></ul>		
Historical mining activity and visible signs of historical mining activities	<ul style="list-style-type: none"><li>There are sections of sparse potentially cleared vegetation, apart from this there were no obvious signs of historical mining activities.</li></ul>		
Visible signs of vegetation stress	<ul style="list-style-type: none"><li>Apart from the areas with reduced vegetation, there were no signs of vegetation stress present onsite.</li></ul>

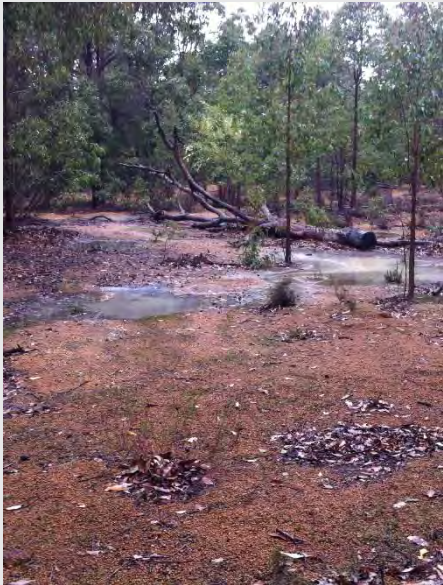
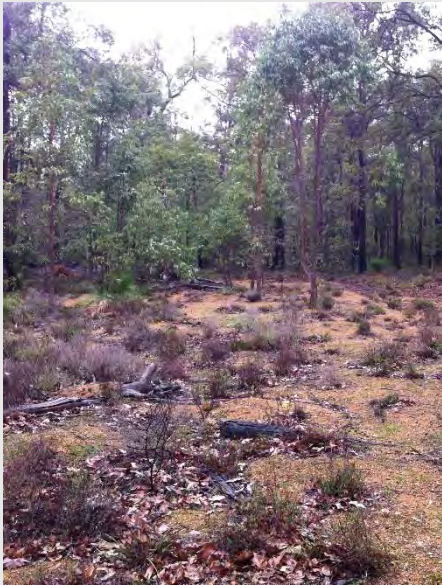
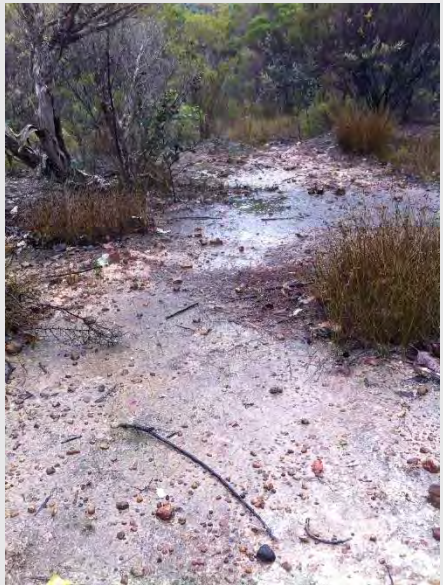
Table 7-26 Teddy Boy Site Inspection Notes

Topography and other site features	<ul style="list-style-type: none"><li>The site slopes slightly to the north but is predominantly flat.</li></ul>		
Flood potential, surface drainage, water bodies	<ul style="list-style-type: none"><li>The surface drainage offsite would likely be down slope to the north.</li></ul>		
Current site activities	<ul style="list-style-type: none"><li>There were no current site activities identified for this site.</li></ul>

Visible signs of contamination	<ul style="list-style-type: none"><li>There were no visible signs of contamination present onsite.</li></ul>		
Historical mining activity and visible signs of historical mining activities	<ul style="list-style-type: none"><li>The site appears to be sparsely vegetated with coarse politic soils,gravels and clays which are inferred be indicative of historical mining practices onsite.</li></ul>		
Visible signs of vegetation stress	<ul style="list-style-type: none"><li>The vegetation onsite is sparse in areas, however there was no other obvious signs of vegetation stress.</li></ul>		
Presence of drums, waste and/or fill material	<ul style="list-style-type: none"><li>There were no drums, waste or fill materials identified onsite.</li></ul>	Photo 101: Teddy Boy	Photo 102: Teddy Boy
Presence, type and conditions of buildings, road or site infrastructure	<ul style="list-style-type: none"><li>There were no buildings, roads or site infrastructure identified onsite.</li></ul>

Presence and condition of water bodies/groundwater bores	<ul style="list-style-type: none"><li>The puddle appeared turbid, likely due to underlying fine soils dissolving into the water. There were no obvious concerns about this surface water observed onsite. There was no other water bodies or groundwater abstraction bores identified onsite.</li></ul>	Photo 103: Teddy Boy	
Surrounding land uses	<ul style="list-style-type: none"><li>State Forest.</li></ul>		
Location of receptors on and within 500 m of site boundary including sensitive receptors	<ul style="list-style-type: none"><li>State Forest.</li></ul>

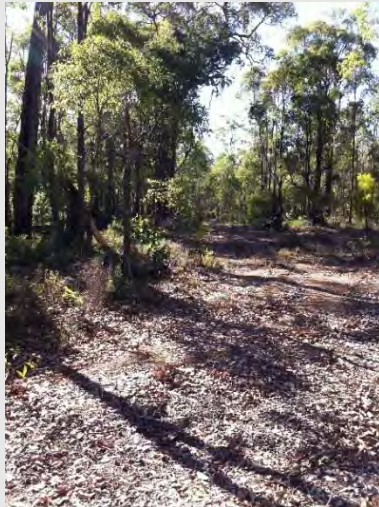
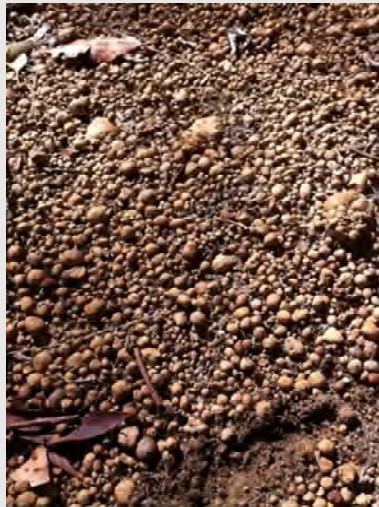
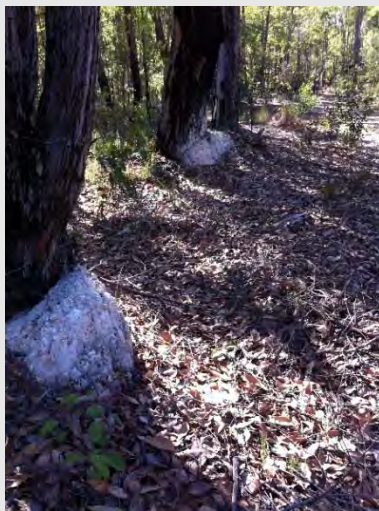
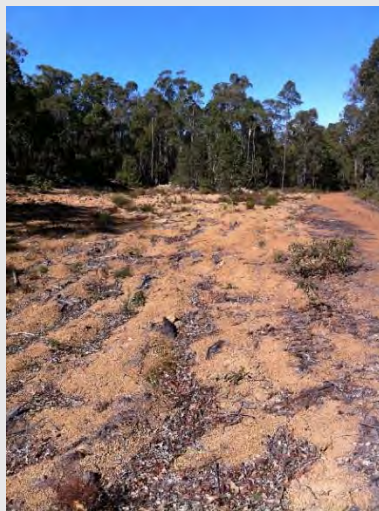
Table 7-27 White Well Site Inspection Notes

Topography and other site features	<ul style="list-style-type: none"><li>The site is predominantly flat.</li></ul>		
Flood potential, surface drainage, water bodies	<ul style="list-style-type: none"><li>There were no surface water bodies identified onsite..</li></ul>		
Current site activities	<ul style="list-style-type: none"><li>There are no known current site activities for White Well.</li></ul>		
Visible signs of contamination	<ul style="list-style-type: none"><li>There are no visible signs of contamination.</li></ul>

Local use of ground/surface waters and evidence of groundwater bores/surface water abstraction	<ul style="list-style-type: none"><li>No use of groundwater or surface water was identified onsite. There was no evidence of groundwater abstractions bores within this area.</li></ul>

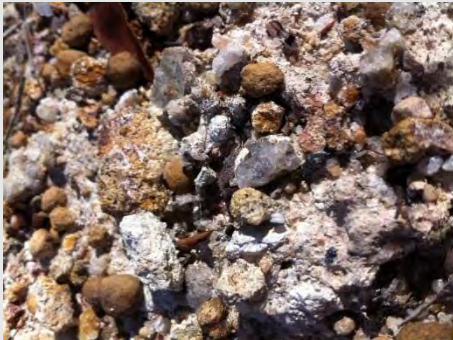
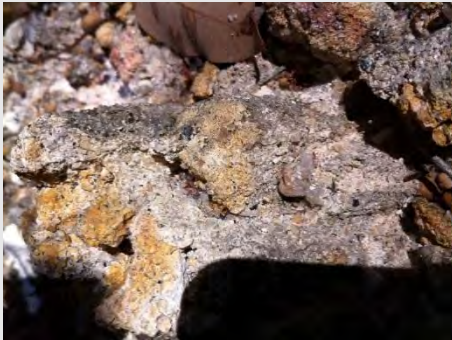
Historical mining activity and visible signs of historical mining activities	<ul style="list-style-type: none"><li>There is evidence of reworked sandy, clays soils which appear as rehabilitated onsite with (Photo 109).</li></ul>		
Visible signs of vegetation stress	<ul style="list-style-type: none"><li>The area consists predominantly of very established bushland, with the exception of the sparse areas of disturbed soil (located off the main access road to site)</li></ul>		
Presence of drums, waste and/or fill material	<ul style="list-style-type: none"><li>There is no evidence of drums or waste, soils appear to comprise reworked/rehabilitated fill material (believed to originate onsite)</li></ul>	Photo 104: White Well	Photo 105: White Well
Presence, type and conditions of buildings, road or site infrastructure	<ul style="list-style-type: none"><li>There were no buildings present onsite. The access road to the site is an unsealed dirt road, which appears to be in good condition.</li></ul>

Aesthetic Issues (e.g. presence/intensity of odours)	<ul style="list-style-type: none"><li>The only aesthetic issue onsite is the sparse area of pisolitic soils identified to the side of the access road, which remains void of vegetation, which appears rehabilitated.</li></ul>		
Nature of site surface (sealed, unsealed, integrity of the seal)	<ul style="list-style-type: none"><li>The site surface is unsealed, comprising predominantly of sandy clay soils.</li></ul>	Photo 106: White Well	Photo 107: White Well
Presence, location and types of stockpiles materials	<ul style="list-style-type: none"><li>There were no stockpiled materials present onsite, with the</li></ul>		
Illegal occupation and illegal dumping potential	<ul style="list-style-type: none"><li>No illegal occupation or illegal dumping activities were identified onsite.</li></ul>
