Dampier Cargo Wharf Extension and Landside Redevelopment Project

Benthic Communities and Habitat Cumulative Loss Assessment

CLIENT: Pilbara Ports Authority

REPORT NUMBER: 21WAU-0068 / R210276

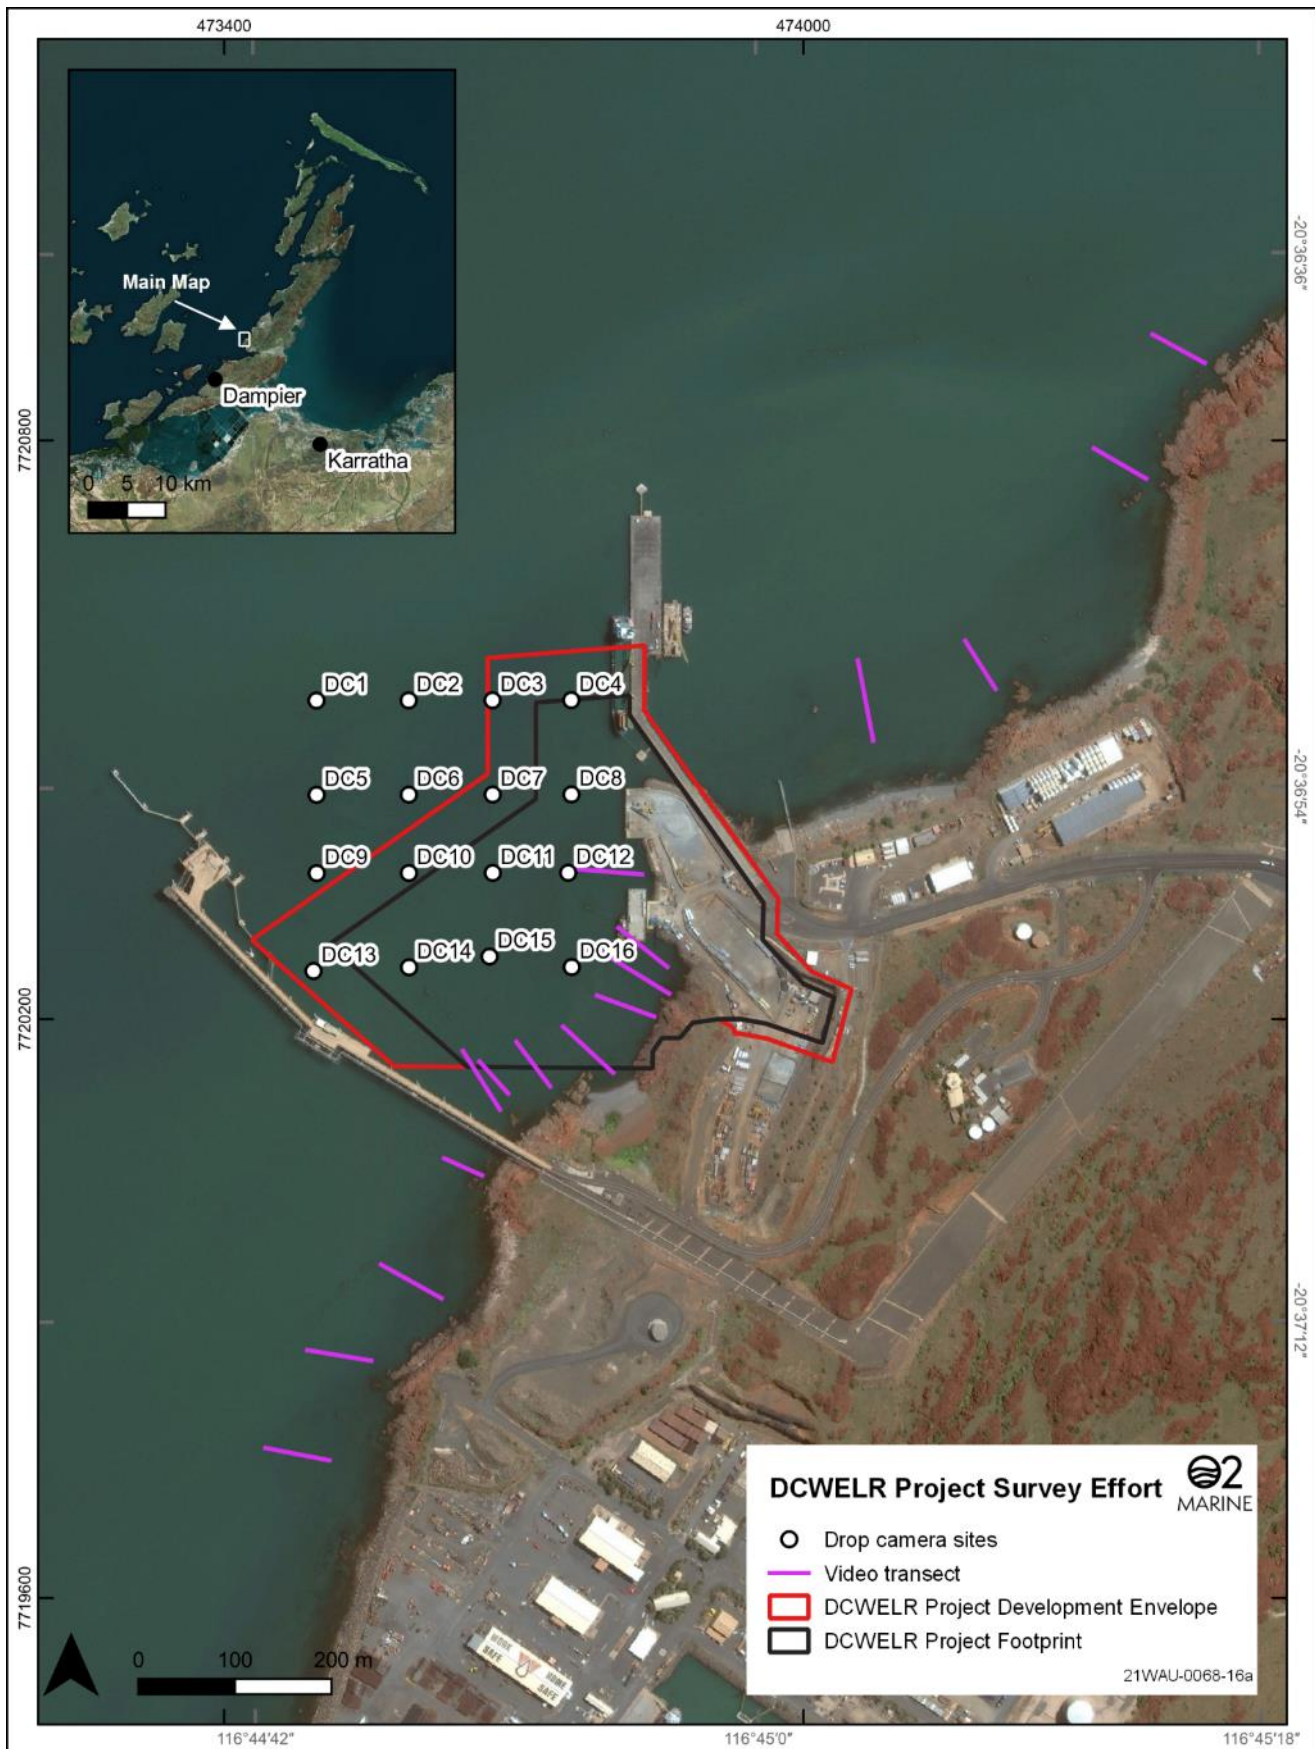
Figure 3 BCH survey transects and drop camera locations within and adjacent to Project Footprint

- a) detailed mapping within and adjacent to the Project Footprint where impacts are most likely to occur (Figure 3).
- b) broadscale ground truthing to validate existing mapping within and adjacent to the established spoil grounds (Figure 4).

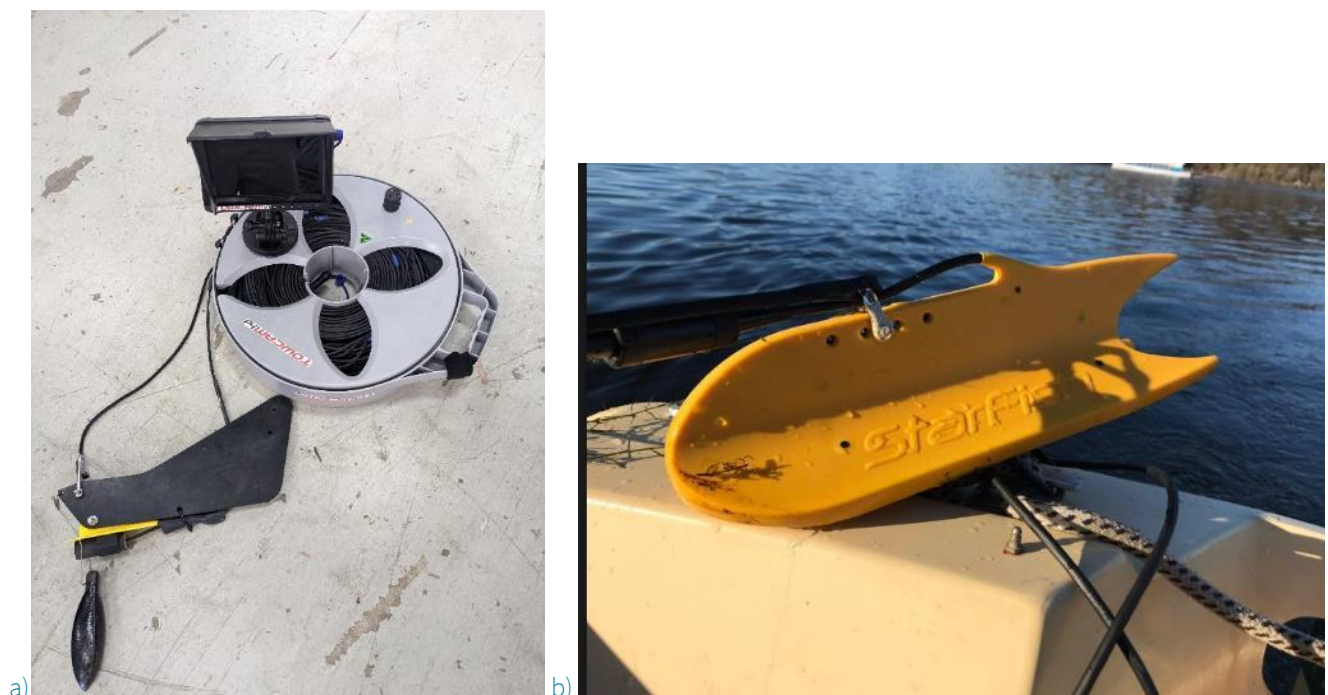
Figure 6 BCH survey equipment: a) TOWCAMhd, b) StarFish 450F Side Scan Sonar.

The 'TOWCAMhd' was utilised as the drop camera at chosen locations from the side scan sonar data.

The two different types of BCH survey equipment are shown in Figure 6.

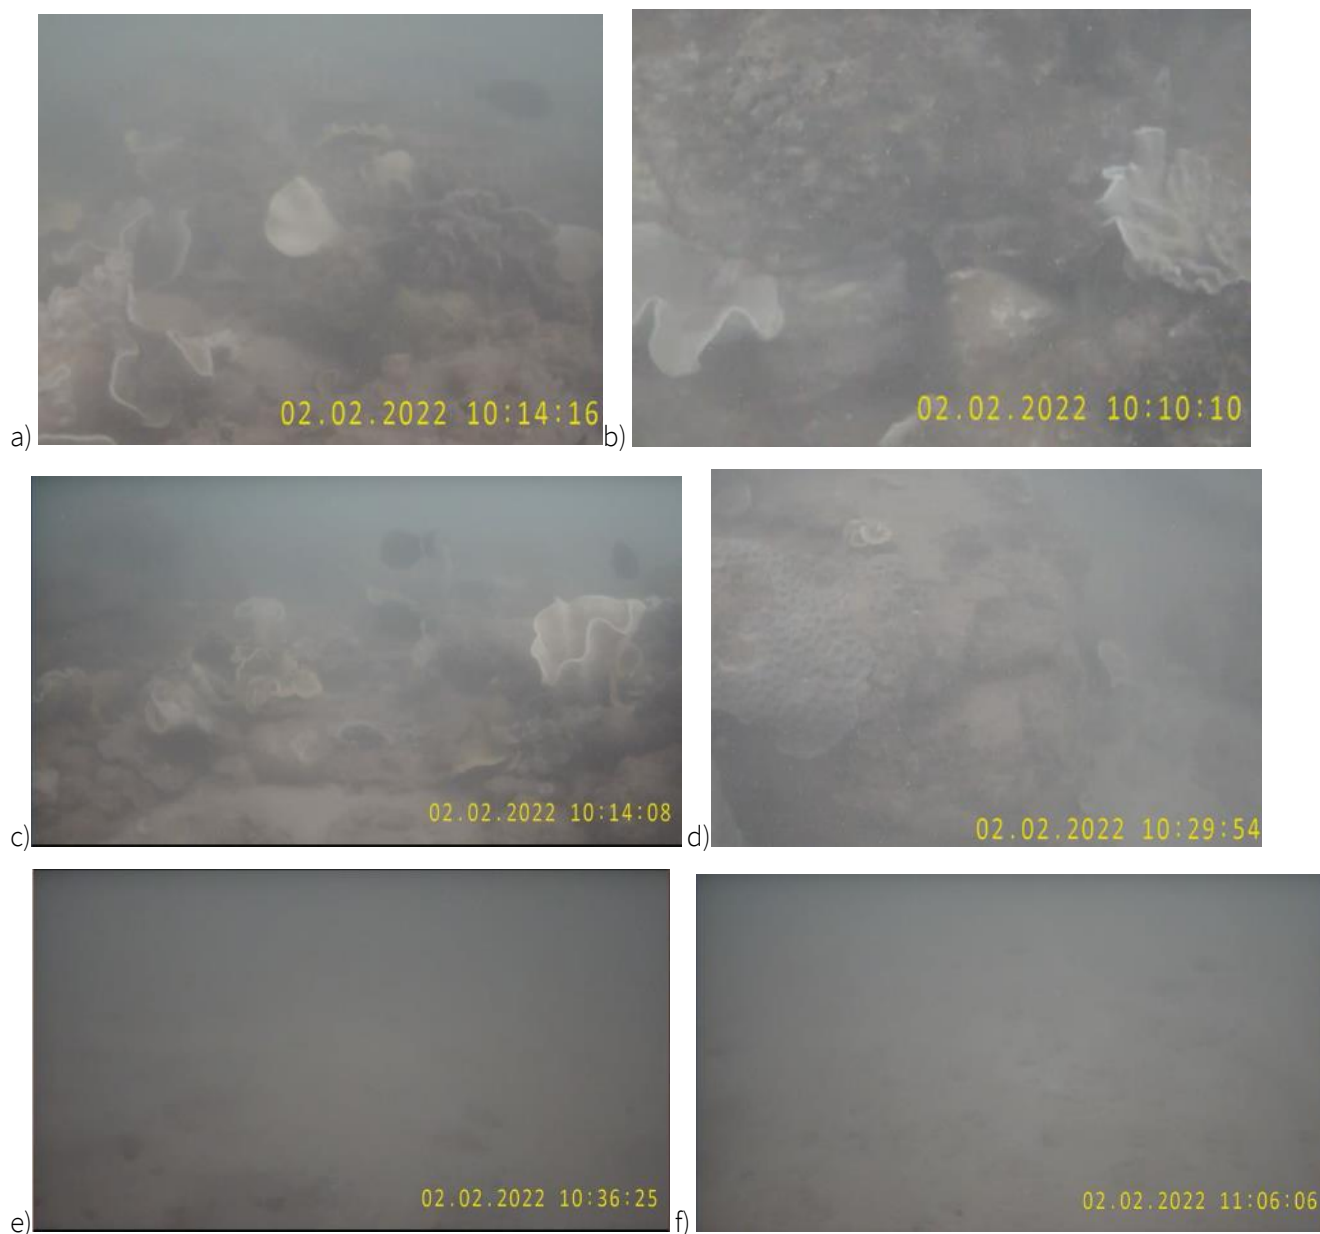
These reefs appear quite healthy with many large and long-lived coral colonies, although some signs of stress and damage was observed with sediment sitting on the surface of some coral colonies, a few partially bleached corals and some partially or completely dead corals. Coral genera in the area are predominantly faviids with *Turbinaria* species, with a mix of other genera making up the remaining cover. There was evidence of new coral recruitment at some locations, with small colonies between 2-10 cm across being relatively common on suitable dead coral substratum, and many fish species were observed on these reefs, both indicative of a healthy reef community.

Images of the fringing coral habitat within the Project Footprint from past (Worley Parsons 2009) and recent (O2 Marine 2022) surveys are shown in Figure 7 a and b) and Figure 8 (a – f).

Figure 7 Coral habitat and bare sediment from DMSF Benthic Habitat Survey (Worley Parsons 2009).

Figure 8 Coral habitat and bare sediment from BCH Validation Survey transects within Project Footprint (O2Marine 2022)

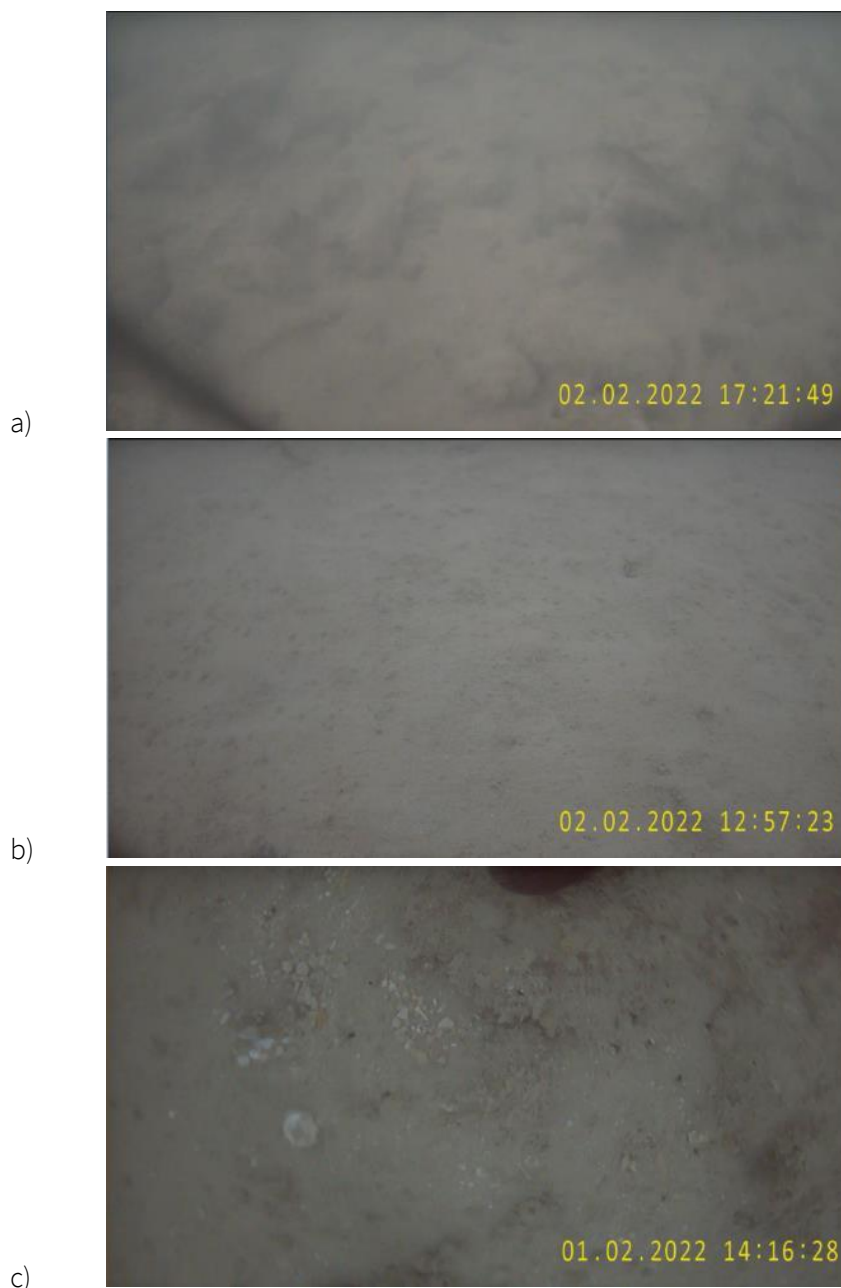
Figure 10 Typical bare seabed found across most of the three established spoil grounds: a) ELI b) A/B c) 2B

Most of the sea floor within the bounds of the established spoil grounds is bare sediment (Figure 10). There are no significant corals within the established spoil grounds. Mixed communities and macroalgae occur in some locations within all the established spoil grounds where there is soft sediment or rubble habitat and where dredge spoil (blasted/dredged rock and rubble) has been previously placed and provides low relief low rugosity habitat.

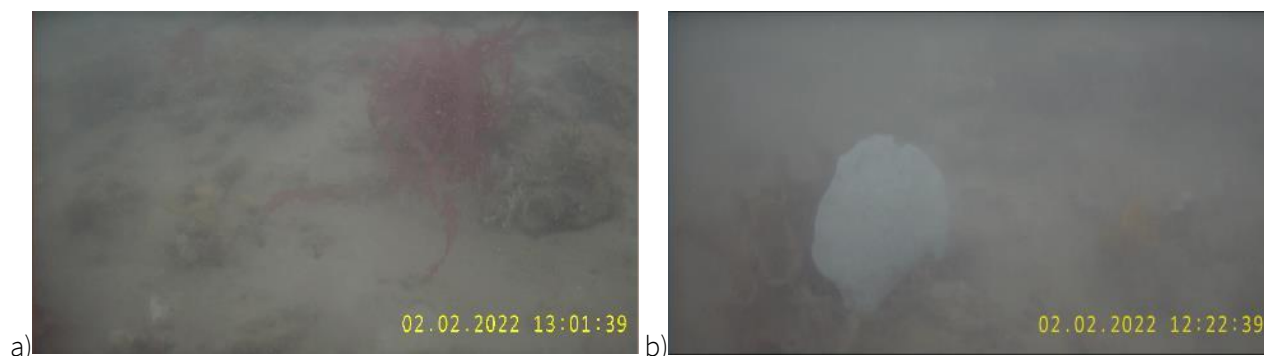
Figure 11 BCH footage from Spoil Ground A/B: a) macroalgae on rubble habitat within A/B b) sponge on rubble habitat just outside A/B

There is moderate cover of mixed communities found just outside the mid-western boundary of Spoil Ground A/B growing on extensive rock and rubble habitat. These communities are clearly resilient as they experience repeated elevated sedimentation as a result of sediment plumes emanating from disposal of spoil at Spoil Ground A/B. Sparse macroalgae and mixed communities are found within Spoil Ground A/B on soft sediment or on natural or disposed rock/rubble (Figure 11).

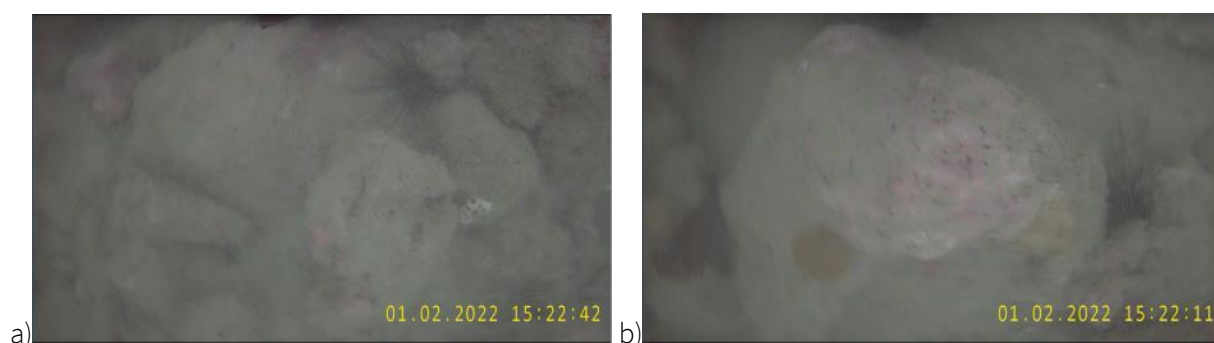
Figure 12 Previously disposed rock and rubble with mixed community and invertebrates in Spoil Ground 2B

Very little BCH is present within Spoil Ground 2B. Sidescan sonar and drop camera footage identified soft sand with isolated low density mixed communities and invertebrates growing on previously disposed rock in the southwest of the spoil ground (Figure 12).

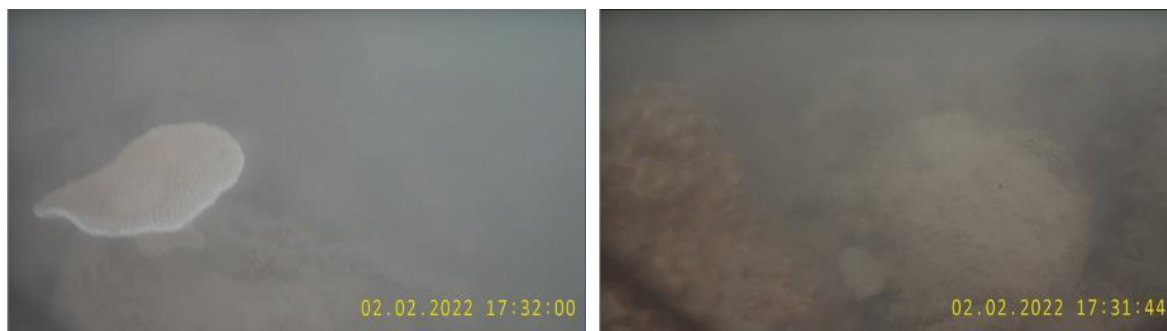
Figure 13 Coral communities growing on previously disposed rock/boulders in southwest corner of Spoil Ground ELI

Coral communities were observed that had colonised blasted/dredged rock previously disposed of in the southwest corner of Spoil Ground ELI (Figure 13). This finding was unique to Spoil Ground ELI and is probably due to its shallow depth and greater light available for coral growth and survival.
