Memo

To	Enrico Chedid/Adam Parker	Company	Mineral Resources Ltd (MRL)
From	Brieland	Job No.	326C
Date	07/07/2021	Doc No.	006 b
Subject	Lamb Creek Surface Water Monitoring Installation and Monitoring Data Review – December 2020 to February 2021

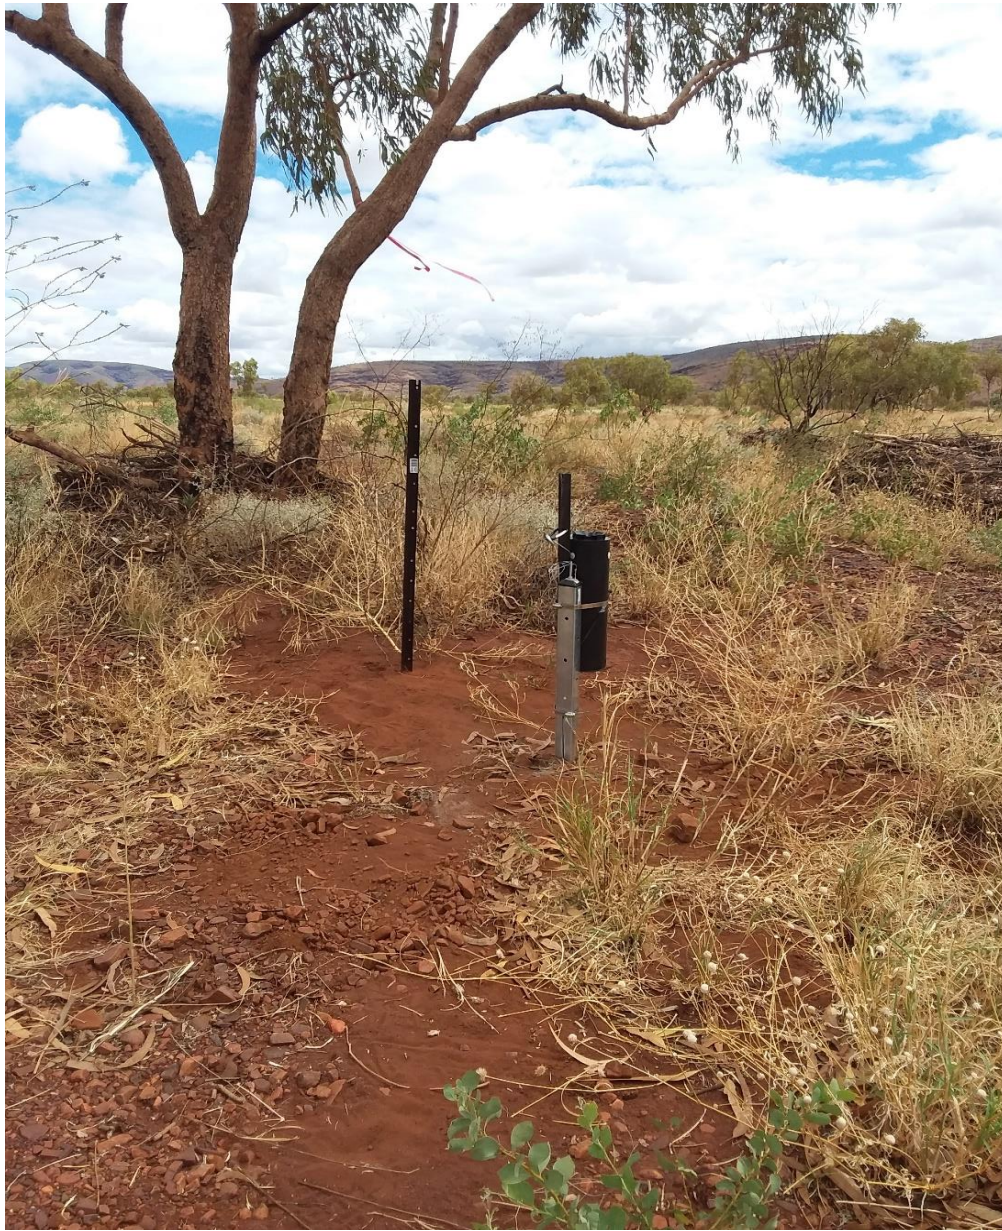
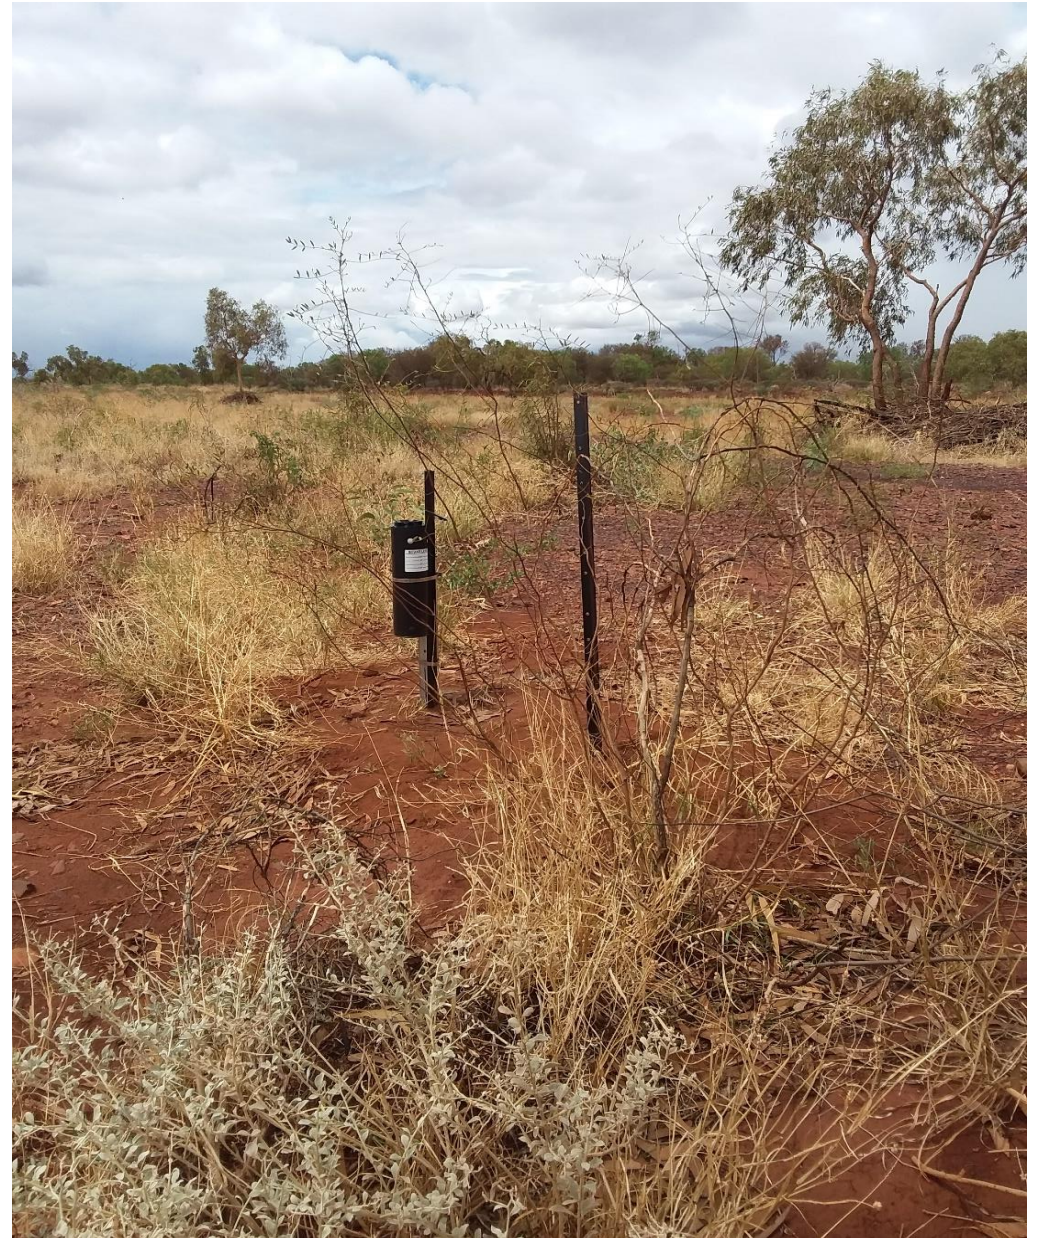
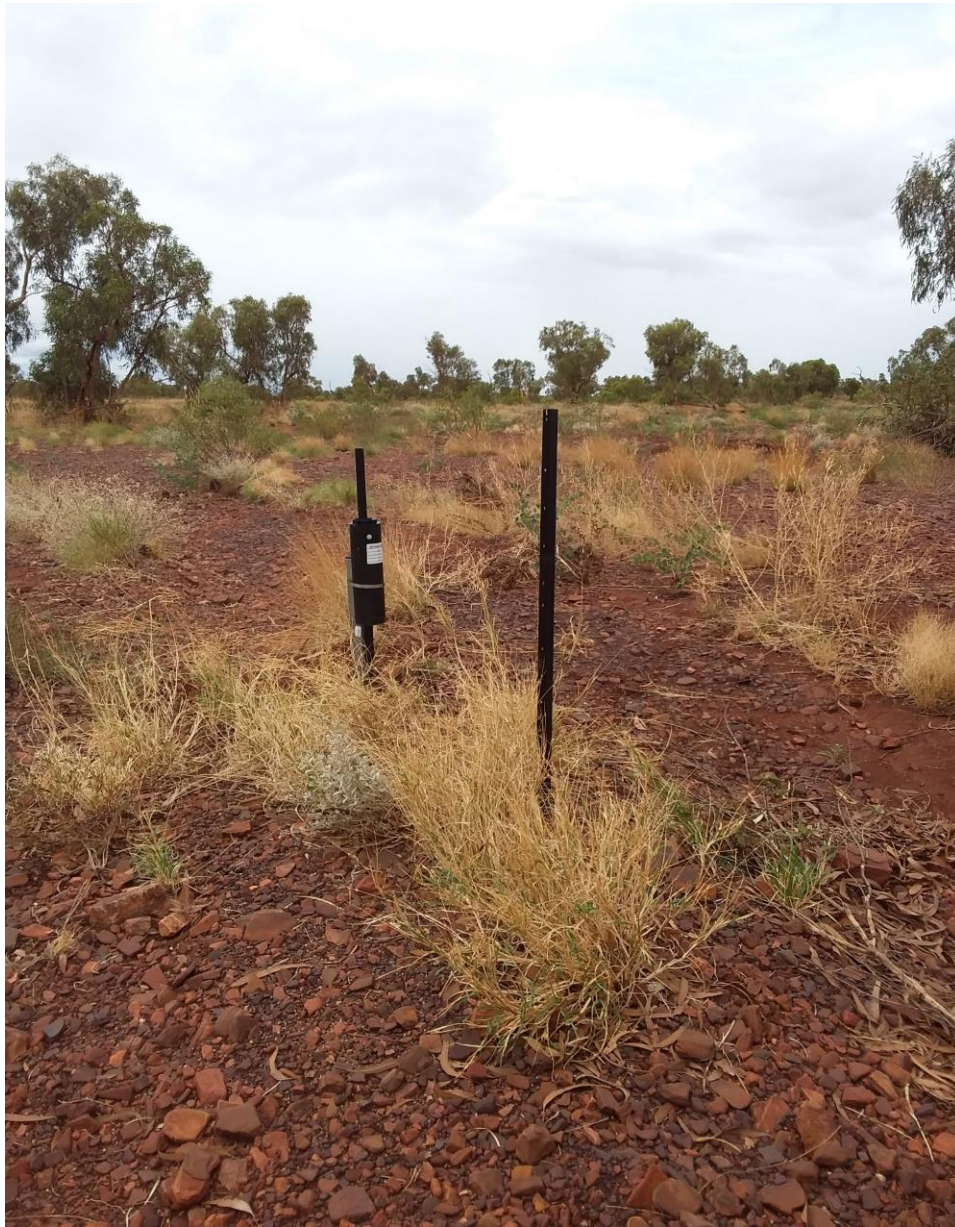
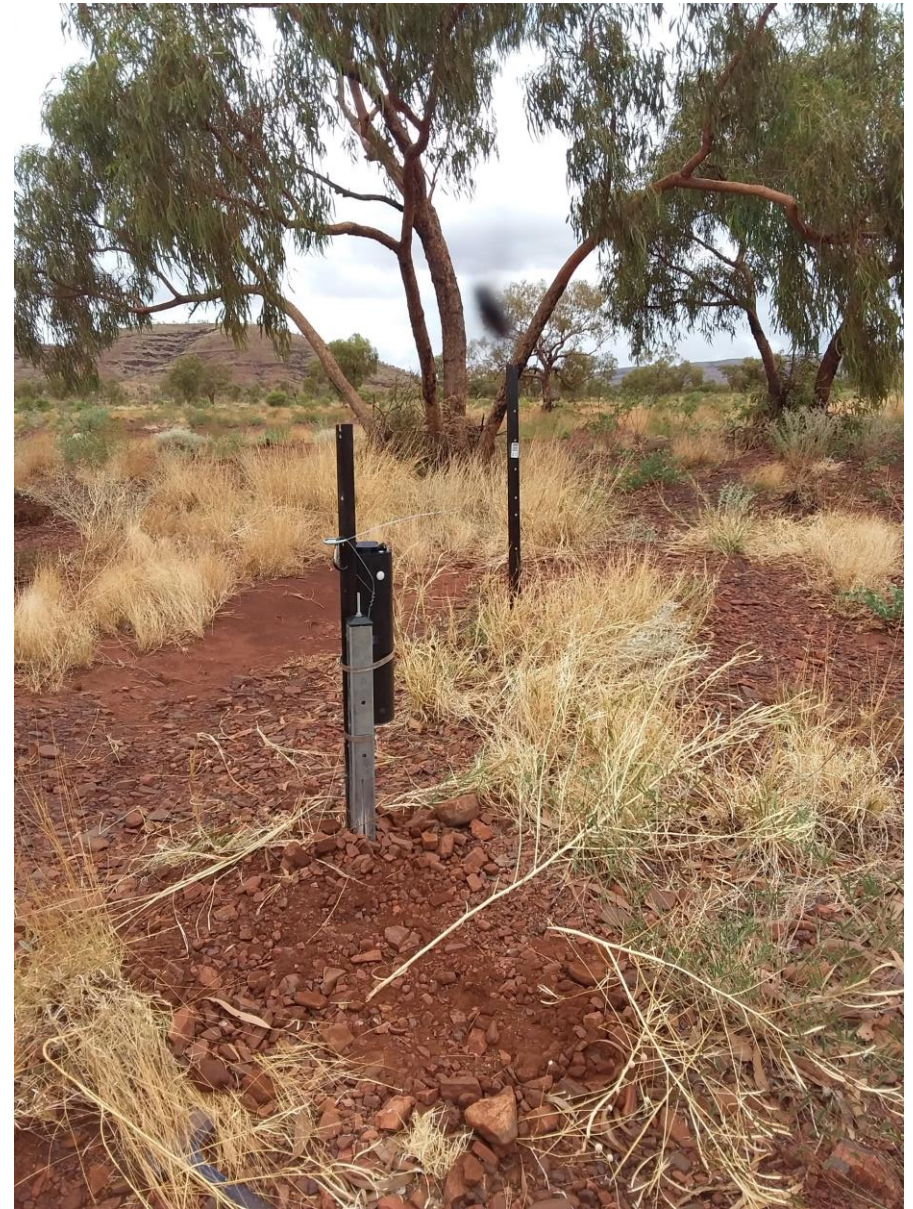
PHOTOS

Mounting kits (with sample bottles inside) were attached to the same star picket as the logger housing at a height of approximately 300mm above the base of the creek. An installation summary is shown below in Table 1, with photos of the installations shown in Photos 1 and 2.

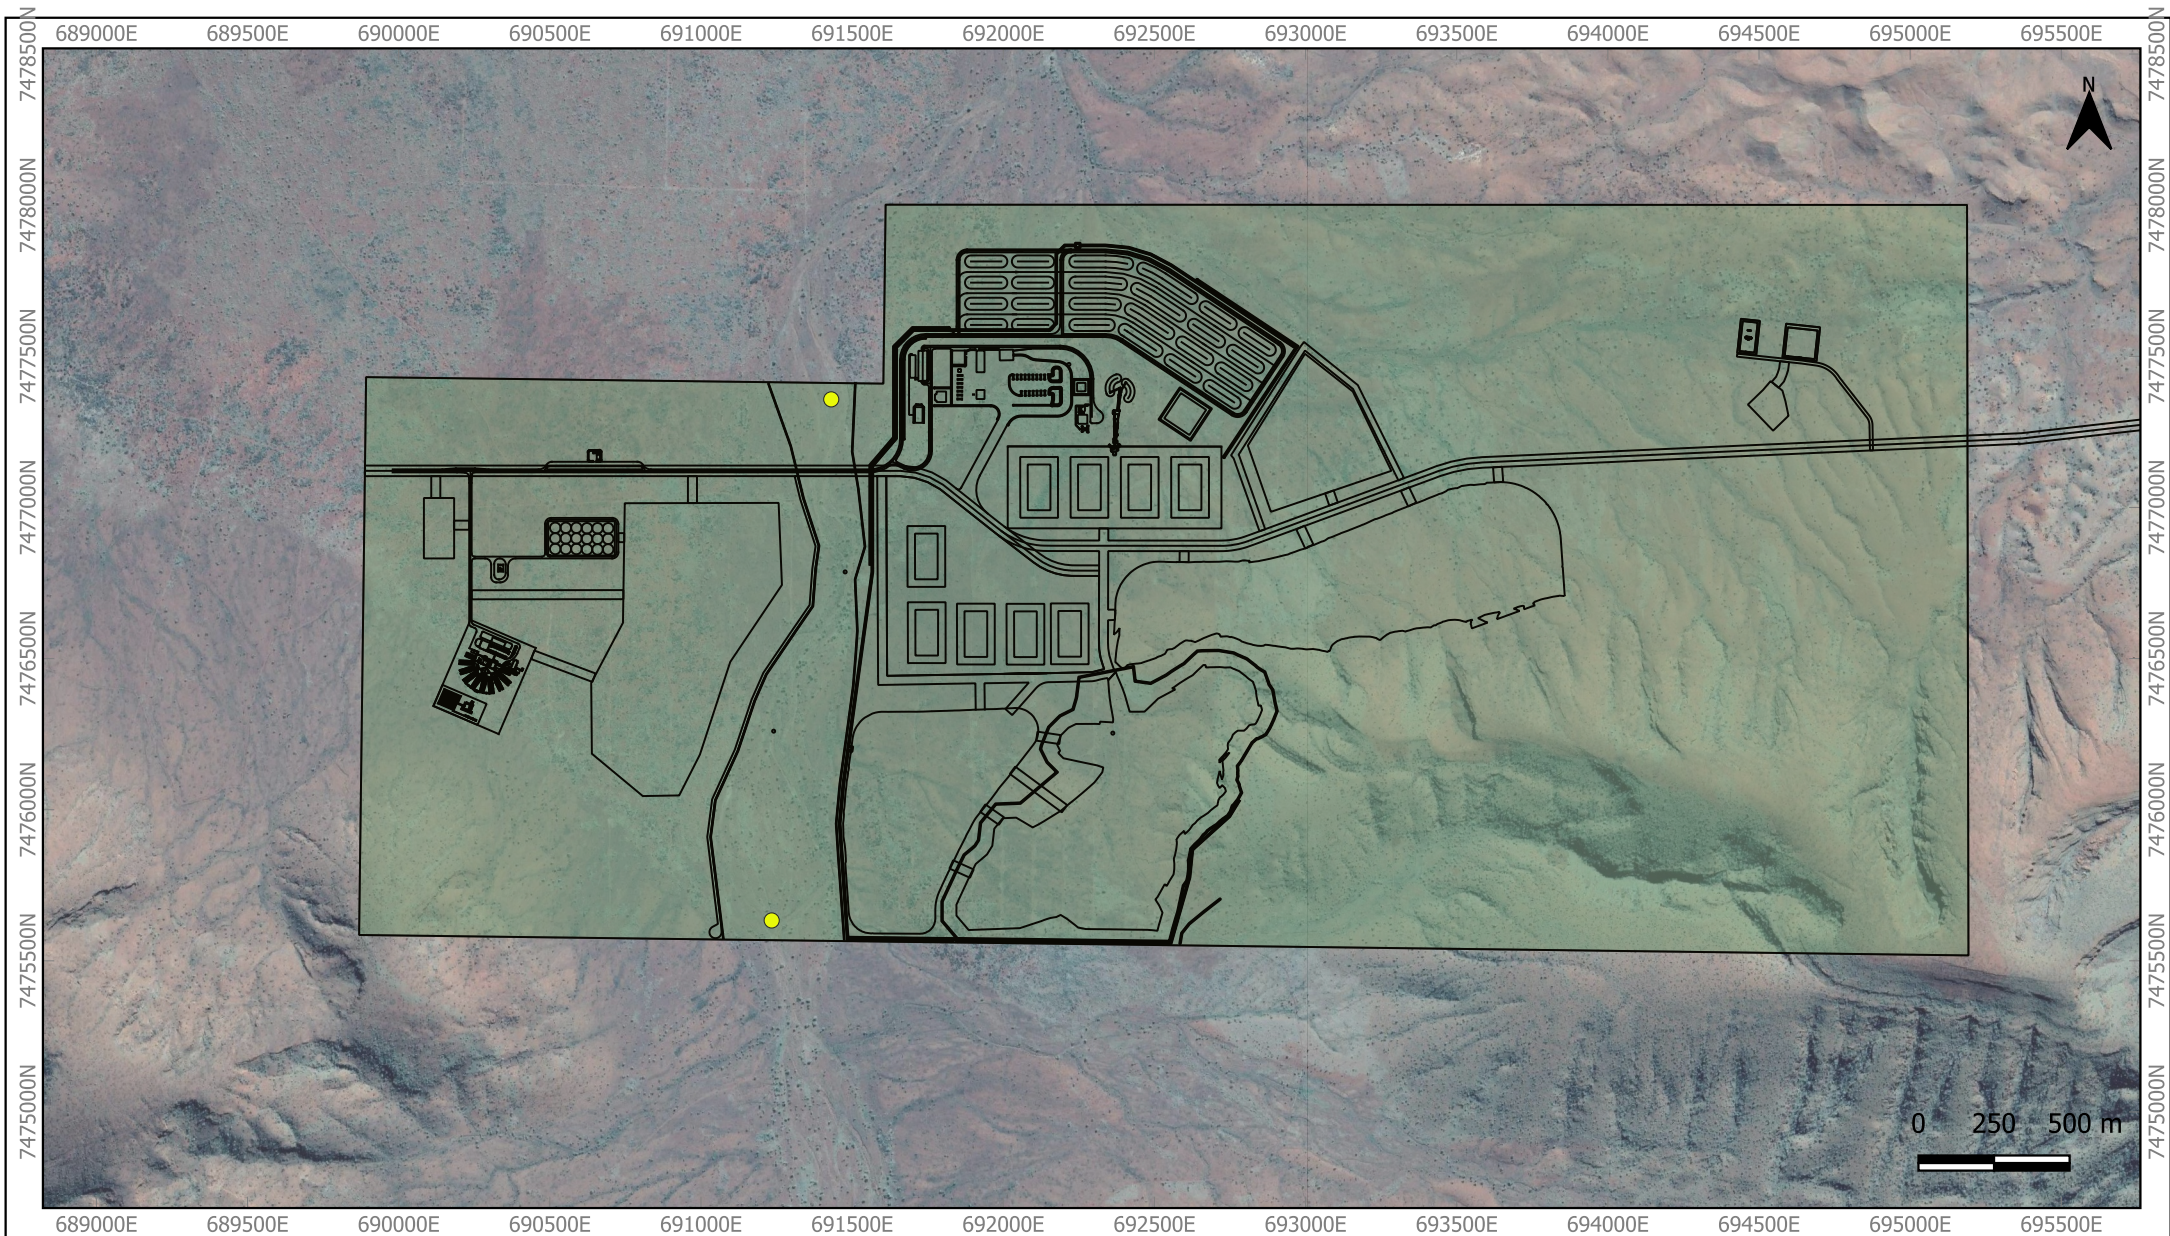
Figure 2

The location of the two monitoring stations that were installed at the Lamb Creek project area are shown in Figure 2. The stations were positioned such that Lamb Creek South is positioned within the main drainage line close to the lease boundary on the upstream side of the project and can be used for reference water quality/flow information. Lamb Creek North was positioned in the same drainage line but at the lease boundary downstream of the proposed project development. Lamb Creek North would provide water quality/flow information at a point where the proposed operations have the potential to impact the surface water regime. Note that the mine layout includes some infrastructure which is located downstream of the Lamb Creek North gauging site, but it was not possible to install a gauging site on the creek line further downstream within the tenement boundary.

Surface Water Monitoring Locations
