# **Contaminated Sites Desk Study**

## **Calingiri Copper Project Caravel Minerals**

**Revision No 1  
May 2018**

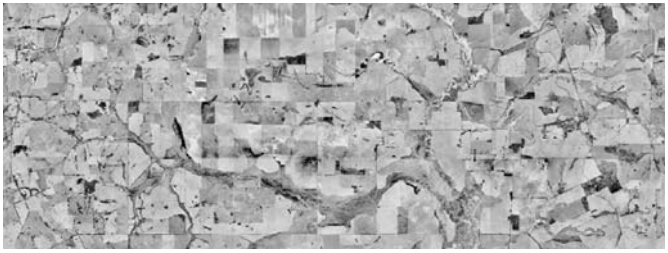
Year: Observation	Image Location within Project	Image
<b>1999:</b> Land has been cleared and appears to be operating for agricultural purposes.

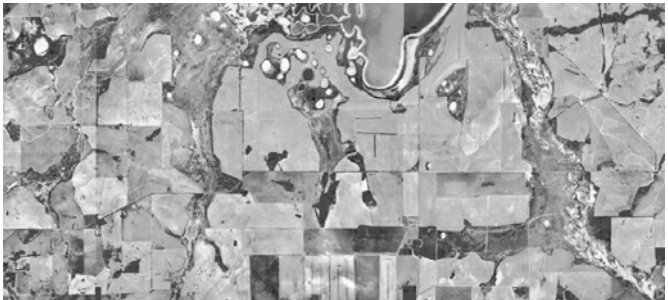
<b>2000:</b> Crop fields can be identified. A rural property is positioned to the South of Lake Ninan.

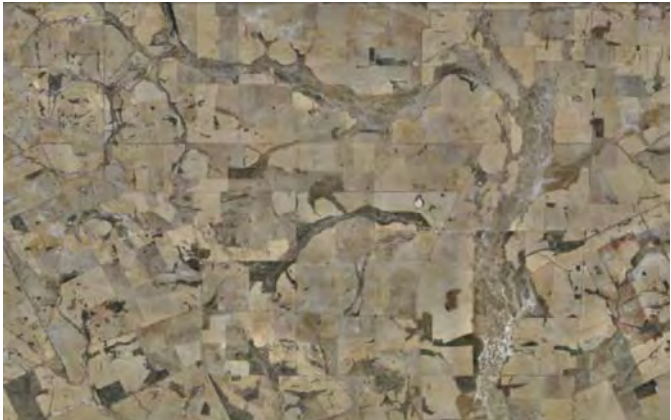
<b>2006:</b> Crop fields and agriculture related infrastructure can be identified.

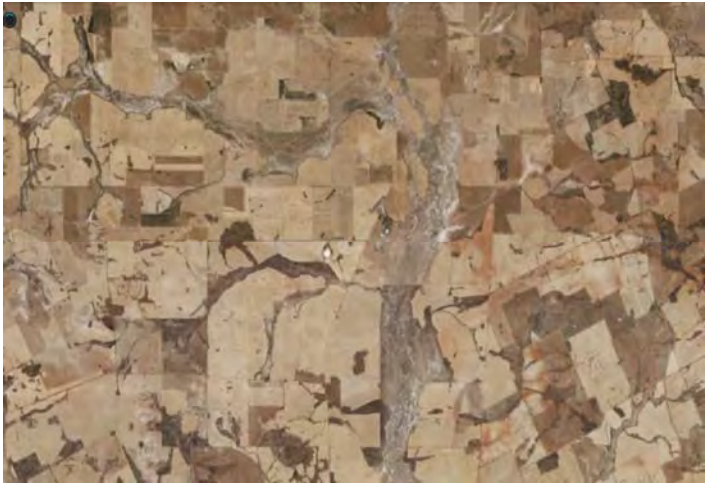
Year: Observation	Image Location within Project	Image
2017: Land uses consistent with previous observations.
