Pluton Resources

Report for Irvine Island Mine Pre-Feasibility Study Groundwater Investigations

July 2011

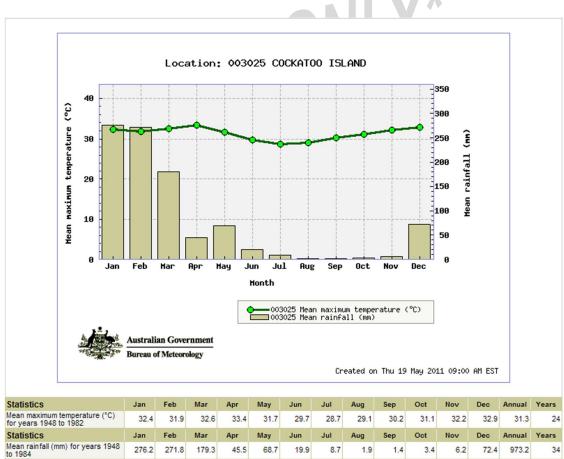
Temperatures are relatively constant with mean maximum temperatures at nearby Cockatoo Island ranging from 28.7°C in July to 33.4°C in April for Cockatoo Island and from 28.2 in July to 35.3 in November for Cygnet Bay (Figure 2).

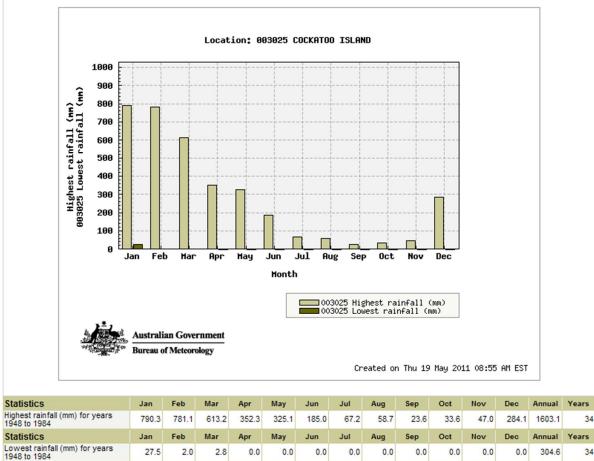
Figure 3 Cockatoo Island climate statistics, rainfall variability (BOM, 2011)

High rainfall events are commonly associated with tropical low pressure systems and cyclones. Being associated to such low pressure systems, rainfall is highly variable (Figure 3) and (

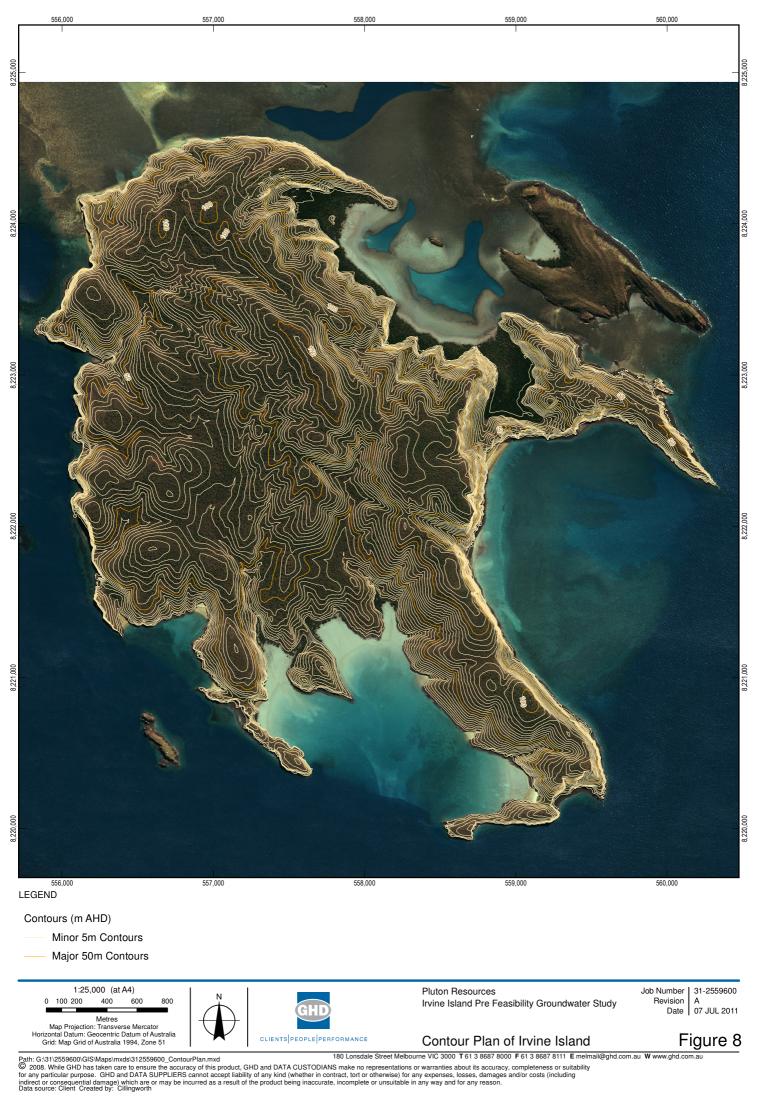
All drainage features appear to be ephemeral and no known permanent water pools are known to occur on the island. The most prominent drainage feature appears to be structurally controlled along a NW-SE striking lineament to the north of the Hardstaff Peninsula (Figure 8). Other drainage features drain small catchment in the undulating terrain and all flow ephemerally into the ocean.

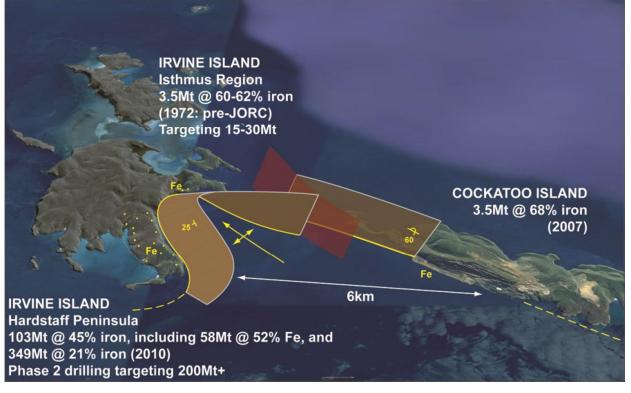
Figure 9 Irvine Island deposit geometry and resource

The geology of Irvine island comprises an extension to the stratigraphy and structure occurring on Cockatoo and Koolan islands in the Yampi sound area, (Figure 9).

The ·structural pattern is dominated by tight asymmetrical folds extending from Koolan Island to Irvine Island. On Koolan Island the southern limb of the folds are overturned (StockImayar, Figure 1). As this limb extends to Irvine Island the sequence is folded into a plunging anticline the nose of which is exposed in the Isthmus on Irvine Island (see Figure 9)

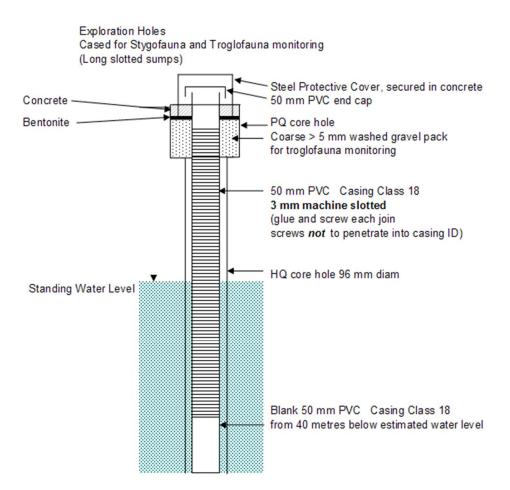
Figure 13 Typical Monitoring bore construction

Groundwater monitoring wells comprise 50mm diameter PVC (Class18) casing and screen. Casing and screen are glued and screwed with stainless steel screws.

The monitoring bores on Irvine Island include bores that constructed as shown in Figure 13. The upper intervals of bores designed as troglofauna holes have been drilled at wider diameter (PQ) than the deeper sections (HQ) to enable coarse (5mm) gravel pack around the slotted interval. A bentonite seal is placed above the screen. The bore construction has been agreed with Stratagen (stygofauna consultants) and applying the standards required by EPA (2007) for Environmental assessment of Subterranean Fauna..

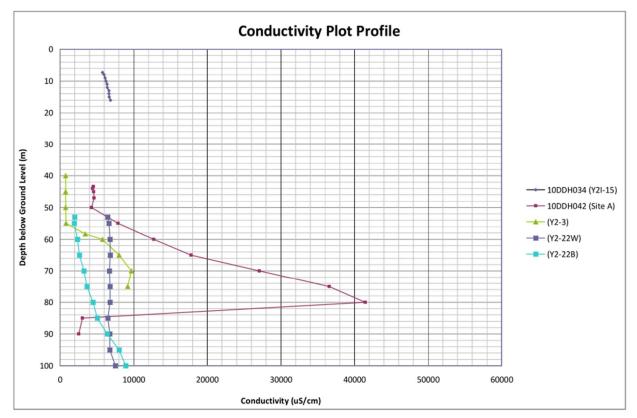
Figure 14 Saline Profile of Selected Wells

An attempt to identify the saline gradient through the formations was made by through running a saline profile on bores that are fully developed and are either uncased or have slotted screens for the entire casing length. Saline profiles were run on a number of bores by using a salinity probe dipper. Results for the profiles are illustrated below as Figure 14. The measurements are in us/cm which is an indicator of salinity.

The above graph illustrates that all the wells show some degree of increasing salinity with depth. Site A (bore 10DDH042 located on the Isthmus at a ground elevation of around RL 50m, shows signs of seawater intrusion with conductivities increasing significantly beyond around 50 mbgl (metres below ground level). The maximum salinity being measured at around 80 mbgl of 40,000 μ s/cm, equivalent to a salinity (as Total Dissolved Solids (TDS)) of around 26,800 mg/L (sea-water ≈35,000 mg/L). The screen interval at Site A is between 45 and 81 mbgl, therefore the saline gradient exhibited in the well is likely to

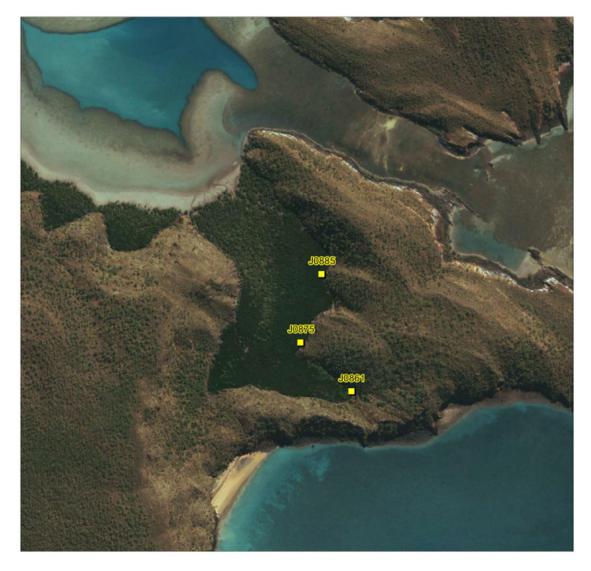
Figure 15 Location of Water level Transducers to Assess Tidal Movement

The temporal patterns in all three pressure transducers indicate that there is a tidal cycle of approximately 14 days with nine day periods of inundation separated by five day periods in which there is no inundation. On a daily basis, there is a tidal rise and fall in water levels for 1-2 data points (i.e inundation over an approximate 4 hour period (<6hours)), with two inundations every 24 hours .
