**Mr I Yujnovich**

## **Local Water Management Strategy – Lot 123 Mortimer Road Casuarina**

V1 – 08 October 2019

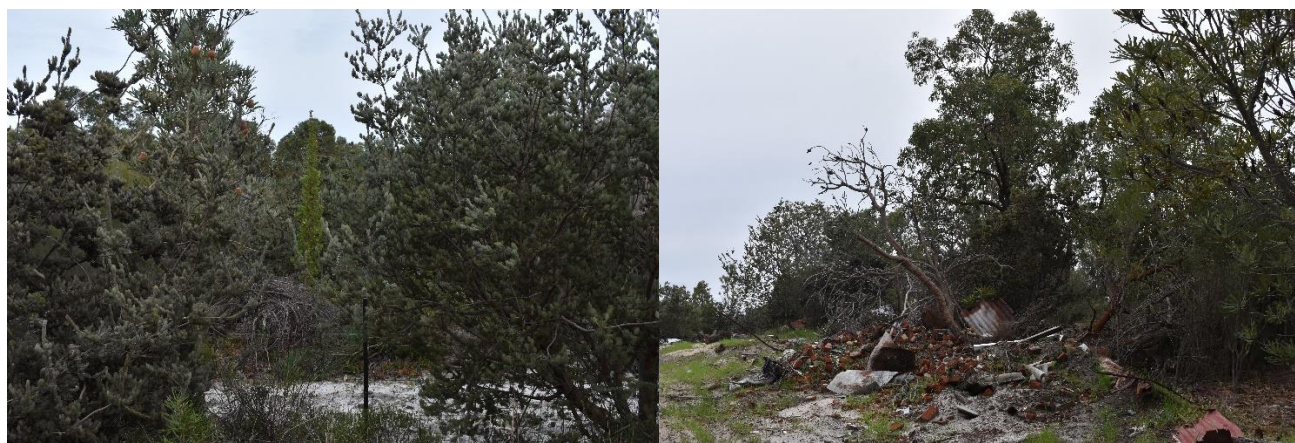
**Figure 4:** Current and previous land use

The current land use within Lot 123 is a 45-ha area of remnant bushland (Figure 4) dominated by Banksia Woodland. A review of aerial imagery held by Landgate (2019) indicates that a house constructed on the south-west portion of the site during the 1960's was demolished sometime between 1985 and 1989.

Current landuse

Remains of dwelling demolished in mid-late 1980s

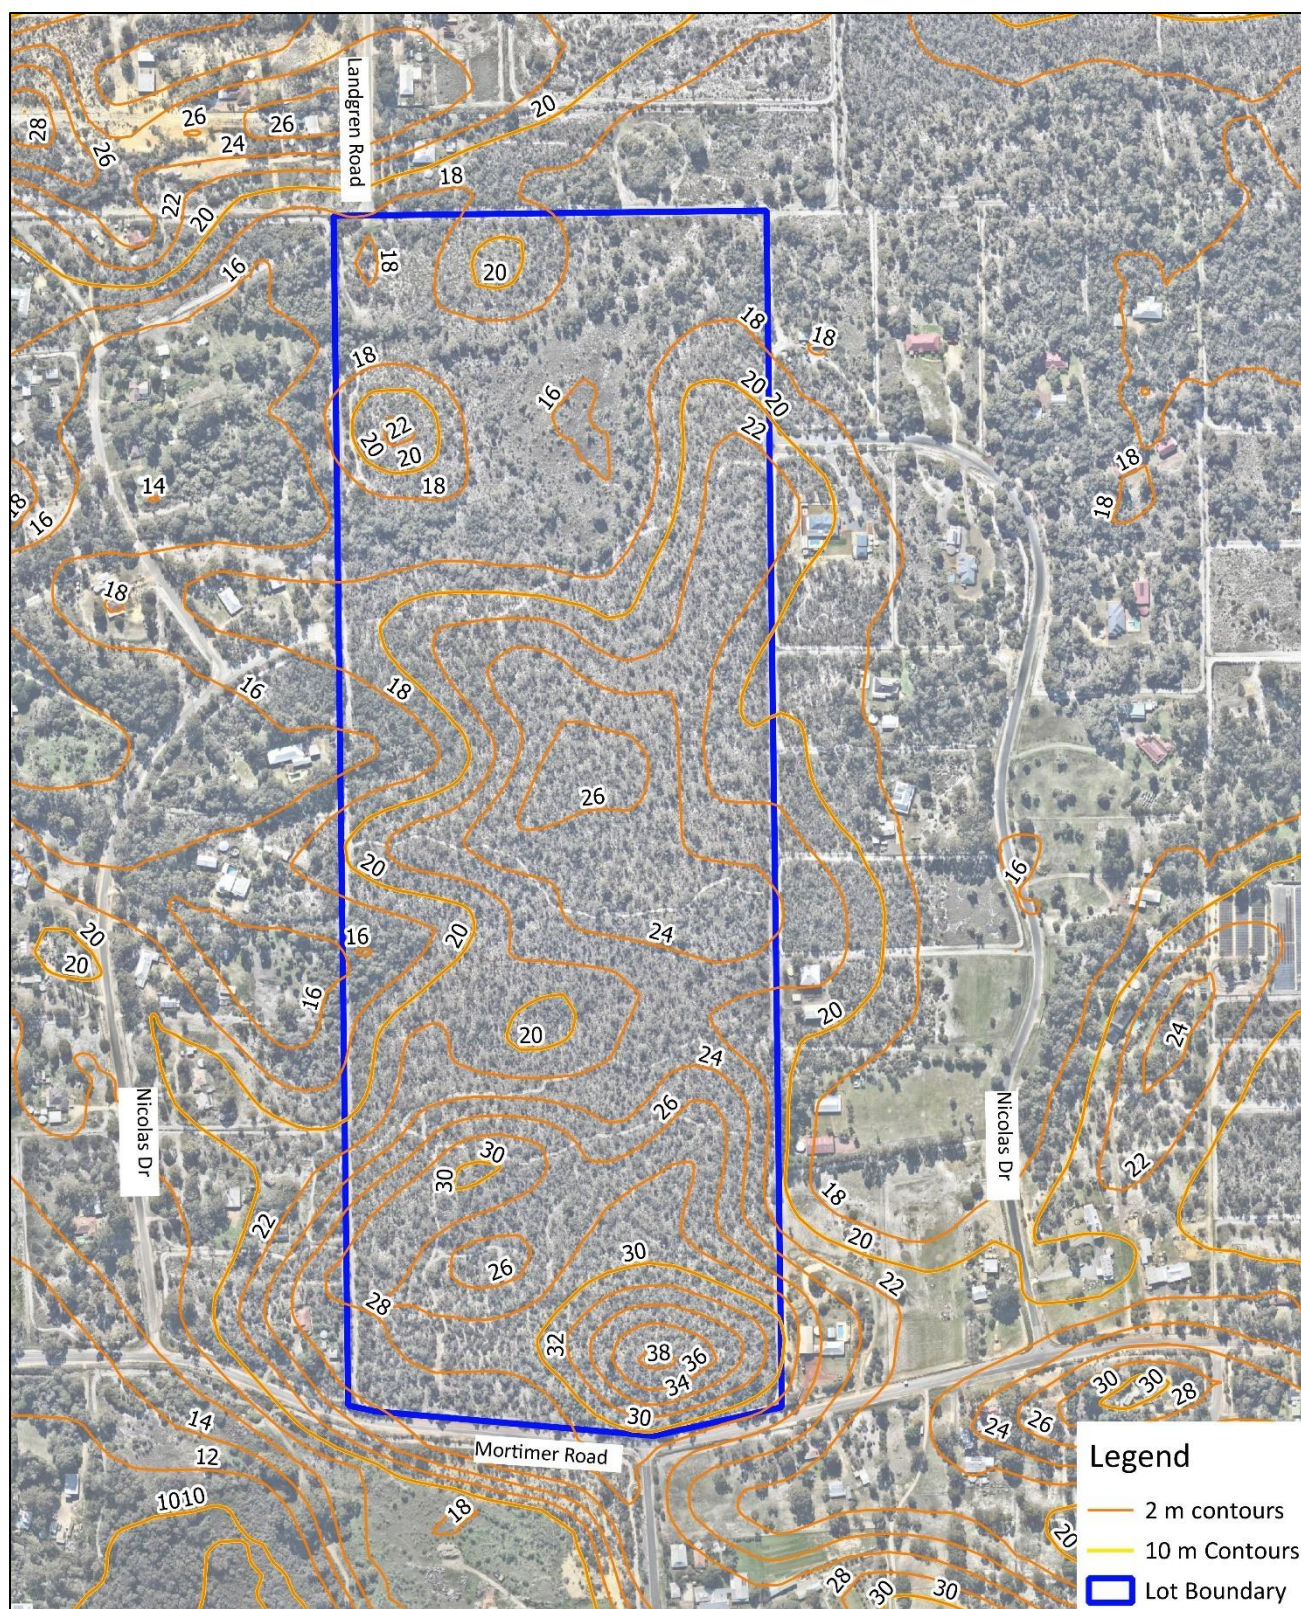
**Figure 5:**  
Site Contours  
Lot 123 Mortimer Rd, Casuarina

The site ranges in height from 18 m AHD in the north to 38 m AHD in the south-east, with some higher areas around the centre of the site (Figure 5). Accordingly, slope across the site is currently variable, and will be modified when development progresses and engineering works are carried out.

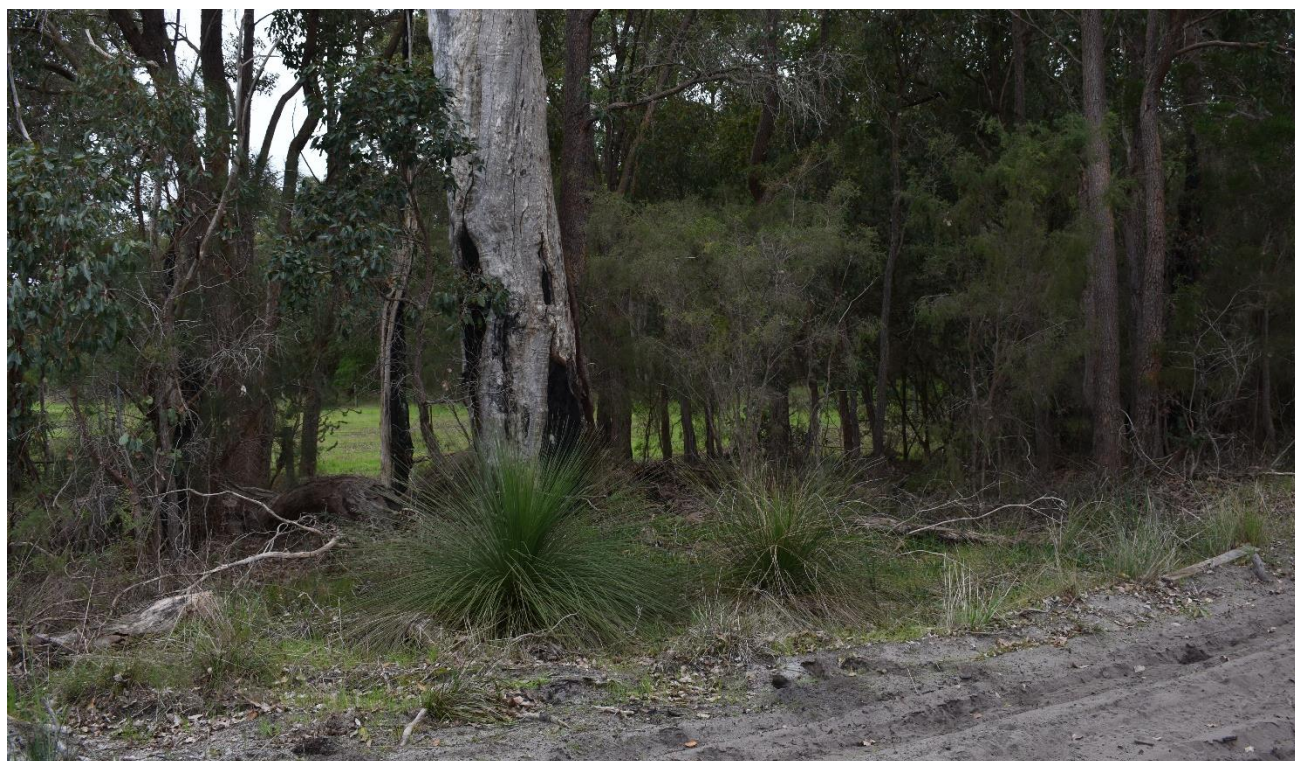
**Figure 9:** Modifications to resource enhancement wetland, Lot 123 and neighbour to the west

Resource enhancement wetlands are described as those that may have been partially modified but still support substantial ecological attributes and functions (Department of Biodiversity, Conservation and Attractions, 2019b). The Geomorphic Wetlands of the Swan Coastal Plain Dataset indicates that the eastern extremities of two wetlands identified by Hill *et al* (1996) are present along the western boundary of Lot 123. The resource enhancement designation indicates that the wetlands have been modified, but 'substantial' ecological attributes and functions are present. For those portions of UFIs 6690 and 13969 located within Lot 123, there has been significant modification to these wetland areas due to the requirement to comply with the requirements of the *Bushfires Act 1954* (WA) to have a cleared firebreak of at least 3 m around the perimeter of the Lot; modifications to the wetland values have also occurred on neighbouring properties to the west through clearing to support rural residential development (Figure 9).

Observations during site assessment activities carried out by Natural Area suggest that the resource enhancement category assigned to the wetlands considered to extend into Lot 123 along the western boundary are no longer applicable due to the extent of modifications that have occurred through clearing and other development activities. The vegetation within Lot 123 is Marri, which can tolerate moist but not wet conditions, suggesting a transition area between wetland and dryland conditions. No formal assessment of the extent of the resource enhancement wetland areas (UFI 6690 and 13969) has been undertaken, thus there has been no formal request to modify their extent and/or classification.
