**CULTURAL HERITAGE
DESKTOP ASSESSMENT,
ZONE 5 BYPASS CHANNEL,
PORT HEDLAND**

A1786866

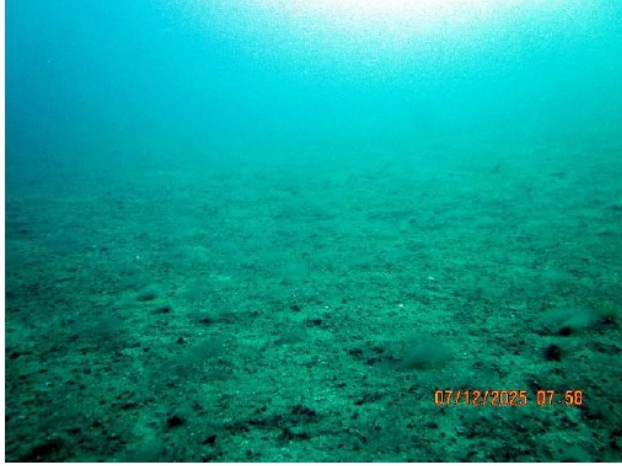
Figure 4. Zone 5A (I) image and sample results (MScience 2025a)

Site Habitat Description (Observed by the Diver)	Seafloor Image at location
Thin veneer of coarse sand with shell fragments likely overlying consolidated clay

- Zone 5A (I) lies at a depth of approximately 15.5 m. Samples taken at Zone 5A (I) indicated the underlying substrate is likely to be consolidated clay, not limestone, and the sediment layer to be approximately 30 cm deep (MScience 2025a:13, Figures 3 and 4). It is assessed that there is no potential for extant cultural heritage at this location.

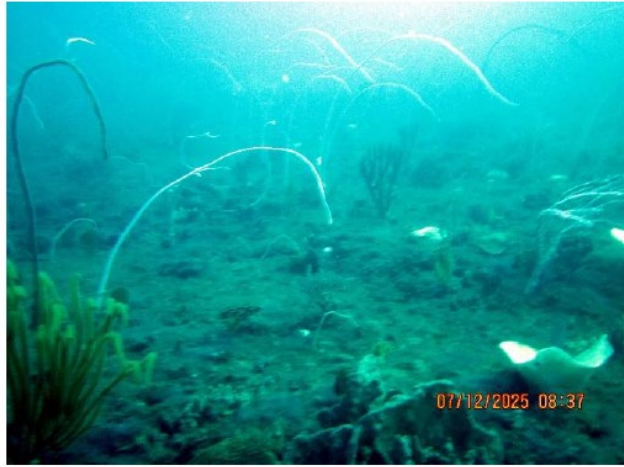
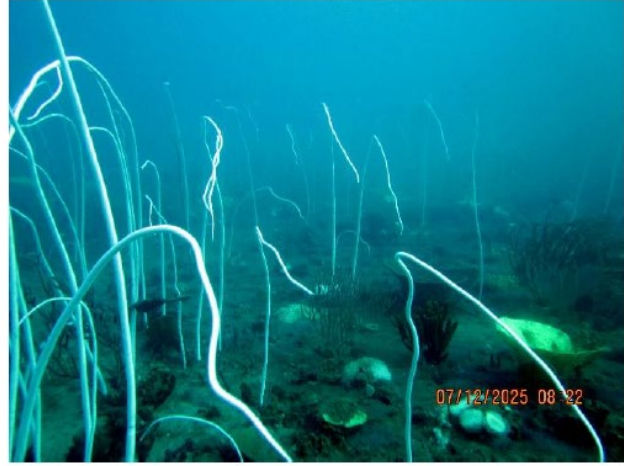
Figure 5. Zone 5A (II) image and sample results (MScience 2025a)

Thin veneer of coarse sand likely overlying hard consolidated substrate (limestone pavement) supporting medium density mixed communities*

- Zone 5A (II) lies at a depth of approximately 16.5 m. Samples taken at Zone 5A (II) indicated the underlying substrate is likely to be limestone pavement, potentially indicating that this feature is analogous to current terrestrial limestone bedrock, and that the overlying sediment layer at this area is approximately 15 cm deep (MScience 2025a:13, Figures 3 and 5).

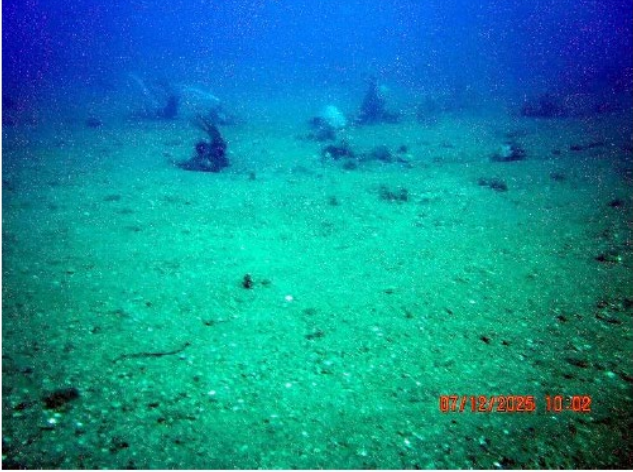
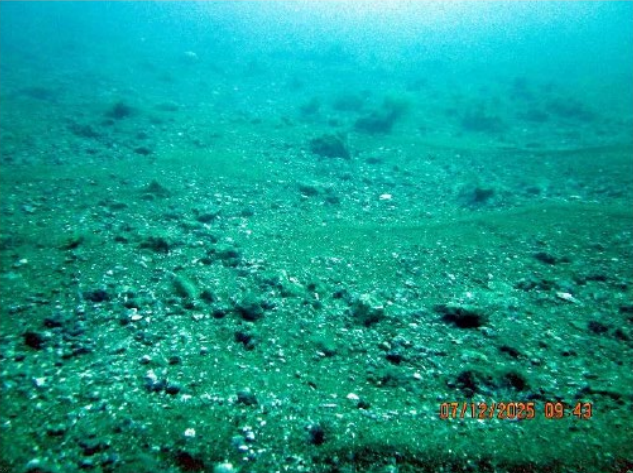
Figure 6. Zone 5A (III) image and sample results (MScience 2025a)

Site Habitat Description (Observed by the Diver)	Seafloor Image at location
Thin veneer of coarse sand and gravel with shell fragments likely overlying consolidated clay

Thin veneer of coarse sand and gravel with shell fragments likely overlying consolidated clay

- Zone 5 (III) lies at depths ranging from approximately 10 m to 13 m. Samples taken at Zone 5A (III) indicated the underlying substrate is likely to be consolidated clay, not limestone, and the sediment layer to be approximately 30 cm deep (MScience 2025a:13, Figures 3 and 6). It is assessed that there is no potential for extant cultural heritage at this location.
