Dampier Palms and Hampton Oval Redevelopment Sand Renourishment Feasibility Study

**Seashore Engineering
June 2018**

Report 062-01-Rev1

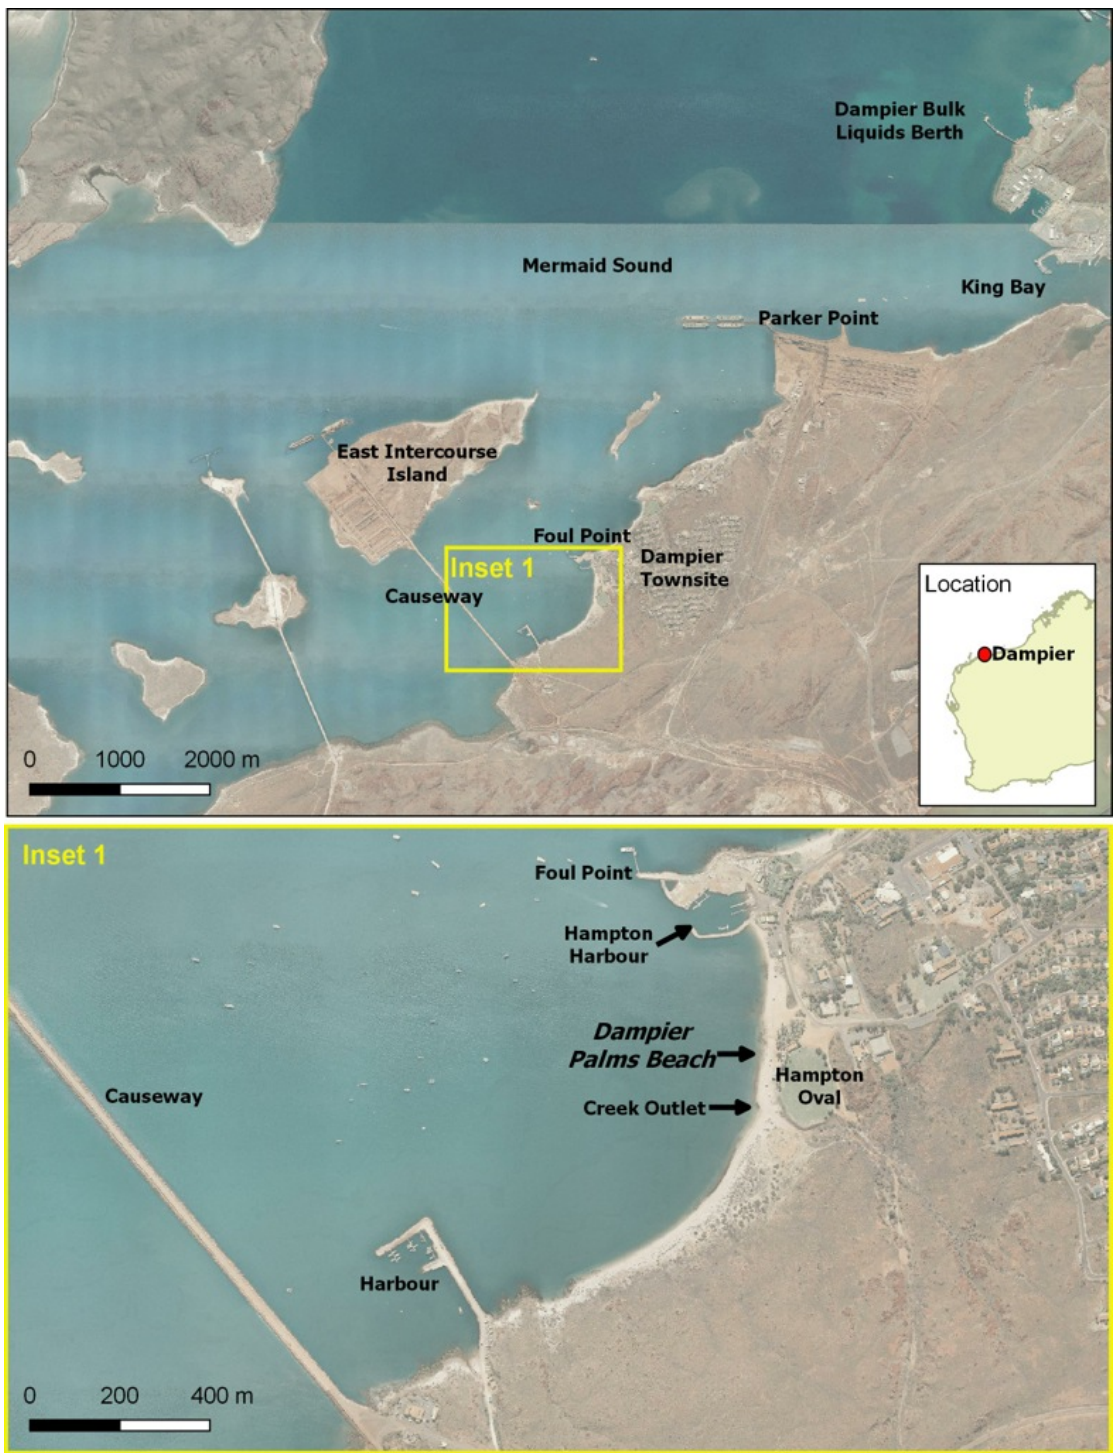
Figure 1-1: Site Figure

Dampier Palms Beach is an west facing beach at the southern extent of Mermaid Sound (Figure 1-1). The beach forms the central portion of a 1200m long arcuate beach which is flanked by rocky headland to the north and south, which have been artificial extended by the installation of breakwaters for recreational and commercial harbours. These harbour effectively block sediment exchange to or from adjacent beaches.

The City of Karratha (the City) has commissioned Seashore Engineering to investigate the feasibility of sand renourishment at Dampier Palms Beach, located at the southern end of Mermaid Sound (Figure 1-1). Sand renourishment is intended to increase the amenity of the beach, as part of the proposed Dampier Palms and Hampton Oval Redevelopment (Appendix A). Objectives of renourishment are to construct a wider beach and increase sand coverage over rock presently exposed along the shoreline.

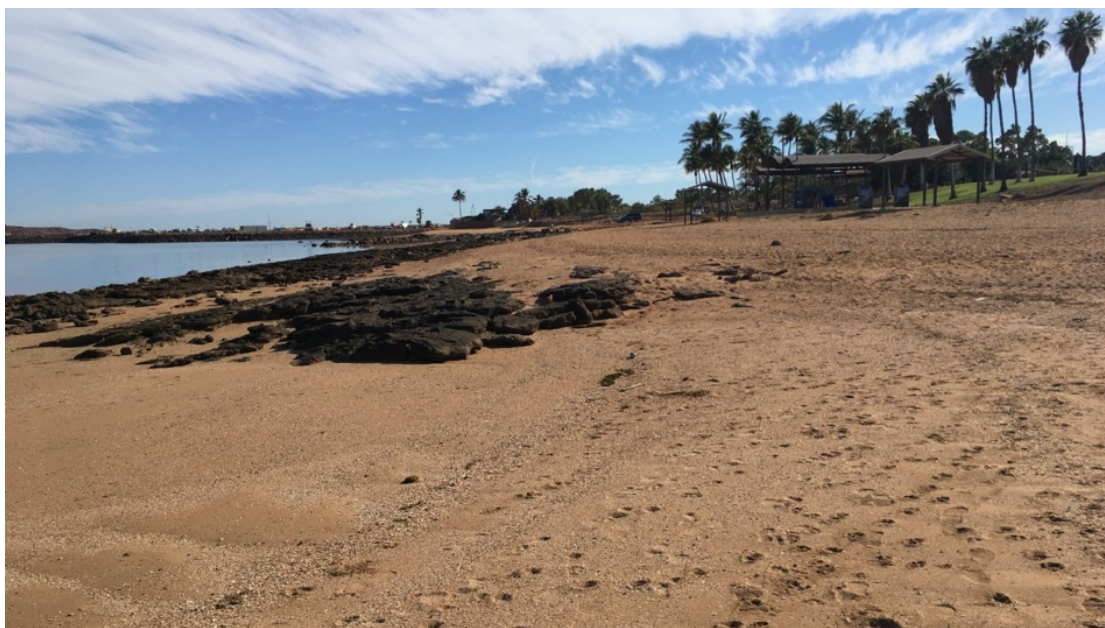
Figure 2-1: Site Photograph – Looking North along Dampier Palms Beach on 30/08/2017

The beach is perched on an almost continuous rock platform, which is exposed during low tides (Figure 2-1). Alongshore sediment transport at the beach is likely to be driven predominantly by wind waves, particularly during tropical cyclones, when higher water levels are also possible. Sections of slightly elevated rock are evident as rock outcrops along the shore, providing local modification to alongshore sediment transport.

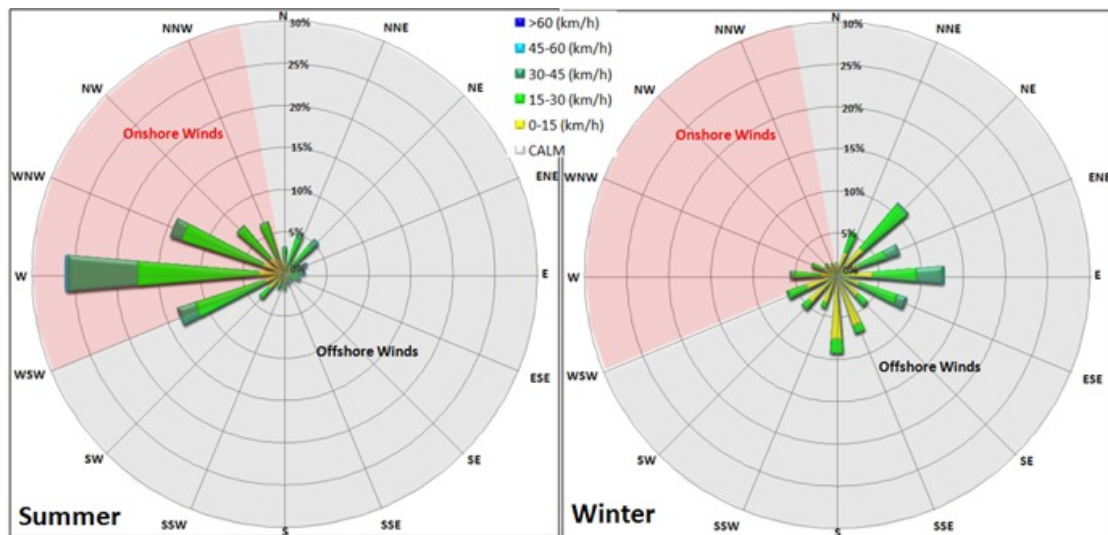
Figure 3-2: Summer and Winter Wind Roses at Karratha Aero 1993-2017

Winter and summer wind roses showing speed and direction frequency from the Karratha Aero record demonstrates the seasonal variation in wind climate (Figure 3-2). Directional bands for onshore winds at Dampier Palms Beach for wind wave generation are shown in red shading. The following is noted:

- During summer months, winds are dominated by moderate to strong WSW to WNW winds, which correspond to prevailing sea breezes. Winds are predominantly onshore at Hampton Oval Beach, generating wind waves across from East Intercourse Island and the causeway; and
- During winter, the sea breeze system weakens and winds become more mild and variable. There is limited occurrence of onshore winds at Hampton Oval Beach.

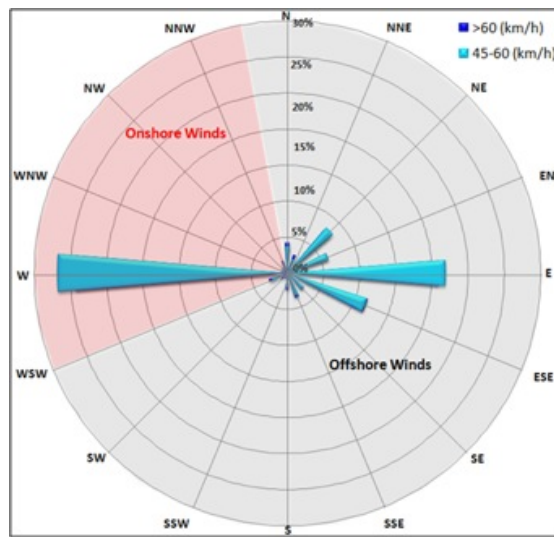
Figure 3-3: Wind Rose for Winds above 45km/hr at Karratha Aero 1993-2017

A wind rose plot showing the directional frequency of all winds above 45km/hr, demonstrates strong onshore winds almost exclusively occur from the west. However, the potential for extreme winds during the passage of tropical cyclones in all directions, depending on cyclone track, is recognised.

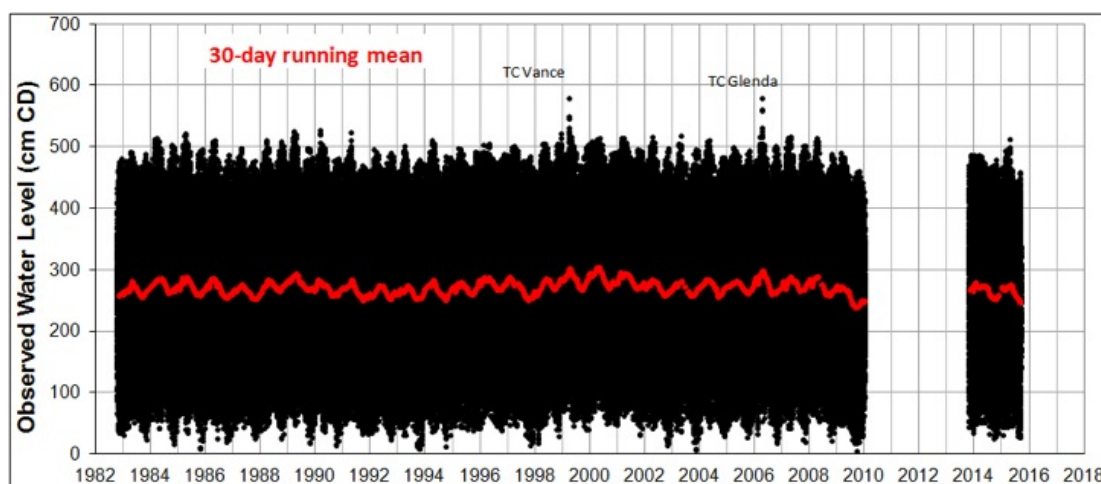
Figure 3-5: Hourly Water Level Observations at King Bay Tide Gauge
(Source: Department of Transport)

Water level observations at Dampier are available since 1983 from the King Bay tide gauge which is managed by the Department of Transport on behalf of Pilbara Ports Authority (Figure 3-5). No observations were available between 2010 and 2013, or after 2015. Water level processes evident in the record include tides, surge event (e.g. tropical cyclones), seasonal and inter-annual mean sea level variations. Water levels are shown to Chart Datum (CD), which is 2.77m below AHD (Australian height Datum, which approximately corresponds to mean sea level).

There has been a relatively low occurrence of high water level events associated with storm surge in the record, with only two events exceeding the highest astronomical tide of +5.10m CD (2.43m AHD). These occurred during severe cyclones which tracked to the west of Onslow and coincided with high tides, with +5.81m CD (3.04m AHD) recorded on 21/03/1999 in TC Vance and on 30/03/2006 in TC Glenda. Low or neap tides restricted water levels to below HAT during the passage of TC Orson (1989), TC Bobby (1995) and TC Olivia (1996), which tracked within 150km west of Dampier with central pressure less than 940hPa.

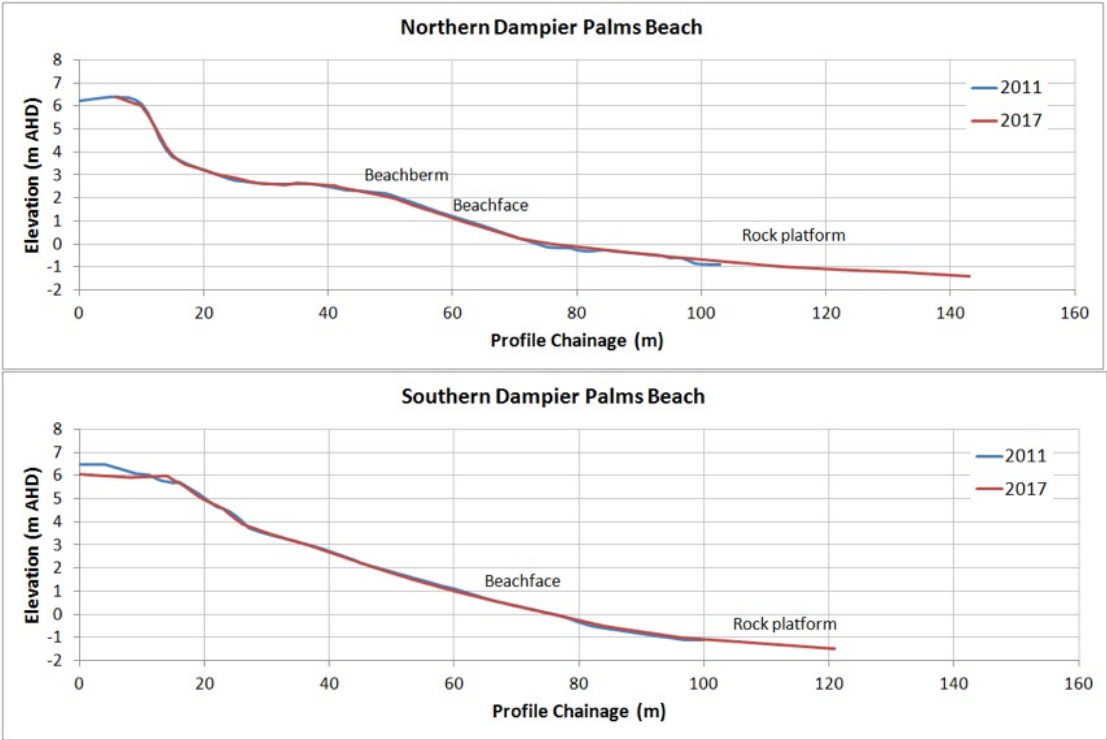
Figure 3-8: Surveyed Beach Profiles

Survey information at the beach is available from a LIDAR survey captured in 2011 and a feature survey in January 2017. Profile changes between the two surveys confirm there has been limited beach change along Damper Palms Beach for the period, with changes at two beach transects shown in Figure 3-8. The location of transects are shown in Figure 3-9.

Key characteristics of the beach profiles include:

- A rock platform at the toe of the beach, generally below -1m AHD;
- A minor berm at +2.2m AHD along parts of the beach, including the northern profile (i.e. a high tide berm);
- Beach grade is generally 1V:11H, measured between the berm and rock platform; and
- Exposed rock outcrops along the reach up to +3m AHD. These provide local interruption to alongshore sediment transport.

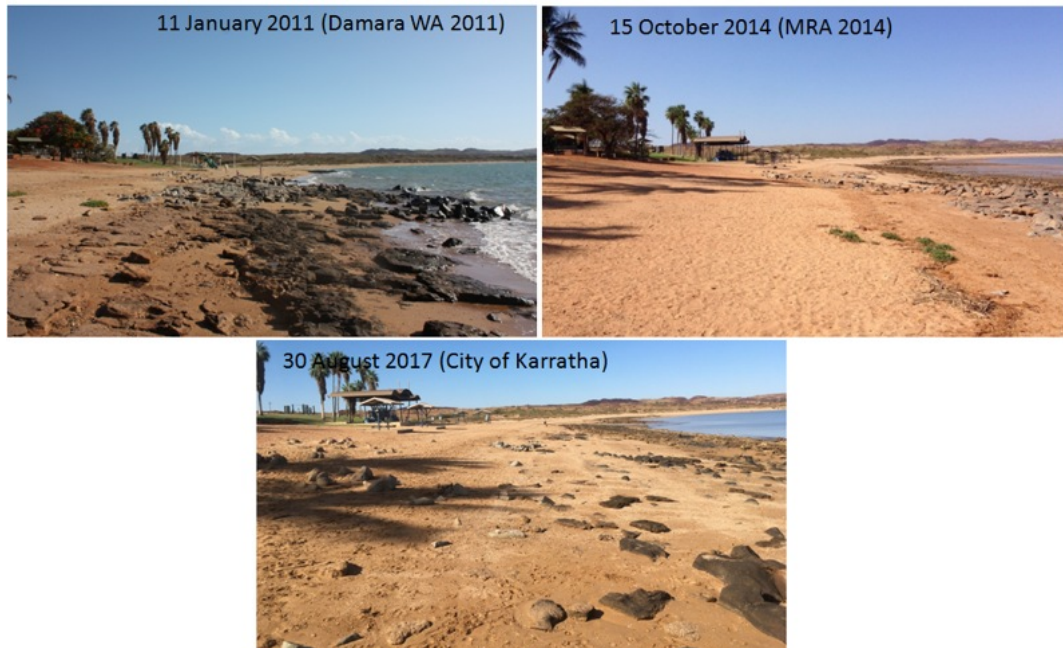
Figure 3-10: Hampton Oval Pavilion – Looking South

Site photographs from three dates have been compared, with sets of photographs at similar locations and field of views provided in Figure 3-10, Figure 3-11 and in Appendix A. The photographs were captured on 11 January 2011 by Damara WA, 15 October 2014 by MP Rogers and Associates and on 30 August 2017 by the City for this project.

Limited beach change is evident in the photographs. Photographs captured at low tide show the extent of the rock platform at the toe of the beach and exposed rock along the shoreline.

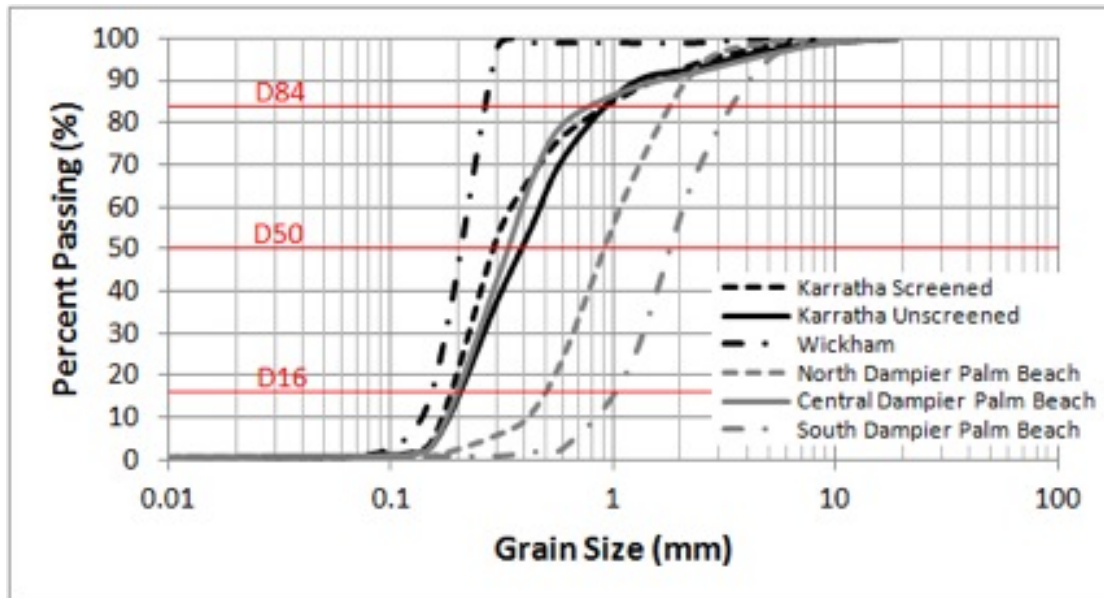
Figure 4-1: Particle Size Distribution Curves

The samples from Dampier Palms Beach show significant variability, with:

- Coarser sediments at the southern and northern sites at Dampier Palms Beach, including approximately 40% gravel (>2mm) at the northern site. This is likely to represent a coarser fraction of sediments along the wider beach, with finer material (more mobile) expected to have been lost between 1968 and 2001 and transported southward. Coarser sediments have likely contributed to greater relative beach stability observed since 2001; and
- The central site is significantly finer, and likely represents a local accumulation of fine material adjacent to the rock control, possibly supplied from the adjacent dune area by pedestrian and vehicle activity.

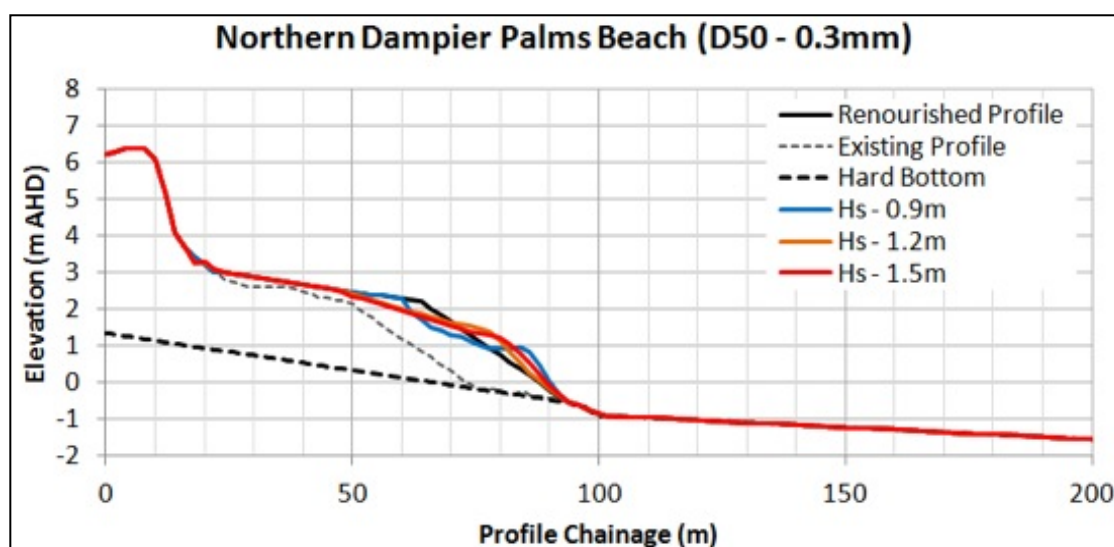
Figure 4-3: SBEACH Model Outputs - Northern Profile and Sediment Size 0.3mm

Profile outputs from each model run are shown in Appendix E, with runs for a sediment size of 0.3mm (D50) at the northern profile shown in Figure 4-3. The profiles demonstrate erosion of the beach berm and transport offshore to lower beachface. Erosion distances at +2m AHD in Table 4-4 provide a measure of the offshore sediment transfer. The following is noted:

- Greater profile response for D50 of 0.2mm and 0.3mm;
- Profile response for D50 of 0.5mm only occurred for wave heights of above 0.9m; and
- Profile responses for each run were similar at the two profiles.

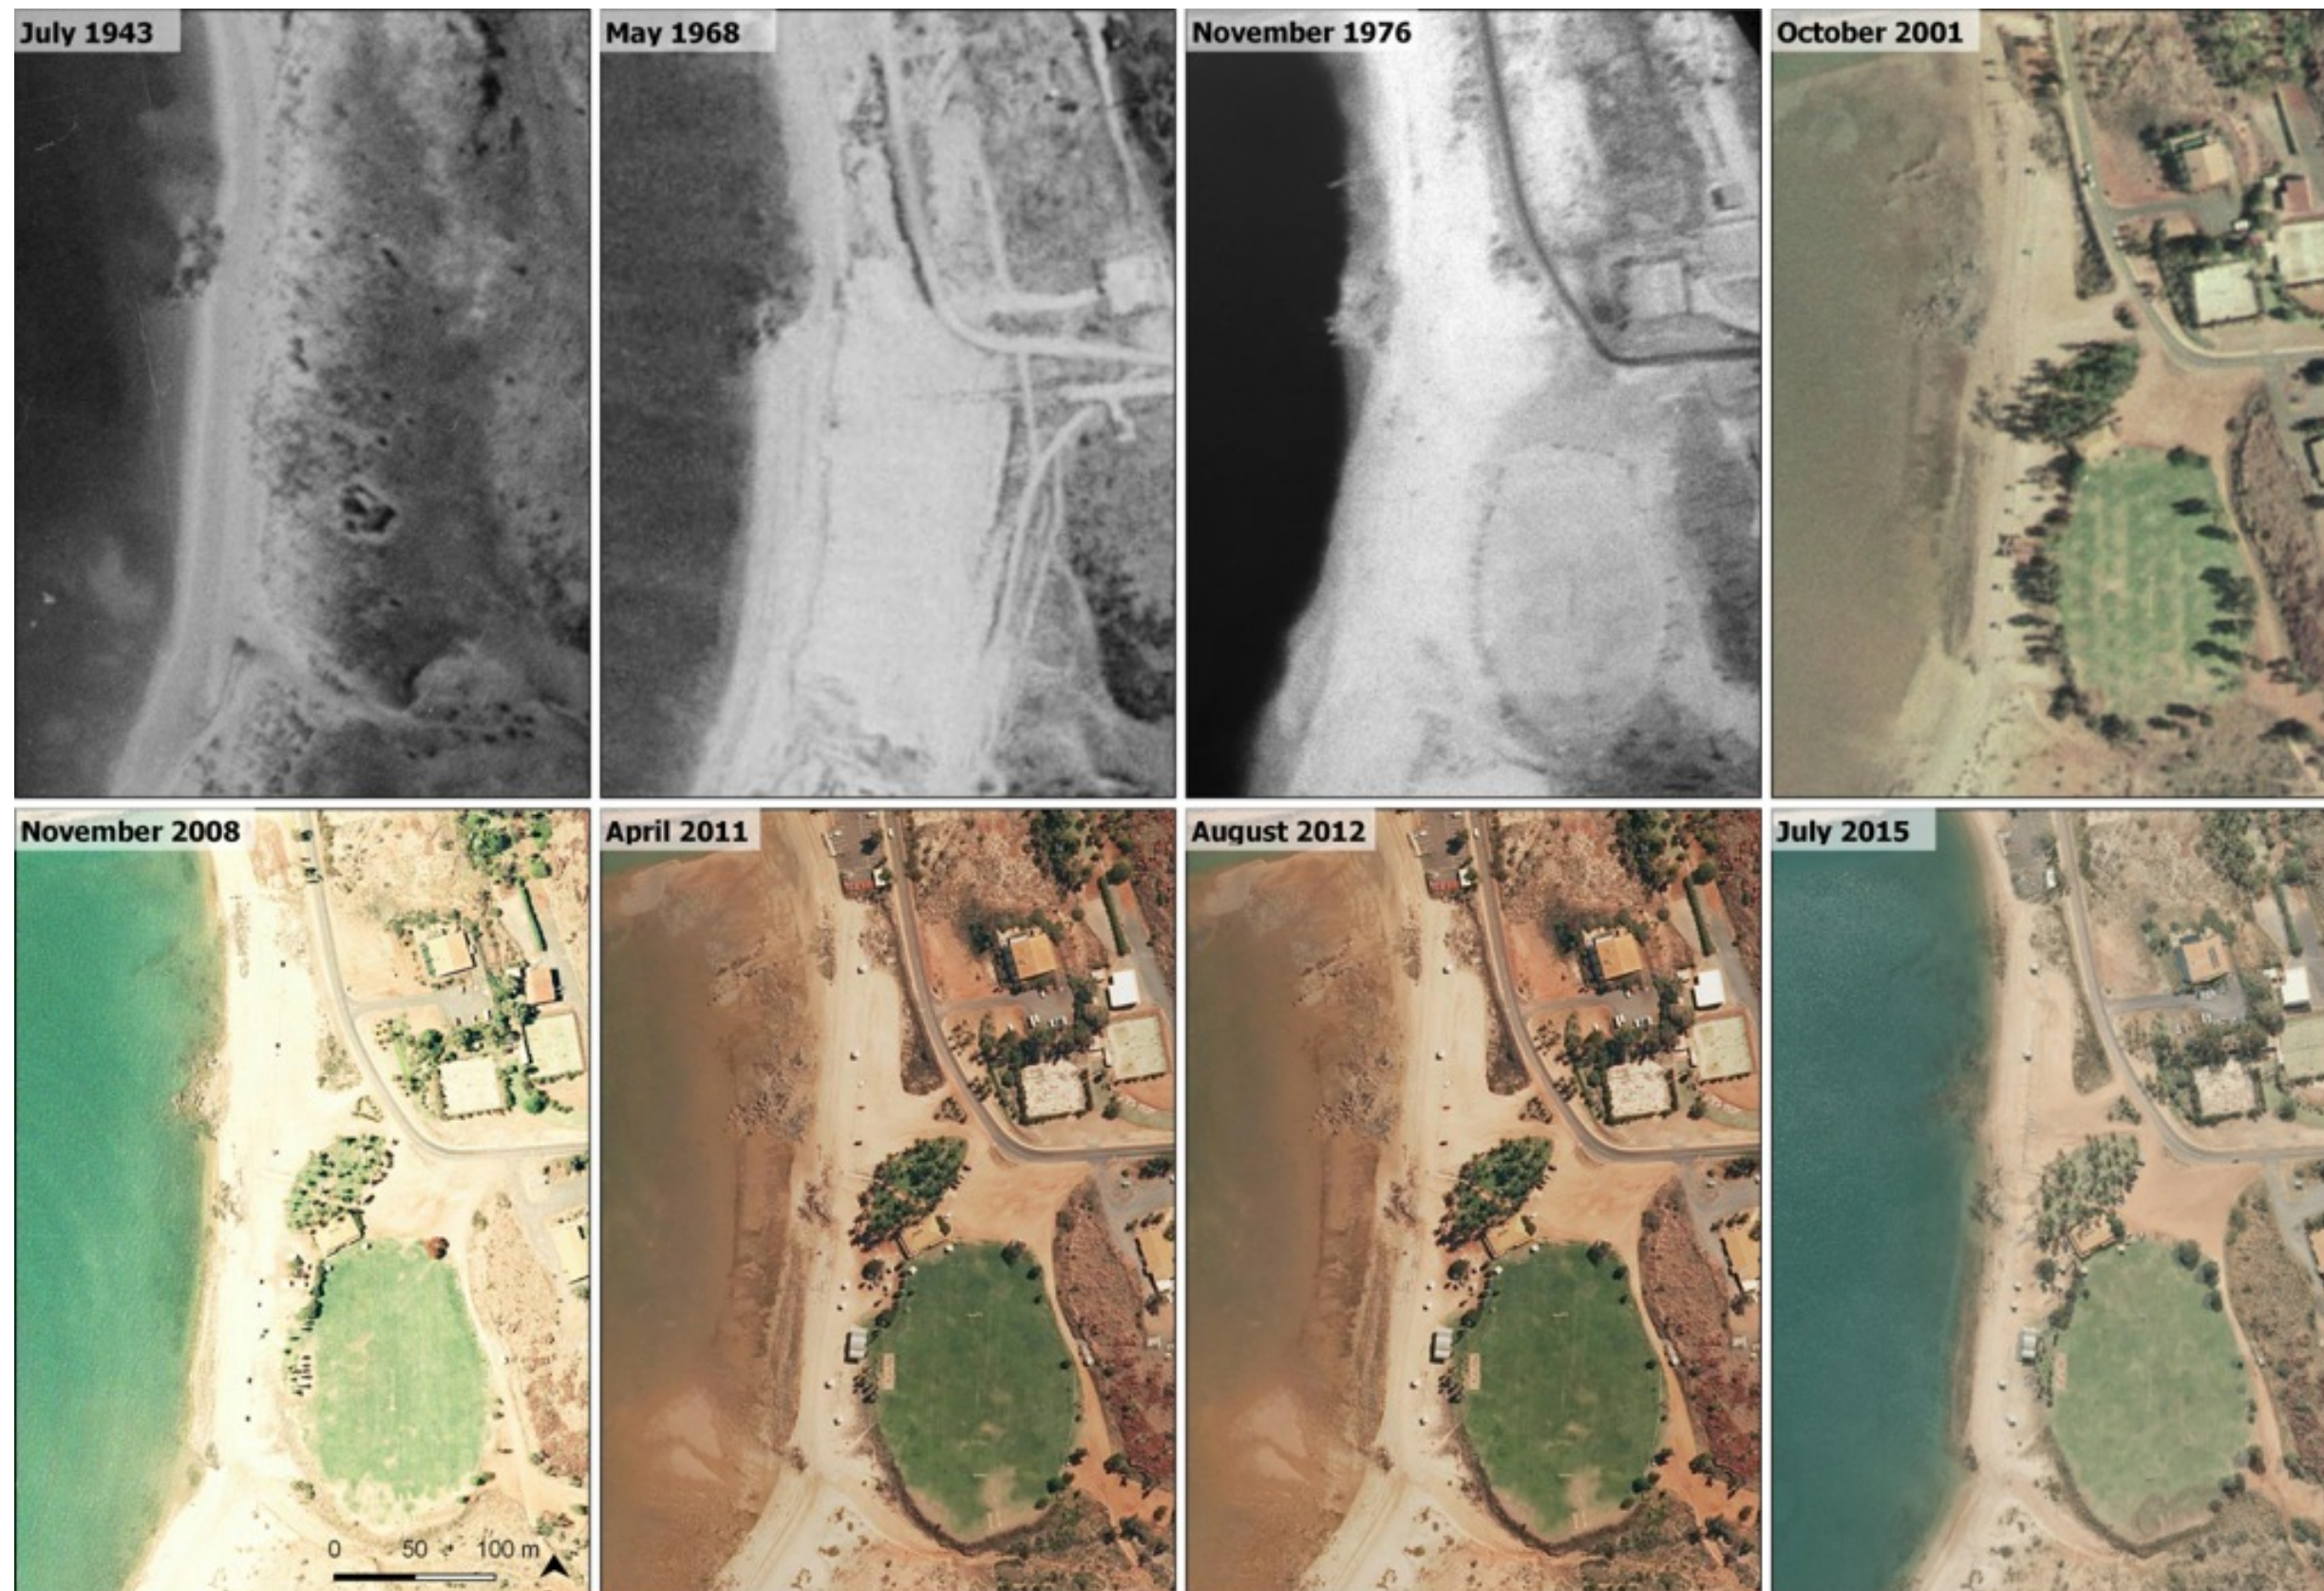
Hampton Oval Beach – Fine Scale

A series of historic aerial photographs since 1943, shown in Appendix D, have been assessed to identify beach changes in the vicinity of Dampier Palms. This understanding is important to infer potential behaviour of sand renourishment placed at Dampier Palms Beach.
