## **Appendix F: Dieback Assessment and Survey Albany Ring Road (Southern Ecology 2020)**

# **Phytophthora Dieback Management Plan: Albany Ring Road**

**Report prepared for  
Main Roads Western Australia  
April 2020**

Main Roads Great Southern Region are proposing to construct stage two and three of the Albany Ring Road Project. Southern Ecology was engaged to assess the development envelope (232.8 ha) for presence of *Phytophthora* species in accordance with regulatory guidelines (Department of Parks and Wildlife 2015) and to recommend management strategies to reduce the spread of soil pathogens during construction.

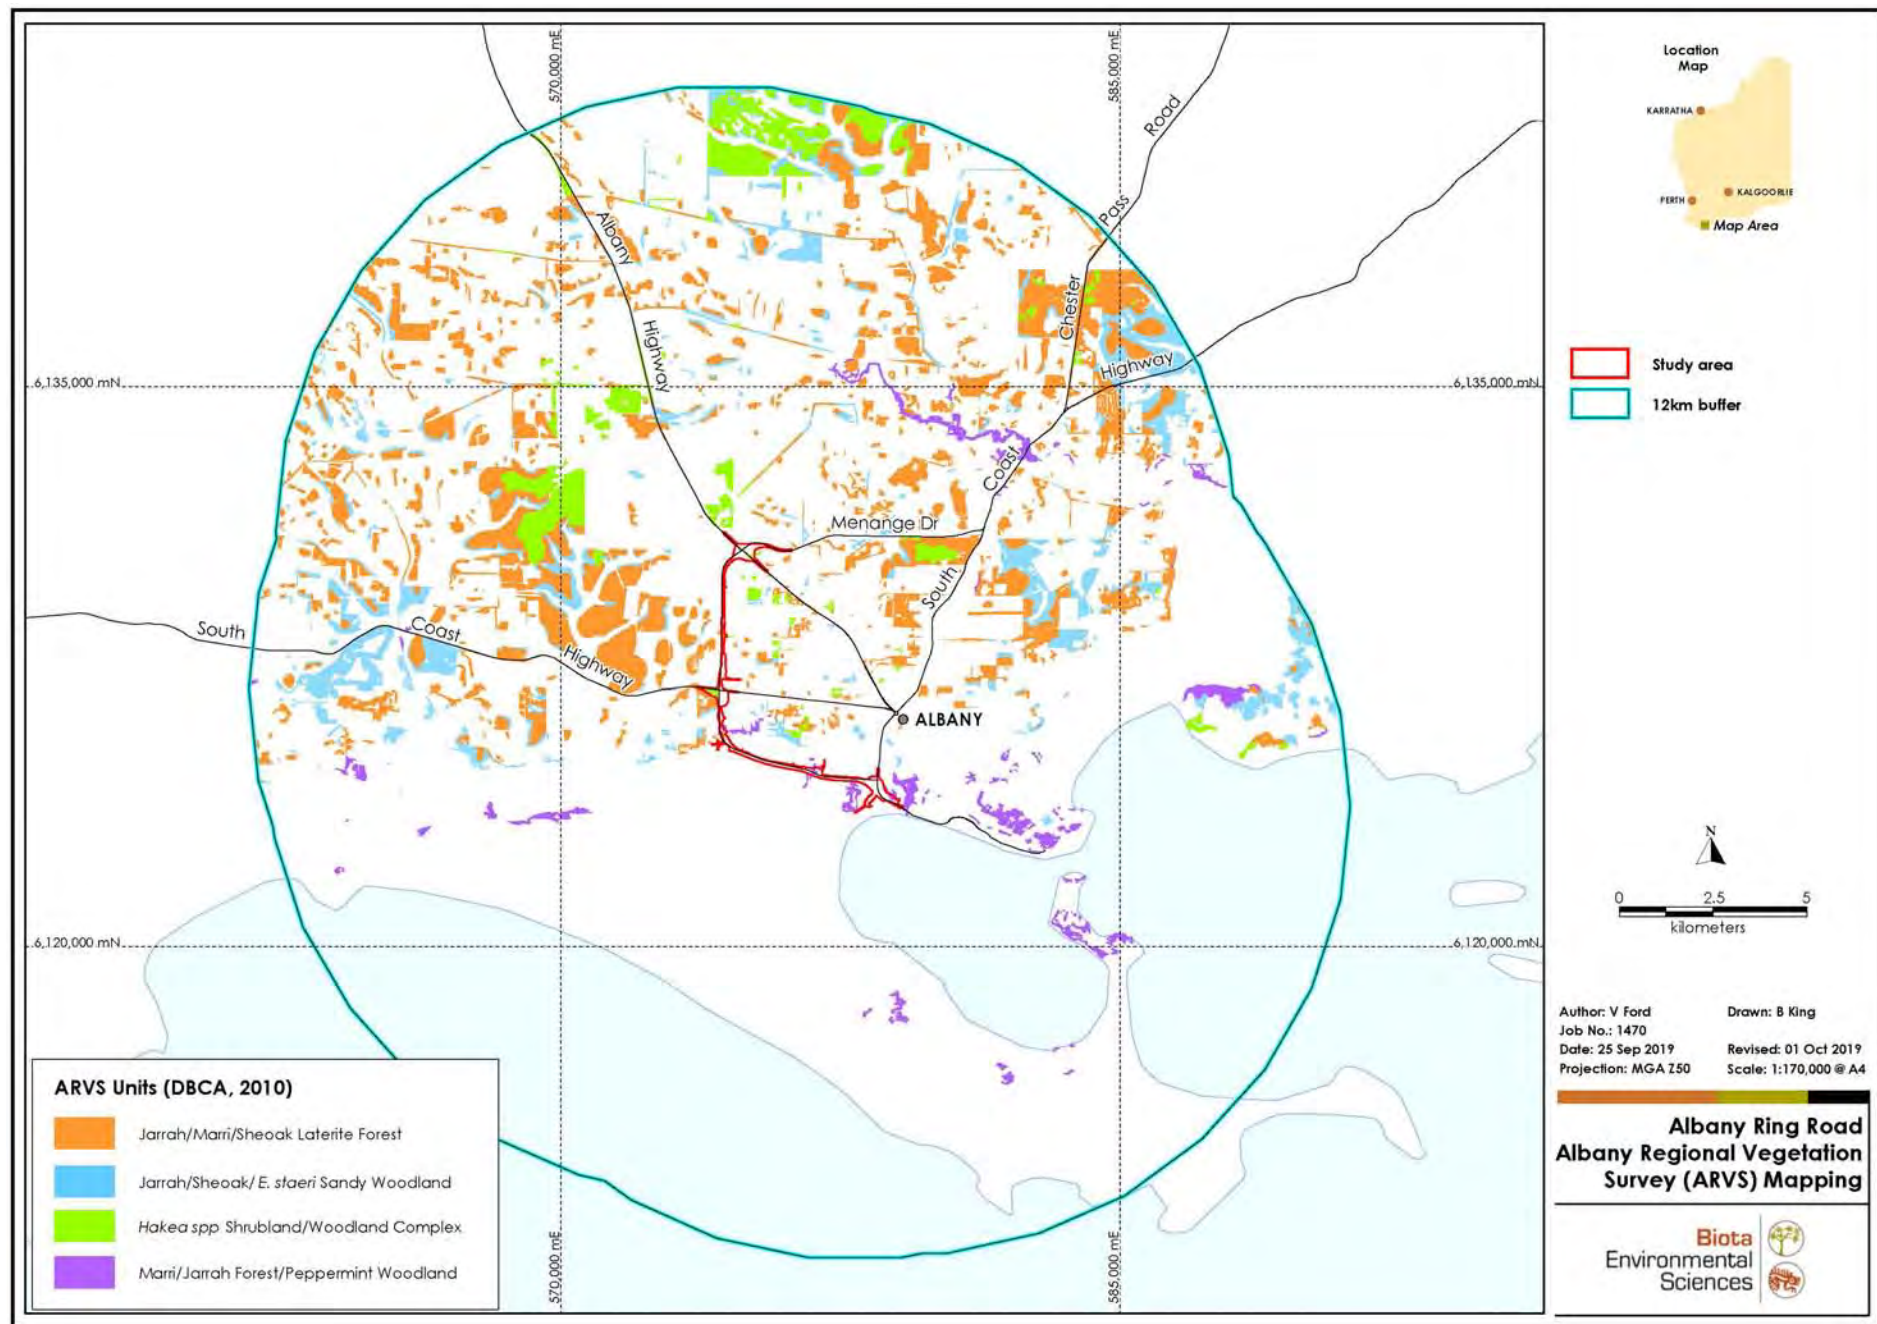
Figure 6.1: Extent of the vegetation units found within the study area in a 12 km radius based on the Albany Regional Vegetation Survey (Sandiford and Barrett 2010).

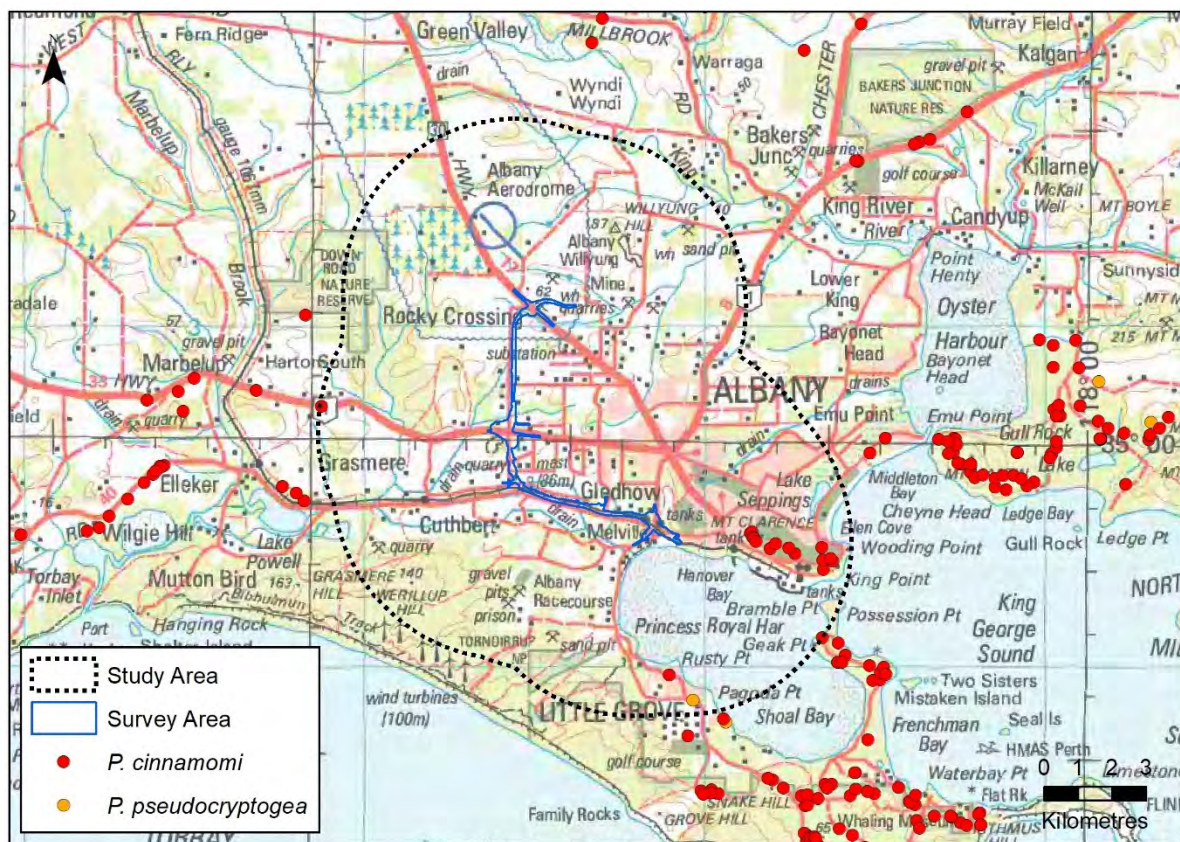
Figure 1. *Phytophthora* species record in the Study Area (5 km buffer around survey Area) derived from the Dieback Information Delivery System (DIDMS) (GAIA 2019).

No previous comprehensive *Phytophthora* Dieback mapping or sampling has been conducted within the Survey Area (Dieback Information Delivery System (DIDMS) (GAIA 2019). *Phytophthora cinnamomi* has been recovered from eighteen soil and root samples within the Study Area, collected between 1994

to 2018. One sample of *Phytophthora pseudocryptogea* is known from the Study Area. All *Phytophthora* records are greater than one km from the Survey Area and are hydrologically separated, therefore have a limited contribution to the disease interpretation in this assessment.

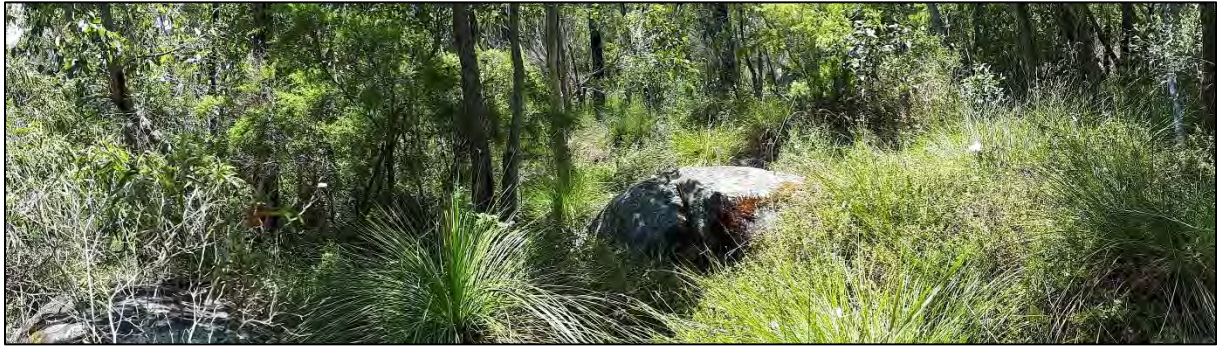
Plate 1. Upland forest (Marri/Jarrah Coastal Hills Forest) on Mt Melville, with sufficient indicator species for interpretation through symptomatic evidence of *Phytophthora*.

The ability to detect *Phytophthora* through symptomatic evidence (interpretability) was highest in vegetation in upland or granite communities in Good to Excellent condition. This graded to low interpretability in Degraded native vegetation and to Uninterpretable in most wetland vegetation types (Plate 1-3). A list of susceptible host species present across the Survey Area is provided (Table 3). The incidence and pattern of disease symptoms in these taxa were considered an indication of the potential presence of *Phytophthora cinnamomi*.

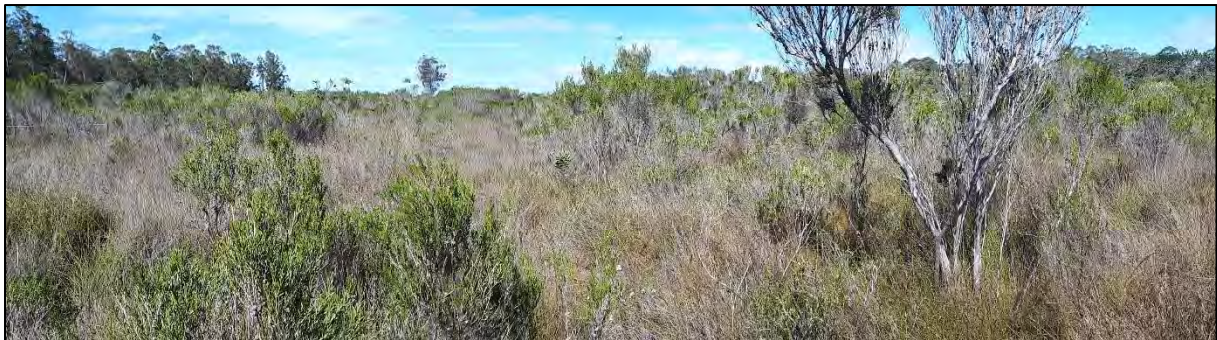
Plate 2. Wetland vegetation (*Homalospermum firmum*/*Callistemon glaucus* Peat Thicket) dominated by species from the Myrtaceae and Cyperaceae that do not display obvious disease symptoms.

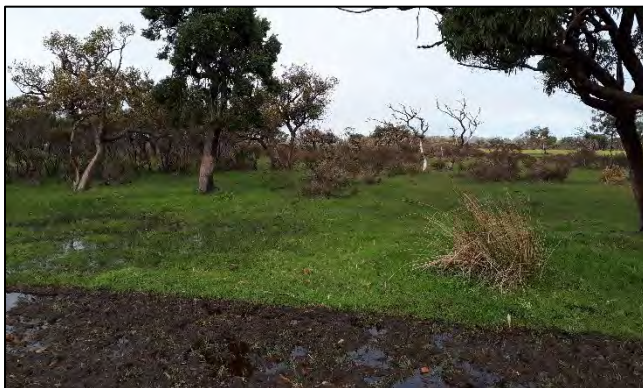
Plate 3. Degraded vegetation (Uninterpretable) in a water gaining site where incipient pathogens are likely to occur but are asymptomatic.

Areas were determined to be Uninterpretable (25.93 ha) either due to a low natural incidence of indicator species (i.e. very long unburnt or wetland type vegetation) or was where native vegetation was in Degraded to Good Condition (i.e. other disturbances may have removed indicator species). No Uninterpretable areas were considered as Protectable due the water gaining hydrology and high-level soil historic disturbance. Excluded areas (191.7 ha) consisted mainly of paddocks, agricultural areas or plantations, where *Phytophthora* species may be present but are asymptomatic.

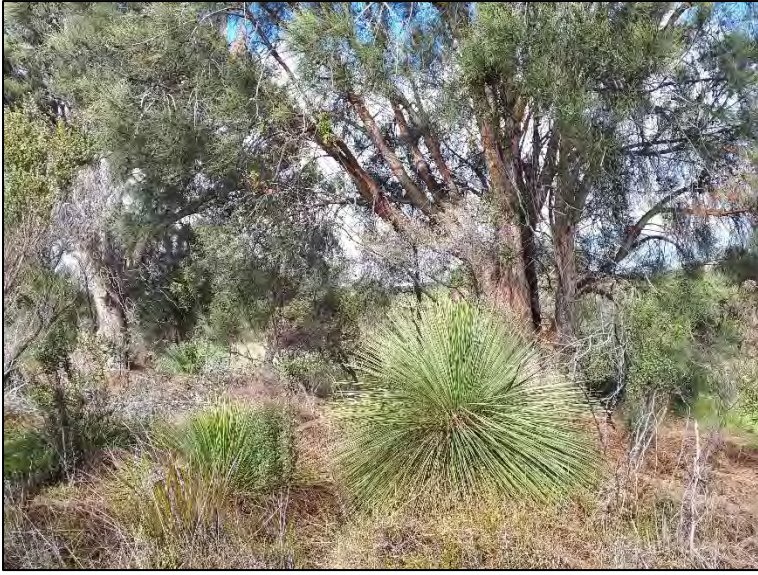
Plate 4. Uninfested and Protectable vegetation.

The field interpretation combined with the soil and root sampling delineated the Survey Area into four disease status categories for the purposes of managing the spread of *Phytophthora cinnamomi* (Table 5, Plates 4 and 5). A total of 1.05 ha was determined to be Uninfested with *Phytophthora cinnamomi*, which occurred in three separate areas in the Survey Area. All Uninfested areas in the Survey Area are considered to be preliminary Protectable Areas. The Protectability of these areas may change depending on project activities and their recommended management is discussed in section 4.4.2.

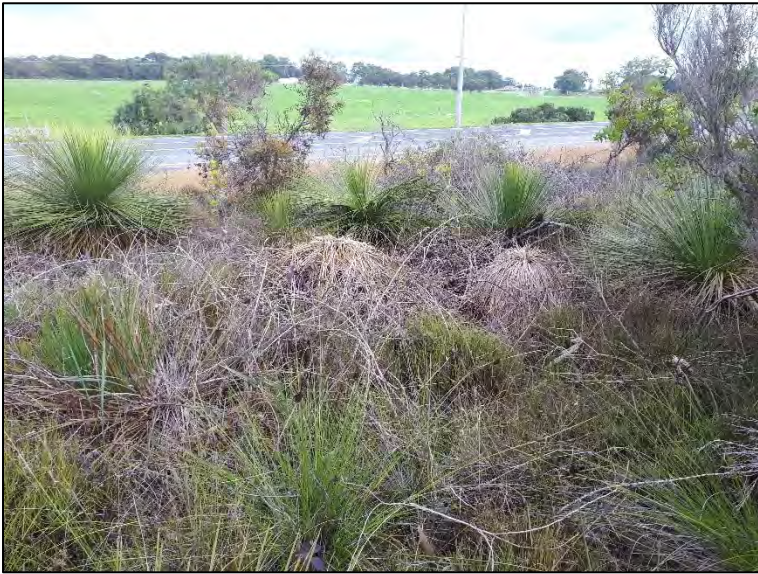
Plate 5. *Xanthorrhoea platyphylla* deaths associated with *Phytophthora cinnamomi*.

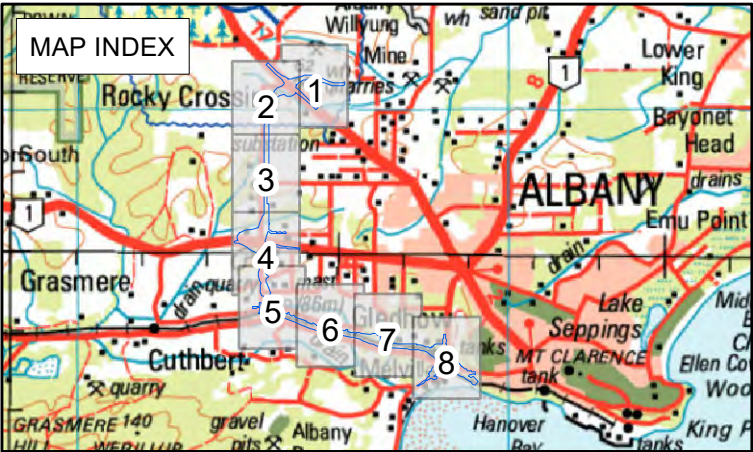
**Map 2 of 8: Phytophthora Dieback Status, Albany Ring Road.**

- P. cinnamomi*
- Negative
- Contours (5m)
- Survey Area

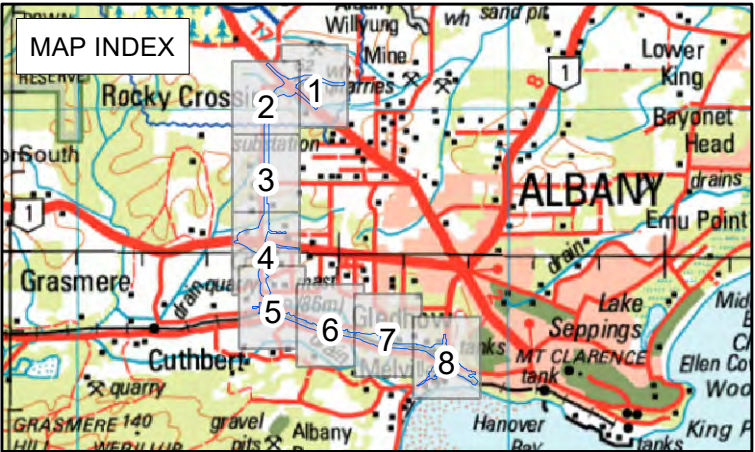
**Map 5 of 8: Phytophthora Dieback Status, Albany Ring Road.**

- Phytophthora Dieback Status
- Uninfested (Protectable Area 1-3)
  - Infested
  - Uninterpretable
  - Excluded
- Soil and Root Samples (Sample No.)
- P. cinnamomi*
  - Negative
  - Contours (5m)
  - Survey Area

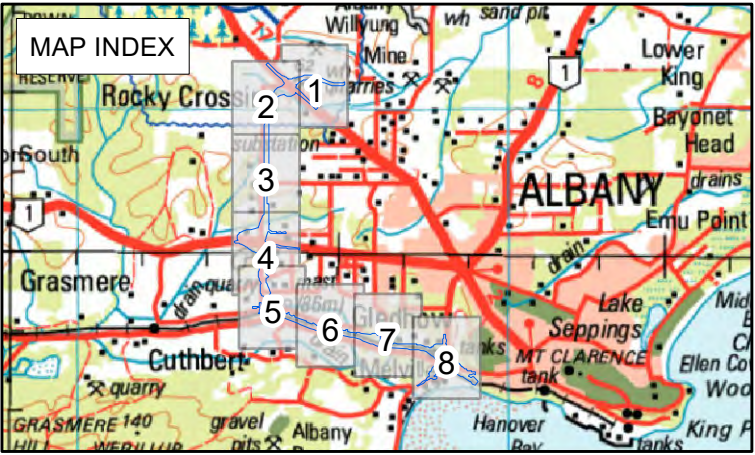
**Map 6 of 8: Phytophthora Dieback Status,  
Albany Ring Road.**

- Phytophthora Dieback Status
- Uninfested (Protectable Area 1-3)
  - Infested
  - Uninterpretable
  - Excluded
- Soil and Root Samples (Sample No.)
- P. cinnamomi*
  - Negative
  - Contours (5m)
  - Survey Area
