Subsea 7

Exmouth Gulf Current Monitoring Field Report

August 2018

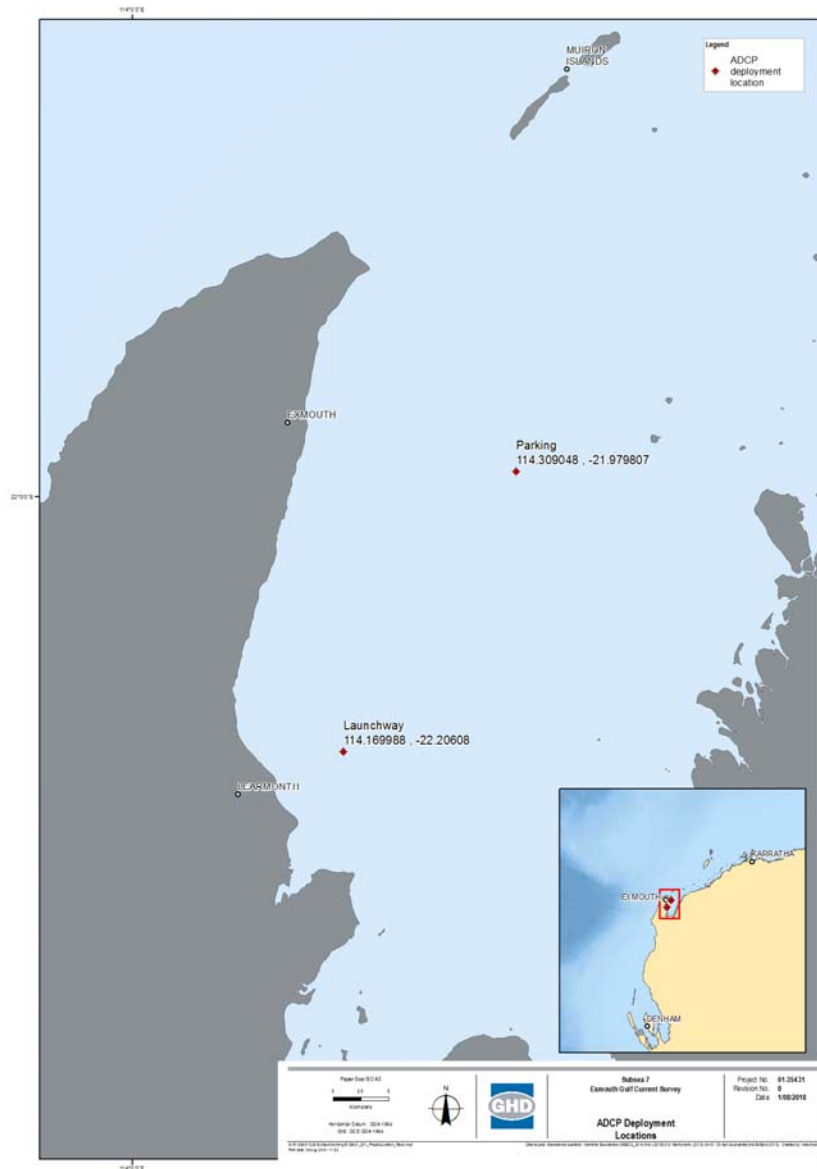
Figure 1 ADCP deployment locations, Exmouth Gulf

The monitoring instruments were deployed at two (2) deployment locations, Launchway and Parking (refer to Table 2-1 and Figure 1), as specified by SS7 in the Exmouth Gulf of Western Australia.

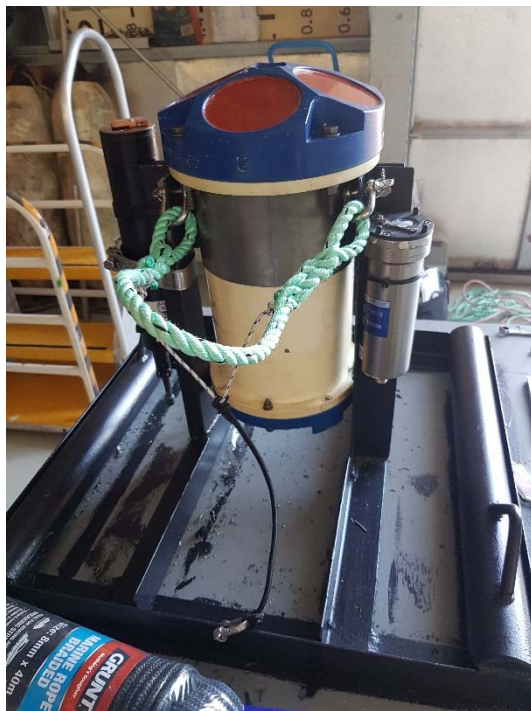
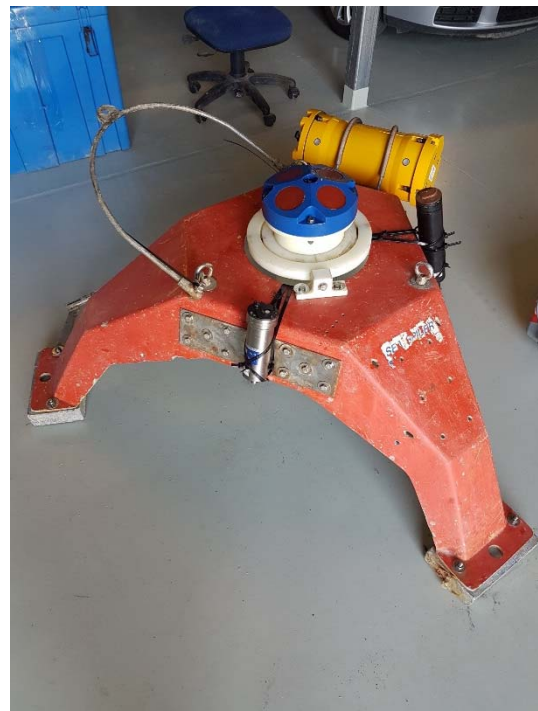
Figure 2 Loggers and ADCP setup pre-deployment for Parking (left) and Launchway (right)

- WETLabs NTU – Turbidity Logger (Figure 2, black cylinder) and;
- JFE Advantech (Kobe, Japan), Photosynthetically Available Radiation (PAR) Logger (Figure 2, silver cylinder).

These loggers were attached to each ADCP frame as shown in Figure 2. The turbidity and PAR loggers were set to 'burst' measurements with the following configuration:

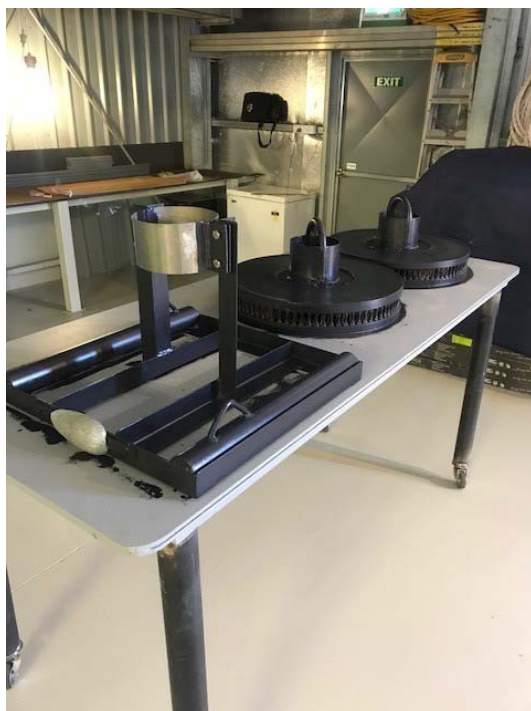
Figure 3 Photos showing ground anchors and ADCP frame (left), and davit and winch deployment (right)
