*Appendix E*  
*Rehabilitation Benchmarking Study*

**REHABILITATION BENCHMARKING STUDY**  
**Prepared for Gunson Resources Limited**  
**by URS Australia Pty Ltd**

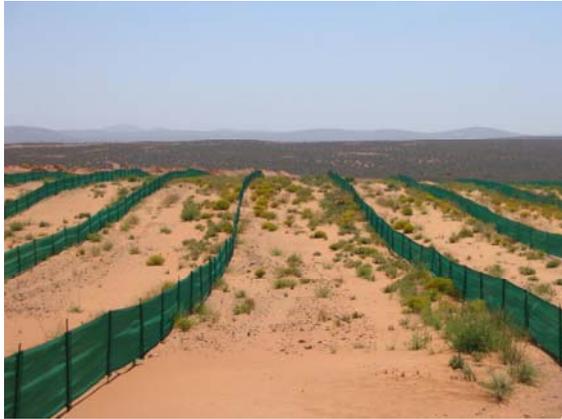
**Plate 5: One year old rehabilitation.**

Much of the rehabilitation programme's success can be attributed to the use of recently cleared topsoil as a source of seed and nutrients, and the use of windbreaks to reduce wind erosion. Field observations suggest that vegetation initially becomes established adjacent to the windbreaks (Plate 5) before colonising the areas between the

windbreaks (Plate 6). It is suggested that, in addition to reducing wind speed and sand mobilisation, the shadecloth used to construct the windbreaks captures moisture from dew and fog, which drains to the base of the windbreak, encouraging germination and plant growth adjacent to the windbreak.

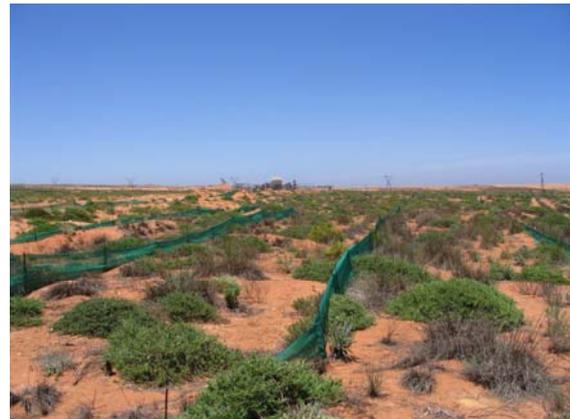
With time, soil stabilisation improves and revegetation progresses. It was observed in the field that a thin crust was present on the sand supporting four-year old rehabilitation, which facilitates stabilisation. Once the soil has been stabilised, the windbreaks are removed and reused in other rehabilitation areas at the site (Plates 7 and 8).

**Plate 7: Four year old rehabilitation prior to removal of windbreaks.**

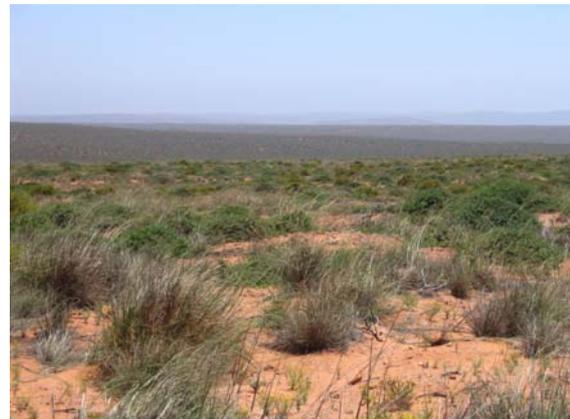
**Plate 8: Four year old rehabilitation following removal of windbreaks.**

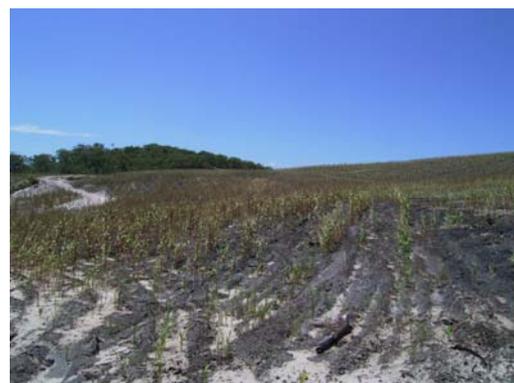
At the start of the wet season, the land is fertilized and seeded with a mixture of native seeds and sorghum and then stabilized by spraying a dilute bituminous substance known as Terolas. The Terolas stabilizes the soil while the cover crop of Sorghum develops. The sorghum provides protection from wind erosion plus organic matter to the soil within the first growing season. Native seeds also develop during the first wet season. The sorghum cover crop dies out after the first season.

**Plate 5.** Soil covered in Terolas, with sorghum crop growing through. Undisturbed vegetation in background.

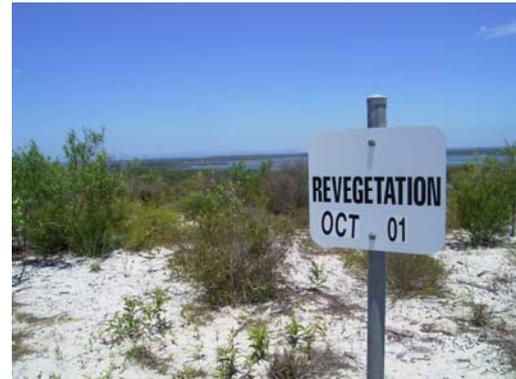
**Plate 7.** Three year old rehabilitation area.

Inspection of the rehabilitated areas of the Ibis Mine indicated substantial success in achieving return of native species and ground cover (Plates 7 and 8). However no data was available for review.

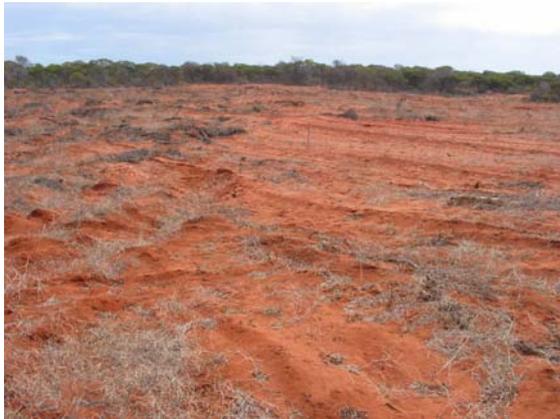
No vegetation sampling was completed at this site due to a very obvious difference in species composition and density between the disturbed and analogue sites (Plate 1). Therefore, emphasis was placed upon soil stability. To assess this factor, three transect lines, of 30 m each, were measured,

**Plate 1.** Coburn test pit site after herbicide treatment.

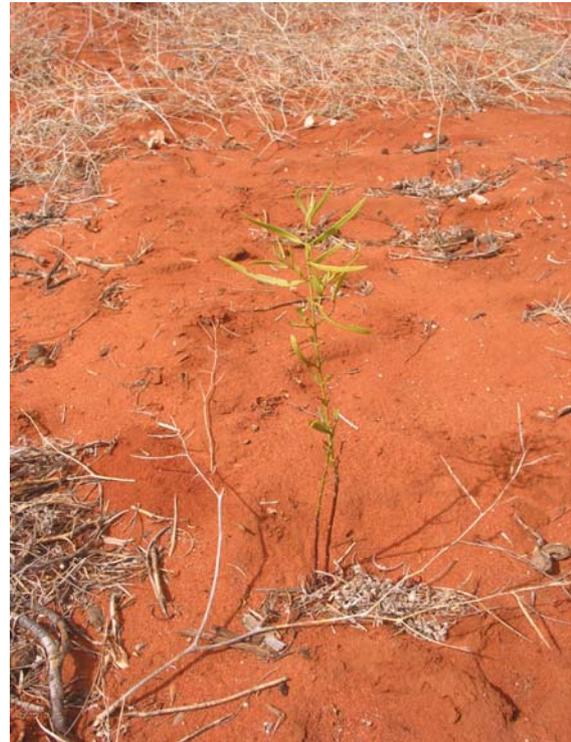
The dominant species present at the site was wild turnip (*Brassica tournefortii*), although all individuals were dead: almost certainly due to the herbicide spraying. A number of native species were also deceased. These included *Acacia ligulata*, *Ptilotus* spp, and *Triodia* spp. Few species had germinated since the spraying (Plate 3), although

occasional individuals of *Triodia* spp, *Acacia ligulata* and *Stylobasium spathulatum* had returned.

**Plate 3.** *Acacia ligulata* seedling on the Coburn test pit site, with dead *Brassica tournefortii* in the foreground and background.

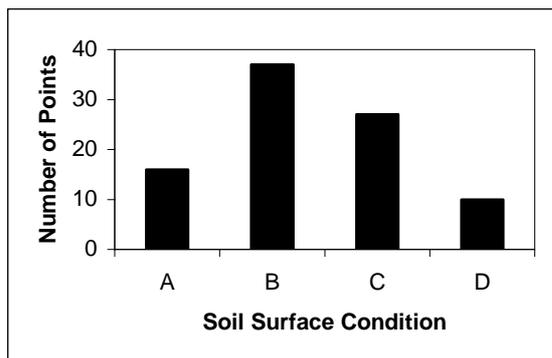
There was no evidence of wind erosion at the site. Much of the soils on the test pit site had formed a weak surface crust (n = 37, 41%; Plate 4, Diagram 2). A further 30% (n = 27) of the area had formed a crust that was located under a thin layer (2-10mm) of mobile sand. A total of 11% (n = 10) of the area had not formed a crust, with the remaining area being covered by brush (dead vegetation).

**Diagram 2.** Condition of soil surface determined using 3 x 30 m (n = 90) transects on the Coburn Test Pit site. Soil Surface Condition key. A = litter, B = crust, C = crust under loose sand, D = loose sand.

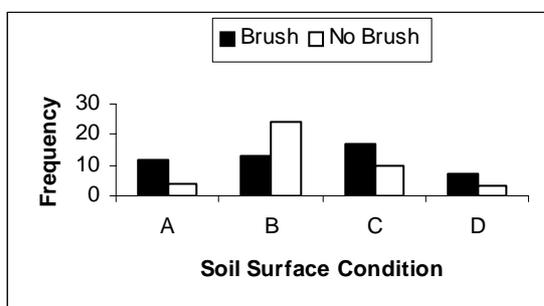
When the soil stability results from brushed and unbrushed areas were compared (Diagram 3), less litter cover was found on the unbrushed areas, as might be expected. The unbrushed sites were also found to have a larger area where the soils have formed a surface crust. In addition the amount of area in which the soil is unstable (no crust) is greater in the brushed area than the unbrushed areas. However the brushing may have an alternative positive effect on seedling germination and growth.

**Diagram 3.** Comparison of soil surface condition between areas that were covered with brush and those that remained uncovered. Soil Surface Condition key. A = litter, B = crust, C = crust under loose sand, D = loose sand.

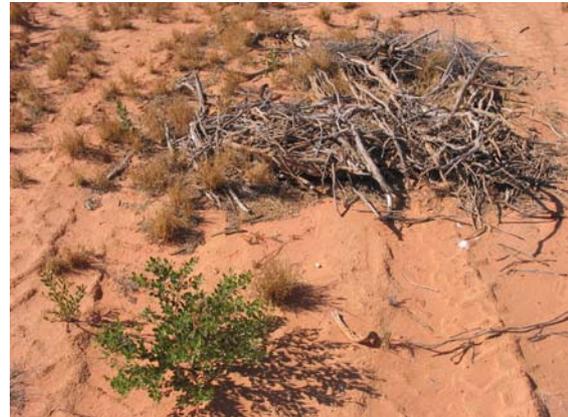
Buffel grass (*Cenchrus ciliaris*) provided the majority of the cover (15%) with pebble bush (*Stylobasium spathulatum* – 1%; Plate 3).

**Plate 3.** Denham road rehabilitation site showing brushing and 12 month growth of *Stylobasium spathulatum* and *Cenchrus ciliaris*.

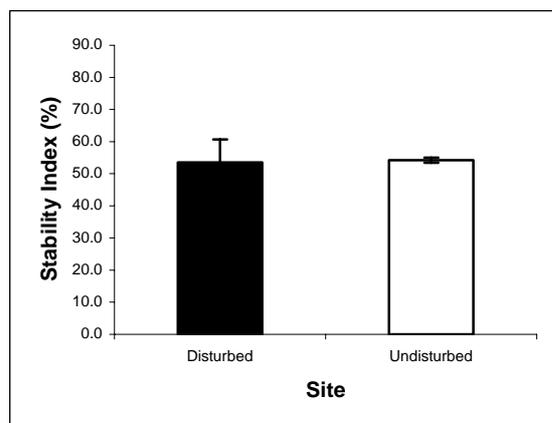
A comparison of soil stability between the two sites showed no difference (Diagram 3).

**Diagram 3.** Zone Stability comparison for disturbed refuse tip site and undisturbed analogue site.

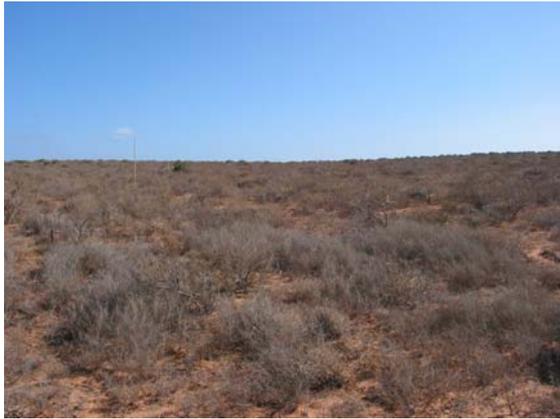
In contrast, the undisturbed sites were dominated by *Cenchrus ciliaris* (8.8%), *Ptilotus divaricatus* (7.3%), *Atriplex bunbyana* (5.3%), with dead vegetation and litter (12.5%) providing further soil protection (Plate 3).

**Plate 3.** Undisturbed site adjacent to the refuse tip rehabilitation site.

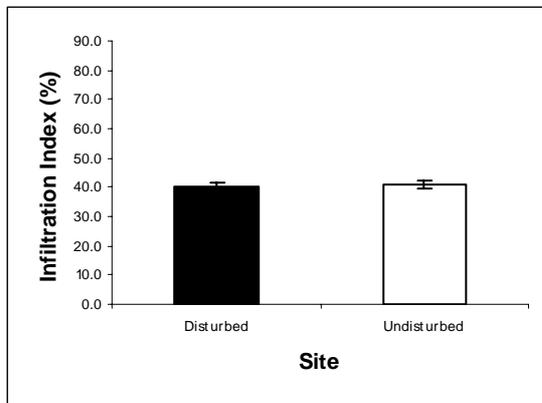
No difference was found between the infiltration indices of the disturbed and undisturbed sites (Diagram 2). This indicated that the sites showed a similar ability to infiltrate water, and therefore decrease water, soil and nutrient loss from the local area.

**Diagram 2.** Zone Infiltration comparison for disturbed Eurardy Station site and undisturbed analogue site.

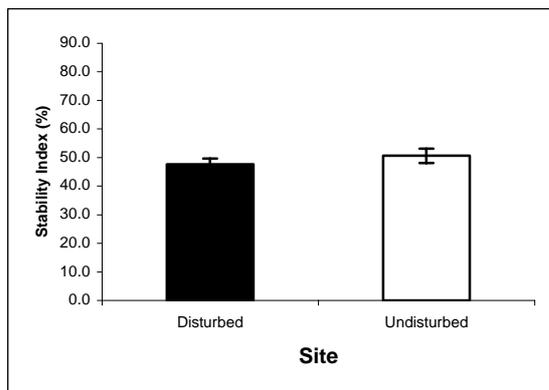
A comparison of soil stability between the two sites showed no difference (Diagram 3), which suggests that the soil of the disturbed site has similar stability to that of the undisturbed site.

**Diagram 3.** Zone Stability comparison for disturbed Eurardy site and undisturbed analogue site.

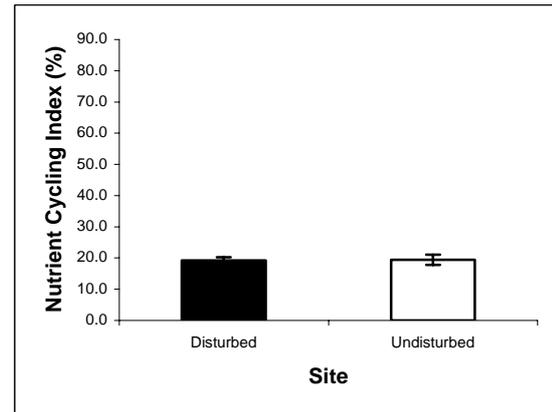
The potential for nutrient cycling did not differ between sites (Diagram 4), with the disturbed sites showing a similar ability to return organic matter and nutrients to the soil.

**Diagram 4.** Zone Nutrients comparison for disturbed Eurardy Station site and undisturbed analogue site.

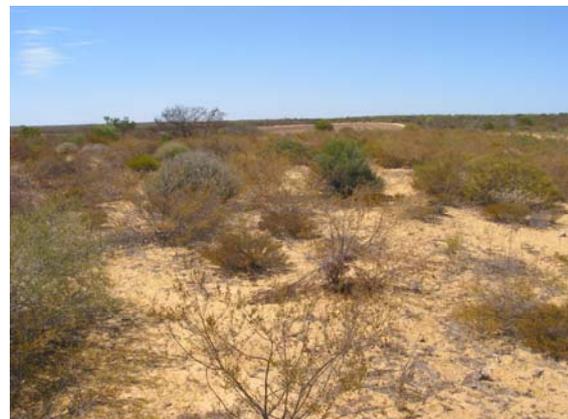
There was no difference in species diversity between disturbed sites ( $14 \pm 0.6$ ) and undisturbed sites ( $14 \pm 0.8$ ). However, the dominant species within the quadrats differed slightly. The disturbed area had a high prevalence of *Thryptomene* species (15.3%), and cover provided by dead vegetation, much of which were deceased annual species (15.2%; Plate 2).

**Plate 2.** The disturbed Eurardy Station site showing the dominant cover provided by *Thryptomene* species.

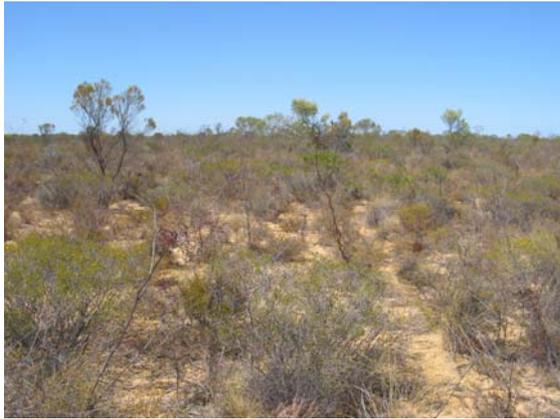
The undisturbed sites also had high percentage cover provided by *Thryptomene* species (11.7%). It was predominantly competing with *Mesomelaena tetragona* (12.2%) and *Melaleuca* spp. (8.8%). Cover was also provided by dead vegetation (12%), with a noticeable lack of annual species (Plate 3).

**Plate 3.** Undisturbed site adjacent to the Eurardy Station rehabilitation site.

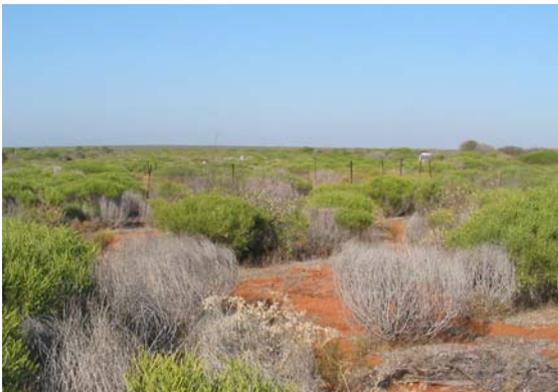
The research conducted during the rehabilitation benchmarking exercise aimed to determine the extent of rehabilitation at the Peron fire buffer site over the 10 years since disturbance (Plate 1). These results were compared with adjacent undisturbed sites (analogue; Plate 2).

**Plate 1.** Peron fire buffer site. Exclusion plot located in the centre of the photograph.

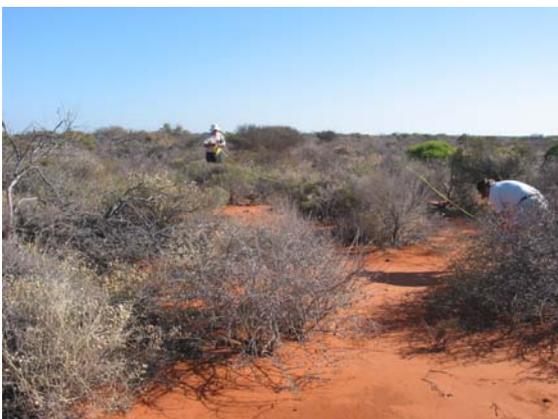
**Plate 2.** Undisturbed analogue site.

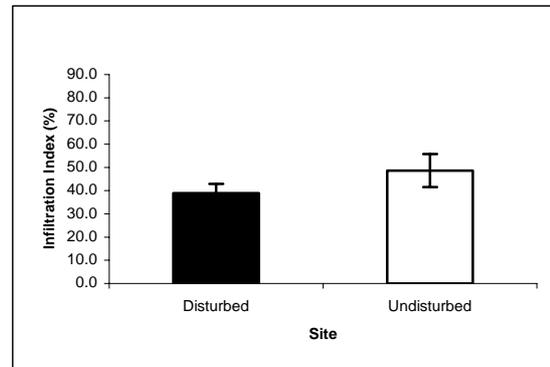
The soils in the undisturbed sites were better able to transfer rainfall into soil-water than those at the disturbed sites (Diagram 2). However, due to the sandy nature of the soils involved, little water loss through runoff is expected at either site.

**Diagram 2.** Zone infiltration comparison for disturbed plots and undisturbed analogue sites.

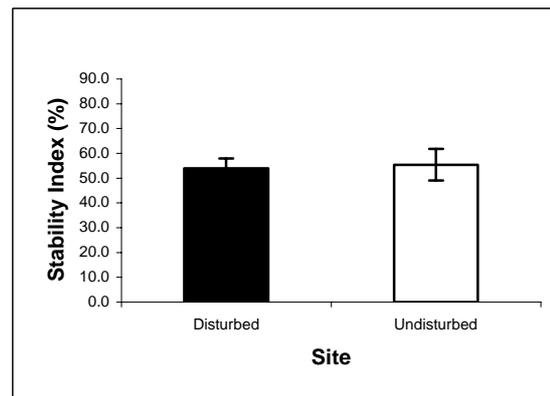
A comparison of soil stability between the two sites showed no difference (Diagram 3). No erosion was observed at either site suggesting that the soils were able to withstand the environmental pressures.

**Diagram 3.** Zone Stability comparison for disturbed plots and undisturbed analogue sites.

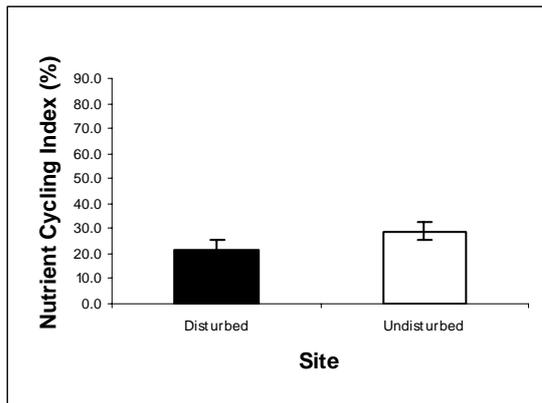
The undisturbed site showed a slightly greater ability to cycle nutrients (Diagram 4). This suggests that the analogue sites are better able to return organic matter and nutrients to the soil.

**Diagram 4.** Zone nutrients comparison for disturbed plots and undisturbed analogue sites.

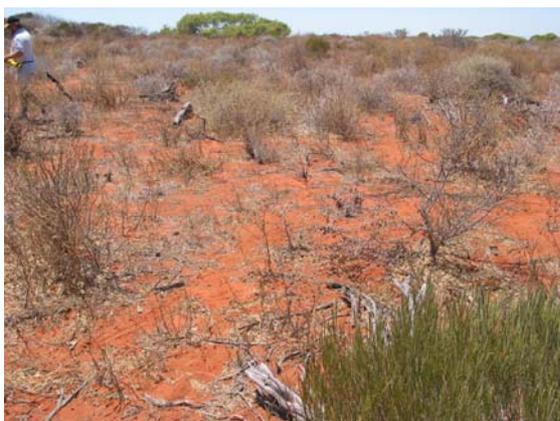
The disturbed sites showed two distinctive communities. Some sites showed dominant overstorey species consisting of *Acacia ligulata* and *Acacia sclerosperma* (eg. Plate 1). Other sites contained very little overstorey, with the vegetation dominated by understorey species such as *Scaevola* spp., *Ptilotus* spp. and *Solanum* spp., as well as a range of annual species (eg. Plate 3).

**Plate 3.** Peron fire buffer site. Vegetation at this site is dominated by *Solanum* spp., *Ptilotus* spp., *Scaevola* spp., and a range of annual species.

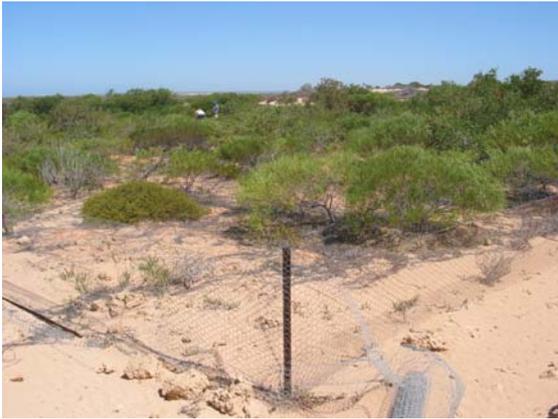
**Plate 1.** Useless Loop rehabilitation site showing rabbit proof fencing in foreground.

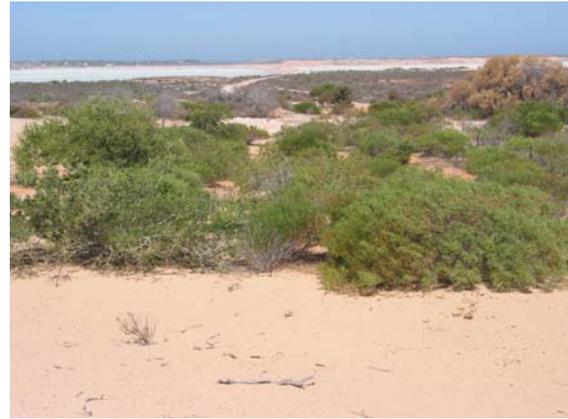
The rabbit exclusion experiment, conducted by the Shark Bay Salt Joint Venture mine, showed positive vegetation results. Where the rabbit proof fence had been removed after five years, the vegetation cover averaged 60%, with a species diversity of 10 (Plate 3). *A. ligulata* was the most dominant, averaging 20% cover. The site where the fence remained in place had a vegetative cover of 70% (Plate 1). *A. ligulata* was again the most dominant species, with a percentage cover of 35%. The site was found to contain 11 different species.

**Plate 3.** Useless Loop rehabilitation site where the rabbit resistant fencing had been removed after a five year period.

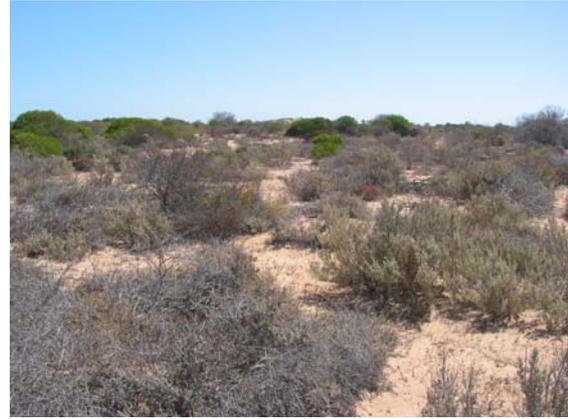
The original vegetation at the site looked to be relatively different to the vegetation at the rehabilitation sites (Plate 4). Percentage cover was similar to the fenced rehabilitation sites (70%), however the dominant species differed. Although *A. ligulata* was present at the analogue site (10%), it did not show the same dominance as that found in the rehabilitation sites.

**Plate 4.** Analogue vegetation for Useless Loop rehabilitation sites.

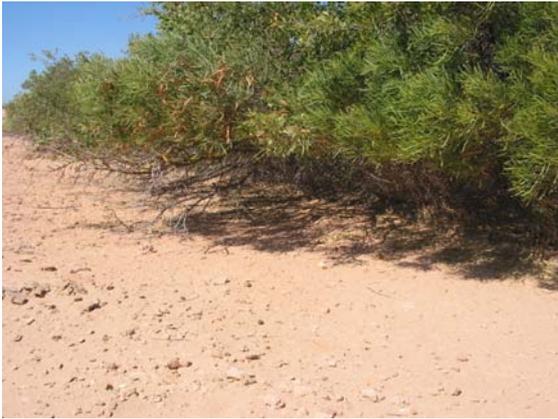
Results from the Useless Loop site suggest that providing rabbit proof fencing to a rehabilitation area significantly increases the vegetative cover of the area. Further photographic evidence highlights this result, showing vegetation hanging over the fenced area to have been severely grazed (Plate 5). Due to the height of the grazing, rabbits are presumed to be responsible.

**Plate 5.** Useless Loop fenced rehabilitation site showing grazing on Acacia species growing over the rabbit proof fencing.

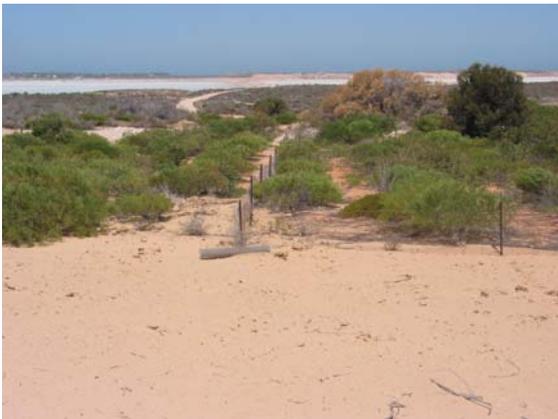
Hand seeding was also deemed successful, as lines where seeding was conducted were still visible 11 years later (Plate 6).

**Plate 6.** Fenced rehabilitation areas at Useless Loop showing lines where seeding initially occurred.
