Robe Valley Deposits Façade Stand-Off Distance Memo

From	Xuzheng Gao
Department	Mine Engineering Geotechnical (MEG)
To	Melinda Brand; Fiona Bell
CC	Agus Rachman; Solomon Oppong
Reviewed By	Agus Rachman; Solomon Oppong
Reference	
Date	13 November 2017
Number of pages	37

Executive Summary

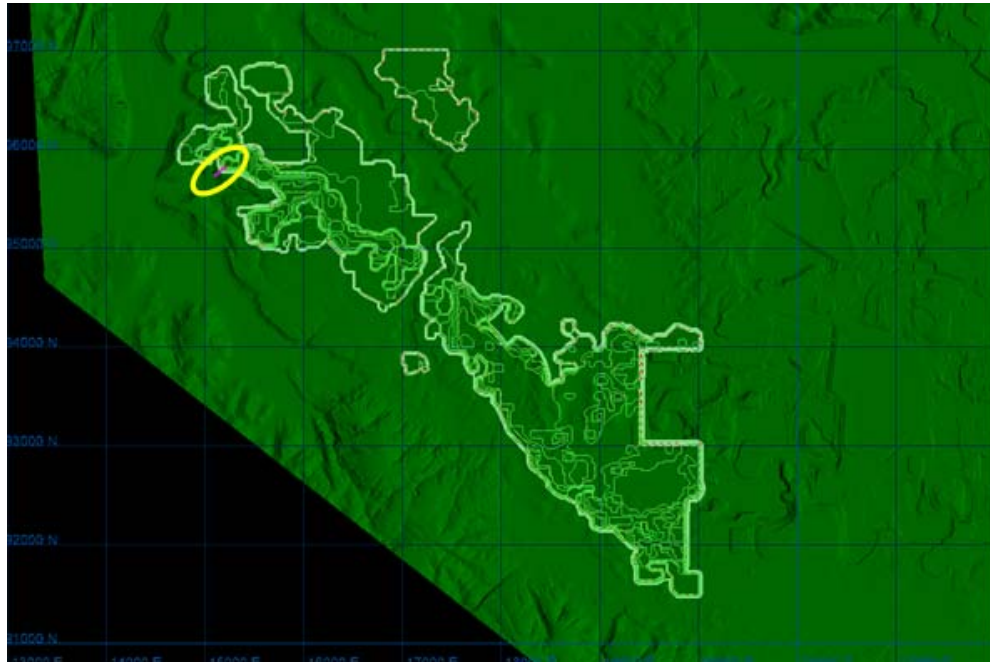
Figure 21. 2016 RTIO Mesa H Analysis Section.

Review of the existing geotechnical data together with updated geological modelling and drilling data across the Robe Valley was undertaken and was analysed taking into consideration the distance to the 1.5 FOS failure surface in order to refine the stand-off distance from the pit crest to the mesa façade crests.

It was found that the FoS for the façade is below 1.5 using a 20m stand-off distance and above 1.5 with 30m stand-off distance. It was recommended that a minimum 30m stand-off is required between the Mesa H pit crest and façade crest.

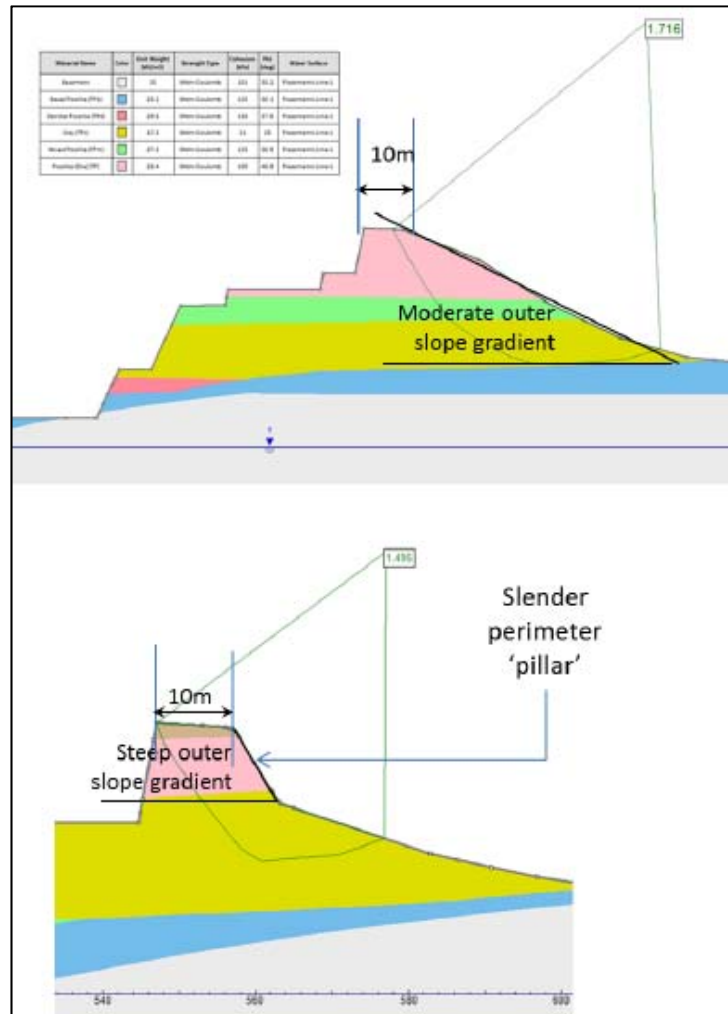
Figure 28. Example of Façade geometry in RTIO 2015 “Mesa B and C Façade Slope Stability Analysis for Closure” Report.

It was determined to be important to consider the likely depth of blast disturbance into the perimeter rock mass, behind the mined batters, which is generally taken as one to two mining bench heights but can be greater depending on the blasting methods used. Further, the impact of the blast disturbance on façade stability will be increased where the outer slope of the mesa forms a steep slope, forming a more slender perimeter "Pillar" as shown in Figure 28.

The long term stability of the mesa façade will be controlled, in part, by the level of blast damage and relaxation undergone by the perimeter material. Xstract recommended a minimum stand-off distance of 20m (i.e. approximately twice the standard mining bench height) be employed where the outer slope of the mesa is relatively steep (i.e. a ‘slender’ perimeter pillar may be formed).

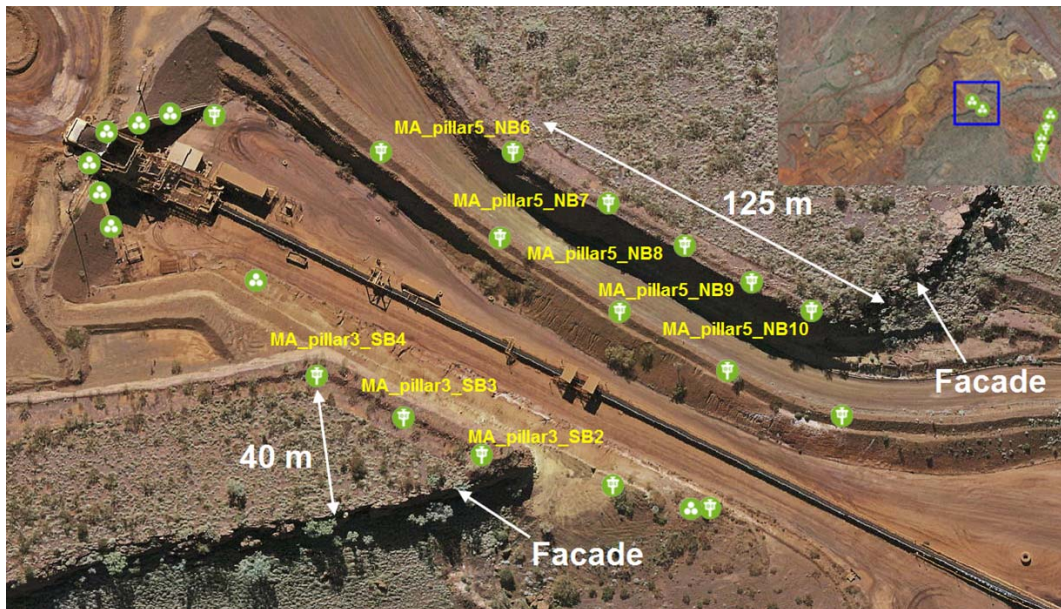
Figure 35. Prisms location in Mesa A Breach Area.

Eight prisms were installed on the cut slopes crest close to the façade in Mesa A Breach area (5 on the North wall and 3 on the South wall) as shown in Figure 35. A cross section of the slopes with the geological setting is shown in Figure 36. The wall in this area intersected HTP, TPH, TPM and TPB with 25m slope height. The Inter Ramp Angle (IRA) is 30 degrees in the north wall and 48 degrees in the south wall. Both are still below the maximum IRA recommended by Snowden in the 2007 report.

The recorded prism movement rates were minor. Five out of eight prisms movements also indicated invalid movement directions (moving towards the wall), possibly impacted by errors in the readings. Therefore, it was concluded that there was no apparent movement trend observed.

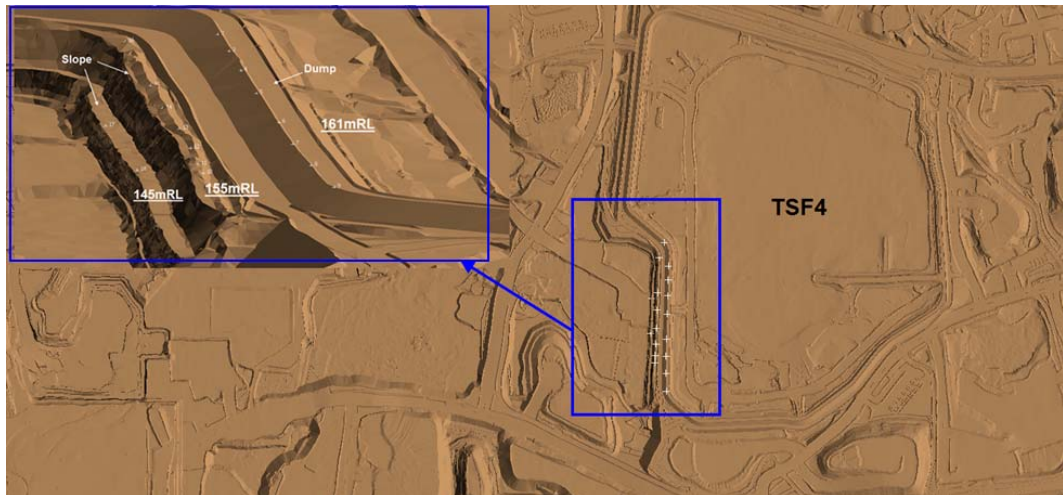
Figure 37. Mesa J TSF4 Prisms Locations.

There is a Tailings Storage Facility (TSF4) behind the east wall of Pit 8 in Mesa J. The distance between the pit crest and the toe of TSF4 is around 25m. In total there are 17 prisms installed on the wall; 145mRL (prisms #17 and #18), 155mRL (prisms #10 to #16) and 161mRL (prisms 1 to 9) and monitored since February 2017 to monitor the impact of TSF4 to the pit 8 stability. The prisms locations are shown in Figure 37 and the as-built wall conditions are shown in Figure 38.

Prisms #1 to #9 are located in the tailing embankment to monitor the tailing slope stability. Therefore they were not included for analysing the slope stability. Only the prisms on the Pit 8 slope (#10 to 18) were investigated.

The recorded prism movement rates were minor with most of them showing invalid movement direction (moving towards the wall) Therefore, it can be concluded that there was no apparent trend of movement observed.

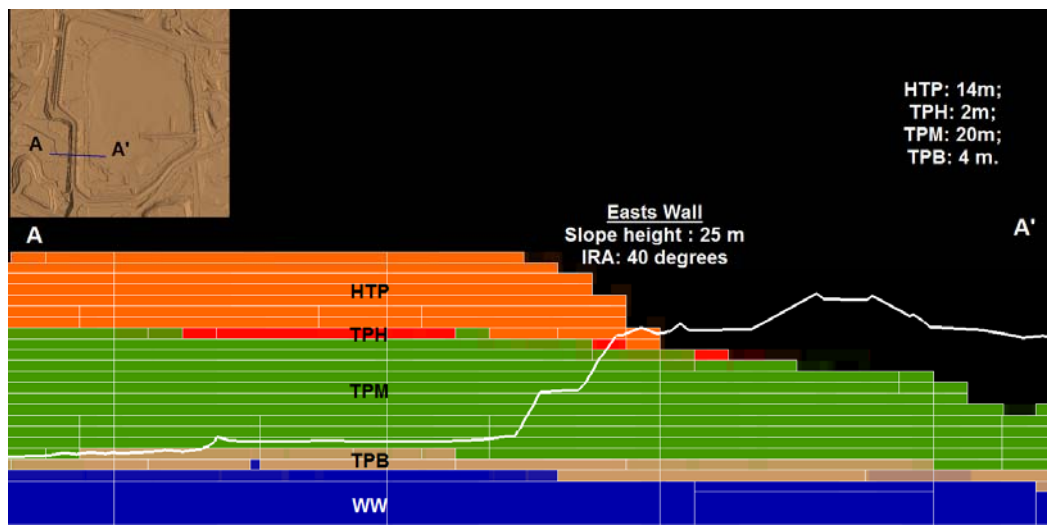
Figure 39. Mesa J South West Dump Cross Section Geology Setting.

The slope intersected HTP (2m) and TPH (20m). The slope height is 25m with IRA 40 degrees as shown in Figure 39 which is lower than the maximum IRA recommended by 3rd Rock in their 2017 Mesa B, C and H FS report for similar material.

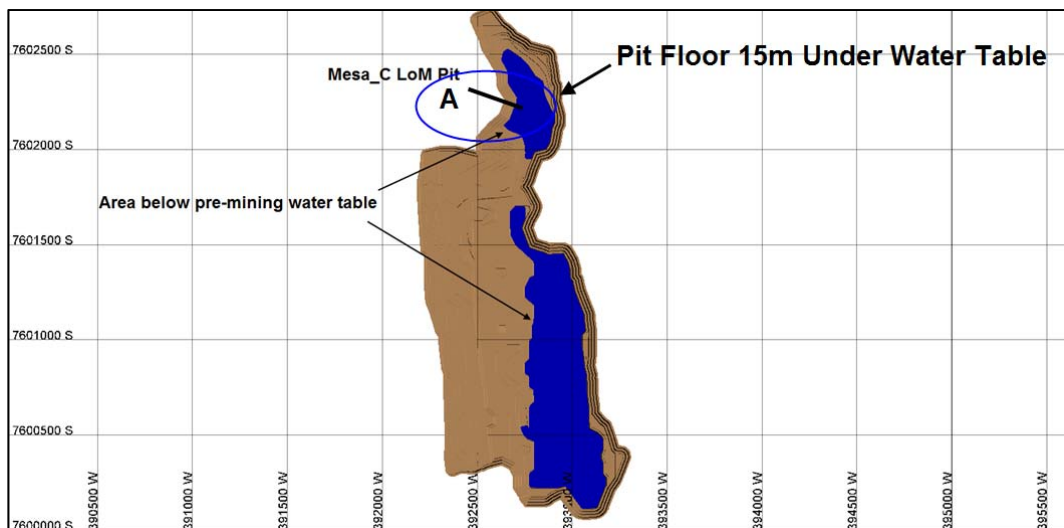
Figure 42. Closure Slope Stability Geotechnical Section in Mesa C.

In order to assess the slope stability close the façade after ground water recovery, two sections were selected from Mesa C and Mesa H in the area where pit floors will be under the pre-mining water table as shown in Figure 42 and Figure 43. The pit floors will be 15m below pre-mining water table in section A Mesa C, and 10m below pre-mining water table in section J of Mesa H.

The closure plan has consequently prioritised these areas for backfill in the future. Additional stability analyses in these sections were intended to check the stability of the slopes prior to backfill.
