## TECHNICAL MEMORANDUM

**Reference No.** 20360083-009-M-RevA

### **BYFORD RAIL EXTENSION – GROUNDWATER AND SURFACE WATER LEVEL MONITORING EVENT – JANUARY 2021**

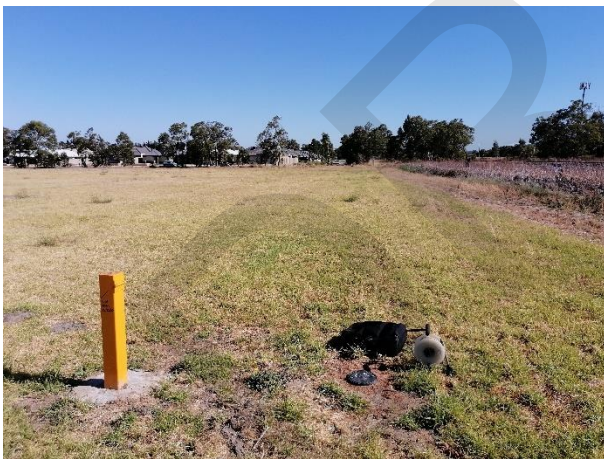
BH5 & BH5A (Flush Gatics) – Rail Reserve

- Deep wells covered by a monument were locked and therefore not accessible by Golder.
- BH5 and BH5A are located within the rail reserve and Golder could not obtain an authorisation to access the area.
- BH7A was noted to be blocked with mud.
- The PVC pipe in BH3A was found broken and could not be dipped.
