W2 Diversion – Day 4

<p>STUDY PHASE WAIO PROJECT YANDI CLOSURE LANDFORM SPS SURFACE WATER ENGINEERING DESIGN REPORT</p>	<p>Doc No.: PREP-1200-C-12142/B</p> <p>Page: 112 of 114</p>
---	--	---

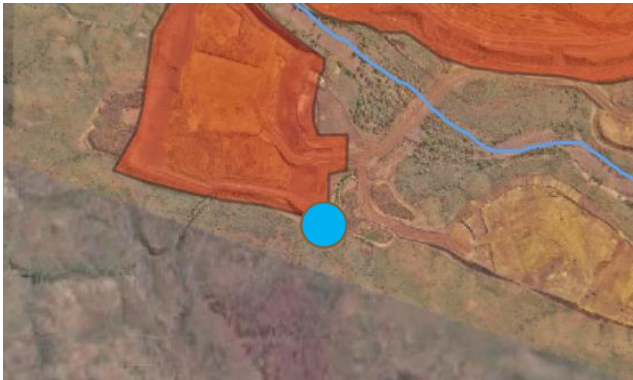
- There is some, but not much, room at the top if required for bund raising.
- Flood bund has very small armour rock – will need to be upgraded. →
- Geofabric exposed at toe of bund as it cannot be keyed into ground (CID) →
- Upstream natural analogue shows the creek ~20m wide with trees on the side with an alluvium base. →
- Works required for this diversion include widening of cut, work to create an aquifer throughout entire length of diversion and placement of larger armour rock on the bund.

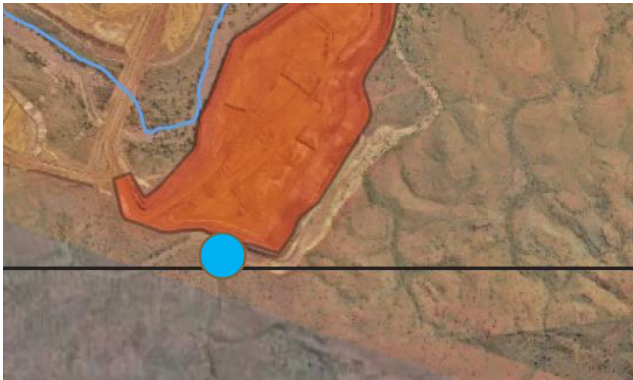
- Lamb Creek bunds appear to be well constructed - need to check rock size on as-built and design drawings and compare with photos taken. →
- Unlikely that submerged rock toes were constructed. Need to check latest flood levels for 0.1% AEP to determine if they need to be raised.
- Upstream bund may need to be raised; however, there is no room to south due to tenement boundary and no room to north due to pit wall drop-off. →

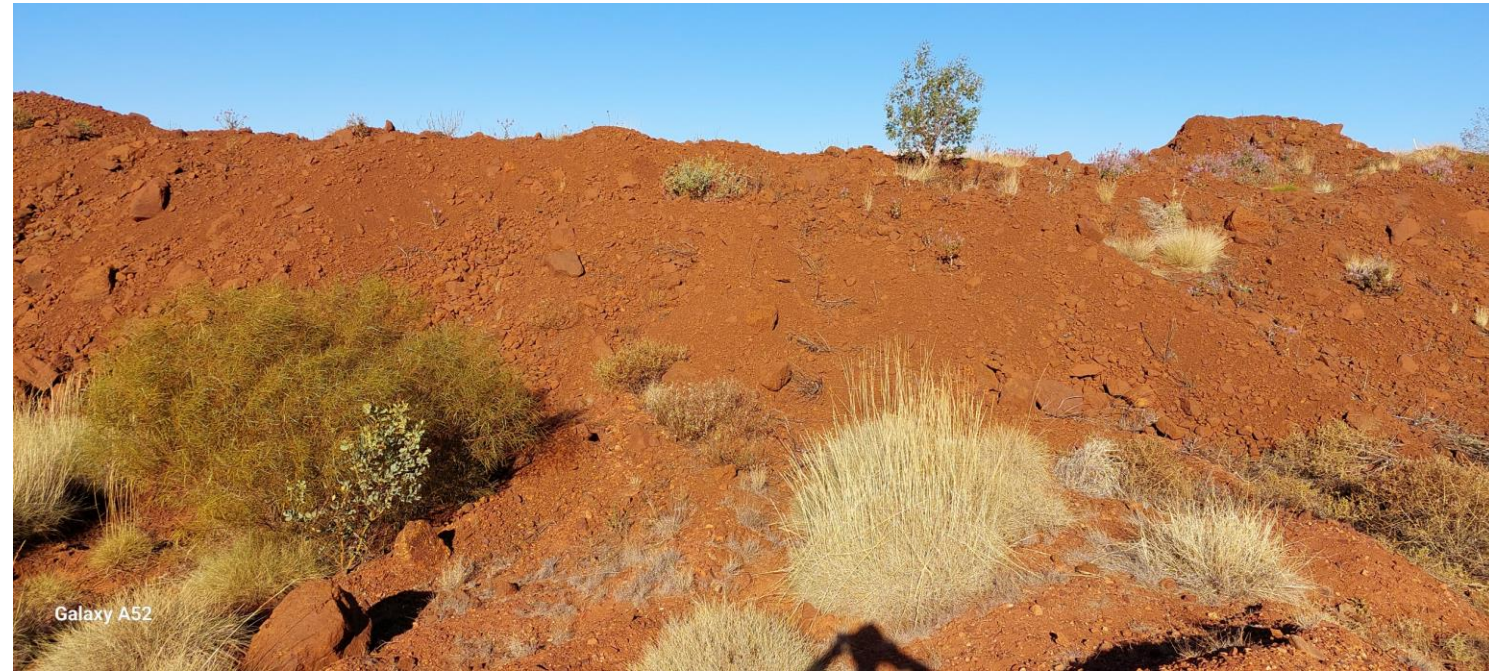
- W5 western corner of remnant CID is low and appears disturbed (material dumped over the top, or CID replaced by loose material) – it is not clear if there is sufficient room to put a bund on top, probably not. →
- Outlet of W5 diversion is OK with some trees. Majority of diversion where in cut has no alluvium/aquifer and no trees. →
- Cut slopes are steep and showing signs of erosion in places. However, the sediment does not appear to be accumulating sufficiently in the channel to support tree/veg growth. Suggests that diversion channel may require upgrading to support revegetation. →

Diversion outlet some trees

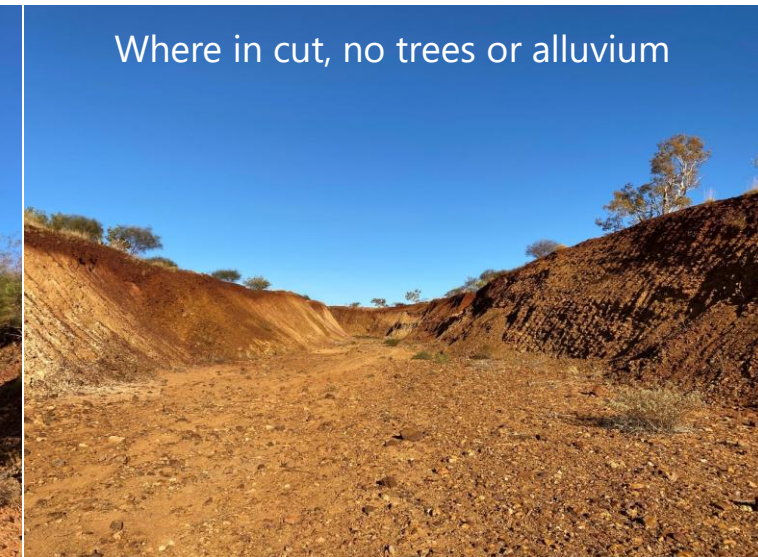
Where in cut, no trees or alluvium

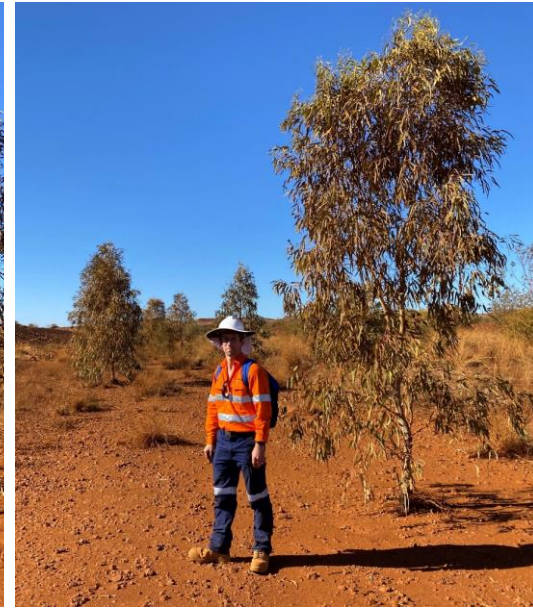
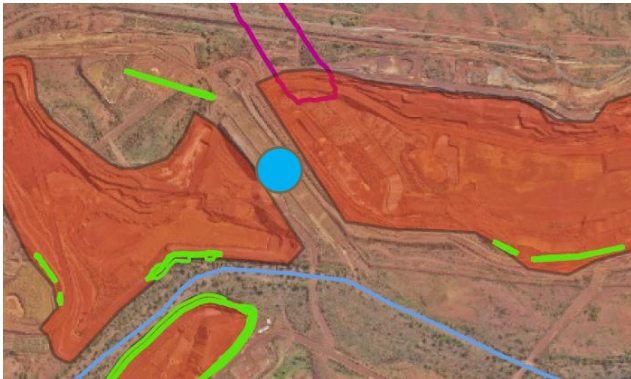
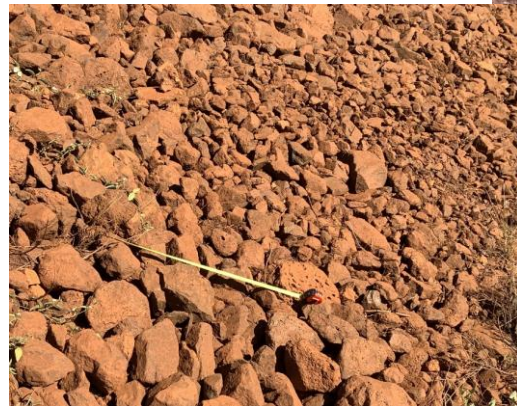
- Trees are growing in the diversion, up to 5-6 m tall. Roots are expected to have extended to the depth of the GCL (~1 m) and may have even punctured it (unconfirmed)? →
- Sediment transport into the land bridge and deposited near inlet. Large sediments slug evident in upstream section (up to 0.6 m). ↘
- Several sections of the flood bunds on the land bridge have rock armour that is undersized for mine closure (<Facing Class). ↙
