**REPORT ON**

**ADDENDUM TO NOTICE OF INTENT:  
PROPOSED INCREASE IN THE STORAGE  
CAPACITY OF THE FIMISTON II TAILINGS  
STORAGE FACILITY AT KCGM**

**VOLUME II – APPENDICES**

05641089-R01

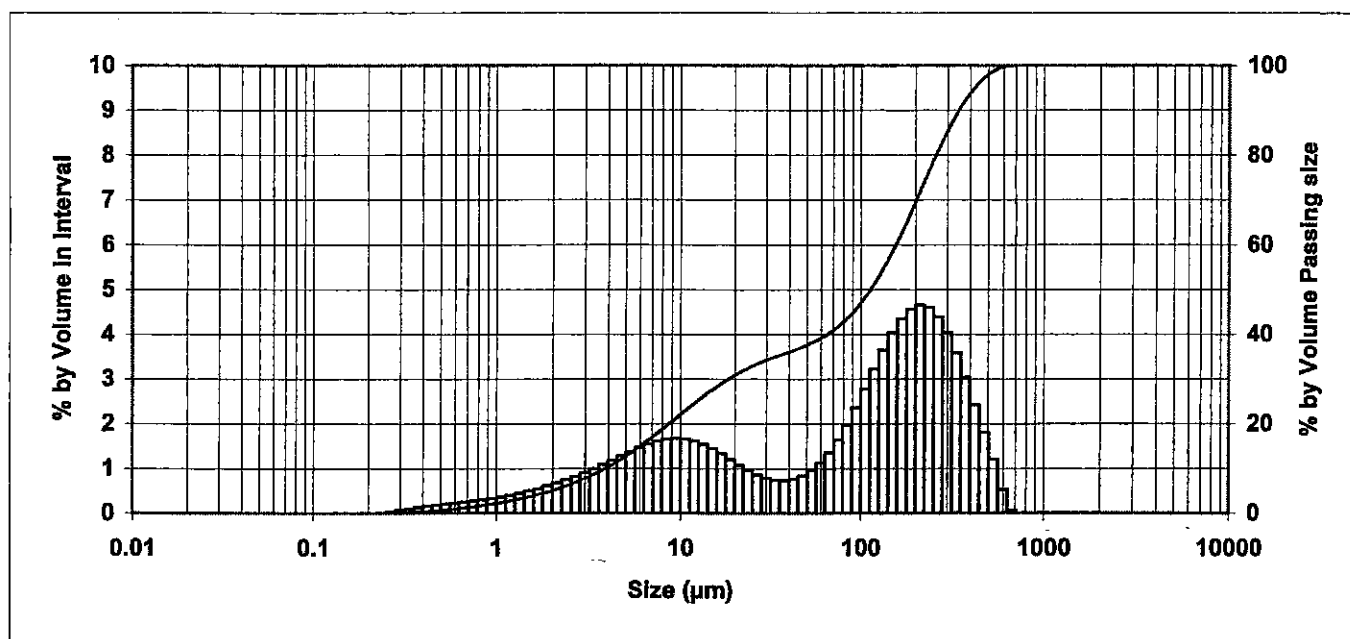
Concentration:	0.0411 % vol	Vol. Weighted Mean D[4,3]:	142.256 $\mu\text{m}$	d(0.1):	3.865 $\mu\text{m}$
Obscuration:	31.72 %	Surface Weighted Mean D[3,2]:	9.241 $\mu\text{m}$	d(0.5):	113.194 $\mu\text{m}$
Weighted Residual:	0.666 %	Specific Surface Area:	0.649 $\text{m}^2/\text{cc}$	P80:	258.919 $\mu\text{m}$
				d(0.9):	344.556 $\mu\text{m}$

0.020	0.00	0.142	0.00	1.002	2.22	7.096	17.17	50.238	37.68	355.656	90.93
0.022	0.00	0.159	0.00	1.125	2.58	7.962	18.78	56.368	38.61	399.052	93.97
0.025	0.00	0.178	0.00	1.262	2.98	8.934	20.43	63.246	39.73	447.744	96.39

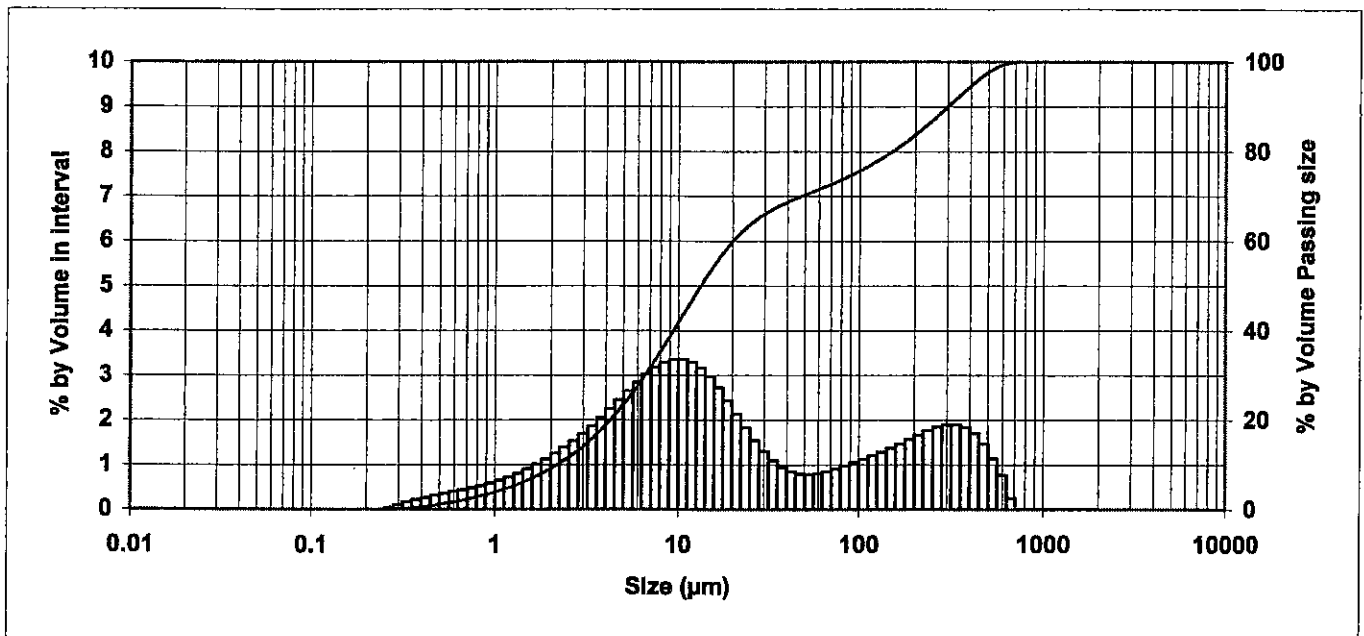
Dispersant: Water  
Additives: 10 millilitres sodium hexametaphosphate  
Sonication: 20 mins ultrasonics  
SOP Name:  
Analysis Model: General purpose  
Result units: Volume

Concentration: 0.0248 % vol Vol. Weighted Mean D[4,3]: 81.604  $\mu\text{m}$  d(0.1): 2.174  $\mu\text{m}$   
Obscuration: 33.72 % Surface Weighted Mean D[3,2]: 5.184  $\mu\text{m}$  d(0.5): 13.271  $\mu\text{m}$   
Weighted Residual: 0.89 % Specific Surface Area: 1.16  $\text{m}^2/\text{cc}$  P80: 149.792  $\mu\text{m}$   
d(0.9): 299.721  $\mu\text{m}$

0.020	0.00	0.142	0.00	1.002	3.89	7.098	32.11	50.238	70.38	355.656	92.83
0.022	0.00	0.159	0.00	1.125	4.53	7.962	35.28	56.368	71.16	399.052	94.67
0.025	0.00	0.178	0.00	1.262	5.25	8.934	38.57	63.246	71.96	447.744	96.37

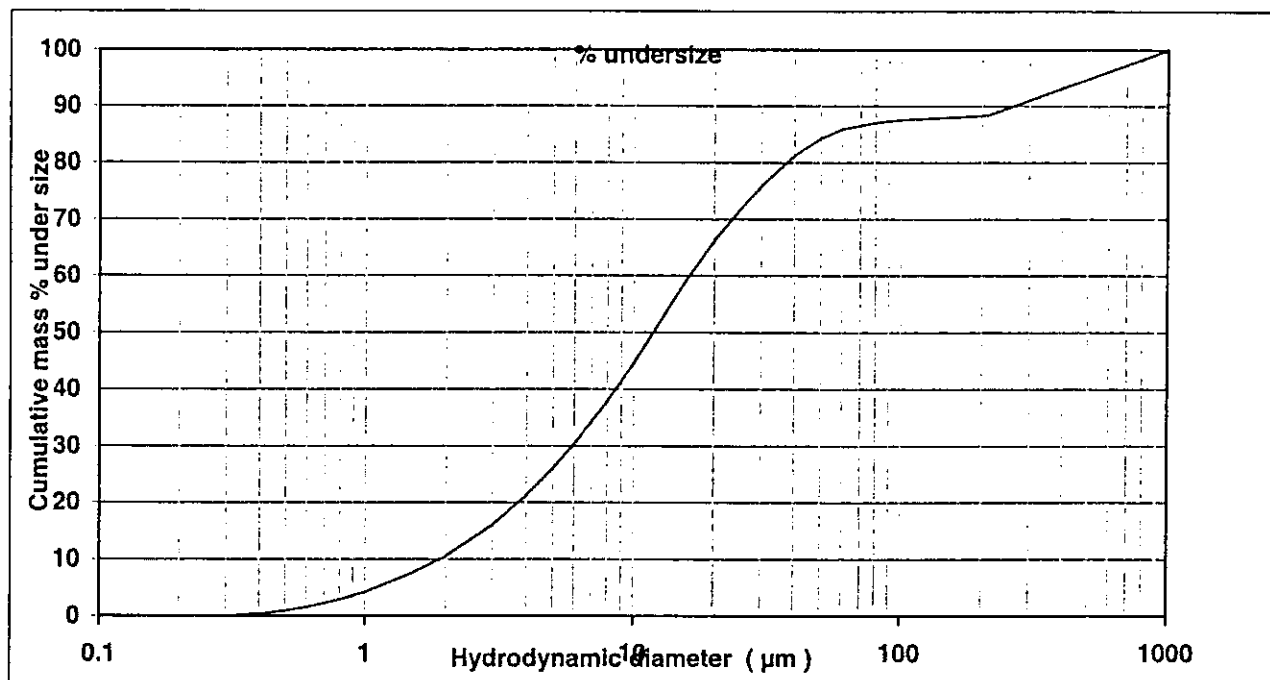
**Analysis:** X-ray sedimentation by Sedigraph 5100  
**Analysis temp.:** 35.5 °C  
**Dispersant:** Water  
**Sonication:** 10 min  
**Additives:** 10mL sodium hexametaphosphate  
**Concentration:** 10 % w/w

**Sample density:** 2.861 g/cm<sup>3</sup> (as measured)  
**Reynolds No:** 18.81  
**Liquid density:** 0.994 g/cm<sup>3</sup>  
**Critical diameter:** 52.00 µm  
**Liquid viscosity:** 0.715 cp

Max size (µm)	Min size (µm)	In %	Max size (µm)	Min size (µm)	In %	Max size (µm)	Min size (µm)	In %	Derived diameters	Size (µm)
1000.00	212.00	11.51	30.00	25.00	3.99	3.00	2.00	5.52	d (0.9)	260.0
212.00	200.00	0.20	25.00	20.00	5.62	2.00	1.50	2.96	d (0.5)	#NAME?
200.00	150.00	0.31	20.00	15.00	8.48	1.50	1.00	3.37	d (0.1)	#NAME?
150.00	100.00	0.41	15.00	10.00	13.08	1.00	0.80	1.33		
100.00	80.00	0.51	10.00	8.00	6.74	0.80	0.60	1.33		
80.00	60.00	1.12	8.00	6.00	7.66	0.60	0.50	0.61		
60.00	50.00	1.63	6.00	5.00	4.29	0.50	0.40	0.51		
50.00	40.00	3.07	5.00	4.00	4.70	0.40	0.30	0.41		
40.00	30.00	5.42	4.00	3.00	5.21	0.30	0.00	0.00

**NOTE :** The sample was wet screened at 212µm.

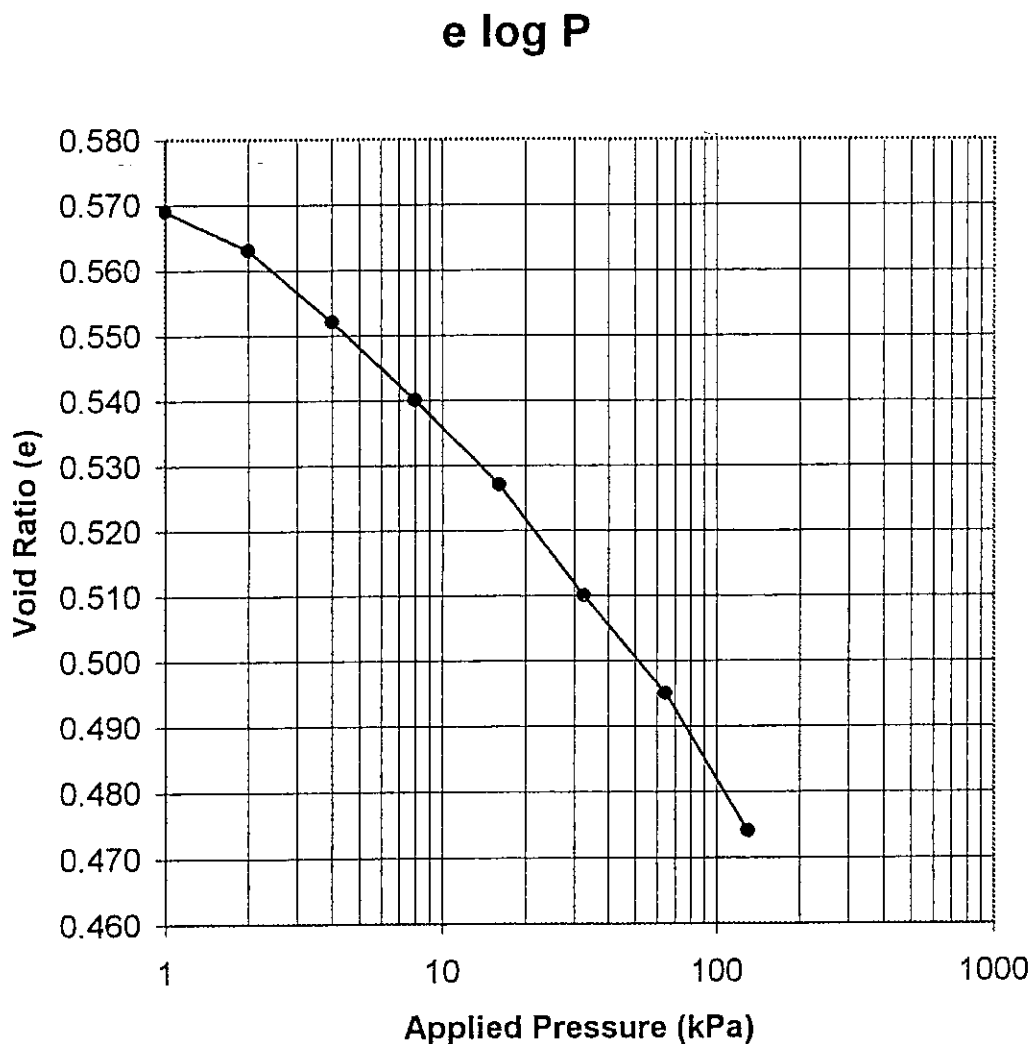
Material Description: Tailings

Test Methods AS1289  
6.6.1 Consolidation Test  
Sampling Procedure: Tested as received

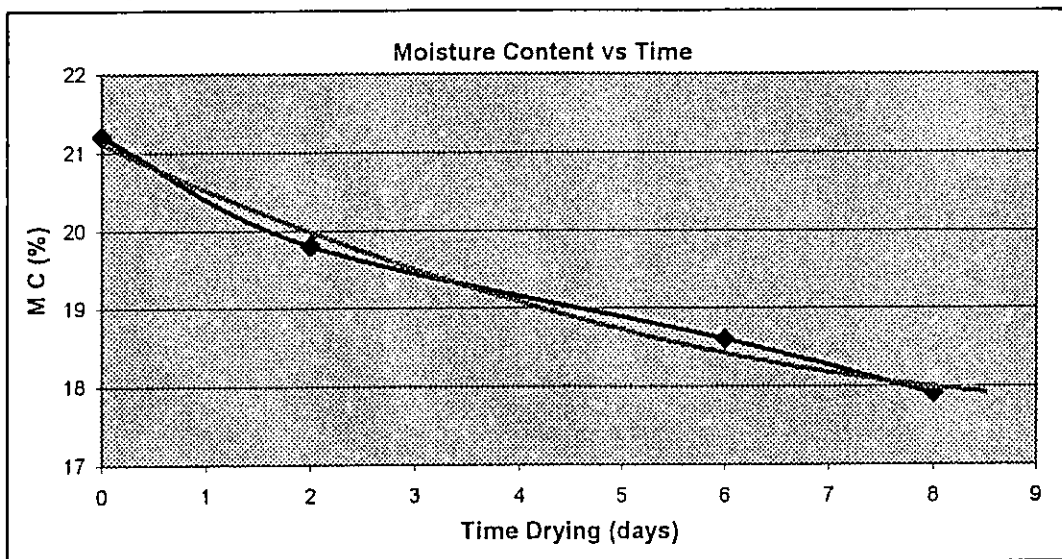
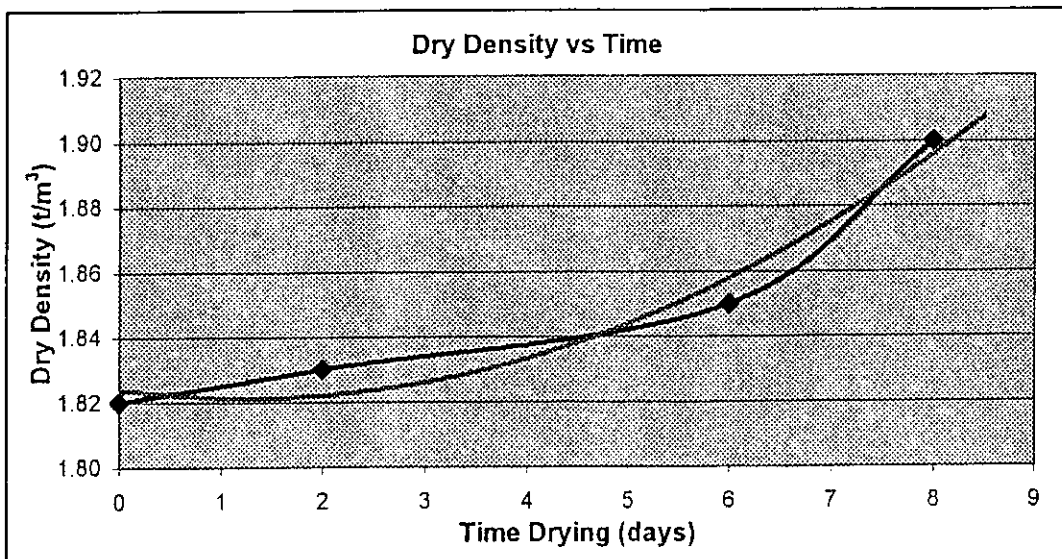
Date	Day	Moisture Content (%)	Dry Density (t/m <sup>3</sup> )
10/06/2004	0	21.2	1.82
12/06/2004	2	19.8	1.83
16/06/2004	6	18.6	1.85
18/06/2004	8	17.9	1.90

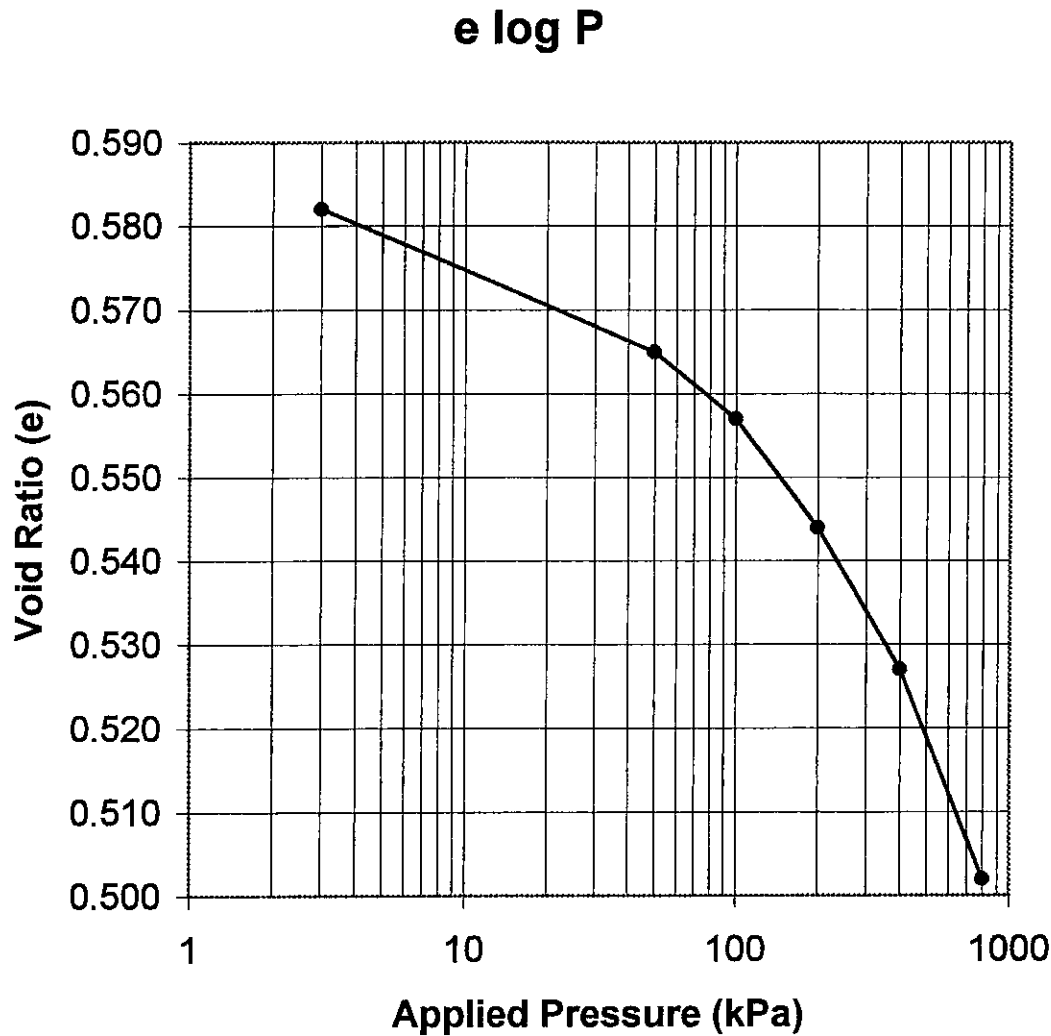
Sample Location: Tube A  
Material Description: Beached Tailings

Test Methods AS1289  
6.6.1 Consolidation Test  
Sampling Procedure: Tested as received

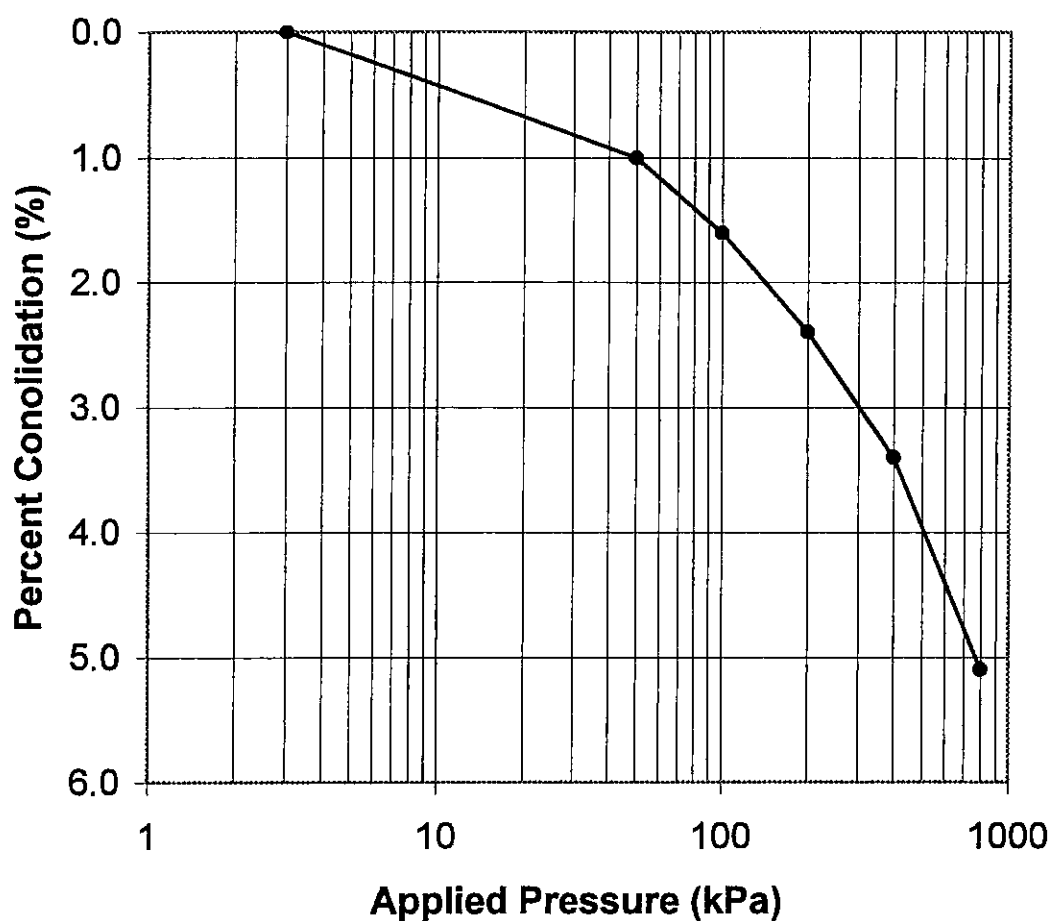
#### % Consolidation log P

Sample Location: Tube A  
Material Description: Beached Tailings

Test Methods AS1289  
6.6.1 Consolidation Test  
Sampling Procedure: Tested as received

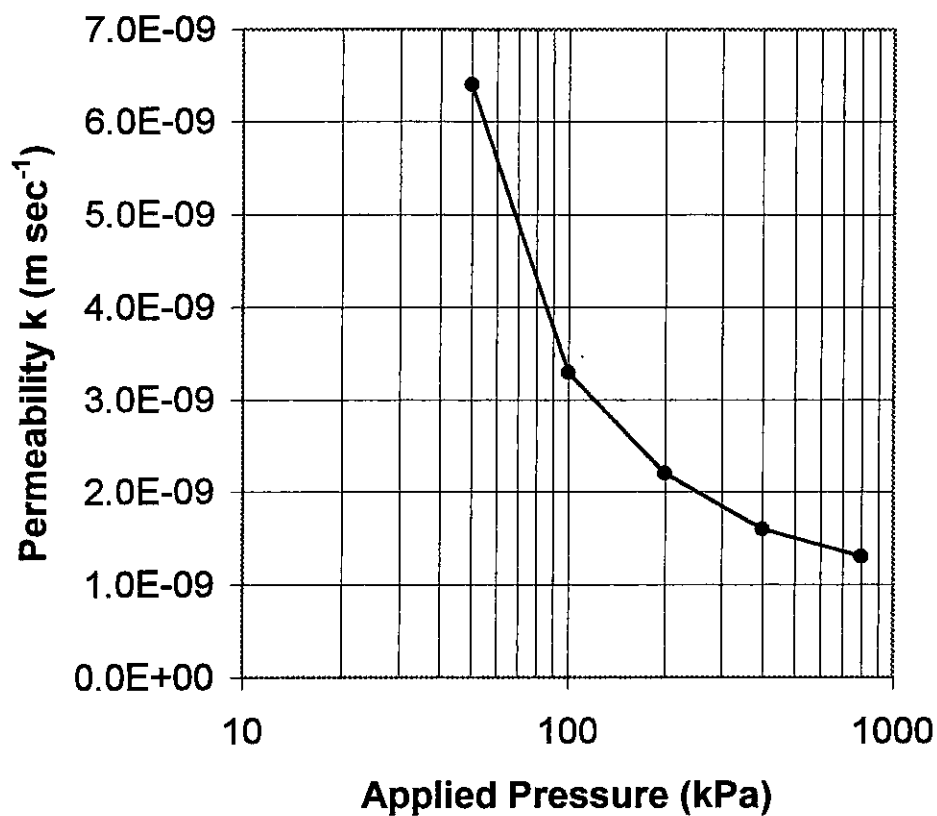
#### Permeability Log P

Sample Location: Tube A  
Material Description: Beached Tailings

Test Methods AS1289  
6.6.1 Consolidation Test  
Sampling Procedure: Tested as received

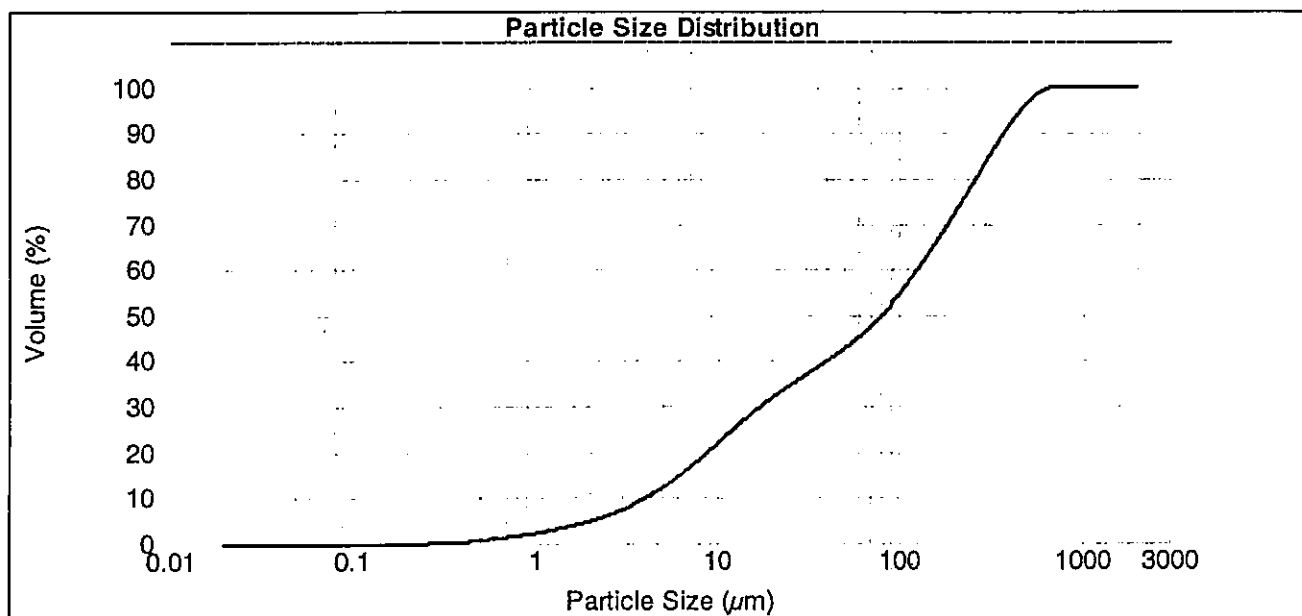
**Specific Surface Area :** 0.643 m<sup>2</sup>/cc

**d(0.8) : 265.005 μm**

Size (μm)	Vol Under %	Size (μm)	Vol Under %	Size (μm)	Vol Under %	Size (μm)	Vol Under %	Size (μm)	Vol Under %	Size (μm)	Vol Under %
0.020	0.00	0.142	0.00	1.002	2.19	7.096	16.42	50.238	42.59	355.656	88.50

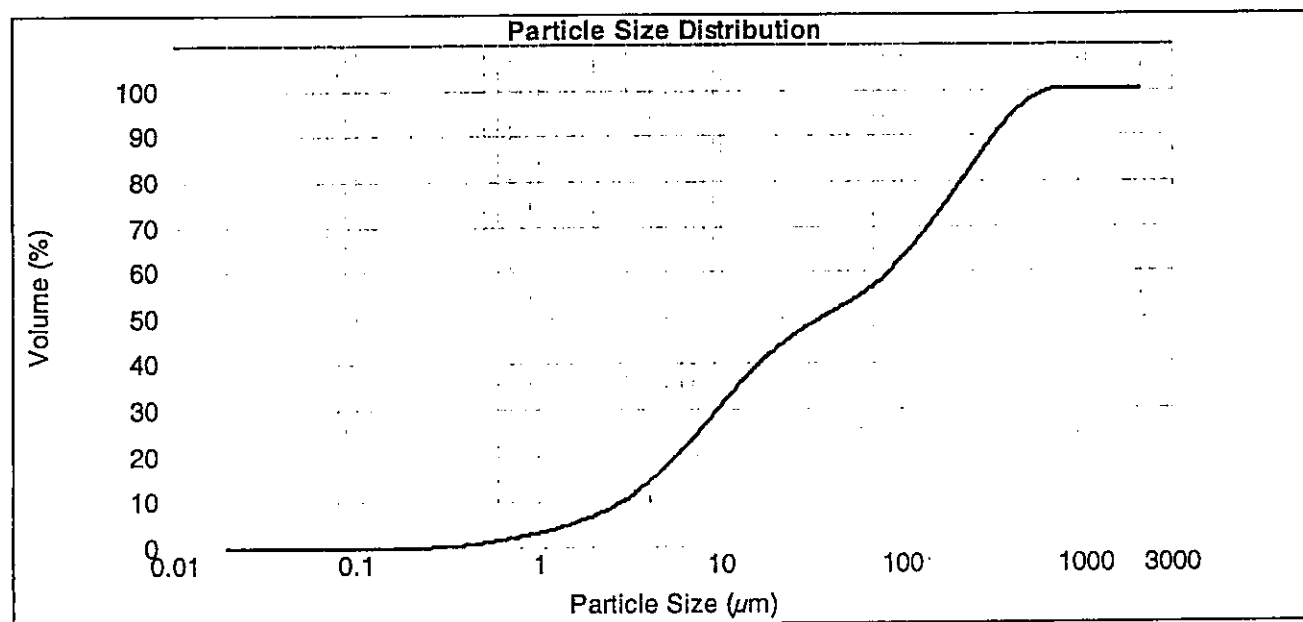
Obscuration : 29.04 % Surface Weighted Mean D[3,2] : 6.841  $\mu\text{m}$  d(0.5) : 37.302  $\mu\text{m}$

Weighted Residual : 2.055 % Specific Surface Area : 0.877  $\text{m}^2/\text{cc}$  d(0.8) : 217.341  $\mu\text{m}$

Size ( $\mu\text{m}$ )	Vol Under %	Size ( $\mu\text{m}$ )	Vol Under %	Size ( $\mu\text{m}$ )	Vol Under %	Size ( $\mu\text{m}$ )	Vol Under %	Size ( $\mu\text{m}$ )	Vol Under %	Size ( $\mu\text{m}$ )	Vol Under %

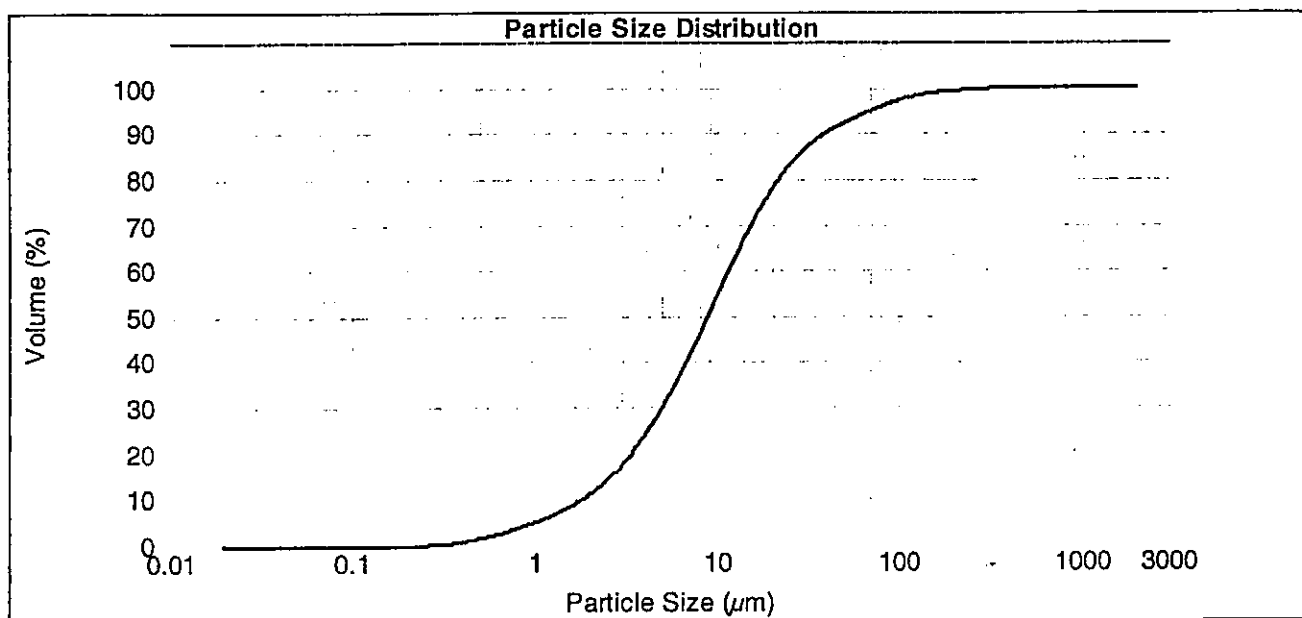
Obscuration : 23.71 % Surface Weighted Mean D[3,2] : 4.118  $\mu\text{m}$  d(0.5) : 9.008  $\mu\text{m}$

Weighted Residual : 0.544 % Specific Surface Area : 1.46  $\text{m}^2/\text{cc}$  d(0.8) : 21.938  $\mu\text{m}$

Size ( $\mu\text{m}$ )	Vol Under %	Size ( $\mu\text{m}$ )	Vol Under %	Size ( $\mu\text{m}$ )	Vol Under %	Size ( $\mu\text{m}$ )	Vol Under %	Size ( $\mu\text{m}$ )	Vol Under %	Size ( $\mu\text{m}$ )	Vol Under %

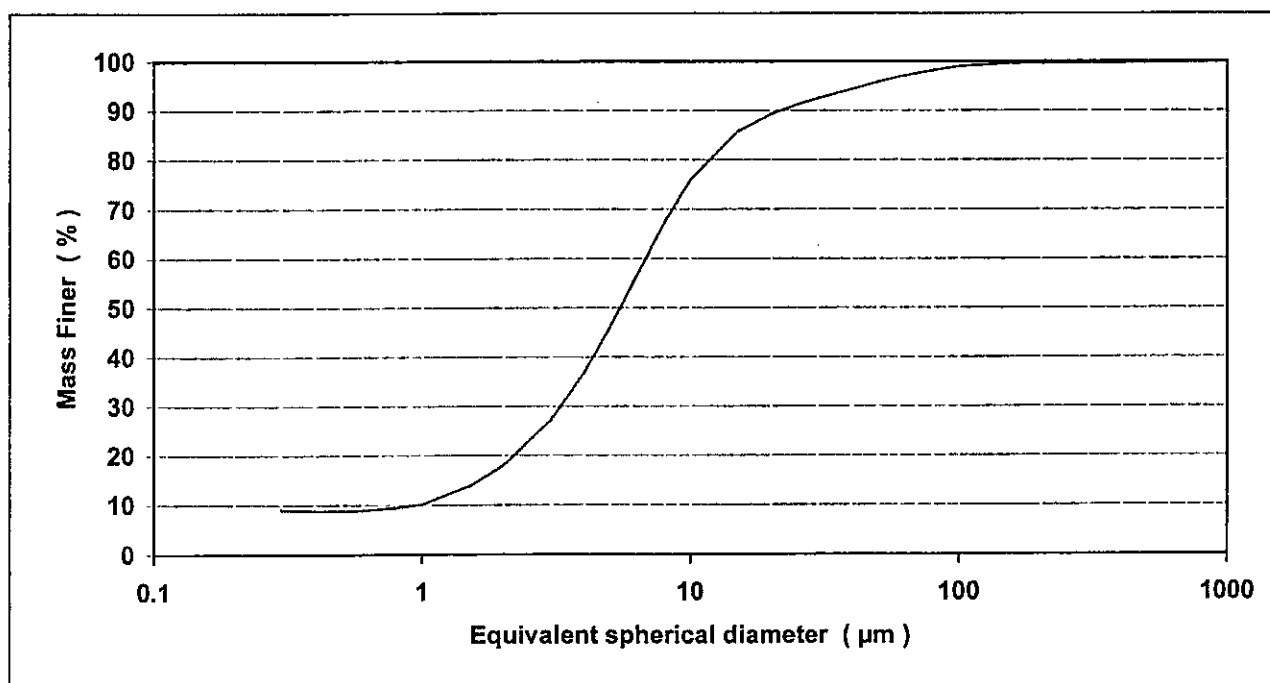
Critical diameter: 52.67 µm

Max size (µm)	Min size (µm)	In %	Max size (µm)	Min size (µm)	In %	Max size (µm)	Min size (µm)	In %	Derived diameters	Size (µm)
2000.00	150.00	0.50	20.00	15.00	1.30	1.50	1.00	9.30	d (0.9)	20.43
150.00	100.00	0.55	15.00	10.00	1.90	1.00	0.80	4.20	d (0.5)	5.37
100.00	80.00	0.80	10.00	8.00	3.50	0.80	0.60	3.70	d (0.1)	0.81
80.00	60.00	1.30	8.00	6.00	9.70	0.60	0.50	0.70		
60.00	50.00	1.10	6.00	5.00	8.50	0.50	0.40	0.50		
50.00	40.00	1.50	5.00	4.00	13.10	0.40	0.30	0.10		
40.00	30.00	1.80	4.00	3.00	8.20	0.30	0.00	8.85		
30.00	25.00	1.50	3.00	2.00	9.20					
25.00	20.00	1.80	2.00	1.50	9.70

NOTE : Data from 2000 µm to 150 µm by wet screening

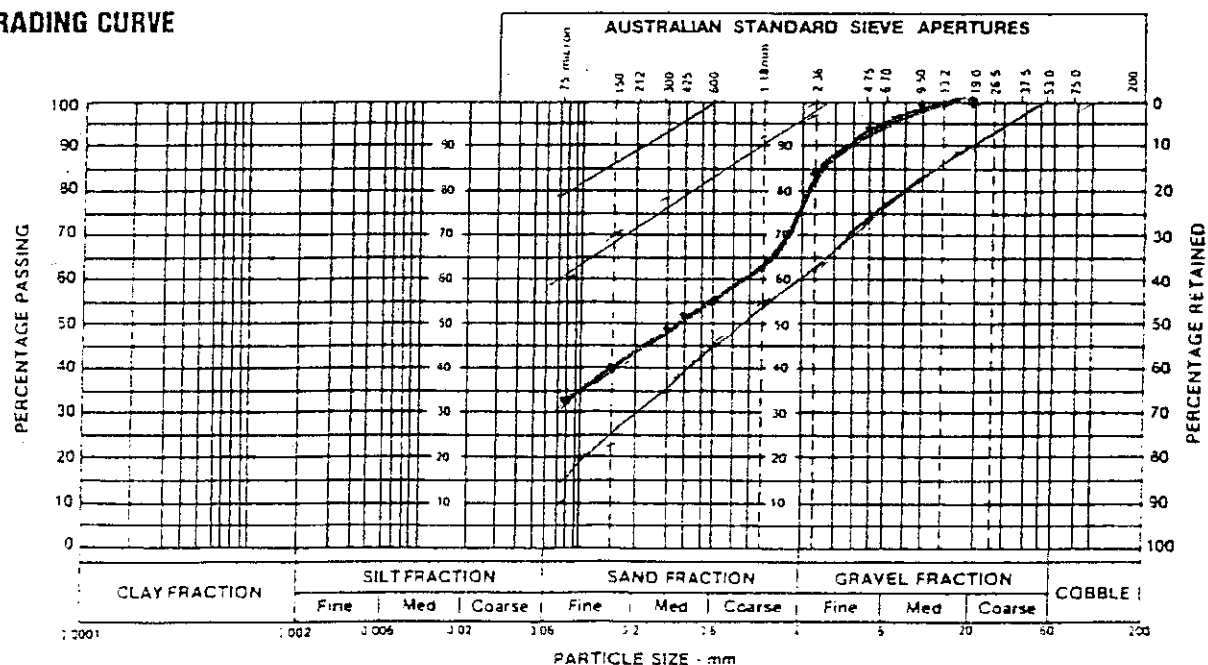
### GRADING CURVE

SIEVING				HYDROMETER			
SIEVE SIZE	% PASSING	SIEVE SIZE	% PASSING	DIAMETER	% FINER	DIAMETER	% FINER
75.0mm	-	1.18mm	67				
37.5mm	-	600 micron	55				
19.0mm	100	425 micron	51				
9.5mm	99	300 micron	48				
4.75mm	94	150 micron	40				
2.36mm	84	75 micron	33

REMARKS: \*\* P3 0.4 - 1.0m / P3 1.0 - 1.8m / P3 1.8 - 2.8m COMBINED

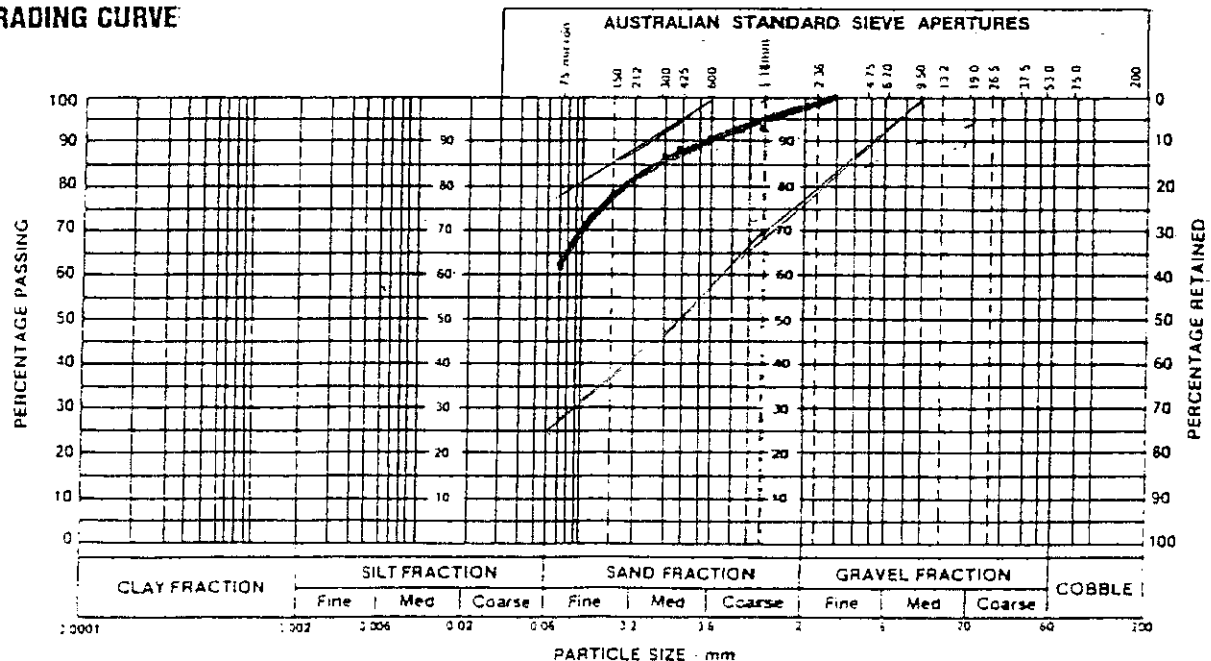
### GRADING CURVE

SIEVING				HYDROMETER			
SIEVE SIZE	% PASSING	SIEVE SIZE	% PASSING	DIAMETER	% FINER	DIAMETER	% FINER
75.0mm	—	1.18mm	93				
37.5mm	—	600 micron	90				
19.0mm	—	425 micron	88				
9.5mm	100	300 micron	86				
4.75mm	100	150 micron	78				
2.36mm	98	75 micron	61

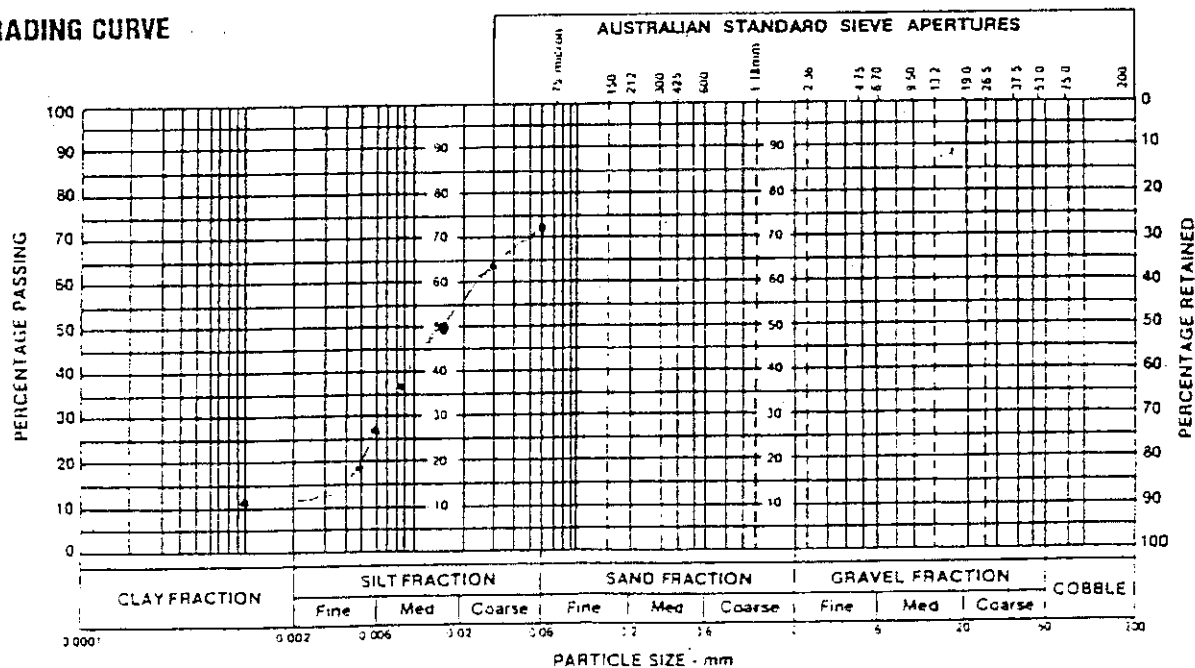
### GRADING CURVE

SIEVING				HYDROMETER			
SIEVE SIZE	% PASSING	SIEVE SIZE	% PASSING	DIAMETER	% FINER	DIAMETER	% FINER
200 mm	-	2.36mm	-	75micron	-	12 micron	44
75.0mm	-	1.18mm	-	60 micron	72	9 micron	36
37.5mm	-	600micron	-	43 micron	68	6 micron	27
19.0mm	-	425micron	-	31 micron	64	5 micron	18
9.5mm	-	300micron	-	23 micron	57	1 micron	11
4.75mm	-	150micron	-	16 micron	50

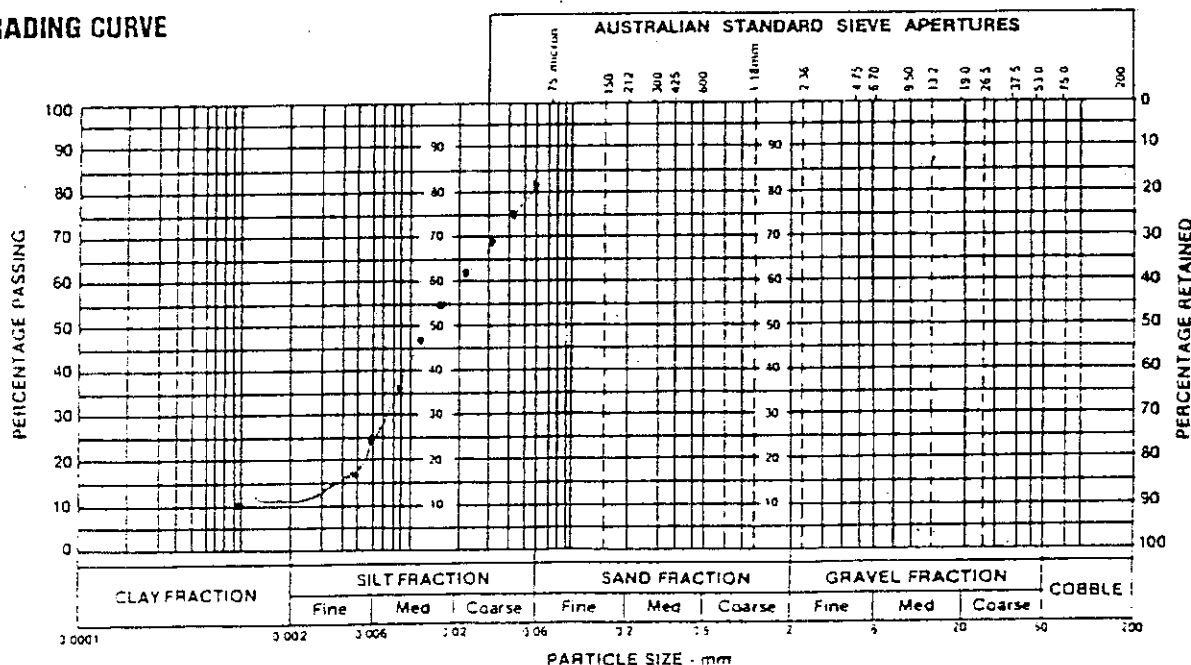
### GRADING CURVE

SIEVING				HYDROMETER			
SIEVE SIZE	% PASSING	SIEVE SIZE	% PASSING	DIAMETER	% FINER	DIAMETER	% FINER
200 mm	-	2.36mm	-	75micron	-	12 micron	47
75.0mm	-	1.18mm	-	58 micron	81	9 micron	36
37.5mm	-	600micron	-	42 micron	75	6 micron	25
19.0mm	-	425micron	-	31 micron	69	5 micron	17
9.5mm	-	300micron	-	22 micron	62	1 micron	10
4.75mm	-	150micron	-	16 micron	55

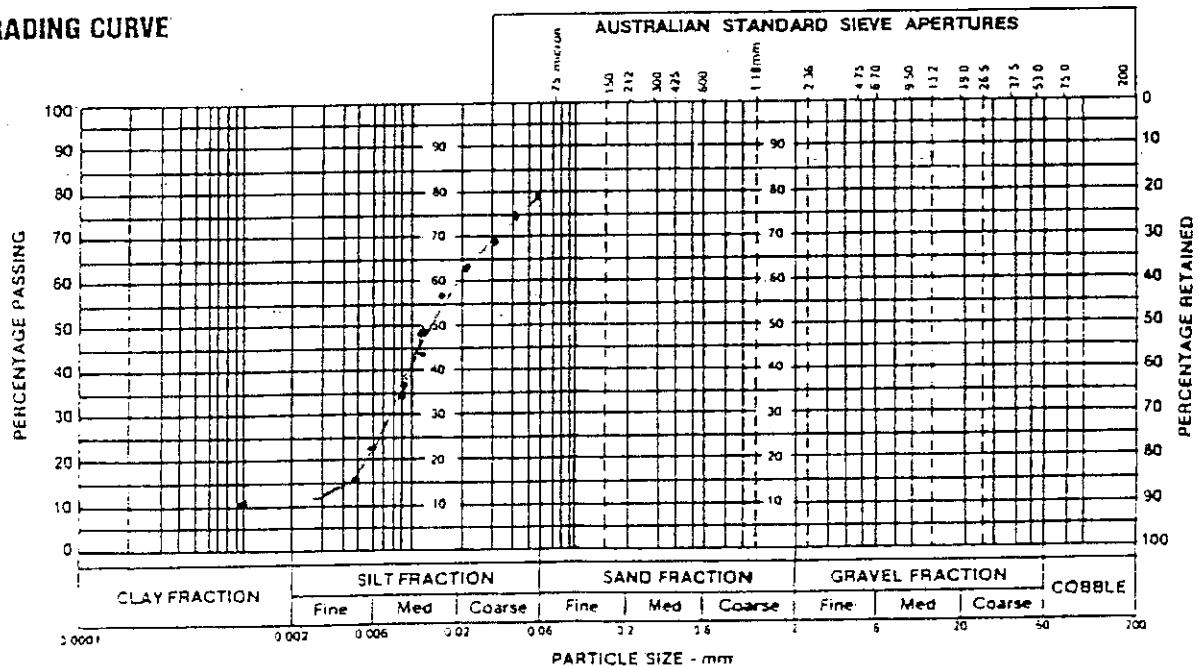
### GRADING CURVE

SIEVING				HYDROMETER			
SIEVE SIZE	% PASSING	SIEVE SIZE	% PASSING	DIAMETER	% FINER	DIAMETER	% FINER
200 mm	-	2.36mm	-	75micron	-	12 micron	49
75.0mm	-	1.18mm	-	58 micron	79	9 micron	35
37.5mm	-	600micron	-	42 micron	75	6 micron	23
19.0mm	-	425micron	-	31 micron	69	5 micron	17
9.5mm	-	300micron	-	22 micron	63	1 micron	11
4.75mm	-	150micron	-	16 micron	56

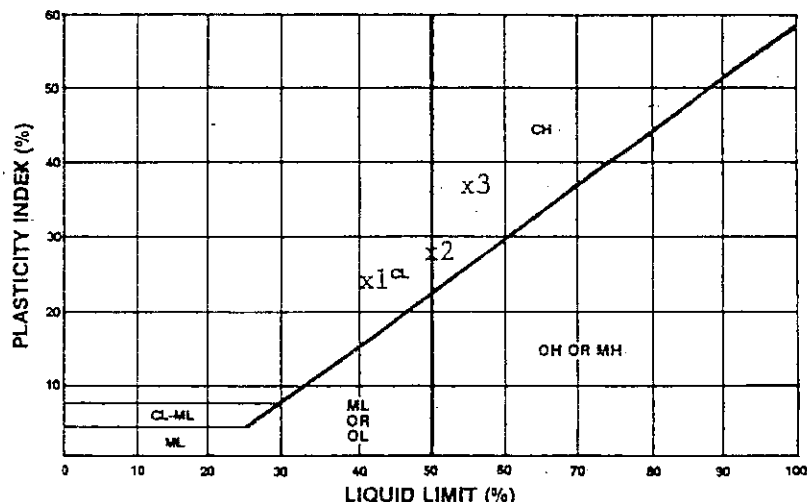
### PLASTICITY CHART (A.S. 1726)

TEST NUMBER	1	2	3		
SAMPLE IDENTIFICATION	**	**	**		
DEPTH (m)	**	**	**		
LIQUID LIMIT (%)	41	50	55		
PLASTIC LIMIT (%)	18	22	19		
PLASTICITY INDEX (%)	23	28	36		
LINEAR SHRINKAGE (%)	11.5	12.0	15.0		
PASSING 425 MICRON SIEVE OF TOTAL SAMPLE (%)	-	-	-

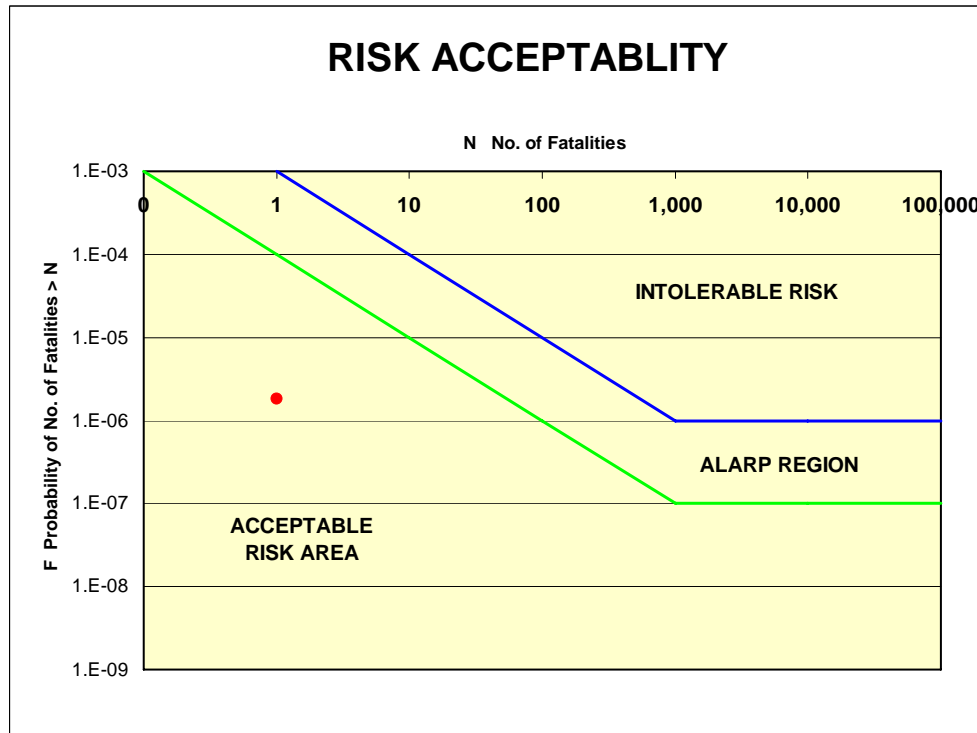
The results are summarised in the F-N chart below, which is based on internationally recognised risk thresholds for large dams.

This study has demonstrated through a quantitative fault/event analysis that, throughout the remaining operational life of Fimiston II, the likelihood of release of water and/or solids to the downstream environment due to a breach of the TSF is estimated to be about 1 in 330,000 per annum. It is evident from the F-N plot shown above that there is an acceptable level of risk associated with a dam break from the Fimiston II TSF. This is based on the estimated (and conservatively rounded up) weighted average exposure of one person at any one time.

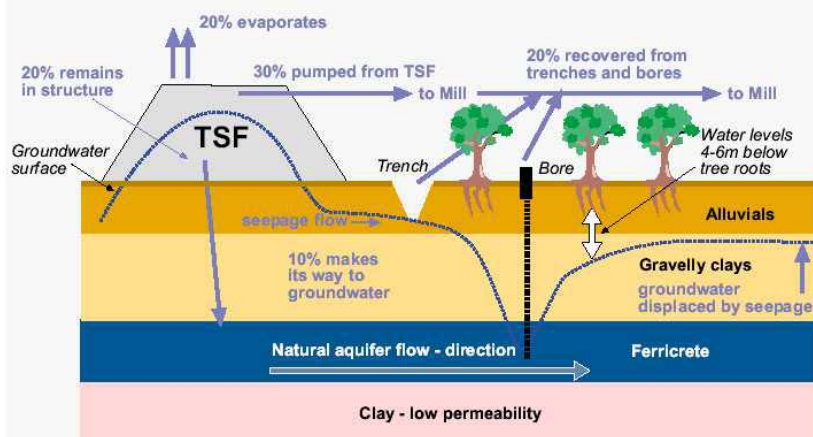
### Where Does Tailings H<sub>2</sub>O Go?

CONCEPTUAL MODEL OF HYDROGEOLOGY NOT TO SCALE % APPROXIMATE
