Water Balance of Lot 123 Mortimer Rd, City of Kwinana

**MONITERING BORE NETWORK**  
**Lot 123 MORTIMER ROAD**

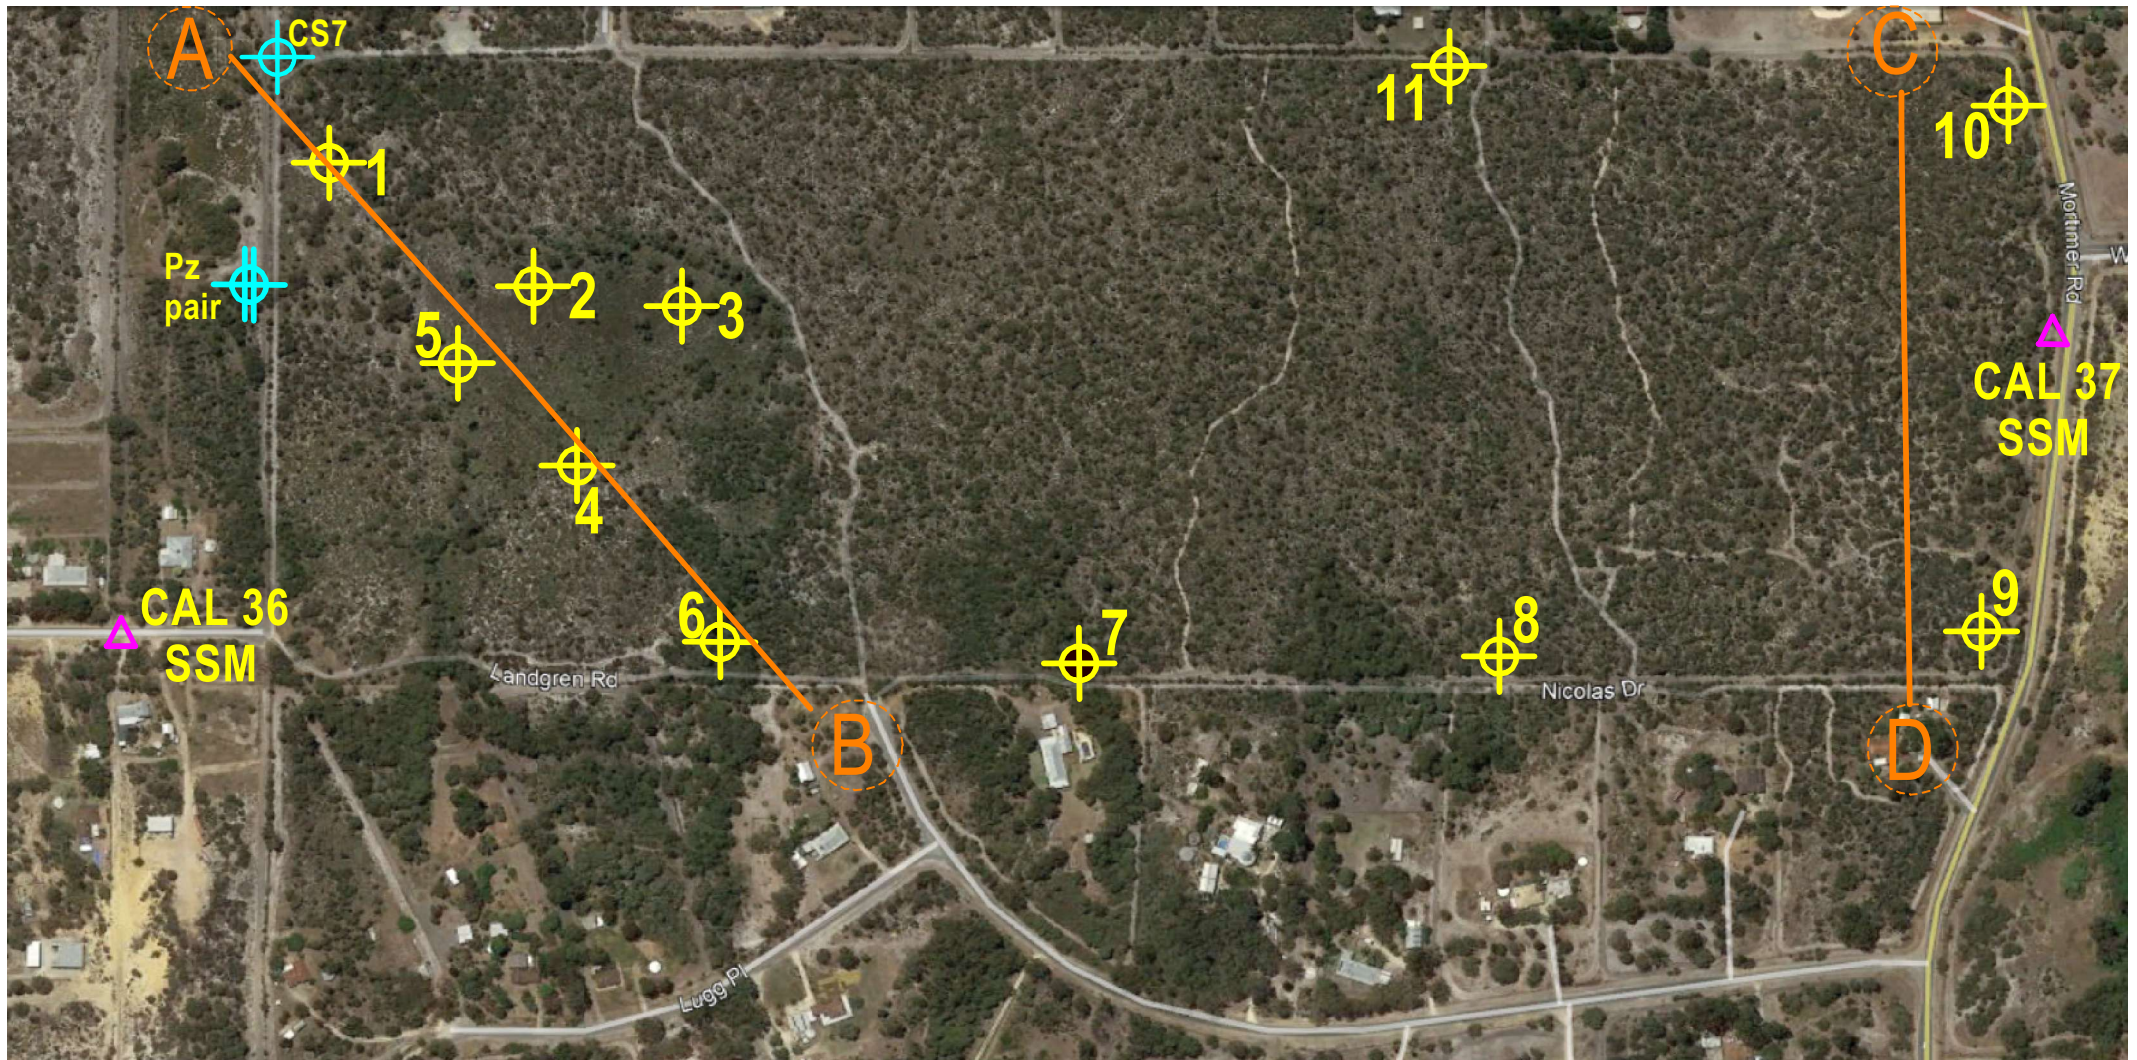
The chart, MONITORING BORE NETWORK, was prepared to show locations of:

- the 11 Bioscience monitoring bores,
- two further other monitoring bore locations marked CS7 and Pz pair at the north end of the property,
- two standard survey marks CAL36 and CAL37, and
- two transects of monitoring bores A-B and C-D have been marked across the property.

It was evident from survey stakes installed and left that the piezometer pair and CS7 had been recently surveyed from CAL36. The wetland that roughly surrounds the bores MMB2-5 has a high point of the monitored groundwater levels in MMB5. This was evident in the spreadsheet charting of groundwater levels (see XLS sheet: Lot 123 Mortimer Road Monitoring Bores) and the AB transect suggests that flow eastward from the wetland goes to MMB1 as the groundwater level in 1 is lower than in 5, 2, 3, and 4 as shown in the upper panel of the chart, BOREFIELD CROSS SECTIONS. However the trend within the last four is draining westward and two further bores 6 and 7 affirm this impression as does the simple profile of the other cross section C-D between bore 10 and 9. Those two bores remaining and not included in this graphical exercise, 11 and 8 also show a fall with drainage to the west. The gradient is up to 1:200.

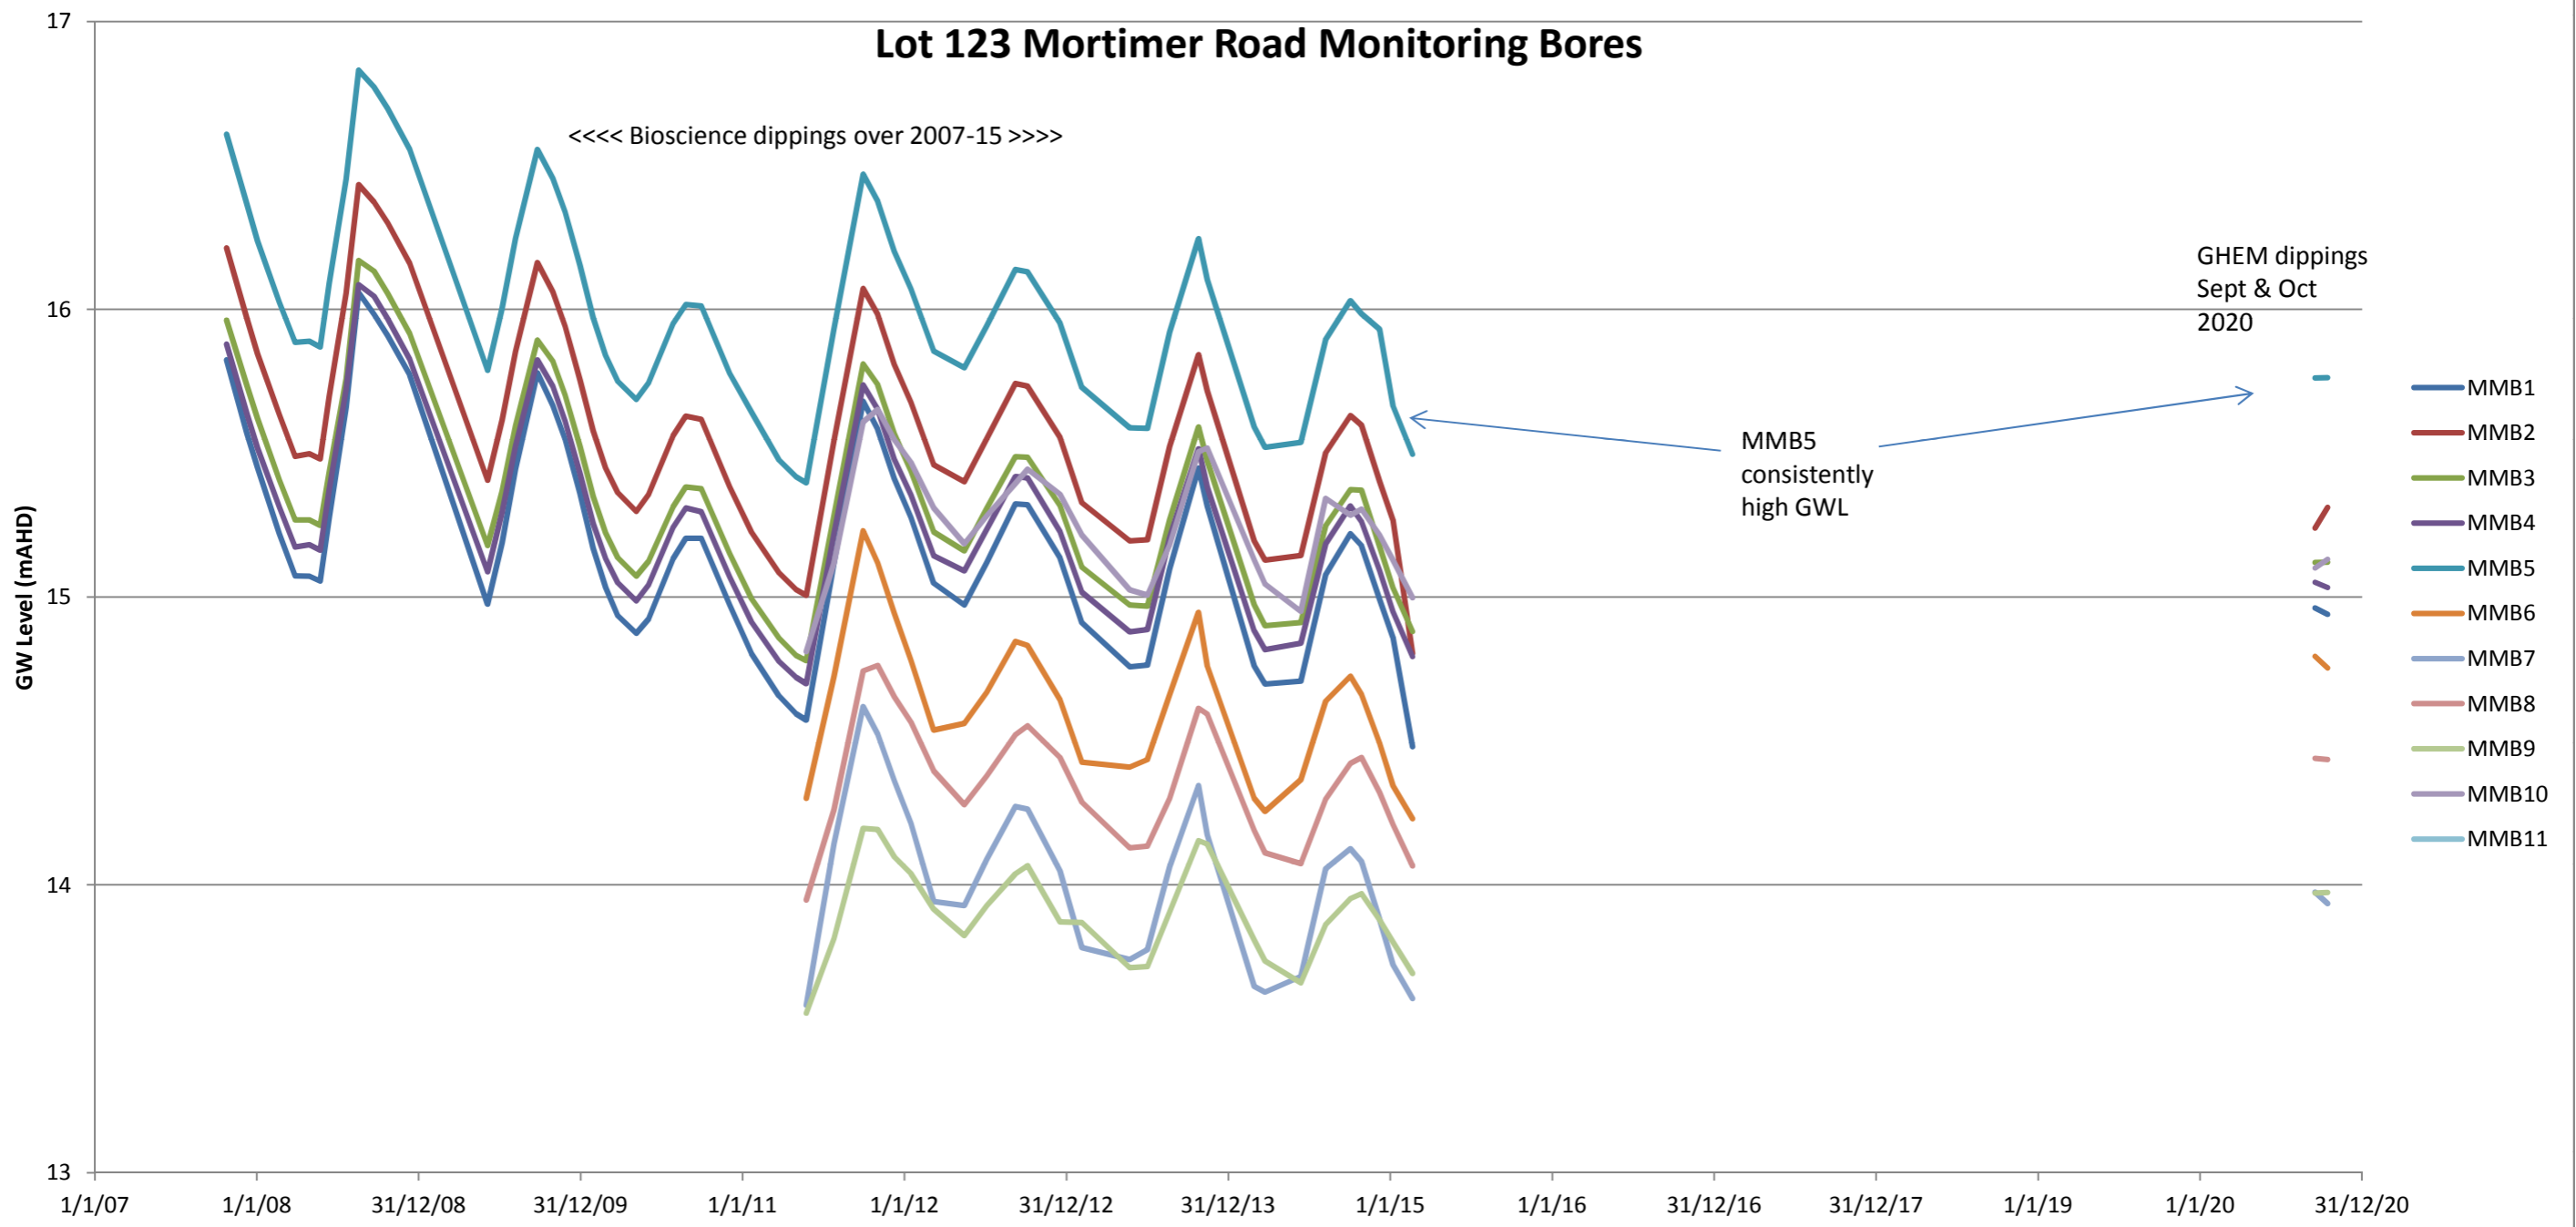
# Lot 123 Mortimer Road Monitoring Bores

<<<< Bioscience dippings over 2007-15 >>>>

GHEM dippings  
Sept & Oct  
2020

MMB5  
consistently  
high GWL
