KCGM HSEC DEPARTMENT, CLOSURE

KCGM Mine Closure Plan 2022 (v1) Volume 1 of 3

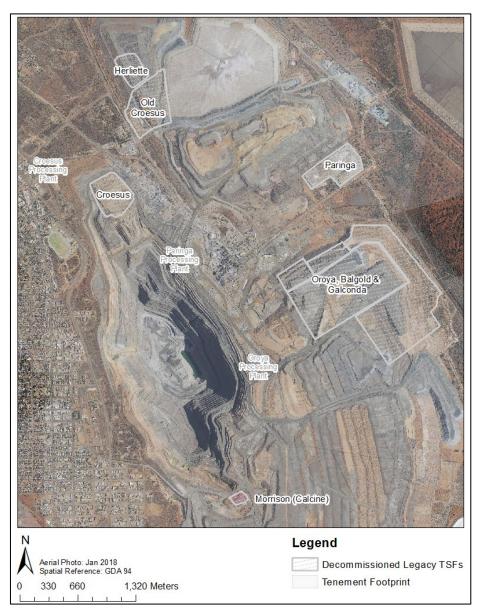
Figure 2-6: Fimiston Historic Decommissioned Plants and TSFs

The Oroya, Paringa, and Croesus Processing Plants were operated until the mid-late 1990s, and have since been decommissioned, demolished, and rehabilitated (encapsulated or mined through) by KCGM (Figure 2-6). Tailings dams associated with these processing plants have also been decommissioned and, in some cases covered with waste rock during construction of the Fimiston Waste Rock Dumps (WRDs) (Figure 2-6).

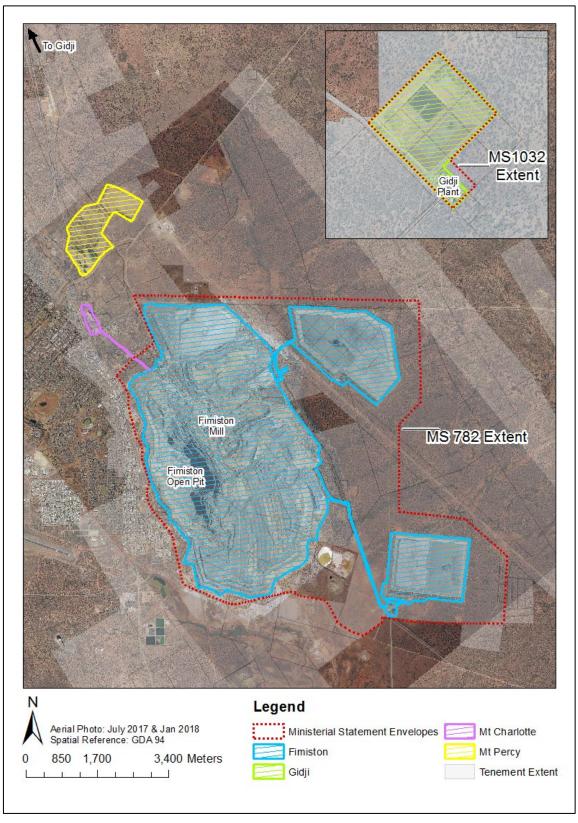
Figure 2-7: Operational Areas Current Disturbance and Extent of current Ministerial Statements (July 2022)

It should be noted that the Operational Areas are governed by differing legislative instruments and approvals (e.g., Ministerial Statements), which are discussed in detail in Section 3. The extents of Ministerial Statements 1032, 188, and 782 are shown in Figure 2-7.

KCGM has two key legislative requirements for developing a MCP; conditions within Ministerial Statements (MS) issued to KCGM and tenement conditions associated with tenements held by KCGM, including prior commitments within Notices of Intents and Mining Proposals (listed as tenement conditions) pertaining to rehabilitation and closure. The details of these commitments are contained in the KCGM Closure Legal and Other Obligations Register (Appendix 1). The Fimiston and Gidji Operational Areas each have separate MS, which are outlined below. Figure 2-7 presents the extent of each active MS in relation to the Operational Areas.

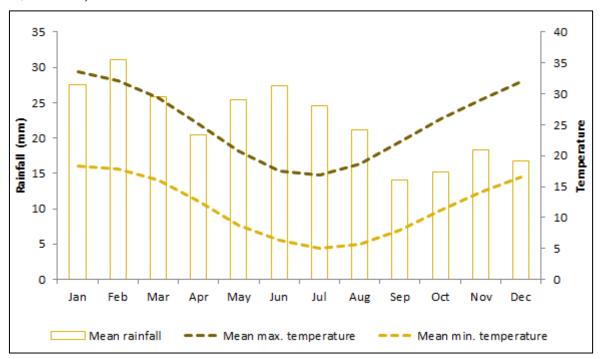
Figure 5-1: Long-term Monthly Climate Averages for Kalgoorlie-Boulder (1940-2019)

The Kalgoorlie region has a semi-arid climate with hot summers and mild winters. Annual rainfall varies between 108 and 530 mm with an average of 266 mm, with rainfall occurring during all months of the year (Figure 5-1). Significant summer rainfall is experienced due to tropical monsoon systems moving across the state from the north. Winter rainfall generally originates from broad frontal lows that move in from the west.

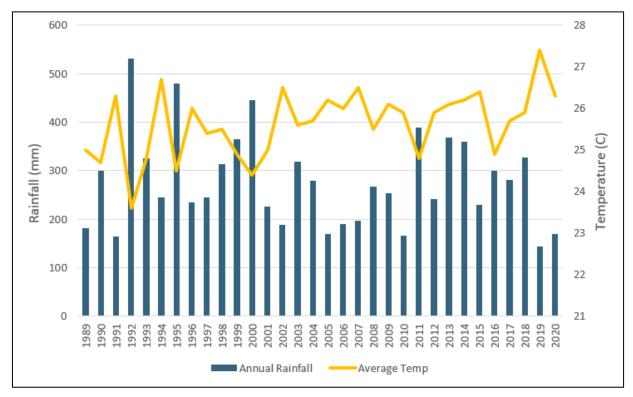
Figure 5-2: Annual Rainfall and Temperatures for KCGM's operational period

Rainfall and temperature annual averages during KCGM's operational period are presented in Figure 5-2. The graph illustrates the low rainfall and high temperatures experiences over the last few years, particularly 2019 and 2020. The impact of this has been noticeable in vegetation monitoring data.

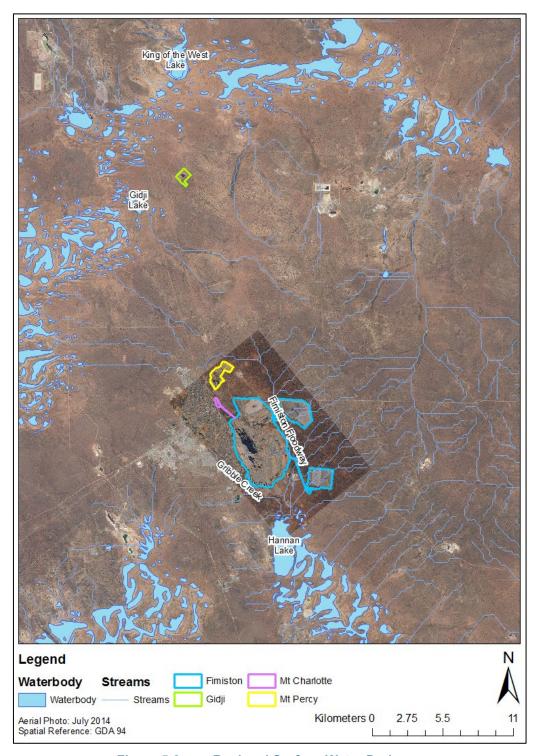
Figure 5-3: Regional Surface Water Drainage

The Gidji Operational Area is located close to a topographic low associated with an east trending series of playa lakes, including the King of the West Lake to the northeast. Surface drainage in the immediate vicinity of Gidji Operational Area is poorly defined but is considered to be generally north (Figure 5-3).

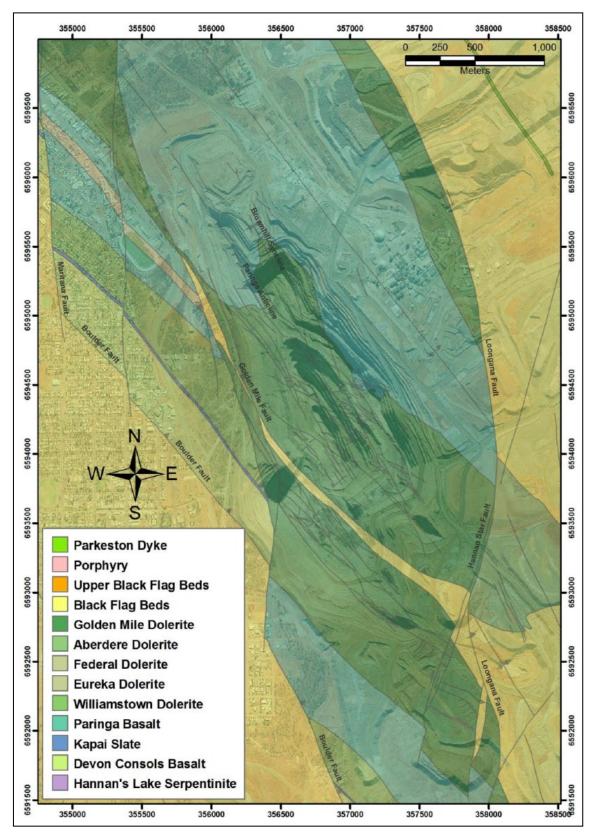
Figure 5-4: Fimiston Lithology

Approximately 80% of the rock mined from the Fimiston Open Pit is Golden Mile Dolerite, with the remaining rock composed of Paringa Basalt (14%) and sediments belonging to the Black Flag Beds (approx. 4%). Black Flag Beds are also referred to as Black Flag or Black Flag Shale. Figure 5-4 provides a surface map of Fimiston lithology. The mineralising event at the Golden Mile led to geochemical enrichment in various elements including the following; gold, silver, bismuth, cadmium, mercury, antimony, tellurium in waste lithologies and variable enrichment in arsenic, boron, molybdenum, selenium and zinc within the Black Flag lithology (MBS Environmental 2020).

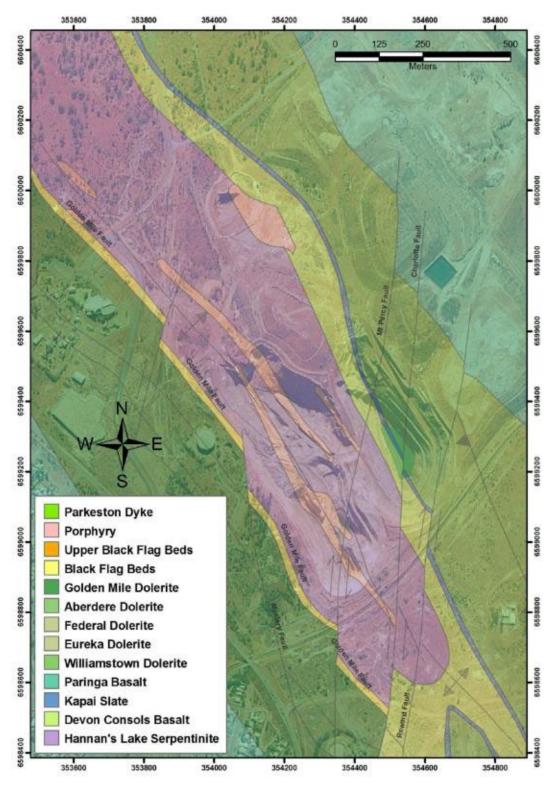
Figure 5-5: Mt Percy Lithology

The main rock types at Mt Percy are the Hannans Lake Serpentinite, Devon Consols Basalt, Kapai Slate, and Williamstown Dolerite (Figure 5-5). The Hannans Lake Serpentinite is the major rock type in the Sir John and Mystery Open Pits and is a minor rock type in the Union Club Open Pit. All four lithologies are well exposed in the Union Club and Sir John (now backfilled) Open Pits and are intruded by felsic porphyries. Mineralisation is associated with quartz veining (Mt Charlotte style mineralisation) and brecciated lodes with disseminated sulphides associated with felsic porphyries (Fimiston style mineralisation). The deposits at Mt Percy were mantled by lateritic duricrusts that formed local topographic highs. Mining at the Mt Percy Open Pits mainly focused on mineralisation in the saprolite and lateritic residuum and did not penetrate deeply into fresh rock.

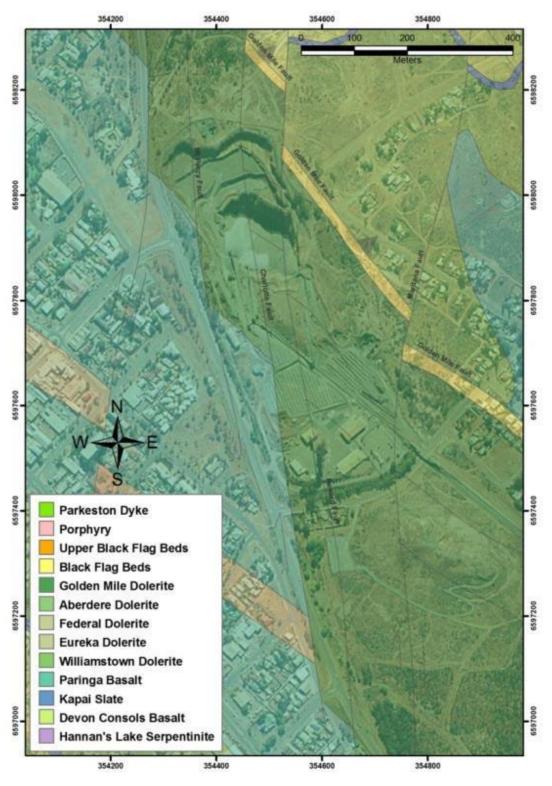
Figure 5-6: Mt Charlotte Lithology

At the Mt Charlotte deposit stratigraphy consists of the basal Hannans Lake Serpentinite, overlain successively by the Devon Consols Basalt, Kapai Slate, Paringa Basalt, Golden Mile Dolerite and Black Flag Beds (minor lithology) (Figure 5-6). The Golden Mile Dolerite is the dominant lithology at the Mt Charlotte operations. Gold mineralisation at Mt Charlotte is stockwork style: an intersecting mesh of conjugate quartz veins that preferentially form within Unit 8 of the Golden Mile Dolerite, due to this stratigraphic control the veins form a steeply plunging pipe-like ore body. The veins are composed of coarse quartz-carbonate with minor scheelite, tourmaline and albite. Extensive wall rock alteration occurs around the veins, the alteration assemblage is quartz-albite-sericite-siderite-ankerite-pyrite.

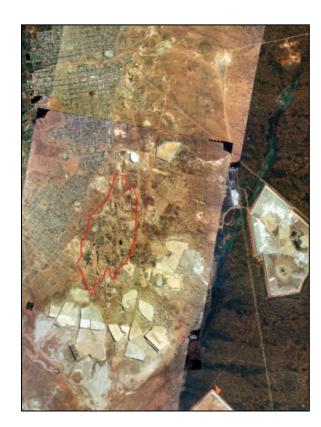
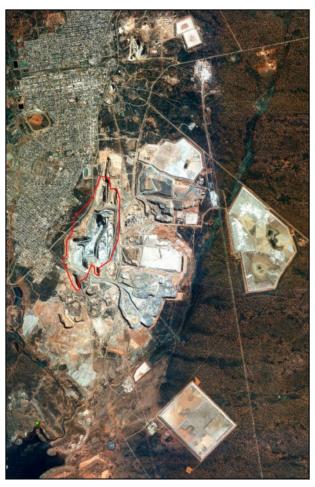
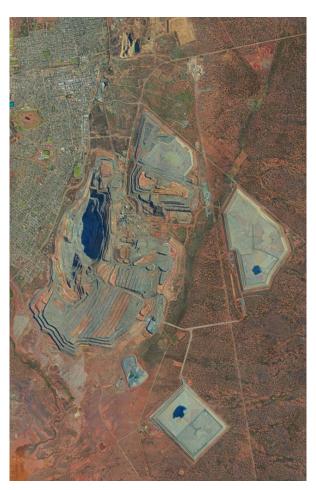
1983 (lighter photo) 1999 2019

(Highly disturbed nature of the Fimiston, Mt Charlotte, and Mt Percy Operational Areas – 2019 extent of Fimiston Open Pit outline shown in red)

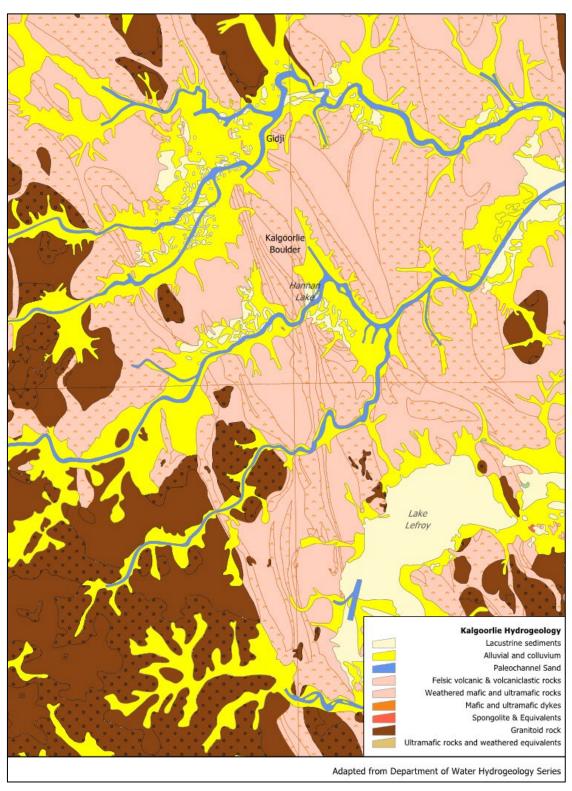
Figure 5-11: Hydrogeology of the Goldfields

The paleochannel system comprises erosion channels in the basement rock, incised during the Jurassic period and infilled with sands (the Wollubar Sandstone) and clays (the Perkolilli Shale) in the Tertiary period. The mapped extent of the Roe Paleochannel system is illustrated in Figure 5-11. The southern branch of the paleochannel system is located to the south of Fimiston Operational Area, below Hannan Lake, and the northern branch in the vicinity of Gidji Operational Area. Hydraulic and hydrochemical investigations into the Roe Paleo drainage have identified that natural recharge occurs at very low rates (less than 0.01% of annual precipitation) via direct infiltration where the sand unit outcrops occur in the upper reaches of the system to the west. Undisturbed groundwater flow within the system is from west to east, draining towards Lake Yindalgooda.

Fimiston II TSF (including Fimiston IIE TSF), Kaltails TSF and Gidji TSF (and the associated Eastern, Gidji TSF and Kaltails TSF borefields), and the Trafalgar Borefield (Figure 5-11).

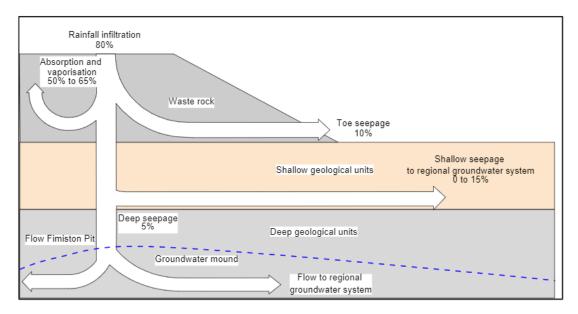
Figure 5-13: Conceptual Flow Model for WRDs

A conceptual numerical model was developed to determine the infiltration, evapotranspiration and rainfall runoff from the rehabilitated WRD surface (KCGM 2020) (Figure 5-13). Cover modelling indicates that most of rainfall on the rehabilitated WRDs will infiltrate the waste rock (80%). However, significant losses are predicted to occur as rainfall percolates through the waste rock due to absorption and vaporisation. Runoff rates from the rehabilitated WRDs are estimated to be small, ranging between 2% of rainfall on the waste dump surface and 5% of rainfall on the side-slopes. Runoff from the WRD surfaces will be conveyed to the Fimiston Pit via drains aligned to existing haul roads, while runoff from the WRD side slopes will flow onto the Eastern Floodway and Gribble Creek sub-catchments, respectively. During large rainfall events, macropores in the WRD form preferential pathways with rainfall infiltration rapidly percolating through the waste rock material. During such events, rainfall may discharge along the toe of the dump to the ground surface or along former drainage lines.

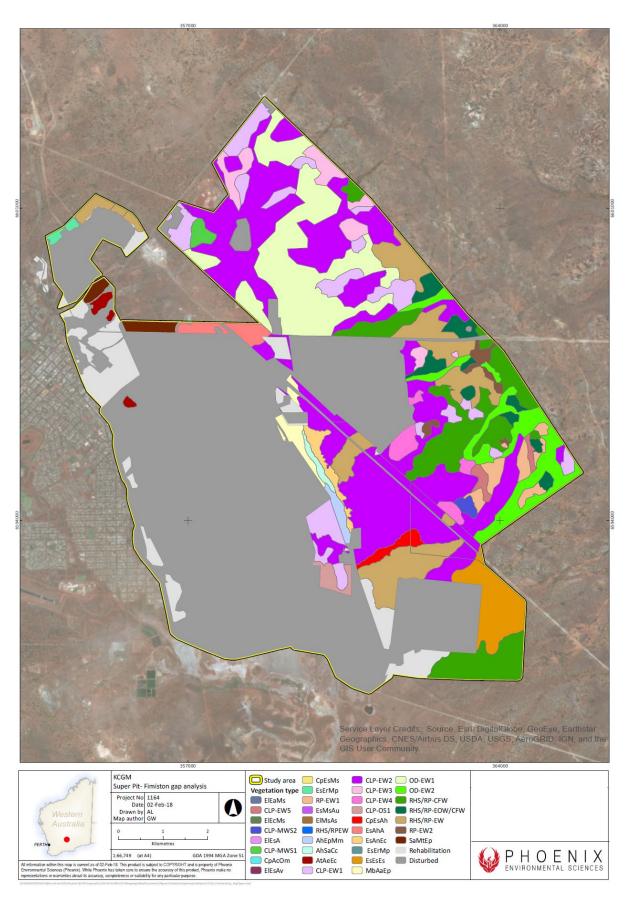
Figure 5-14: Vegetation Types within Fimiston Operational Area

The Fimiston Operational Area contains 25 remnant vegetation types comprising 15 woodlands, two forests and eight shrublands (Figure 5-14). Rehabilitated areas were classified into two types, revegetated woodland and revegetated shrubland. The woodlands comprise mostly mixed *Eucalyptus* spp. over *Eremophila*, *Acacia*, *Senna* and chenopod species. Two Casuarina woodlands over *Acacia* and *Eremophila* species, sometimes with emerging *Eucalyptus salmonophloia* over low shrubland of mixed species, are also present. The shrublands are dominated by *Acacia*, *Eremophila* and *Senna* species over mixed chenopod species. The condition of remnant native vegetation across the study area was variable ranging from Excellent to Degraded.

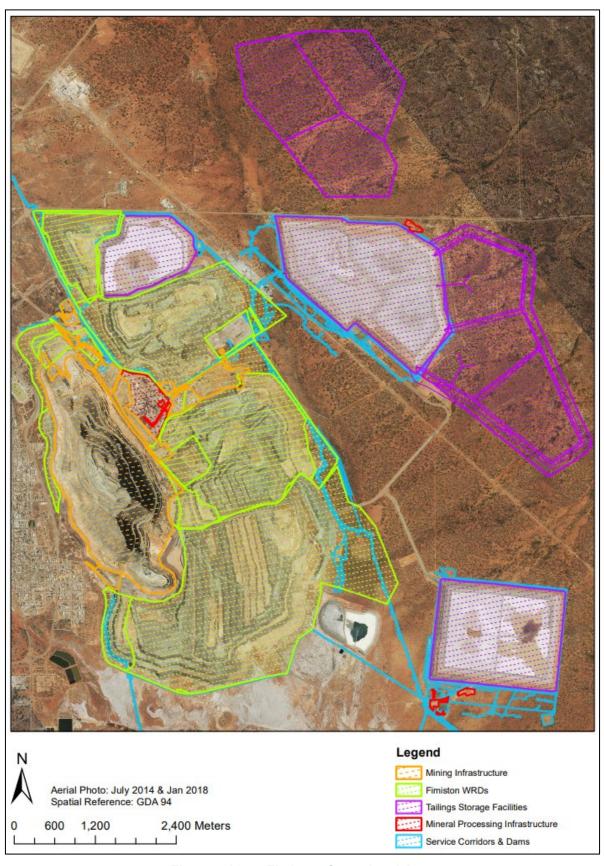
Figure 5-16: Fimiston Operational Area

The Fimiston Operational Area consists of numerous large features, including the Fimiston Open Pit, WRDs, and three active TSF facilities and associated support infrastructure (Figure 5-16).

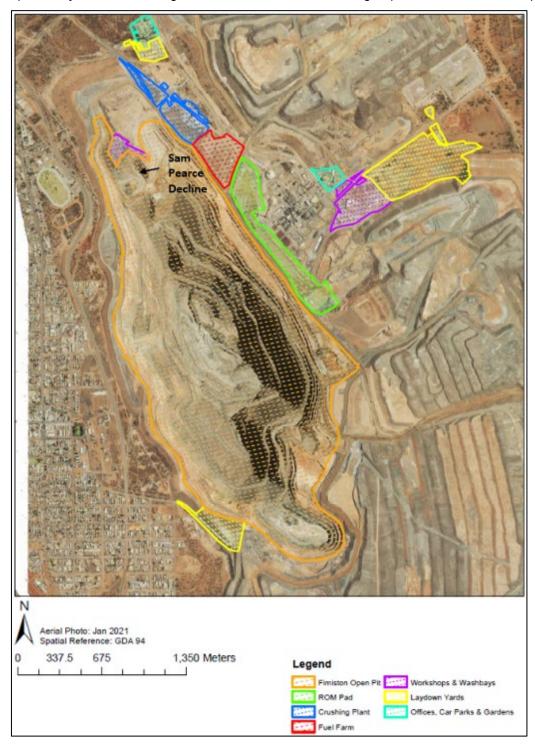
Figure 5-17: Fimiston Mining Infrastructure including Fimiston Open Pit and Sam Pearce Decline (current)

Infrastructure specifically related to mining activities at Fimiston has been grouped within this Domain (Figure 5-17).

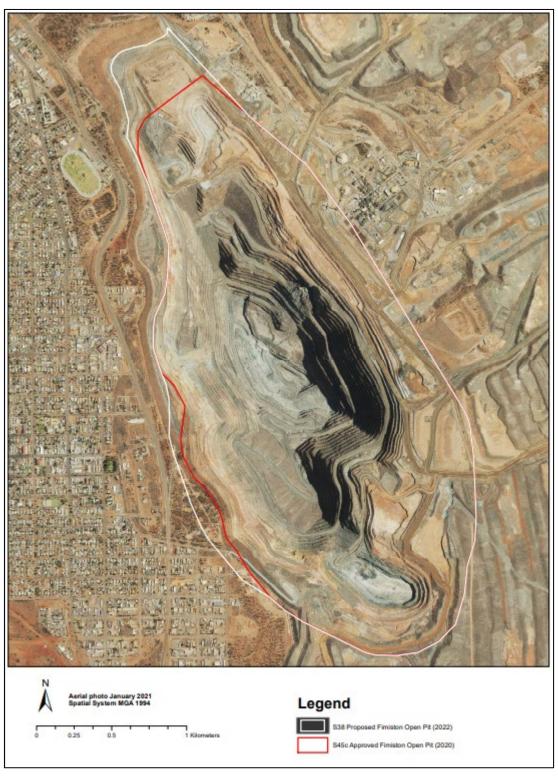
Figure 5-18: Fimiston pit shells

The Fimiston Open Pit (Figure 5-18) is currently the only active open pit managed by KCGM and is planned to continue to be mined until 2034 (2021 LOM Plan). The Open Pit footprint incorporates the Brownhill, Chaffers, Croesus, Golden Pike, North Kalgoorlie, Morrison, Oroya, Stores, Trafalgar, Great Boulder (Fimiston South S45c Approval) and Ivanhoe (Fimiston South S38 approval) pits /cutbacks. The Fimiston open pit is one of the largest open pit gold mines in Australia, extending approximately 1.5 km wide, 3.5 km long and 600 m deep.

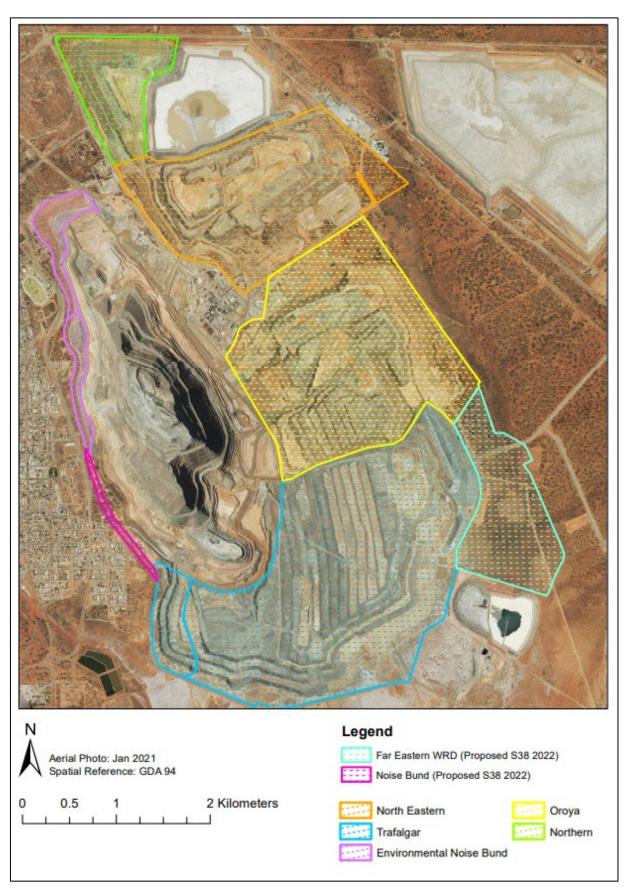
Figure 5-22: Fimiston Waste Rock Dumps

The Fimiston WRD naming conventions are shown in Figure 5-22, and are listed below:

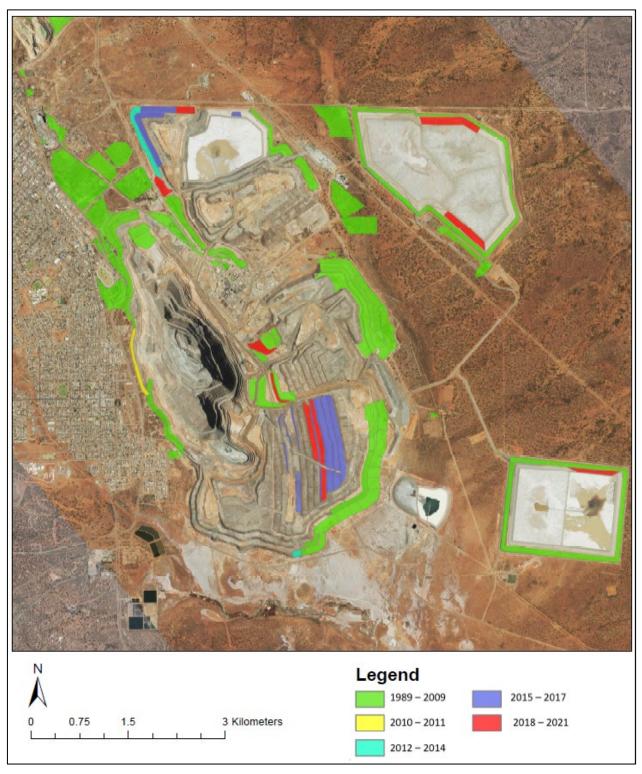
Figure 5-23: Progressive Rehabilitation at Fimiston 1995 to 2021

Throughout KCGM's operating life, since the late 1980's, a variety of as built and rehabilitation designs have been implemented for the WRDs (Figure 5-23), resulting in varied rehabilitation outcomes. During early rehabilitation in the 1990s the DMP *Guideline for Mining in Arid Environments* WRD design was used at KCGM. In addition, specifications in KCGM's original approval documents (i.e., the *Consultative Environmental Review Mine and Waste Dumps – Fimiston – August 1990*; valid for North East, Trafalgar and Oroya WRDs) required the following:

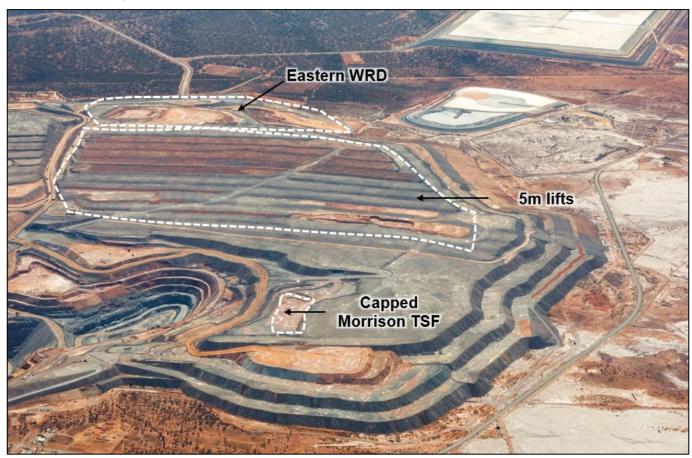
Figure 5-24: Trafalgar WRD viewed from the Southeast (2021)

Previously, the western facing upper area of Trafalgar WRD consisted of 5 m lifts, with a terraced appearance to optimise the available waste dumping capacity (Figure 5-24) under the airport Obstacle Limiting Surface (OLS).

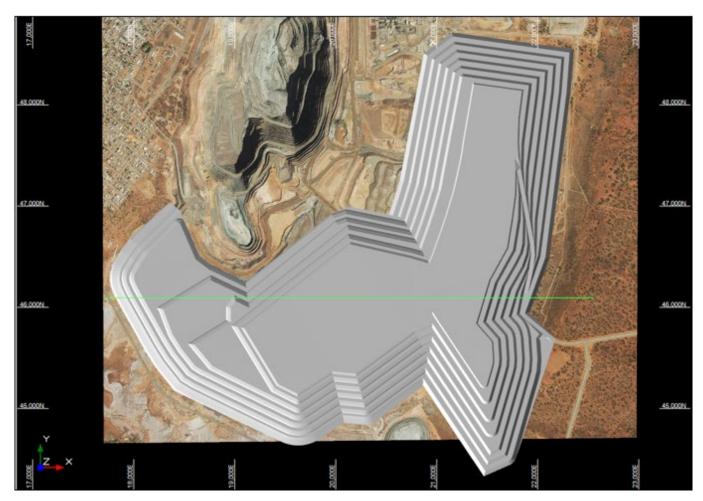
Figure 5-25: Proposed Southern WRD Design (mine site grid)

guiding topsoil placement. The design consists of 16° -17° slopes with 10 m wide berms, and a high percentage rock cover. Extensive technical work supports this design, including trials at Northern WRD.

Topsoil from the footprint area will be recovered and stockpiled. Oxides (Class D) in the impacted rehabilitation have been sampled and will be assessed based on their geochemical properties to determine which areas have growth media materials suitable for recovery. Figure 5-25 shows the new Trafalgar WRD design.

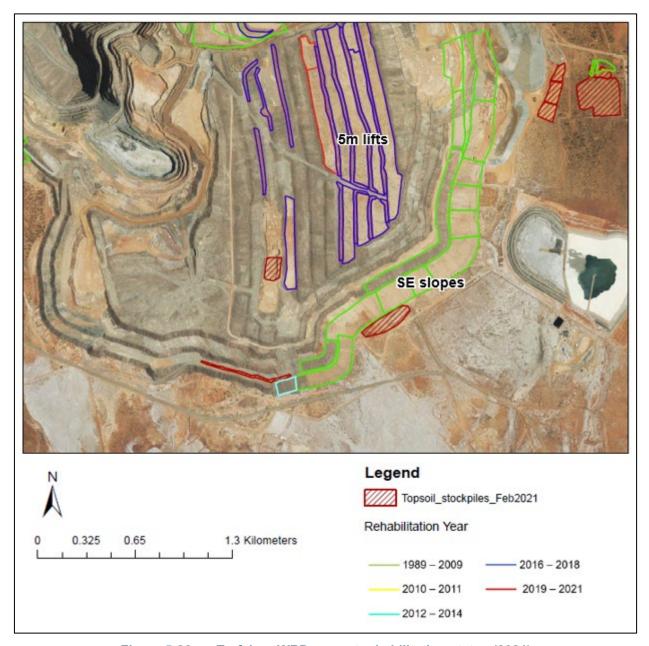
Figure 5-26: Trafalgar WRD current rehabilitation status (2021)

Most of the remnant tailings footprints, left from the State Agreement Kaltails Retreatment Project between 1989 and 1999, as well as the Morrison calcine TSF, are now covered by the Trafalgar WRD, with planned expansion of the WRD expected to cover additional areas north of the Mt Monger road. Capping of these remnant footprints is considered an acceptable management strategy from a Contaminated Sites perspective and prevents wind and water migration of the material. The Morrison TSF, which was previously exposed, has been capped with a traffic compacted domed oxide layer and is encapsulated within the WRD.

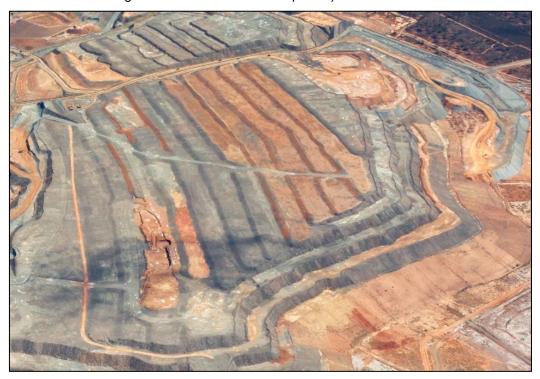
Figure 5-27: 5 m Lift Rehabilitation (2021)

Rehabilitation of the Trafalgar 5 m lifts commenced in 2015 with rocky, shallow batters and very wide benches in alignment with the 'erosion resistant' design (Figure 5-27). Material placement has been guided by the Visual Amenity rating of the location, with better rehabilitation materials used on the western facing "highly visual" slopes.

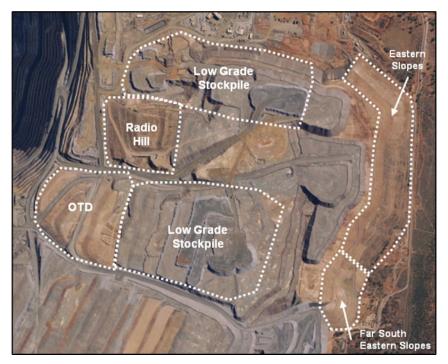
Figure 5-28: Oroya WRD Areas

The Oroya WRD is an active WRD, located to the north of, and abutting Trafalgar WRD, separated by the haul road to the Eastern WRD. It encompasses Radio Hill and Old Tetley's Dump (OTD) (Figure 5-28). The WRD is still active, with almost two thirds of the WRD comprising Marginal or Subgrade stockpiles which will be processed during operations.

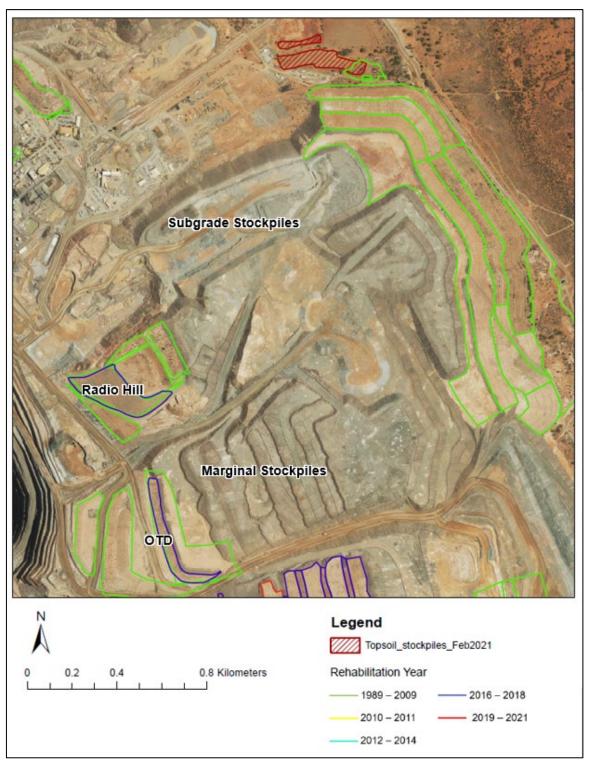
Figure 5-29: Oroya WRD Current Rehabilitation Status (2021)

Rehabilitation has been completed on Oroya WRD since 1998 (Figure 5-29). Rehabilitation styles vary between areas, but generally consist of pushing down the batters to between 18° and 20°, retaining a berm where possible for surface water management, thick sheeting with rehabilitation material obtained from the footprint or oxide material, construction of contour drains, deep ripping and seeding.

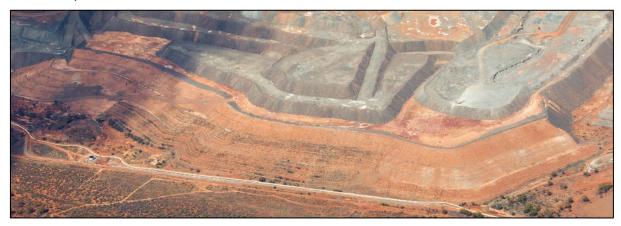
Figure 5-30: Oroya WRD, Eastern slopes (2021)

Oroya WRD has some good revegetation areas, particularly on the lower eastern slopes (Figure 5-30). Better quality materials were used on Oroya lower Eastern slopes, with several trials for the use of mycorrhizal fungi and 'moonscaping' completed. The depth of materials applied to the southern slopes (abutting Trafalgar) has been significant, with the amount of surface rock cover insufficient to mitigate erosion. The batters have three "water harvesting" drainage control berms which have not been cut accurately along the contour, resulting in the concentration and subsequent spilling of storm runoff. In the original design, these contour berms were to have discharged to drop structures, but they were not installed. However, as the contour drains were installed inaccurately, the drop structures would not have functioned as intended and the final rehabilitation outcomes would not have been improved.

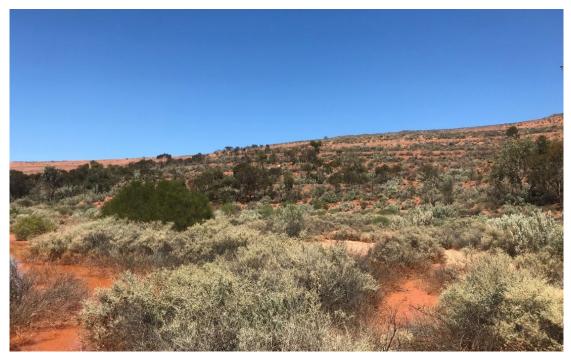
Figure 5-31: 1998 Rehabilitation – southern lower lift (2013 below and 2021 above)

A section of the bottom lift of the eastern batters of the Oroya WRD (Figure 5-31) was rehabilitated in 1998 by pushing the slopes down to 14°, sheeting with growth medium, deep ripping and cutting in narrow backsloping contour berms. Seeding was undertaken at 10 kg/ha with application of Agras 1 fertiliser at 100 kg/ha, with different seed mixes applied to the lower, middle and upper parts of all slopes. In recent years, vegetation in this area is showing stress due to high average annual temperatures and several years of low annual rainfall (as discussed in Section 5.1.1).

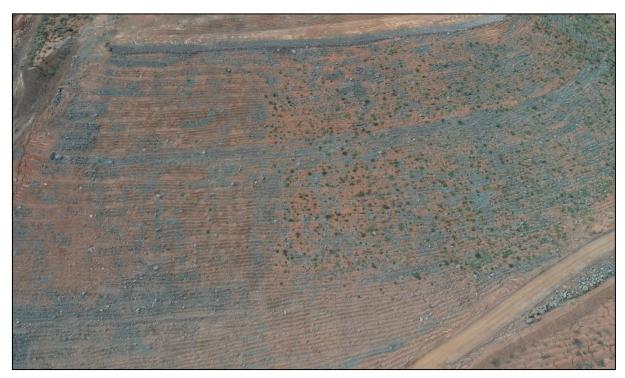
Figure 5-34: Radio Hill (2019) after remedial works (note vegetation difference between Class D (left) and Class A (right) soils)

Due to the medium visual amenity rating of the area, and potential relocation of the Public Lookout, remedial works were implemented on the WRD in 2017/8 (Figure 5-33). The WRD has been recontoured, sheeted with a layer of waste rock, and had growth media reapplied. A robust rocky crest bund and backsloping rock crest area, to prevent tunnel erosion through the upper oxides, also forms part of the design. The area was rehabilitated again in 2017/8, with a rock capping placed over the oxide waste and subsequent replacement of original Class D topsoil. Additional Class A topsoil was brought in to supplement the works. Significantly improved regrowth has occurred on the Class A soils compared to the Class D soils, highlighting the difference in soil properties (Figure 5-34).

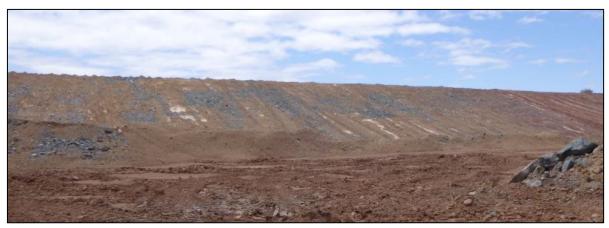
Figure 5-35: OTD Remedial Works in Progress 2017 (Oroya WRD)

Visual observations of this dump indicate that although vegetation growth has marginally increased, it is performing poorly vegetatively and erosionally. This is most likely due to placement of excessive poor quality oxide material. Due to the visual amenity rating of the area, and potential relocation of the Public Lookout, remedial works were implemented on the upper WRD lift in 2017 (Figure 5-35). The WRD has been stripped of excess material and a robust rocky crest back slope of 10m as part of the design. The upper surface was also reshaped to prevent overtopping. Vegetation performance has been slow, due to the salinity of the material and insufficient rain in recent years.

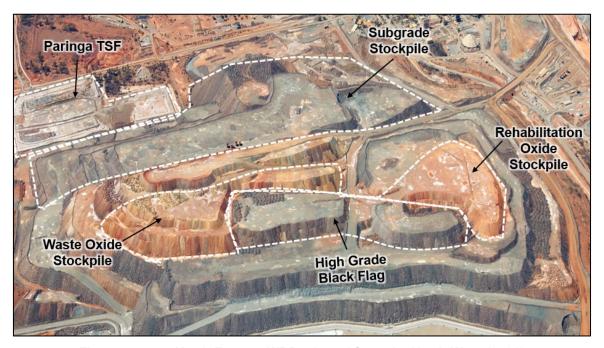
Figure 5-36: North Eastern WRD, viewed from the North West (2021)

The North Eastern (Central) WRD (Figure 5-36) is an active waste dump, with the southern half consisting of subgrade and marginal stockpiles which will be processed during operations. A substantial volume of Pit oxides was stockpiled on the western upper section of the WRD during development of the Golden Pike Cutback intended to be used within rehabilitation of flat surfaces on the Fimiston WRDs. An inactive and closed City of Kalgoorlie-Boulder rubbish tip has been buried to the north of the north east ramp. The approved design for older rehabilitation of the Northeast WRD is the same as for the Southern (Oroya and Trafalgar) WRDs (20 m benches with berms at 10 m intervals). Berms are 4 to 5 m in width, and the rehabilitated slopes are 20° or less. A portion of the rehabilitation completed on the eastern side of the WRD has performed well, most likely due to the rockiness of the final surface. The north eastern portion has been capped with a very thick layer of oxide, and has erosion cullies.

Figure 5-36 shows the NE WRD current status and Figure 5-37 shows the final design of NE WRD.

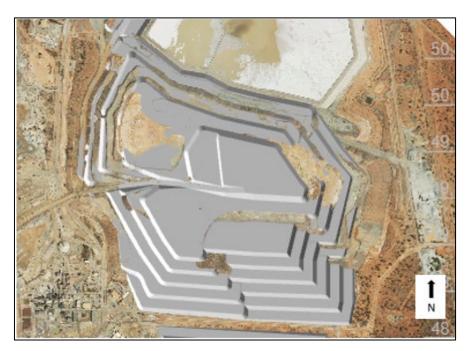
Figure 5-37: North Eastern WRD final (mine site grid)

In general, the closure design consists of 16° -17° slopes with 10 m wide berms, and a high percentage rock cover. Extensive technical work supports this design, including trials at Northern WRD. However some areas will require site specific adjustments due to historic placement of materials or are already rehabilitated as per approved designs. An additional upper approved lift of competent waste rock is being tipped to encapsulate most of the oxide on the upper NE section. The southern half of the WRD consists of subgrade stockpiles. These will be processed, and replaced with waste rock.

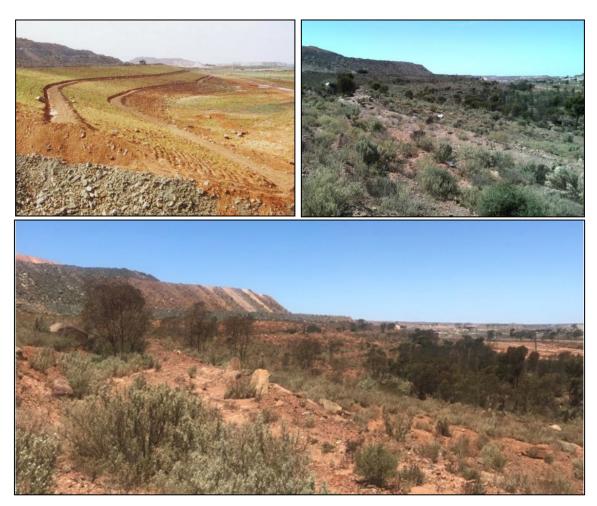
Figure 5-38: North Eastern WRD Black Street Rehab 1998 (left), 2013 (right), and 2021 (below)

The north western slopes, located immediately north of the Black Street trials, were rehabilitated in 1998 (**Error! Reference source not found.**). Visual observations indicate that this area appears to be performing well vegetatively, with minor erosion present. Overall, KCGM does not consider this area to be a high risk in terms of poor rehabilitation performance.

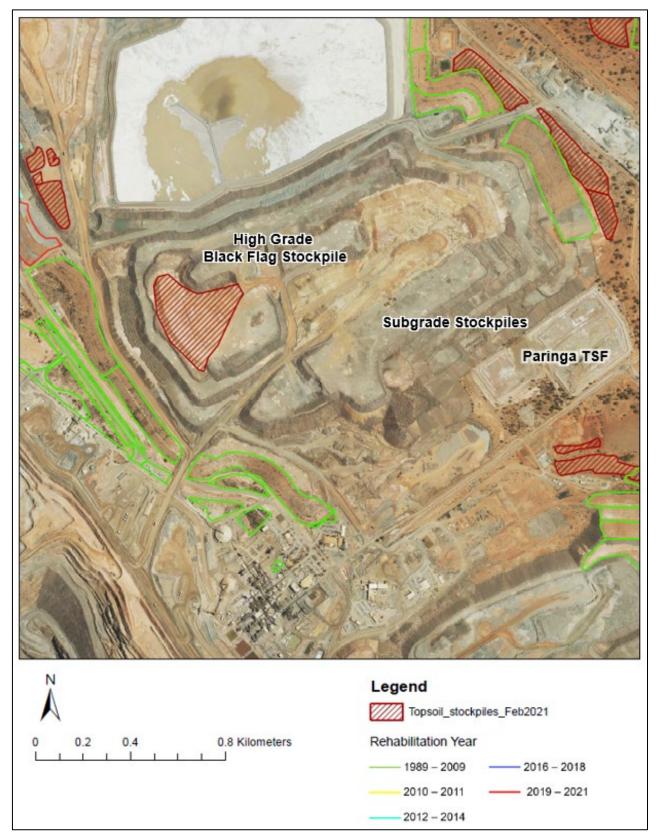
Figure 5-39: North Eastern (Central) WRD Current Rehabilitation Status (2021)

Progressive rehabilitation of the Northeast WRD has occurred between the mid-1990s and 2007 in three main areas; Black St Trials, Pad 19 and the Eastern Slopes (Figure 5-39).

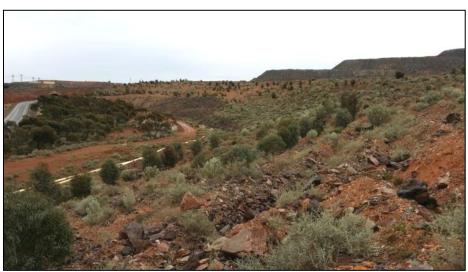
Figure 5-40: Pad 19 Rehabilitation Progress (2014)

Observations from 2015-2017 have shown a continued trend of vegetation recruitment, with minor erosion developing (Figure 5-40). Overall, KCGM does not consider this area to be a high risk in terms of poor rehabilitation performance.

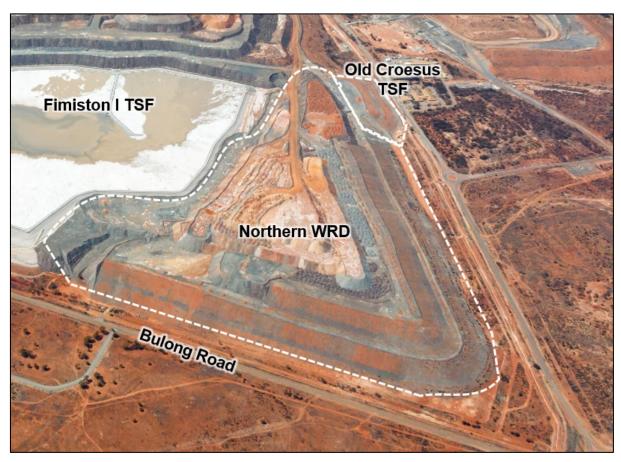
Figure 5-41: Northern WRD Viewed from the North (2021)

BF shale waste material is co-disposed with waste rock within the Northern WRD, with a buffer of 40 m for high ANC dolerite/basalt on the external faces of the dump and capping of 5 m of benign material on the final upper surfaces of the dump.

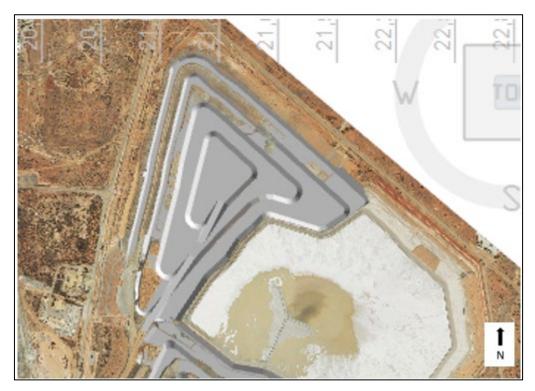
Figure 5-42: Northern WRD Final Design (mine site grid)

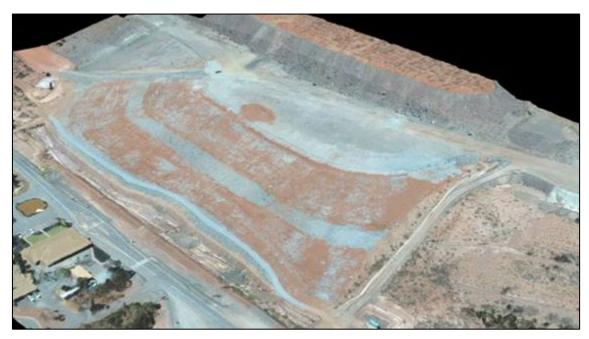
Figure 5-43: Old Croesus 2021 Capping and Completed Rehabilitation

Due to the continued erosion of the western flank of the TSF, remedial works were conducted during the 2020/21 period, with the TSF reshaped to a single slope, and then capped with waste rock (Figure 5-43). The upper surface was also levelled off and capped with waste rock. A robust crest bund with a backslope has been installed for water management. Class D subsoil was used as a growth medium. The slope will be seeded in 2021, although some vegetation recruitment has already occurred naturally. The TSF is now fully encapsulated.

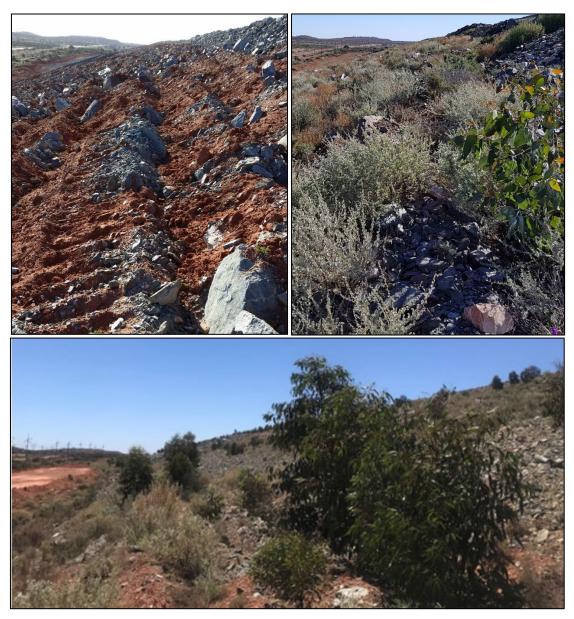
Figure 5-44: Northern WRD Western First Lift Face 2014 (top left), 2017 (top right) and 2021 (bottom)

Sections of the first and second lift of Northern WRD were used as a trial of the newly developed erosion resistant rehabilitation design. The lift was battered to 16° or 17°, with 200 mm of rehabilitation materials from nearby stockpiles applied (excluding within a rocky band 50 m up slope) and the surface ripped to produce a sufficient rocky surface cover to reduce erodibility. Rehabilitation continues on the Northern WRD when areas become available, using the same design and implementation methods. The outcomes of the trial were successful, and have been implemented across the Fimiston WRD, as new areas become available.

Hand seeding was implemented between 2014 and 2016 on these slopes, with very good vegetation recruitment. The area is showing good vegetation diversity with Eucalyptus and other perennial species noted. No erosion had been observed.

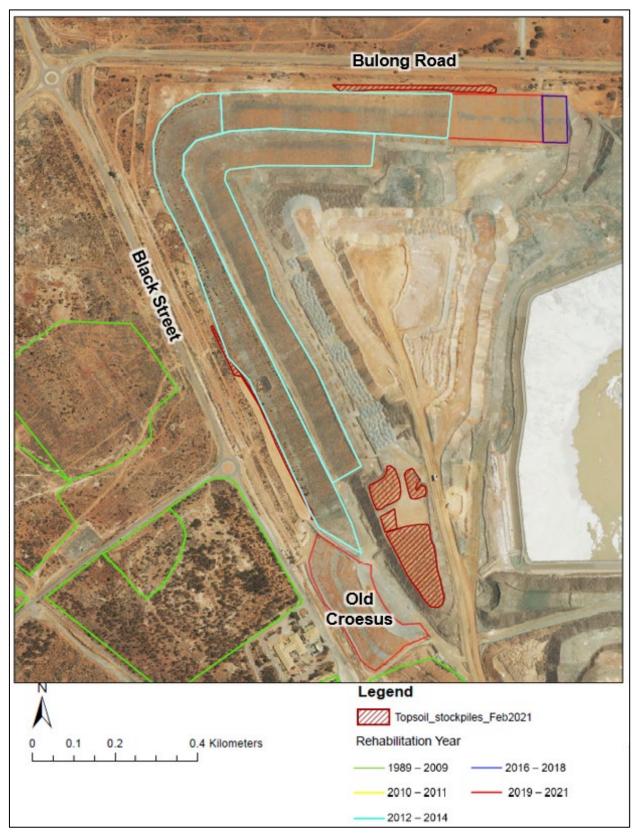
Figure 5-45: Northern WRD current rehabilitation status (2021)

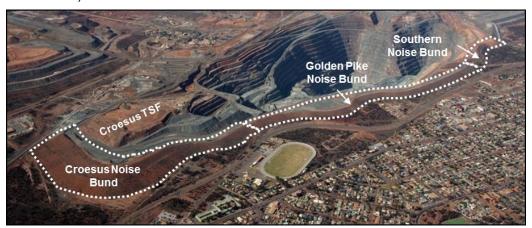
Figure 5-46: Environmental Noise Bund

Located on the western side of the Fimiston Open Pit, the Environmental Noise Bund has been constructed from competent waste rock (with small oxide areas) to reduce noise carried across the town from mining and processing activities. It will be retained post closure to assist with noise impact to the City of Kalgoorlie-Boulder. The ENB has three distinct sections (Figure 5-46):

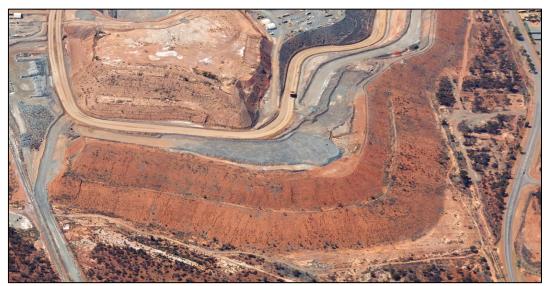
Figure 5-47: Croesus Noise Bund (2021)

The Croesus NB (Figure 5-47) is located at the north-western corner of the Fimiston Open Pit and is Highly Visible from the Goldfields Highway. The Croesus NB partially encapsulates the Croesus processing plant footprint (decommissioned in 1997).

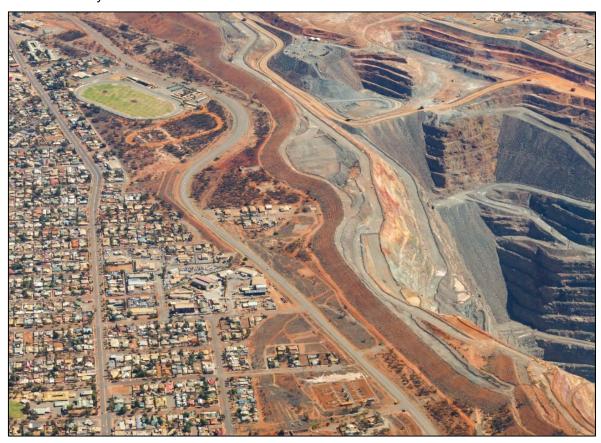
Figure 5-48: Golden Pike Noise Bund (2021)

The Golden Pike Noise Bund (Figure 5-48) was constructed to replace the original noise bund that was to be mined through during the Golden Pike Cutback. It is constructed from waste rock (predominately dolerite and basalt) and,

in some areas, oxide material. It is a single lift and ranges in height from 14-17 m. In 2017 a wall remediation project in Fimiston Open Pit resulted in a narrowing of the width of the Golden Pike NB footprint in the vicinity of the project, with no change to the western side of the NB.

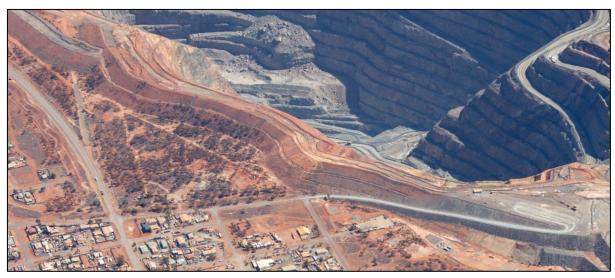
Figure 5-49: Southern Noise Bund (2021)

The Southern NB (Figure 5-49) was initially constructed in 1991 with one 15 m lower lift and 10 m upper lift in waste rock and oxide, and rehabilitated in 1995/1996. The southern section was constructed in 2003 from oxide and rehabilitated shortly after.

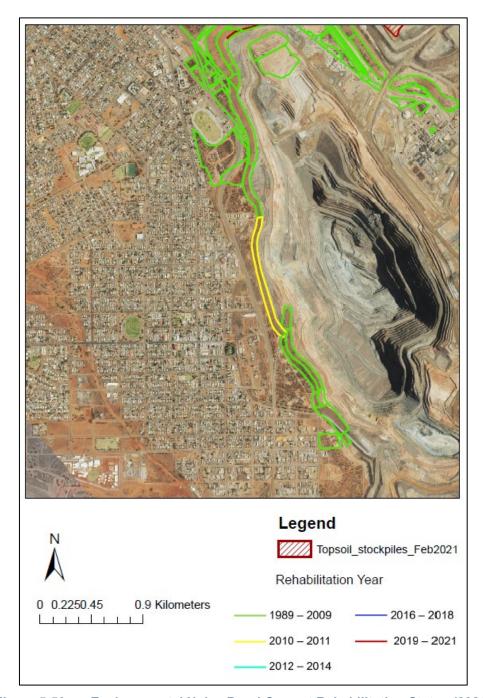
Figure 5-50: Environmental Noise Bund Current Rehabilitation Status (2021)

All sections of the Noise Bund have been rehabilitated, with techniques reflecting rehabilitation philosophy at the time of construction.

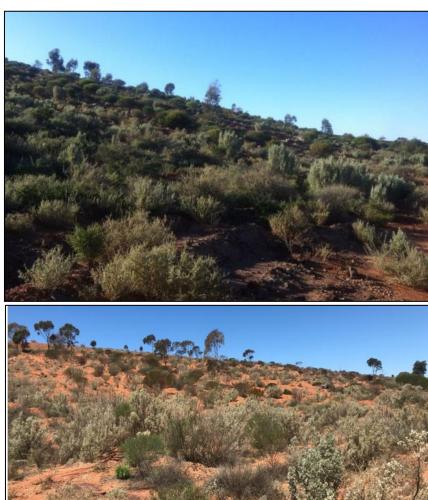
Figure 5-51: Croesus Noise Bund Lower Lift, Western Side 2013 (top) and 2021 (bottom)

In 2009, the southern section of the first lift of this waste dump was re-graded to approximately 20°, sheeted with 300 mm of rehabilitation material and seeded by hand.

Visual observations during 2012 to 2014 have highlighted vegetation success on the lower lifts. Vegetation monitoring conducted in 2014 indicated that this landform has achieved 'satisfactory' rehabilitation success, although there were marked differences in some measures between transects. Erosion monitoring of this landform in 2014 showed actively eroding gullies, most likely due to the remaining thickness of the topsoil in some areas and the low percentage rock cover on the surface.

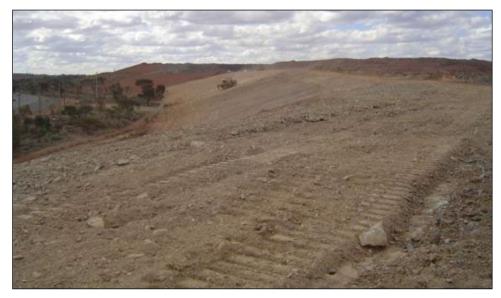
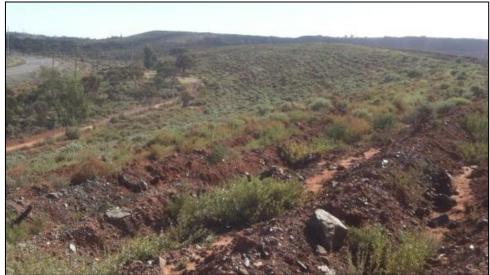
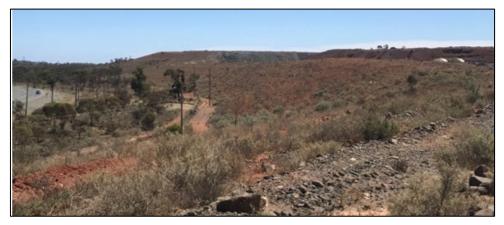
Figure 5-52: Golden Pike Noise Bund

(Top: Battering 2011. Middle: 2013 Progress of rehabilitation Bottom: 2021)

Visual observations from 2012 have noted good recruitment of lower storey species and minimal erosion (Figure 5-52). There is a small section of gullying which developed following large rainfall events in early 2013 where insufficient water control on the dump top led to ponding against the crest bund, with eventual failure of the bund. Due to the depth of material placement, gullying depth is limited by underlying waste rock and is unlikely to continue to deepen.

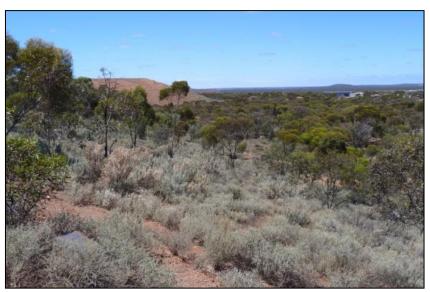
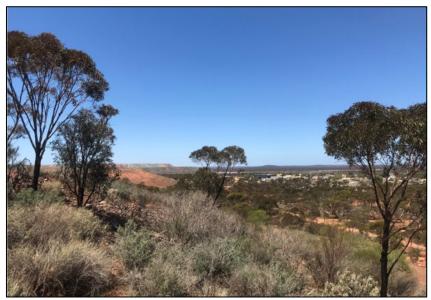
Figure 5-53: Southern Noise Bund Lower Lift Status of Rehabilitation 2013 (top) and 2021(bottom)

Visual observations from 2012 have indicated that the lower lift has excellent vegetation condition with high diversity, all three strata and several species indicating the community has attained some level of resilience (Figure 5-53). The upper lift is not performing as well, with limited species diversity and cover, possibly due to quality of rehabilitation material used. Some gullying has been observed in the northern section within rock drains, although this appears to be self-armouring.

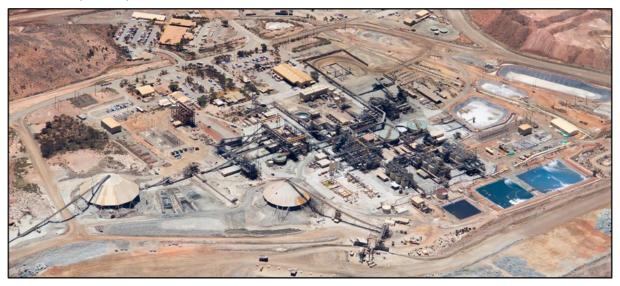
Figure 5-54: Fimiston Processing Plant, facing west

The Fimiston Processing Plant (Figure 5-54) was constructed with the inception of the KCGM Fimiston Open Pit in 1989. It covers approximately 20 ha, and is located to the east of the Fimiston Open Pit. Two parallel circuits process refractory sulphide ore from the Fimiston Open Pit and Mt Charlotte Underground Mine. The licenced milling production rate at Fimiston is 14.5 Mtpa. During operations, ore processing at Fimiston is managed in accordance with DWER Part V Licence Conditions. The Fimiston Plant was reported to the DWER as a potentially contaminated site (AOC57).

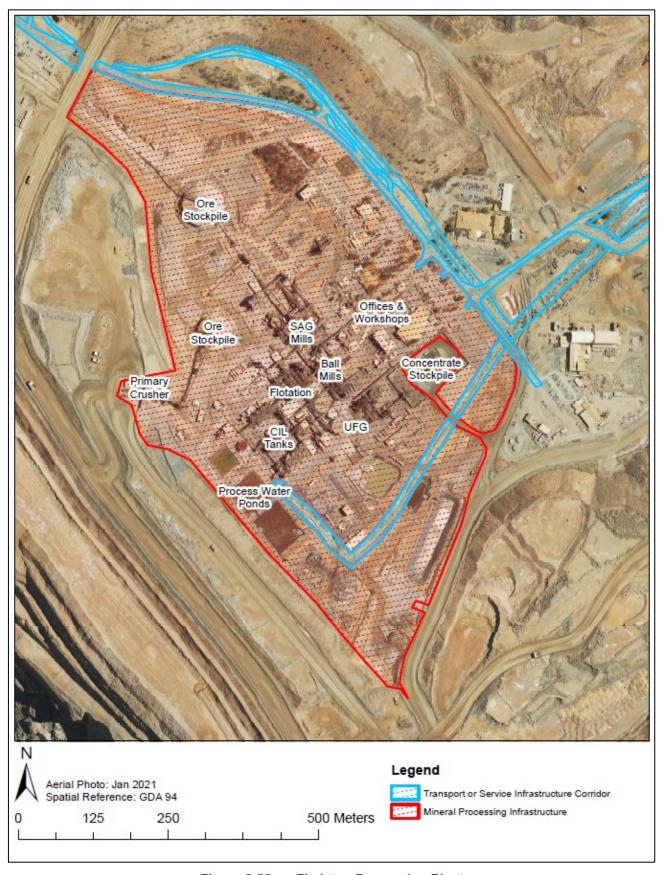
Figure 5-55: Fimiston Processing Plant

The plant comprises (as shown in Figure 5-55):
