KCGM HSEC DEPARTMENT, CLOSURE

KCGM Mine Closure Plan 2022 (v1) Volume 1 of 3

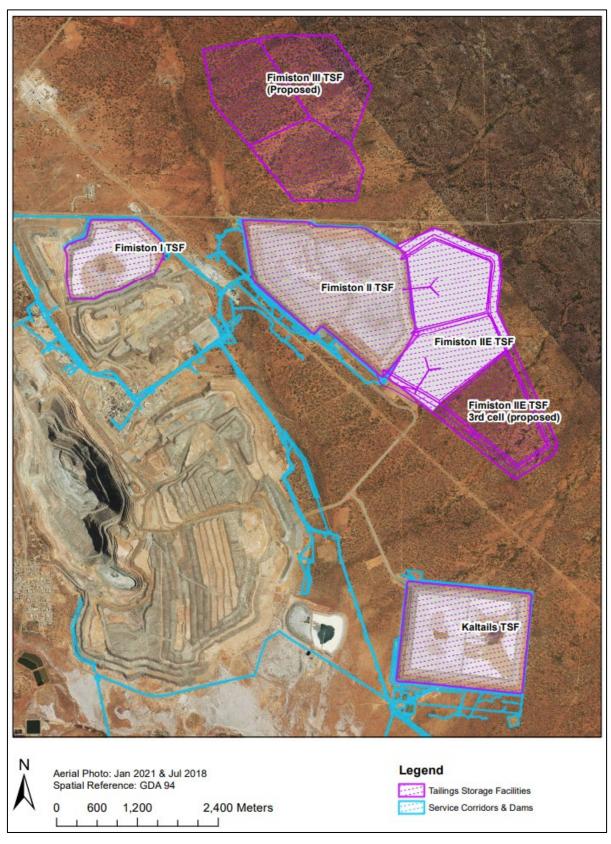
Figure 5-56: Fimiston Operational Area Tailings Storage Facilities

Approximately 12 Mtpa of tailings solids are pumped through bunded delivery lines as slurry from the Fimiston Plant to the Fimiston I, Fimiston II and Kaltails TSFs, with decant return water pumped back via central decant systems to the Plant for reuse (Figure 5-56). The operation of the TSFs is managed through Works Approvals, a Part V Licence and Mining Proposals (including geotechnical aspects).

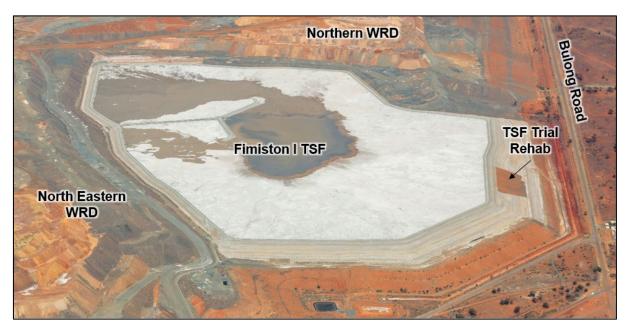
Figure 5-57: Fimiston I TSF (2021)

The Fimiston I TSF (Figure 5-57) covers an approximate footprint area of 120 ha and is located to the south of (and adjacent to) Bulong Road. The facility was originally constructed in 1988/1989 as four cells and sub-aerial slurry discharge via multiple spigot discharge points commenced in 1989. The starter embankments were constructed from clayey sand/sandy clay sourced from within the storage footprint. Subsequent upstream raise construction has utilised tailings sourced from within the impoundment. During operations, the original four cells were combined into two (Fimiston I West and Fimiston I East) and subsequently into a single operational cell that also incorporated the north and south cells of the Croesus TSF (Golder, 2013). The facility is currently at a height of 44 m and has a maximum approved height of 60 m, and the external slopes are approximately 3-3.6H:1V (Golder, 2017b).

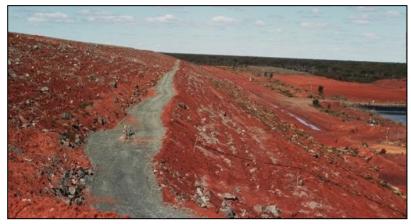
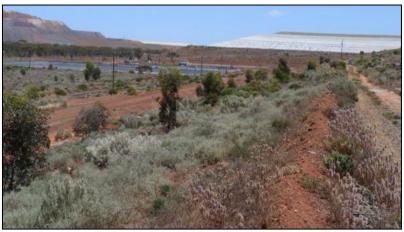
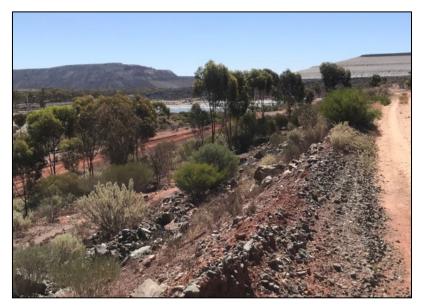
Figure 5-67: Fimiston II TSF 2003 Rehabilitation of Lower Lifts

Facing East 2004 (top). Facing North 2013 (middle) & 2021 (bottom)

Fimiston II starter embankment and the first tailings lift were rehabilitated from December 2000 to 2003, commencing with the northern batter and working around to the western batter. The tailings material was covered with 1 m of hard rock and 300 mm of topsoil, with rock lined drop drains installed in some of the rehabilitated areas to facilitate surface water control. Seed was applied at a rate of 9 kg/ha using a hydro-mulcher, which sprayed the seed mix combined with fresh water and shredded newspaper.

This area of rehabilitation was "On track, continue monitoring" during 2011 LFA monitoring (Outback Ecology, 2012a). All key indices of ecosystem function (stability index, erosion, and lower storey plant cover) were within the average regional range. Vegetation is predominantly chenopod shrubs with a limited overstorey of perennial species. Visual observations indicate that vegetation recruitment is reduced in northern areas, possibly as a result of the harsh aspect and significantly reduced rainfall in recent years. Visual observations from 2012-2014 indicate that the south western slopes, with a southern aspect, shows particularly good vegetation growth and appears to be relatively stable with minimal erosion (Figure 5-67).

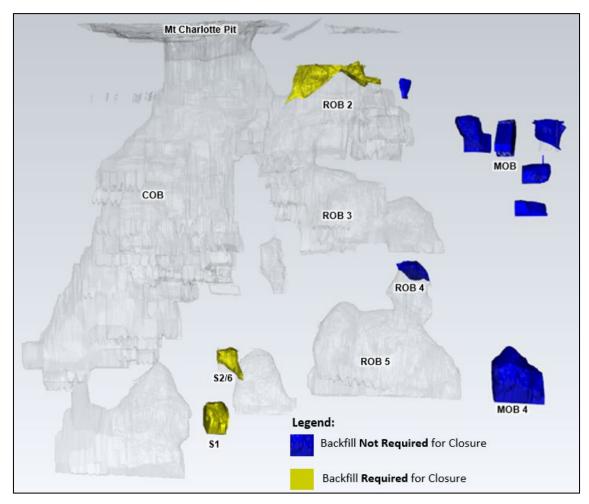
Figure 5-92: Plan showing Major Voids greater than 15 m width and current status of voids requiring backfill

Collapse or settlement could occur if an underground void became unstable to the extent that it unravelled, and under these conditions the instability could potentially migrate towards the surface. Figure 5-92 shows the extent of the underground workings at Mt Charlotte and provides some indication of the actual depth below surface of the original mine voids prior to backfilling. Operational waste and crushed waste supplied through the Mt Charlotte Open Pit are used to backfill old stopes. In Figure 5-92, large voids that are currently at over 80% backfill volume are shown in grey; voids that require backfill and are under 80% fill are shown in yellow; voids that are considered stable and will not require backfill are shown in blue.

Collapse or settlement could occur if an underground void became unstable to the extent that it unravelled, under these conditions the instability could potentially migrate towards the surface. Figure 5-92 shows the extent of the underground workings at Mt Charlotte and provides some indication of the actual depth below surface of the original mine voids prior to backfilling. Operational waste and crushed waste supplied through the Mt Charlotte Open Pit are used to backfill old stopes.

Beyond a minor span of 15 m, flat voids can be unstable, and if unrestrained, falls could occur until a stable arched back shape is formed. These can occur in the major voids (Figure 5-92), and are of two types:

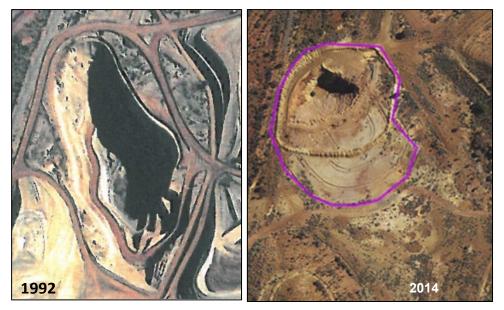
Figure 5-97: Sir John Open Pit Feature (showing extent of backfill) 1992 to 2014

of Fame site) and Black Flag Beds shale was removed from a cleanup of the Mt Percy ROM Pad (Figure 5-97). The Sir John Open Pit was reported to the DWER as a potentially contaminated site (AOC31).

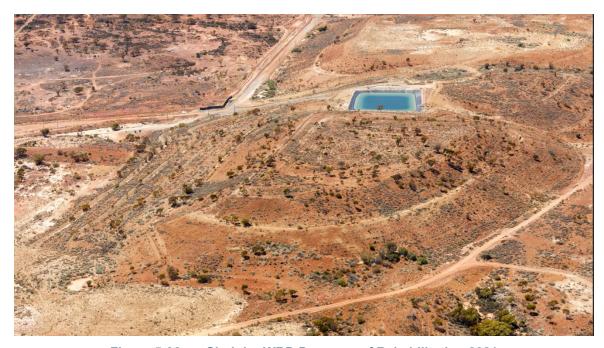
Figure 5-98: Sir John WRD Progress of Rehabilitation 2021

The Sir John WRD (Figure 5-98) was rehabilitated in 1993 by re-shaping to approximately 16°, sheeting with lateritic rehabilitation materials, contour ripping and seeding. Monitoring transects were installed for the first time in 2010 and 2011 and monitoring in 2011 classified this area as "On track, continue monitoring" (Outback Ecology, 2012b). Visual inspections from 2012 to 2014 have noted that the WRD has good vegetation condition (Figure 5-99) with multiple life stages and evidence of reproduction present; however, there are some minor erosion gullies.

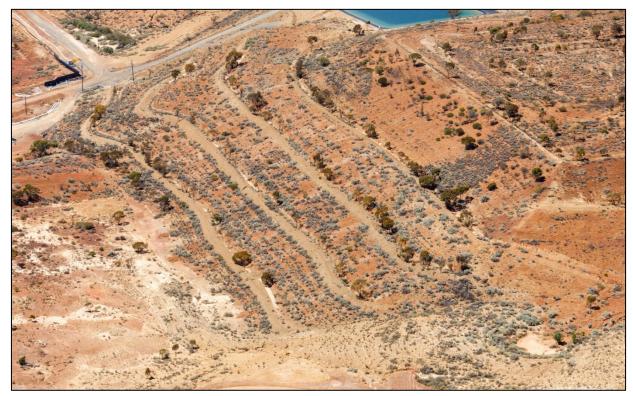
Figure 5-99: Sir John WRD Western Batter Progress of Rehabilitation

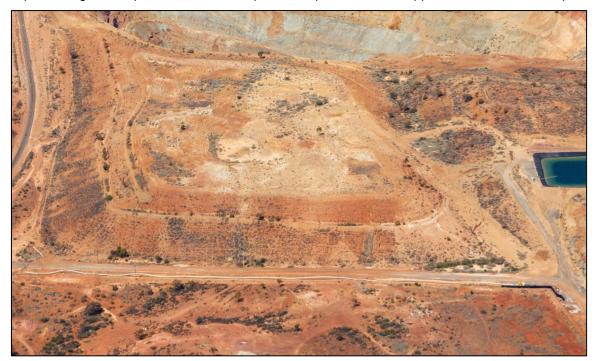
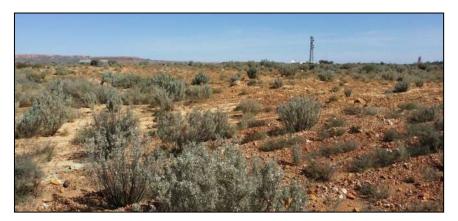
Figure 5-100: Union Club WRD Upper Surface (Bottom 2014; Top 2021)

EFA monitoring in 2011 classified this area as "On track, continue monitoring" (Outback Ecology, 2012b). Visual inspections from 2012 to 2014 indicate that lower storey vegetation is comprised mostly of salt tolerant species, such as *Atriplex* (Figure 5-100). Upper storey species were sparse on the batter and top of the dump, with

Casuarina sp. observed in areas where water was ponding at the dump toe. Erosion gullies were observed from the mid-slope drainage berm (cut in after material placement) located in the upper third of the outer slope.

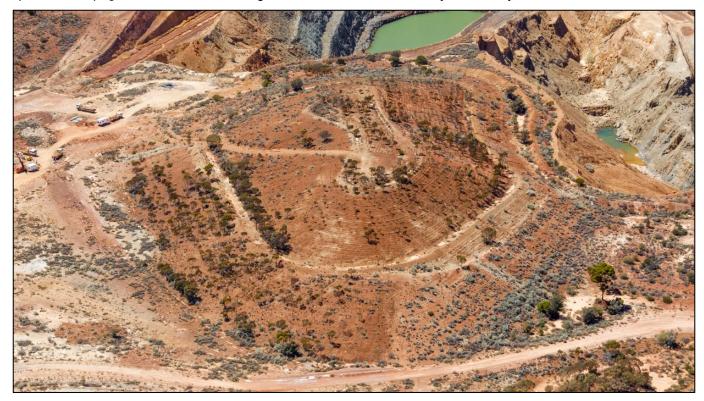
Figure 5-101: Mystery WRD (2021)

LFA monitoring in 2011 classified this area as "Below expectation" (Outback Ecology, 2012b). However, visual inspections from 2012 – 2014 indicate that vegetation appears to be in good condition (Figure 5-101), with multiple life stages and evidence of reproduction. A review by botanical professionals in 2012 described the vegetation community as a low mixed *Eucalyptus spp.* woodland over a sparse to open mid *Atriplex nummularia* shrubland over a sparse to open low *Atriplex vesicaria*, *Maireana pyramidata* and *M. glomerifolia* shrubland over isolated *Enneapogon caerulescens* grasses, with the surface relatively erosionally stable.

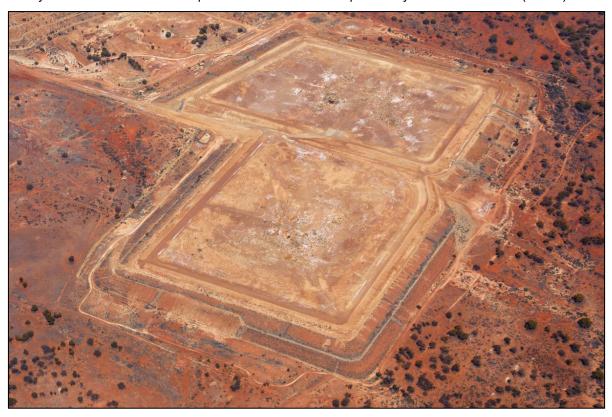
Figure 5-102: Mt Percy TSF (2021)

The Mt Percy TSF (Figure 5-102) was operational between 1985 and 1997. The facility consists of two cells, covering approximately 55 ha. The starter embankment was constructed of clayey run of mine oxide waste followed by upstream lifts constructed of selected run of mine waste to produce external batters of approximately 16 to 20°. Deposition was as sub-aerial slurry discharge via multiple spigot discharge points around the perimeter. It was decommissioned and rehabilitated in 2001.

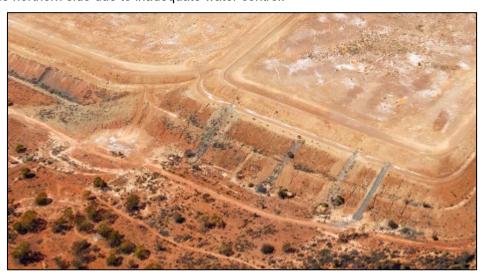
Figure 5-103: Erosion and Water Control Repairs on Mt Percy TSF Completed in 2019 (2021)

Visual observation of the feature shows that excessive erosion of the external batters is occurring in some areas outside of the monitoring transects. Rock lined drop drains have been installed in some areas in response to erosion occurring after the rehabilitation was completed (Figure 5-103). Significant gullying has occurred in the central area of the northern side due to inadequate water control.

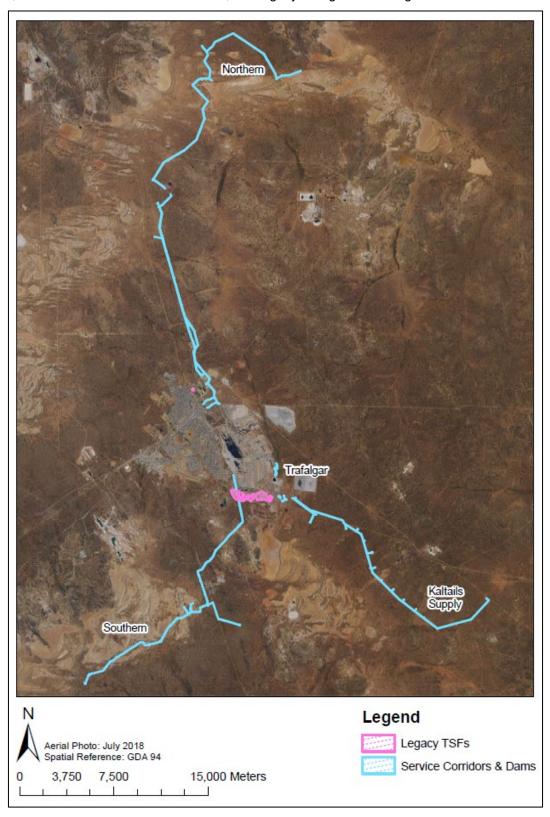
Figure 5-104: Regional Operational Area

The Regional Operational Area (Figure 5-104) is defined by exploration areas, groundwater and service infrastructure, access roads and service corridors, and legacy tailings and mining features.

Three regional production borefields are operated by KCGM, namely the Kaltails, Northern and Southern Borefields and are used to supply water to the Fimiston Plant (Figure 5-104). All borefields are operated under DWER licences.

This feature includes all access roads (unsealed tracks) in the KCGM Regional Operational Area (Figure 5-104). All roads are currently in active use and will be progressively rehabilitated as they are no longer required. Service corridors include all water pipelines, power line corridors and other service corridors.

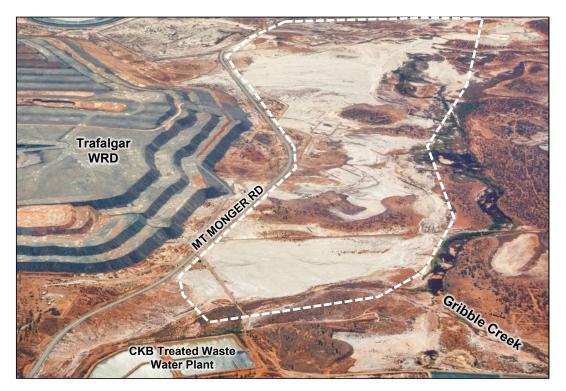
Figure 5-105: Morrisons Flats Historical Tailings 2021 (right of Mt Monger Rd)

Morrisons Flats (Figure 5-105) is an area related to historical tailings storage located to the south of the Fimiston Operational Area. Tailings have been deposited in this area since before the turn of the 20th century, processing ore from the Golden Mile. Due to mineral processing methods used at the time, much of these tailings were enriched in heavy metals, including gold. Reprocessing of old TSFs in the Morrisons Flats area was undertaken as part of the State Agreement Kaltails Project between 1989 and 1999. Selected areas of the remaining TSF footprints were covered or rehabilitated to the north of Mt Monger Rd by KCGM, with further expansion of the WRD planned to gradually cover the remaining footprints. Residual footprints remain to the south of the Mt Monger road. Erosion of the historic tailing dams has resulted in an area of outwash toward Hannan Lake to the south.

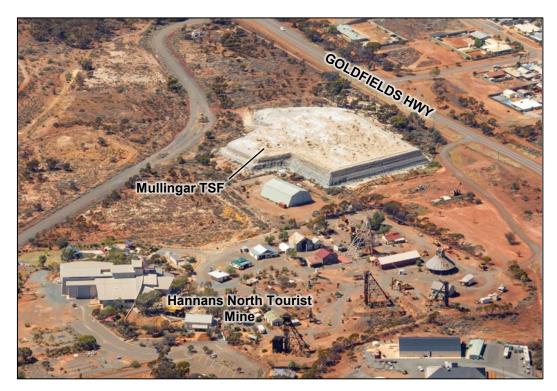
Figure 5-106: Mullingar Tailings Storage Facility (2021)

The Mullingar TSF, located on the southern portion of the Hannans North Tourist Mine, is the last remaining hand-built TSF on the Golden Mile (Figure 5-106). It was constructed by hand pre-1960 with steep (48°) external batters, has an area of 1.65 ha and is approximately 9 m high. The TSF is not included on a register of heritage sites The Mullingar TSF has been reported to the DWER as a potentially contaminated site (AOC12) and rehabilitation of the facility will be required to comply with the requirements of the Contaminated Sites Act. For this reason, the TSF will need to either be encapsulated in situ or rehandled to an appropriate location.

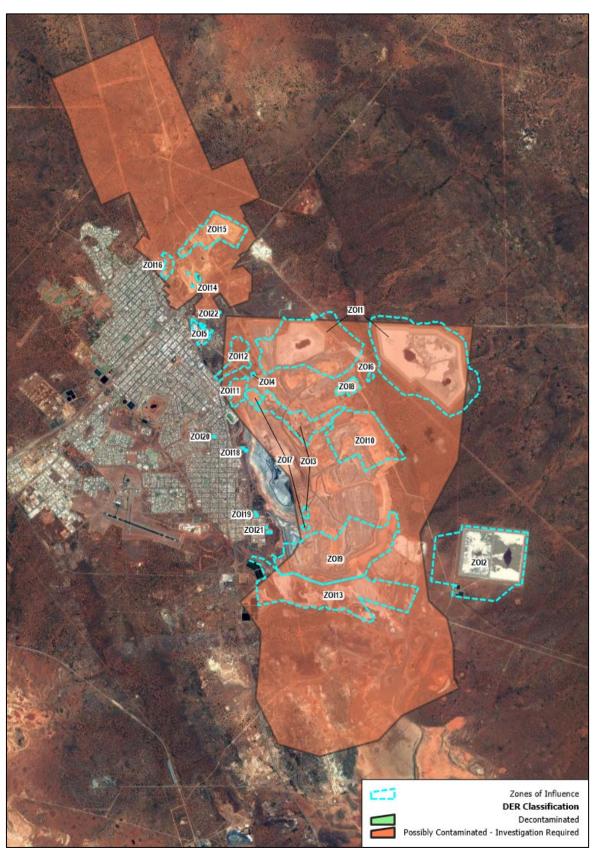
Figure 5-107: Fimiston, Mt Charlotte, and Mt Percy Contaminated Sites

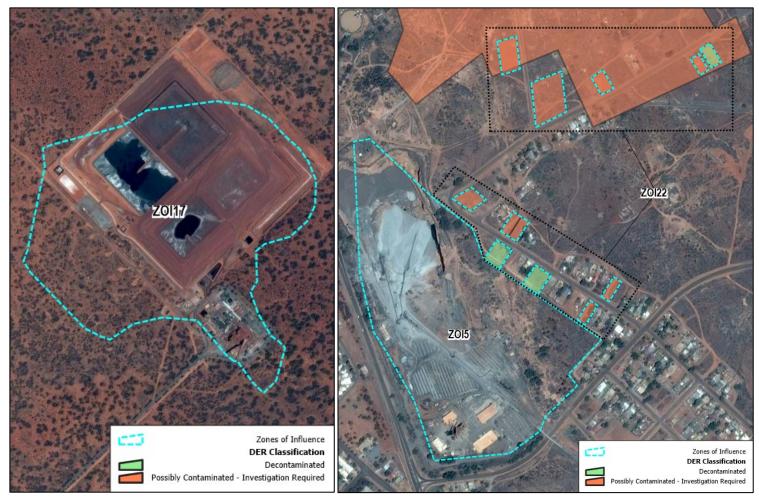
Figure 5-108: Gidji (ZOI7), Mt Charlotte (ZOI5), and Williamstown (ZOI22) Zones of Influence

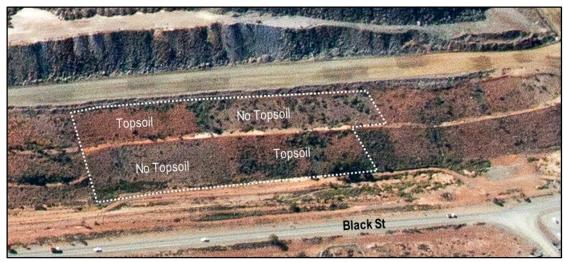
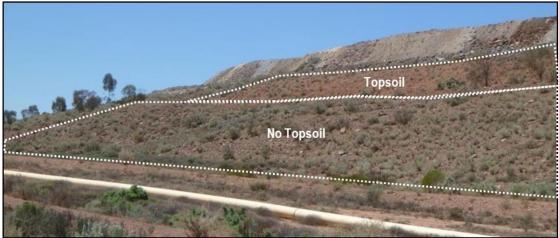
Figure 5-109: North Eastern WRD 'Black St Trials' Trial 1 Section Location

Trial 1 was established in 1992 to investigate waste rock landform revegetation, with and without the application of topsoil on waste rock/oxide (Figure 5-109). The applicable site was spread with topsoil to a depth of 20 cm, ripped and then sown with an 8 kg/ha site specific seed mix, and spread with Agras MoZnCu fertiliser at a rate 200 kg/ha. The two treatments included:

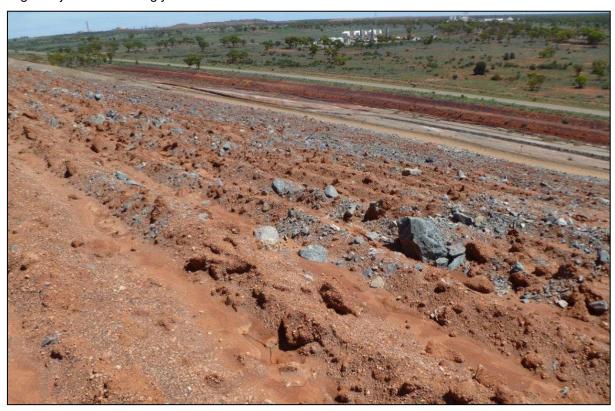
Figure 5-110: Fimiston I TSF Trial Immediately after Completion of Earthworks (Feb 2017)

After rock capping, the trial area was topsoiled using material from a stockpile that was approximately 5 m high and significantly compacted (Figure 5-110). After receiving good rainfall, germination occurred from seed stored within

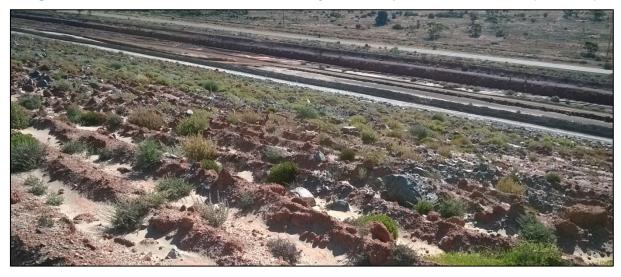
Figure 5-111: Fimiston I TSF Trial Observed Germination after Rains (July 2017)

the seedbank, evidencing the amount of viable seed contained in the topsoil stockpile (more than 15 years old) (Figure 5-111).
