ARROWSMITH HYDROGEN PROJECT

(AHP1)

REHABILITATION PLAN

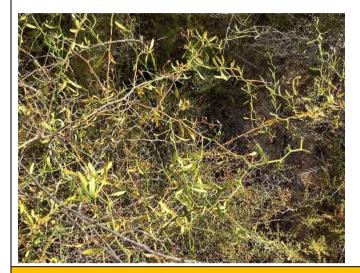
Dense spinescent shrub to 3 m high, growing in sand or loamover limestone (WAH 2021).

Within the survey area this species was observed as an intricate, spinescent shrub although open and significantly smaller than the recorded size.

Habitat: in vegetation type **McArGaTS**; Melaleuca cardiophylla, Acacia rostellifera and Grevillea argyrophylla tallshrubland, on near-coastal limestone outcropping.

Location: Northwestern (more coastal) portion of the survey area.
