BHP Iron Ore Pty Ltd

Marillana Creek (Yandi) Closure Plan

May 2025, Revision 6

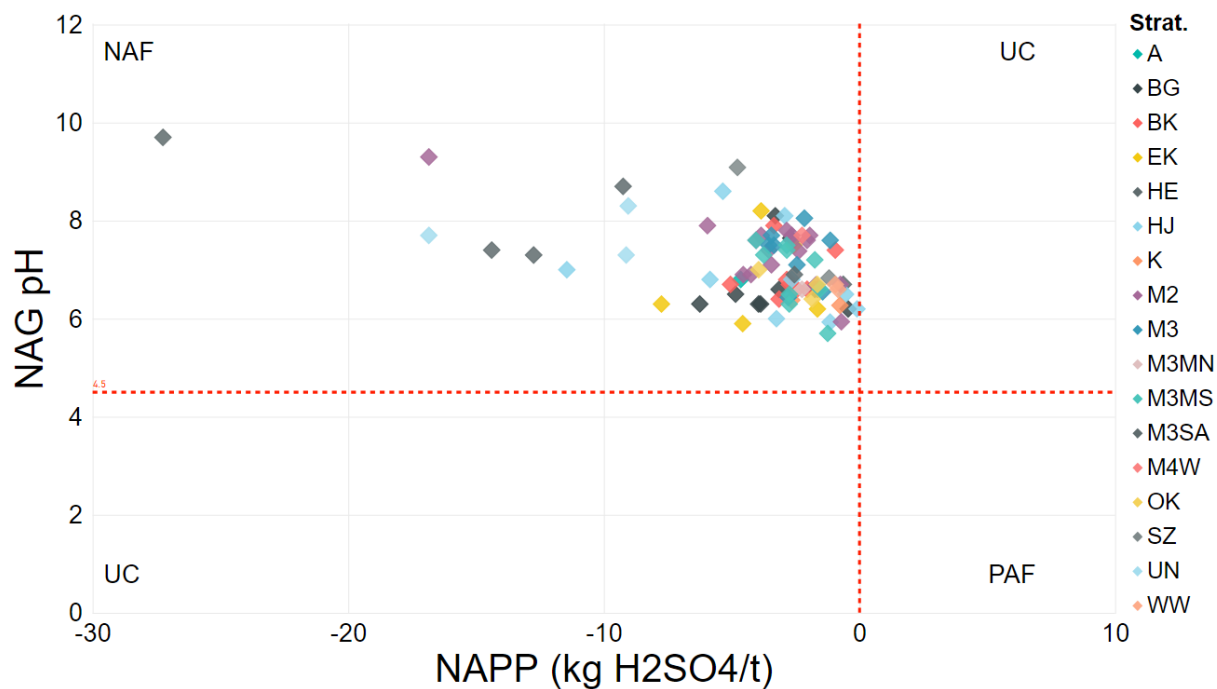
Figure 5-6 AMIRA classification - NAPP and NAG pH data for all Yandi samples

Notes: two NAF Weeli Wolli samples not shown due to highly negative NAPP values of -120 and -323 kg H₂SO₄/t.

All samples submitted for environmental test work were classified as NAF (AMD0) based on a combination of the AMIRA (2002) (NAPP vs. Net Acid Generation; NAG pH) (Figure 5-6) and Price (2009) (ANC vs. Maximum Potential Acidity; MPA) (Figure 5-7) classification systems.

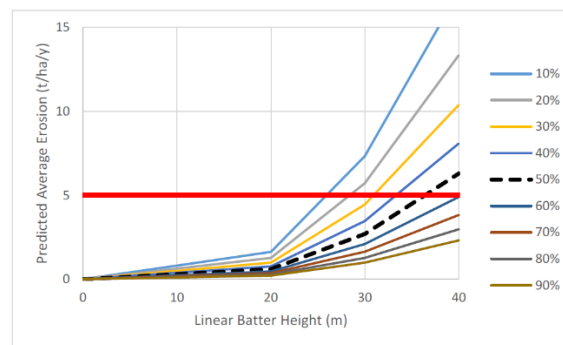
Figure 5-13 Erosion profiles showing the effect of rock addition

Notes: Inherent rock cover level is shown in the black dashed lines

Figure 5-13 shows the effect of adding rock to the more erodible Yandi overburden types (M2 East, M2 West, M4 East, and M4 West) that could not be used to construct a 30 m high batter for all the gradients assessed (Table 5-12). The graphs in Figure 5-13 show the predicted average annual erosion rates for calculated rock cover values ranging from 10% to 90%. Higher rock contents could reduce erosion to acceptable levels for 30 m batters for all materials.

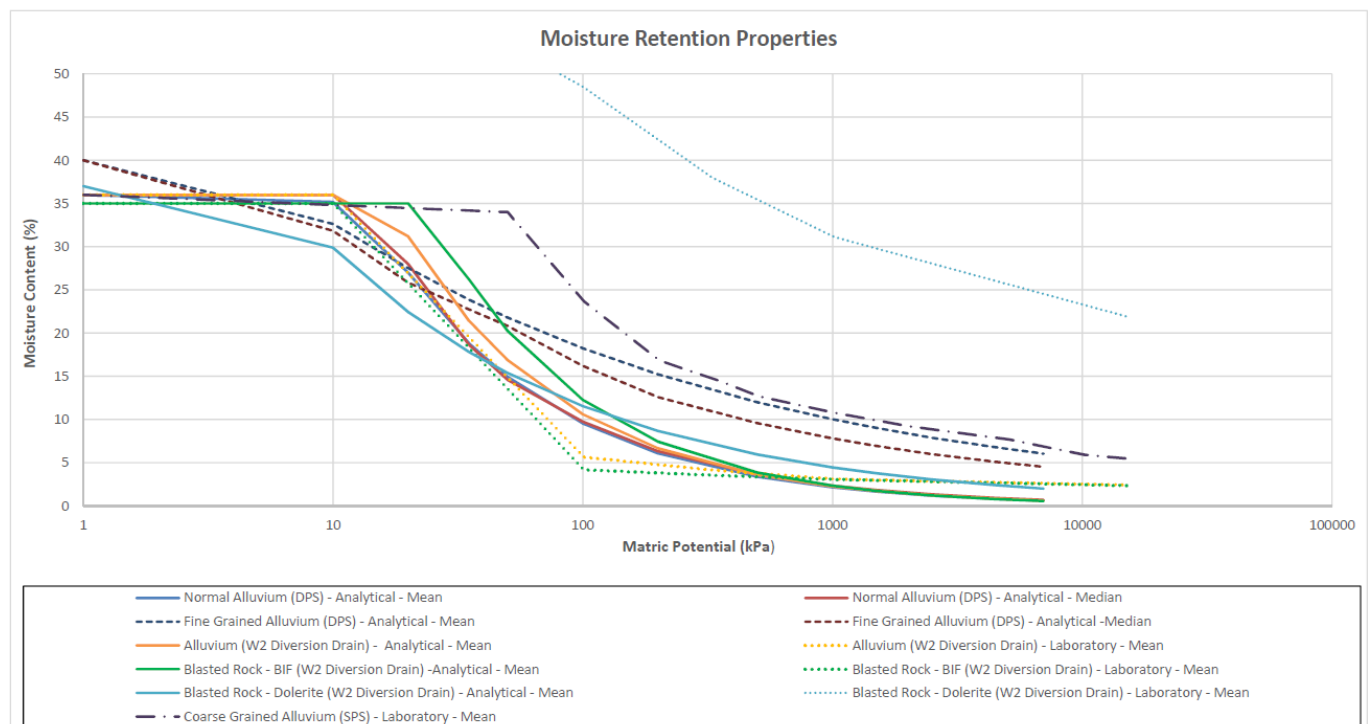
Figure 5-15 Moisture retention curves

Source: AQ2 (2017)

Moisture retention curves for the natural alluvium compared to blasted rock are shown in Figure 5-15. The results show that (AQ2, 2017):

The unsaturated hydraulic properties and moisture content of alluvium and the blast samples for the W2 diversion are similar for the soil matric potential range in which the riparian trees operate (refer to Section 5.6.3). Thus, blasted rock (with a particle size distribution at least as "fine-grained" as the W2 blast) could support riparian vegetation under unsaturated conditions (AQ2, 2017).

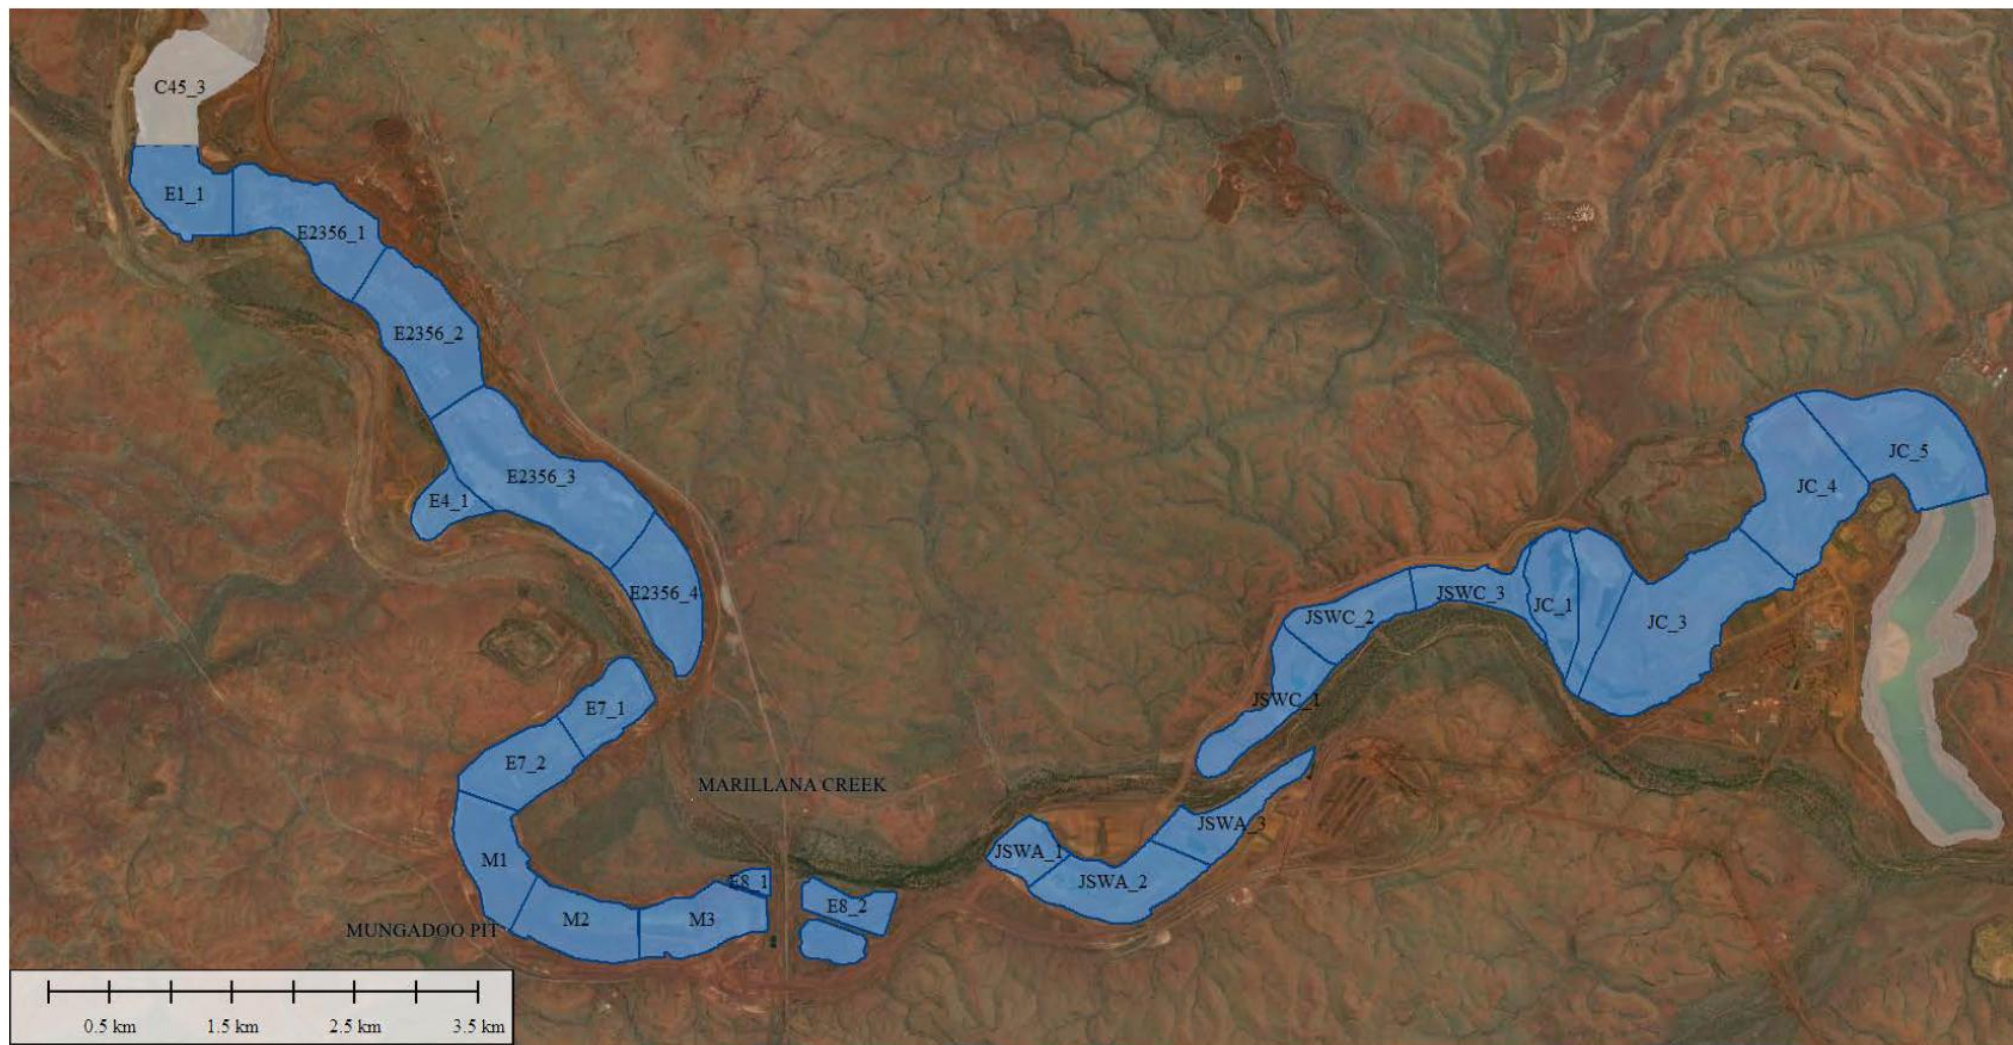
Map 5-29 **E7 / Mungadoo model extent**

Source: AQ2 (2023a)

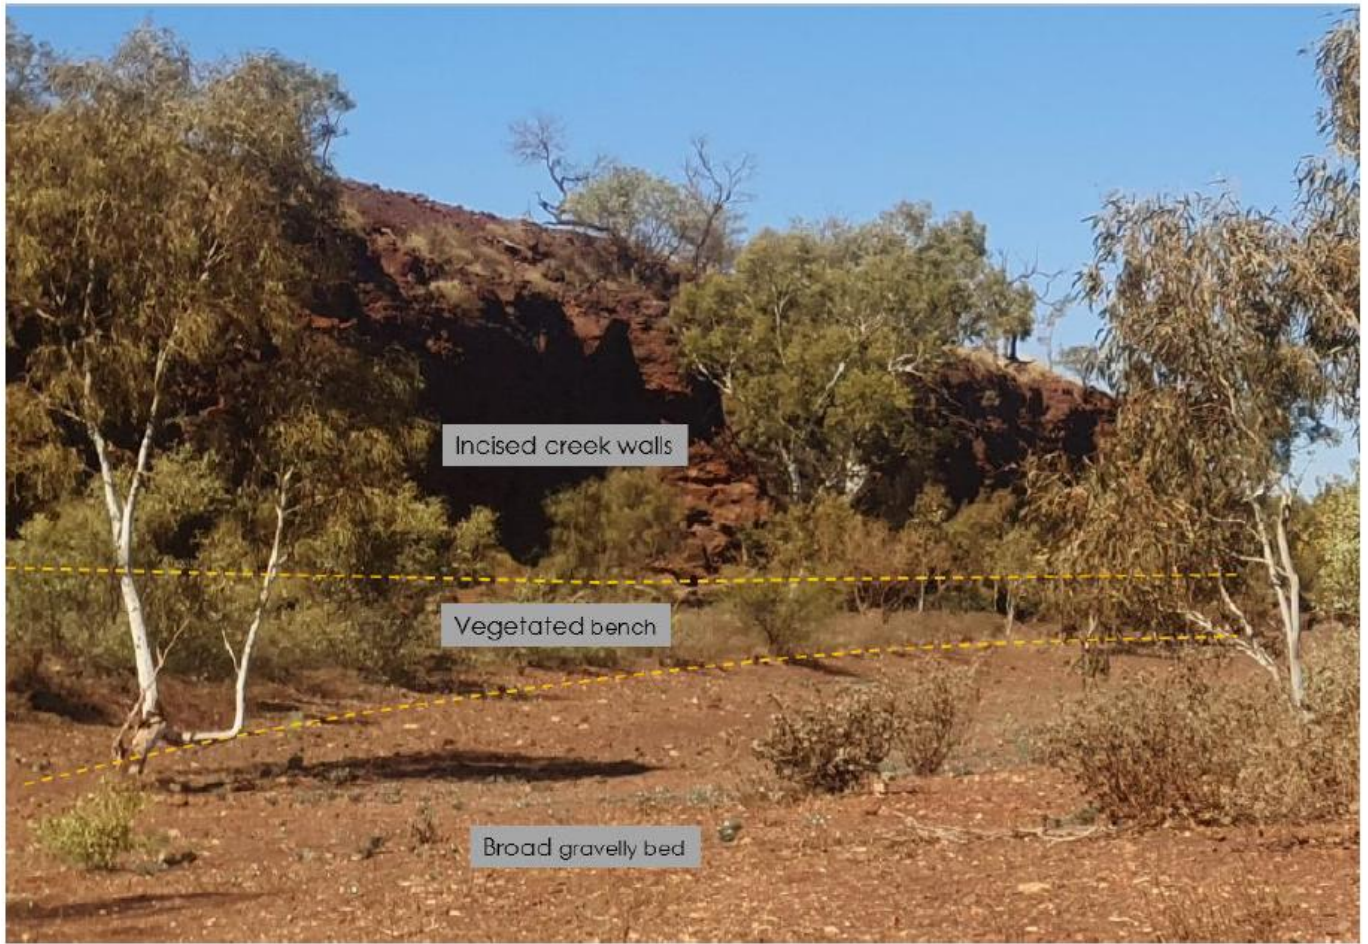
Figure 5-44 **Site observations of Marillana Creek incised reach features**

Source: Okane (2023c)

The pit backfill plan is to primarily retain pit walls in their as-mined configuration (where geotechnically stable). If geotechnical design criteria are not met, buttressing, or reprofiling (laybacks) may be implemented. The incised sections of the Marillana Creek channel (Figure 5-44) show steep walls and low, flat marginal benches that are well vegetated, providing a suitable proxy for buttresses.

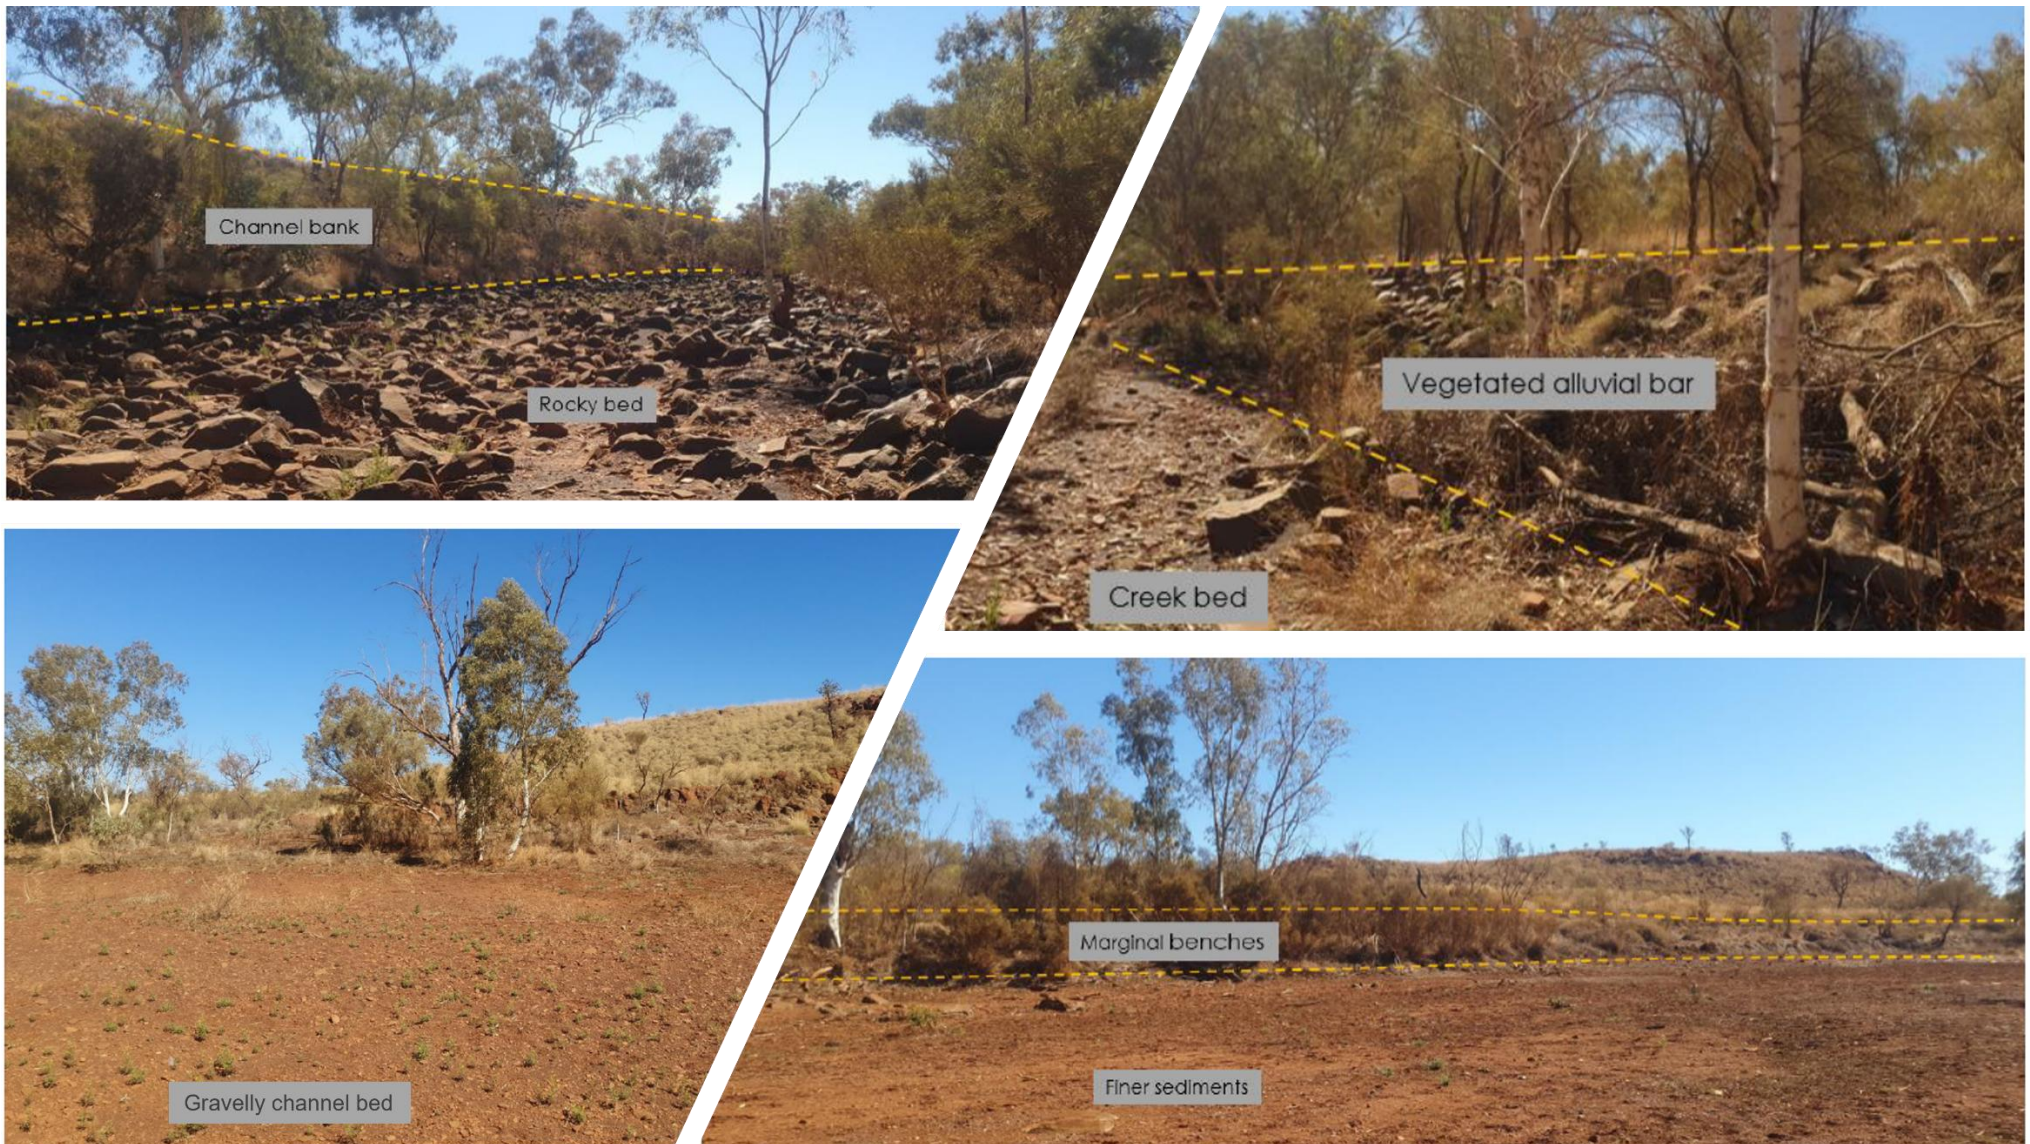
Figure 5-45 Site observations of Marillana Creek anabranching reach features

Source: Okane (2023c)

The well-vegetated, anabranching channels, and alluvial bars in Marillana Creek (Figure 5-45) provide diverse habitats for flora and fauna and could serve various purposes in the backfill design, including mitigating scour from infrequent operation of the flood channels, potentially lowering local groundwater levels, providing flood refuge, offering habitat, and enhancing overall amenity.

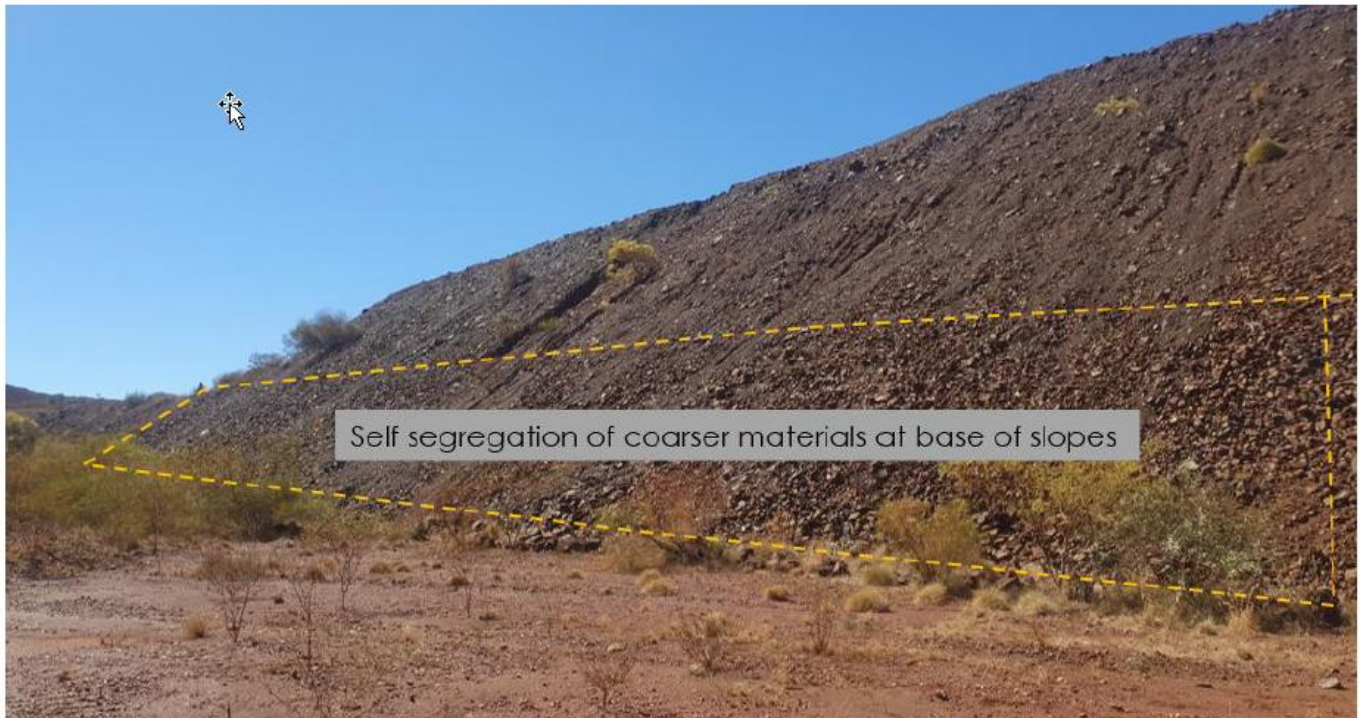
Figure 5-46 West W1 OSA exhibiting segregation of materials

Source: Okane (2023c)

As outlined in Section 5.14.1.4, the permeability of the backfill has a significant influence over closure outcomes with backfill layers having higher conductivity resulting in lower groundwater levels and less salinity, and hence less requirement for backfill. The permeability testing outlined in Section 5.2.4.3 indicated that stockpiled material is mixed and unlikely to have a significant range of hydraulic conductivity. Therefore, selective placement of LCID / UCID / mixed backfill in the mine voids appears unlikely to be practical or to make a difference in how groundwater moves within the backfilled material. However, the Okane site investigation identified the potential for significant gravity segregation in OSAs (Figure 5-46) which presents opportunities for separating finer and coarse fractions by utilising higher (~20 m+) tip heads during backfilling to facilitate bulk sorting (Okane, 2023c).

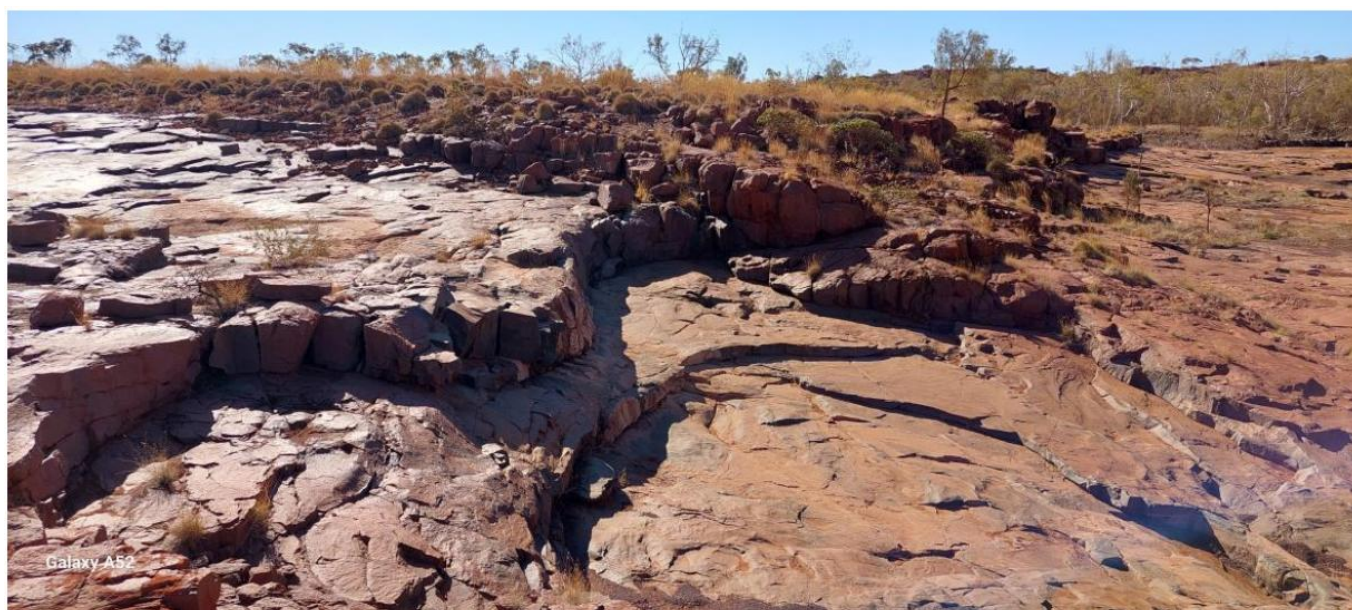
- Mimics or resembles natural features reflective of the local area and would be a nominal halfway point between the stepped and sloped dissipators (perhaps closer to the sloped).
- Would contain features similar to those seen at Flat Rocks (Figure 5-79) including uneven ground, bumps, small drops and irregularities.
- Has a nominal width of 150 m as the irregular features would result in more energy dissipation within the flood channel compared with the sloped dissipator.

Figure 5-79 Natural energy dissipation features at Flat Rocks

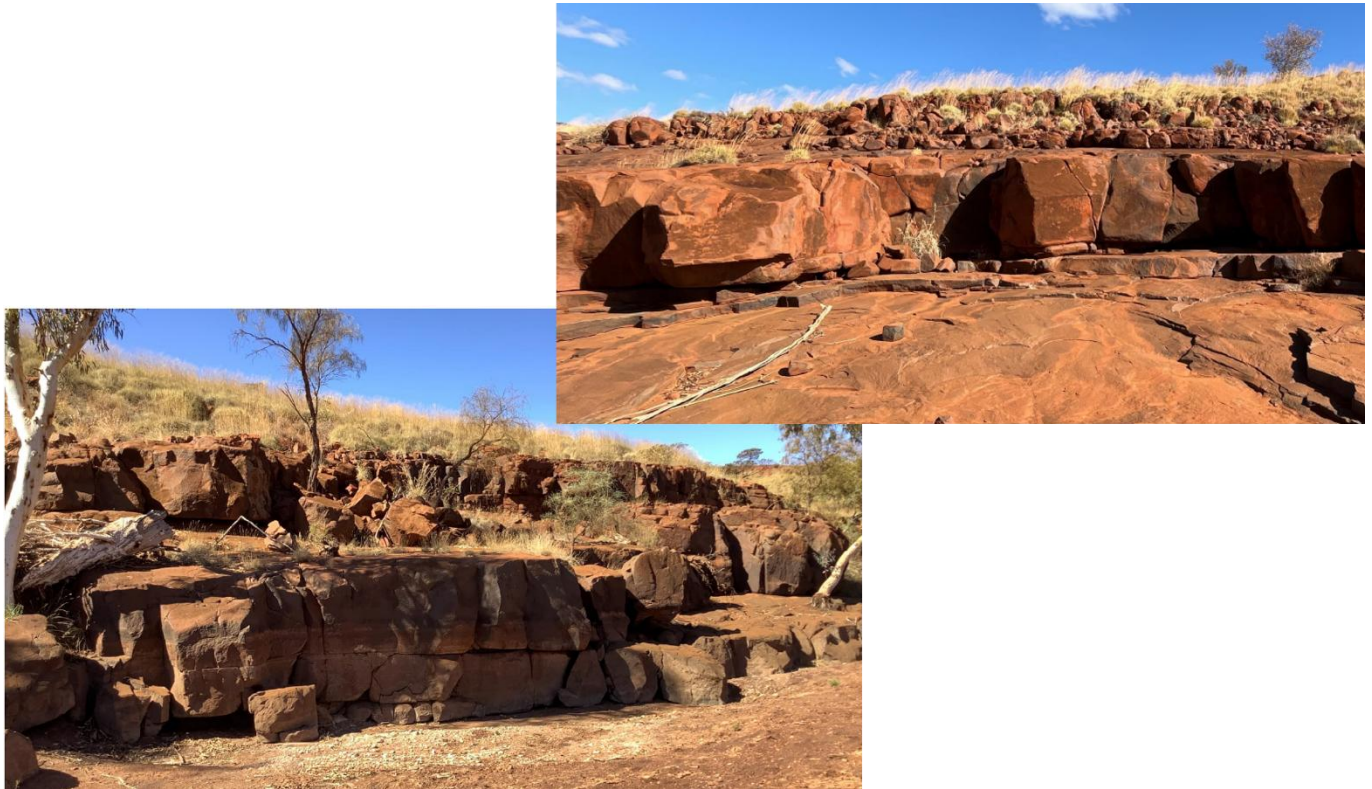
Figure 5-82 Examples of natural analogues of ~1.5 m cut in dolerite to deter access

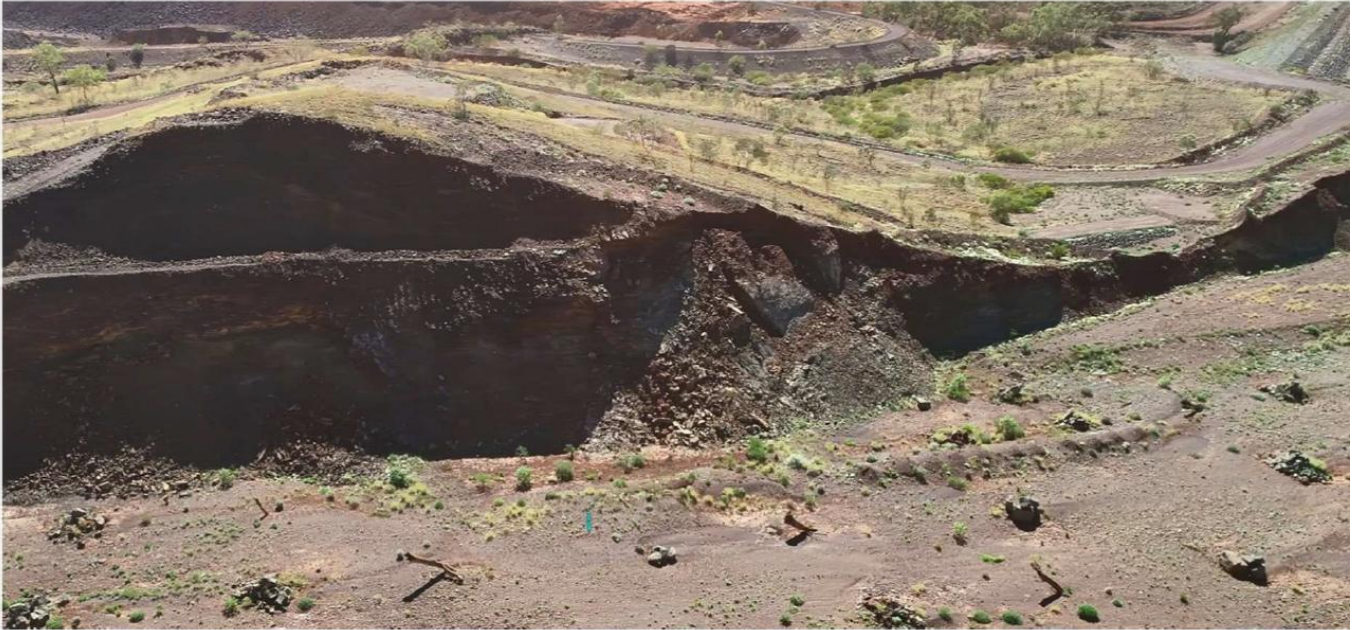
Figure 5-110 E1 diversion oblique view example of erosion / slumping

Source: WAIO (2020b)

Some areas of erosion and slumping have been observed (for example see Figure 5-110 which was taken in 2020), however, this is consistent with the design expectation that the system will evolve to a natural state over many years, and is not considered to require any intervention (WAIO, 2020b).

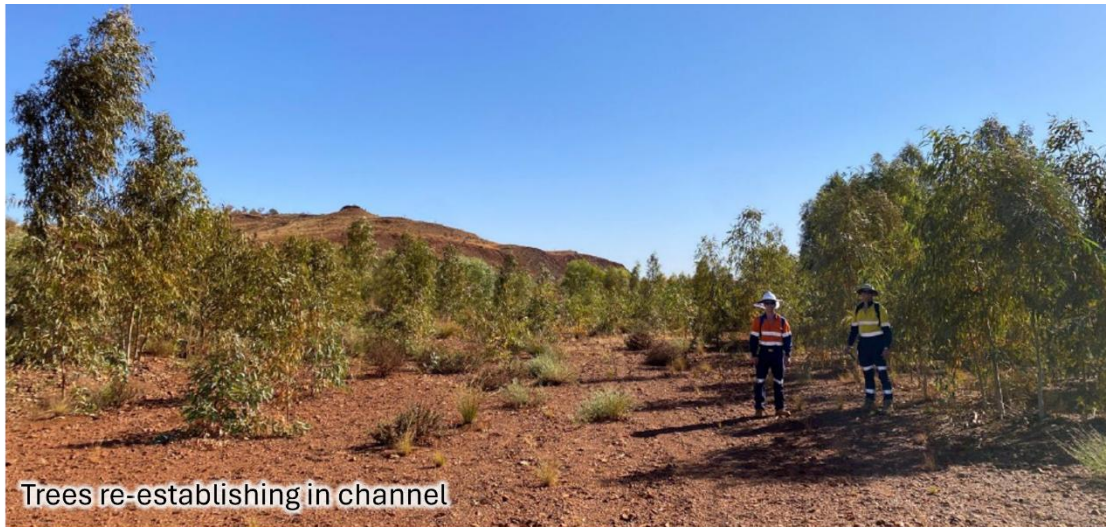
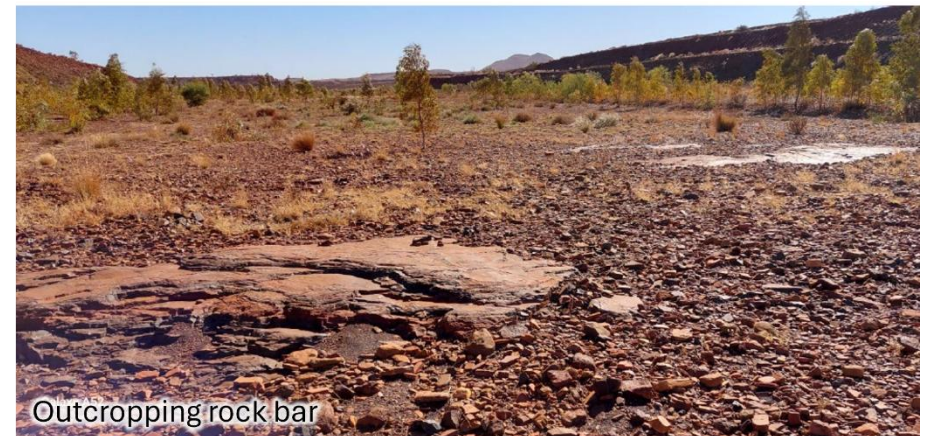
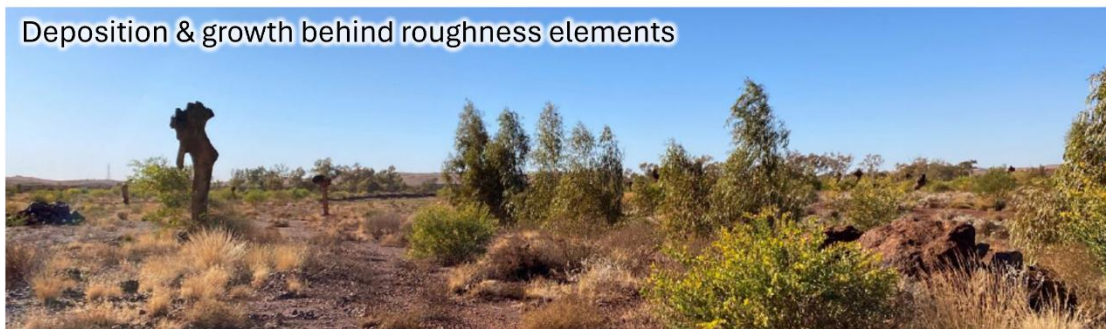
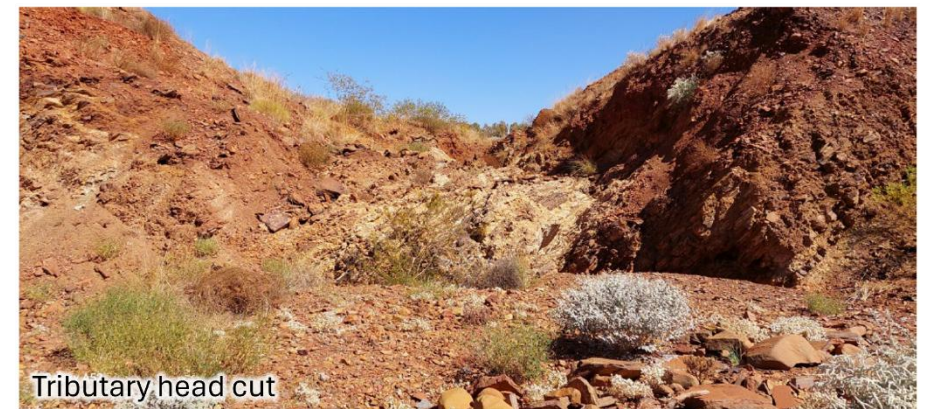
Figure 5-117 Photographs from Advisian 2023 site visit

Source: Advisian (2024a)

Advisian conducted an inspection of the E1 and E4 creek diversions in August 2023 and concluded that the diversions are functioning as intended and will require little or no intervention for closure. Observations from the site inspection are (Advisian, 2024a) (Figure 5-117):

- Vegetation growth is performing well; many trees 5 m to 6 m high were noted in the main channel with smaller shrubs and trees on floodplain areas.
- Roughness elements (tree stumps, rock piles, boulder piles) have performed well, and there is evidence of deposition and vegetation growth behind these elements, as intended.
- Scour / head cutting was observed for a tributary entering the E1 diversion, however, the extent of the upstream cutback was limited and appeared to have stabilised on protruding BIF. Sediment deposited in the creek from the cut back appeared to be integrating into the landform.
- A rock bar is outcropping in E4 diversion could be utilised to create an ephemeral pool.

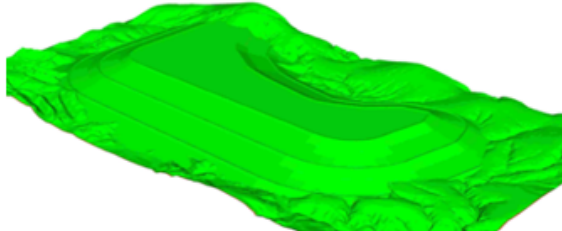
Figure 9-4 OSA landform development stages during mine planning

Range Analysis	Development Strategy	Engineering	Implementation
OVERVIEW	The waste and landform considerations will generally be at a high level due to a limited waste understanding caused by the model maturity.	A conceptual 9 degree OSA final design with no ramps developed for extents that considers preliminary geochemistry and landform requirements. Assumes all waste/LG/BG dumped ex-pit.	Executable rehabilitated designs are developed to inform the as-tipped designs. The design is to consider the material properties of the waste and physical environmental conditions of the area.	Mine Operations execute the OSA and landform structure in accordance with the approved as-tipped design. Waste schedule optimises waste placement objectives to minimise haulage and rehabilitation costs.
OSA LANDFORM REQUIREMENT

KNOWLEDGE LIMITATIONS	<i>Initial drilling program that has broadly defined a known mineral deposit. Footprint of conceptual OSA should consider drainage alignments and future pit and infrastructure footprints.</i>	<i>Infill drilling has allowed for the development of resource models that consider the waste risks of the deposit.</i>	<i>Infill drilling completed, resource and mining models available with a good understanding of lithologies and PAF potential. Site specific material characterisation work may not yet have been completed but reviews of adjacent studies has been undertaken.</i>	<i>Monthly review of compliance to plan undertaken to ensure compliance with design during execution of landforms. As material competency investigations are completed, mine plans are amended to optimise waste placement objectives if possible.</i>

Potential requirements for OSA designs are integrated into the Master Area Design for a mine and are refined throughout the mine planning process (Figure 9-4). During the early stages of mine planning (see 'Range Analysis' and 'Development Strategy' on Figure 9-4), conceptual OSA landform designs are used to delineate OSA locations and disturbance extents for approval purposes. In these strategic planning stages, the overall landform extent and conservative assessment of slope angle is used to estimate a final disturbance area. As more localised information becomes available and knowledge improves, a final landform design will be developed (see 'Engineering' stage on Figure 9-4) which will transition into an executable design. During construction, assessments are undertaken of compliance to plans based on survey data.

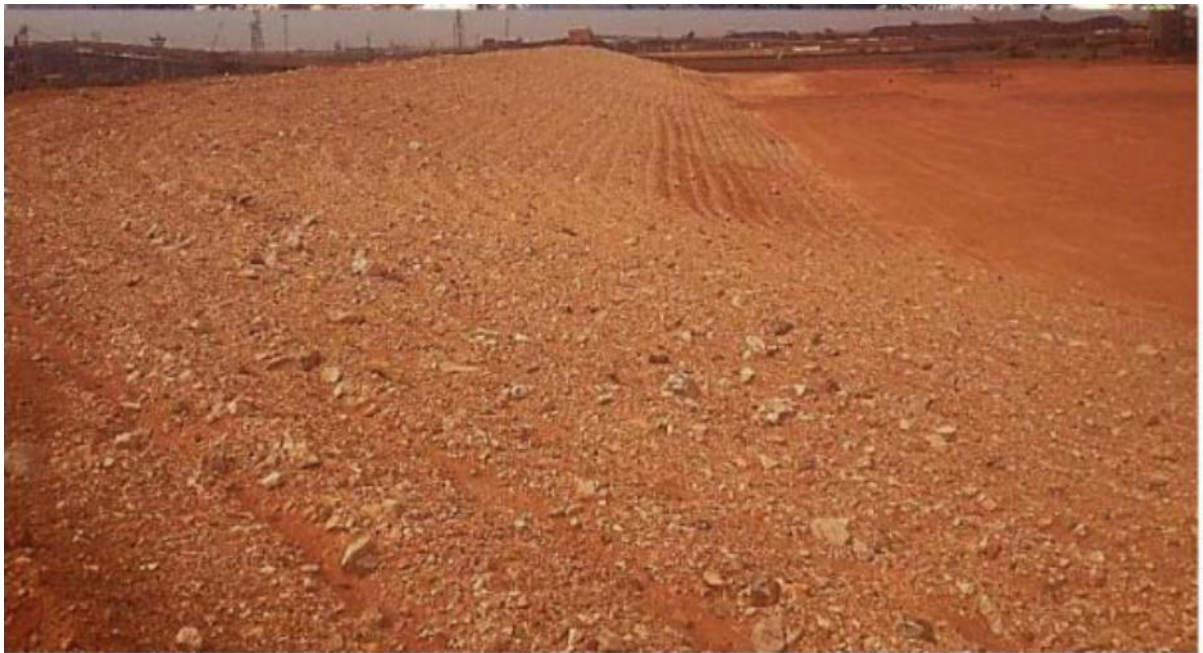
Figure 9-9 Contour ripping

- Application of inorganic or organic amendments informed by assessment of the growth media and research findings (refer to Appendix K).
- Surveyed contour ripping or scarifying of surfaces following the application of soils to maximise water infiltration and enhance revegetation success (Figure 9-9). When scarifying on the contour is not appropriate due to physical constraints (such as narrow areas or areas constrained by infrastructure or natural features), a herringbone technique may be used (Figure 9-10). Where there is high rock content and natural surface roughness of the final designed surface, contour ripping may not be required. Based on the outcomes of research and trials across BHP's operations, a no-rip approach is the preferred approach, where possible. This can be achieved through deep ripping to treat compacted areas prior to the spread of armouring material / growth media.

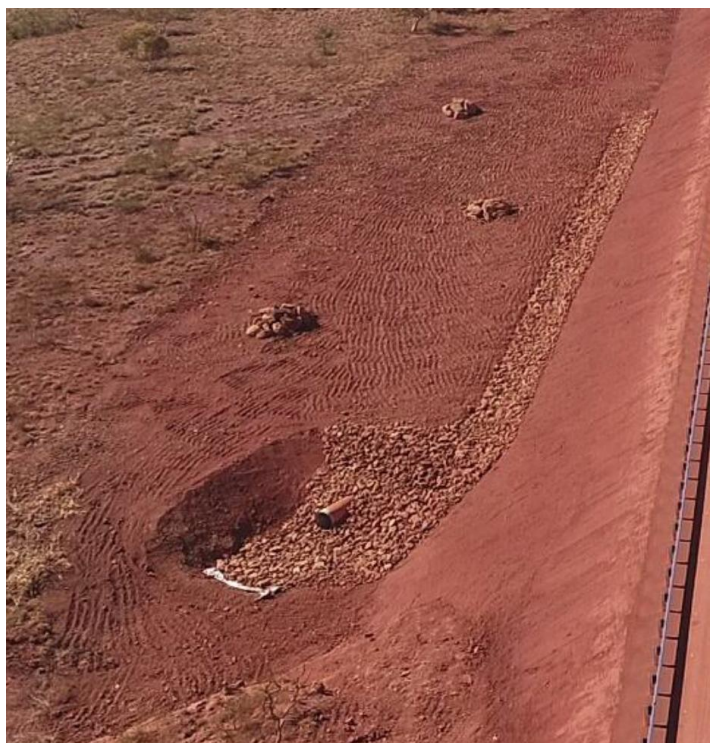
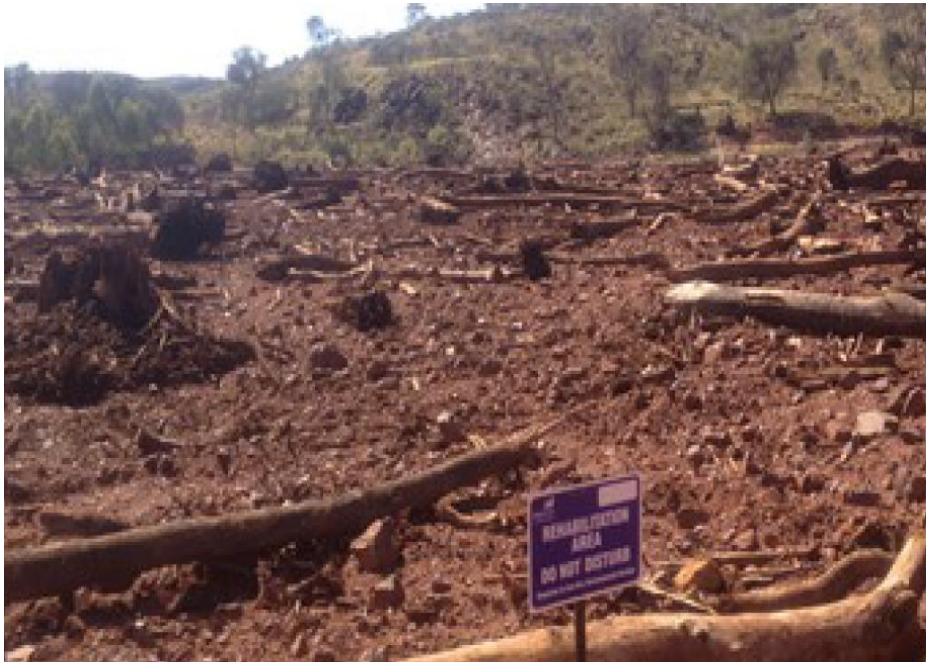
Figure 9-11 Example of placement of logs & branches as fauna habitat

- Selective placement of logs or smaller woody debris and / or boulders (if available) across the re-profiled surface (Figure 9-11) and / or constructing rocky cliff features (where potential exists) to provide additional habitat areas for fauna species recorded prior to mining.
