**RE: MARILLANA CREEK INFILTRATION PROJECT  
GEOTECHNICAL MAPPING AND INVESTIGATION REPORT**

**MARILLANA CREEK INFILTRATION PROJECT  
GEOTECHNICAL MAPPING AND INVESTIGATION REPORT**

**REF: 045500REP02\_REV0**

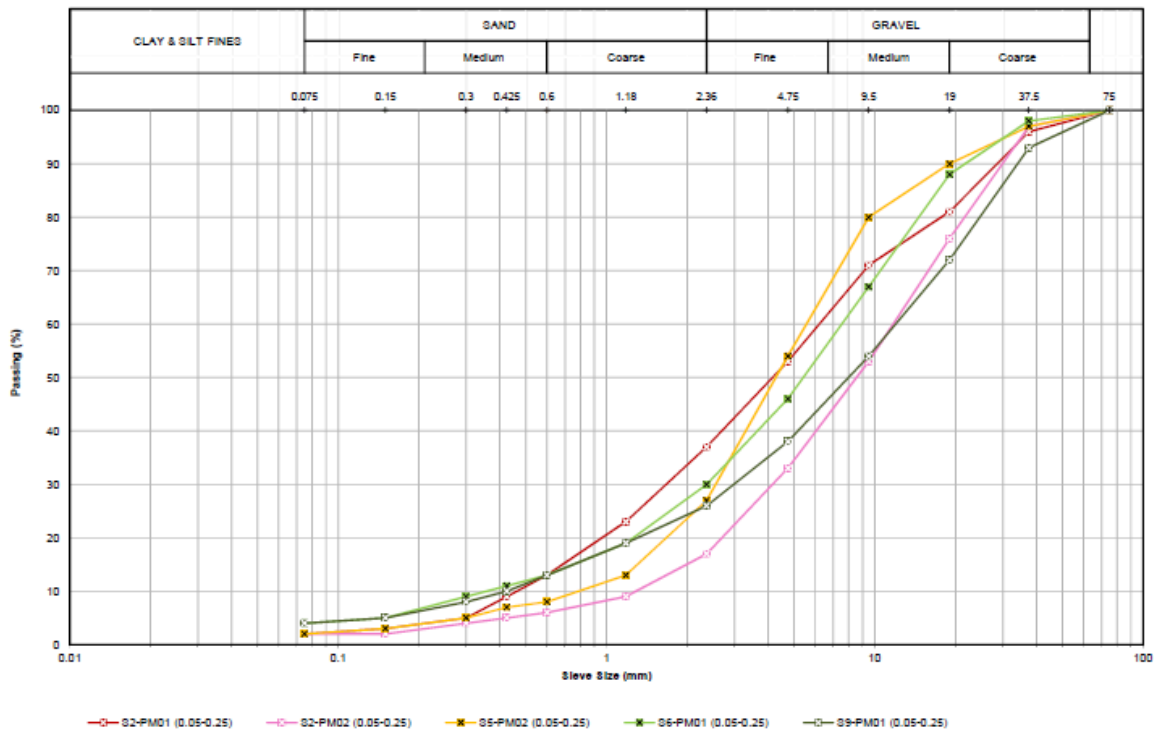
Of the 10 particle size distribution results 5 contained fines while the other 5 did not. The particle size difference between samples is mostly attributable flow conditions, with coarser materials considered to indicate higher surface flow velocities. Fines, in the form of silt, comprised between 0 and 4% of the creek bed material, with sand comprising between 17 and 37%, and gravel between 63 and 82%. Figure 3 below shows the grading curve plots for those samples with fines present. Figure 4 below shows the grading curve plots for those samples with no fines present.

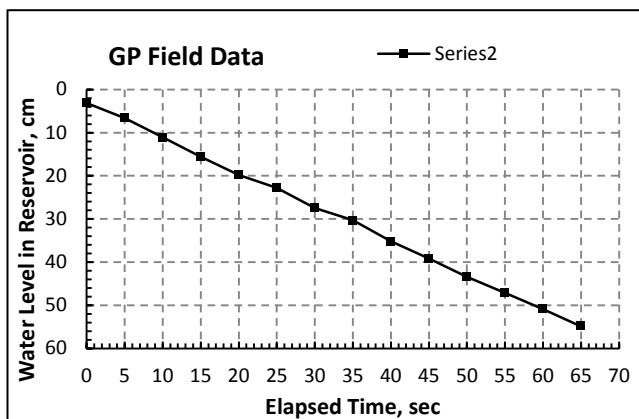
<b>Type of Reservoir used</b>	<u>Inner</u>			<b>Reservoir Constant</b>	RC	35.22	cm <sup>2</sup>
<b>Radius of Well hole</b>	r	3	cm	<b>Depth of Well hole</b>	d	0.05	m
<b>Well water height - Set 1</b>	H <sub>1</sub>	5	cm	<b>Well Water Height - Set 2</b>	H <sub>2</sub>		cm

Field Saturated Hydraulic Conductivity

$K_{fs} = 8.44E-02 \text{ cm/s OR } 8.44E-04 \text{ m/s}$

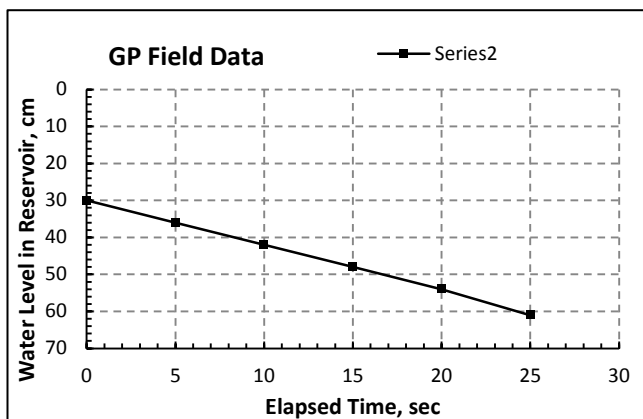
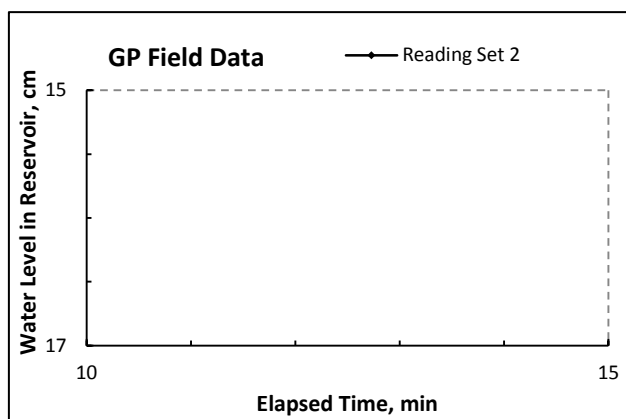
Type of Reservoir used	<u>Inner</u>			Reservoir Constant	RC	35.22	cm <sup>2</sup>
Radius of Well hole	r	3.75	cm	Depth of Well hole	d	0.075	m
Well water height - Set 1	H <sub>1</sub>	14	cm	Well Water Height - Set 2	H <sub>2</sub>		cm

Field Saturated Hydraulic Conductivity

$K_{fs} = 3.81E-02 \text{ cm/s OR } 3.81E-04 \text{ m/s}$

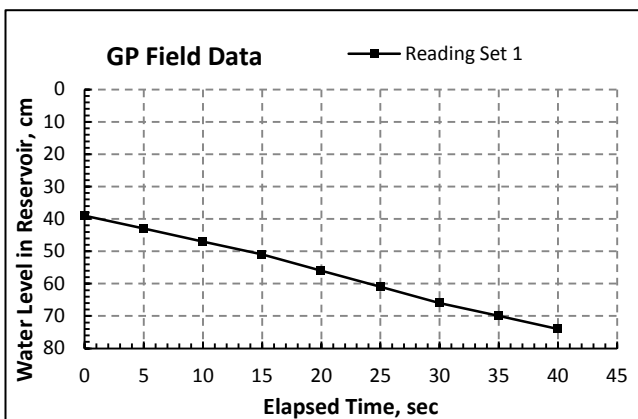
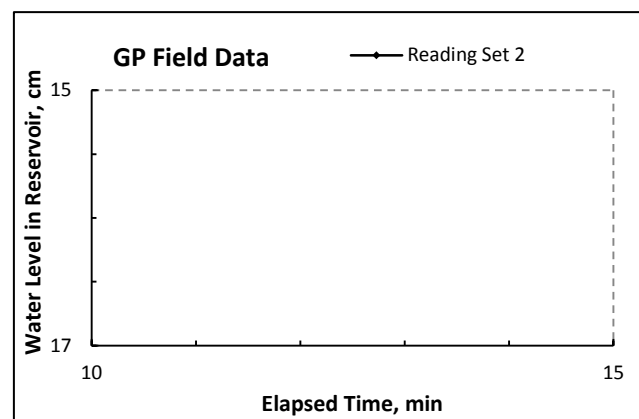
<b>Type of Reservoir used</b>	<u>Inner</u>		<b>Reservoir Constant</b>	RC	35.22	cm <sup>2</sup>
<b>Radius of Well hole</b>	r	3.75 cm	<b>Depth of Well hole</b>	d	0.05	m
<b>Well water height - Set 1</b>	H <sub>1</sub>	8 cm	<b>Well Water Height - Set 2</b>	H <sub>2</sub>		cm

Field Saturated Hydraulic Conductivity

$K_{fs} = 4.60E-02 \text{ cm/s OR } 4.60E-04 \text{ m/s}$

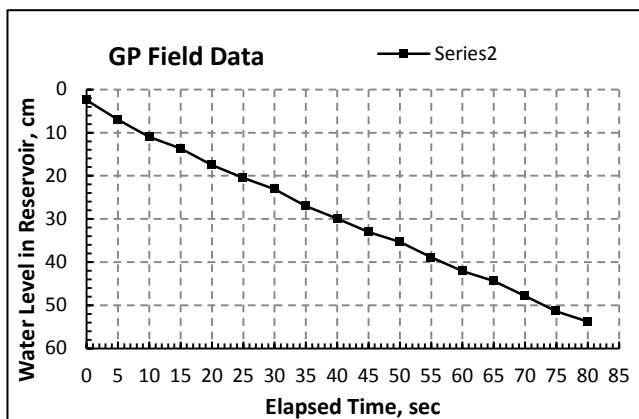
<b>Type of Reservoir used</b>	<u>Inner</u>			<b>Reservoir Constant</b>	RC	35.22	cm <sup>2</sup>
<b>Radius of Well hole</b>	r	3	cm	<b>Depth of Well hole</b>	d	0.75	m
<b>Well water height - Set 1</b>	H <sub>1</sub>	7	cm	<b>Well Water Height - Set 2</b>	H <sub>2</sub>		cm

Field Saturated Hydraulic Conductivity

$K_{fs} = 4.97E-02 \text{ cm/s OR } 4.97E-04 \text{ m/s}$

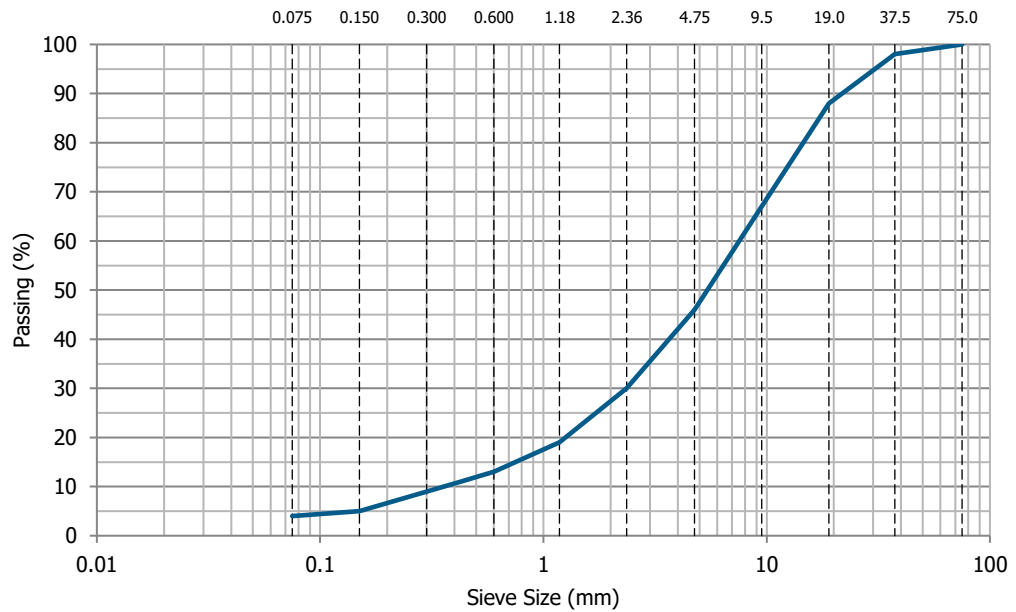
## AS1289.3.6.1 Particle Size Distribution

SIEVE SIZE (mm)	PASSING (%)	SIEVE SIZE (mm)	PASSING (%)
75.0	100	1.18	19
37.5	98	0.600	13
19.0	88	0.425	11
9.5	67	0.300	9
4.75	46	0.150	5
2.36	30	0.075	4
