FY23 Ministers North SUR Phase 1 Hydrogeological Drilling Completion Report

**Jim McDiarmid
30 March 2023**

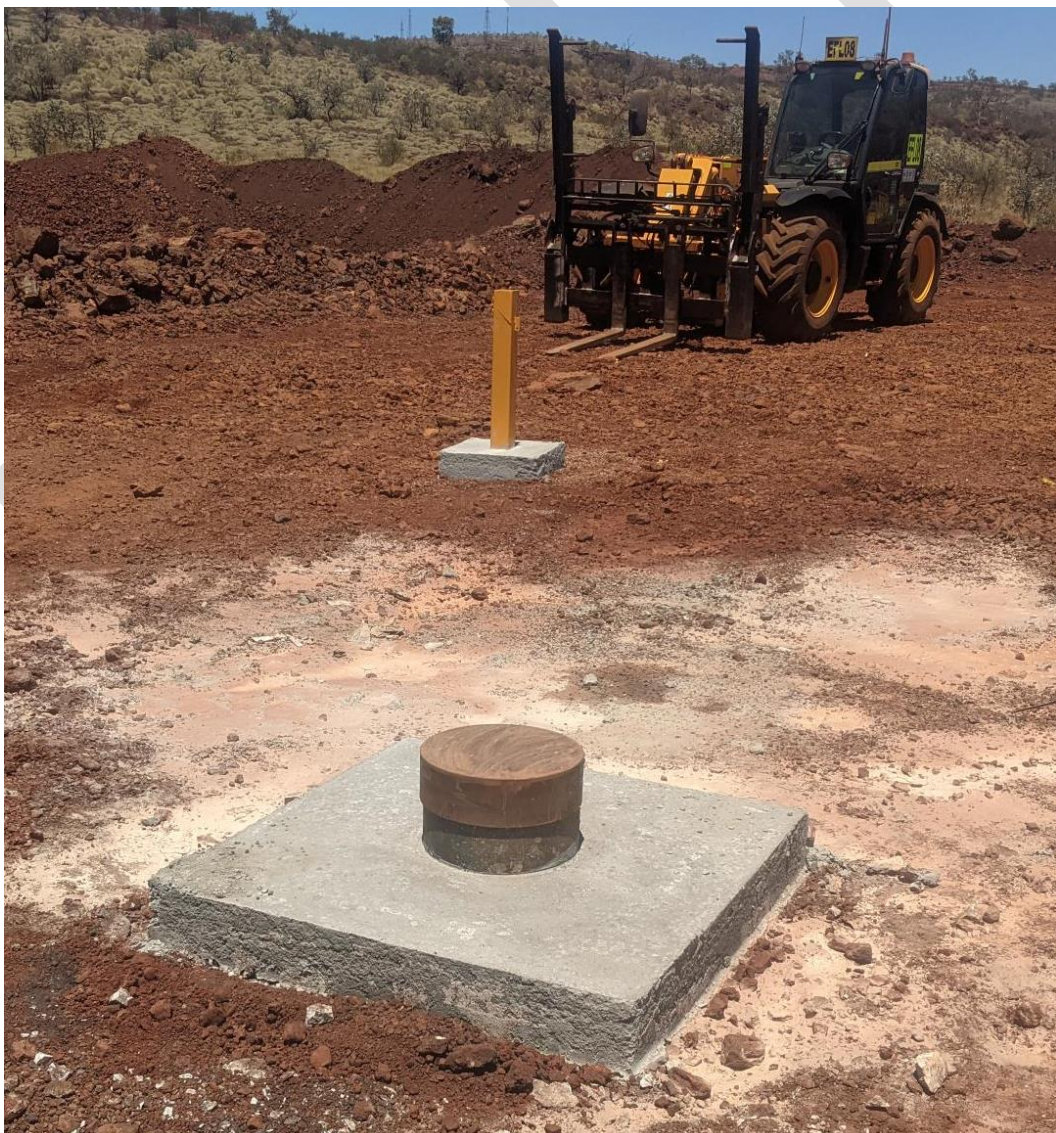
Figure 5: HMN0042-P and HMN0046-M headworks
