Memorandum

Date	15 October 2019
To	Jon Hanna
CC	Suzi Wild
Authorised Sender	Tim Law ton, Russel Sanders
Our ref	RED NPH Ministers North Conceptual Hydrogeological Model Rev 3
Subject	Ministers North Conceptual Hydrogeological Model

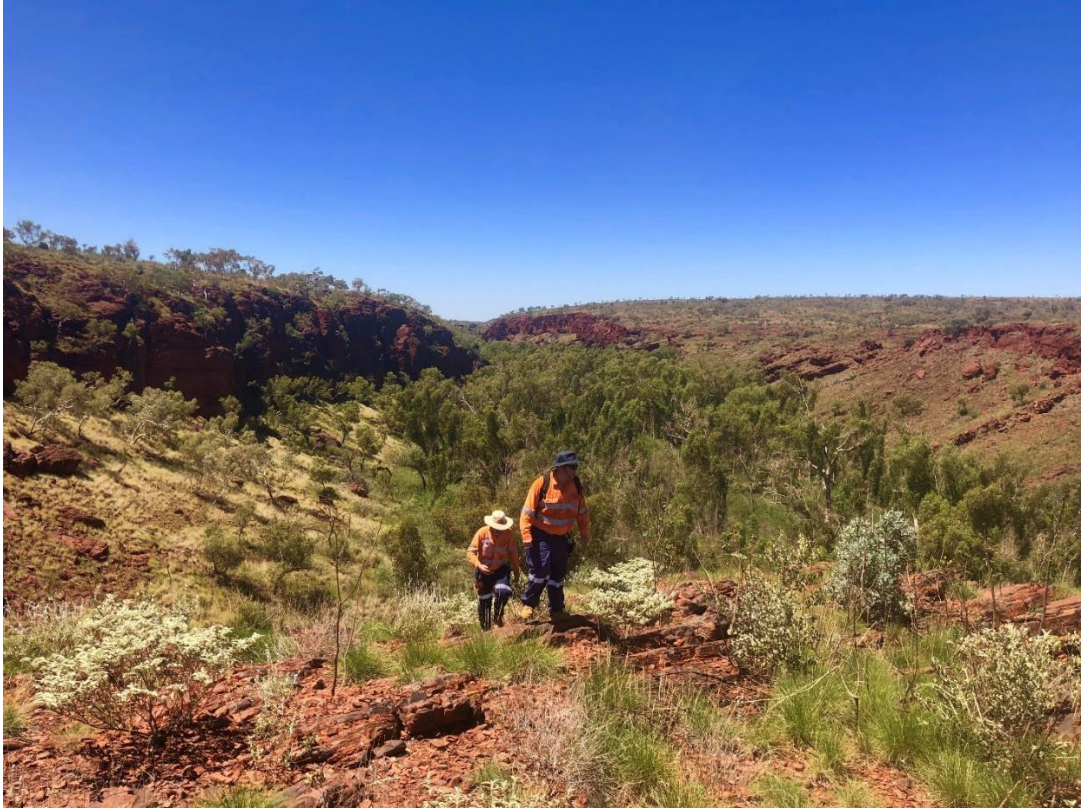
Photo 1: View looking eastwards into incised and heavily vegetated area of Yandicoogina Creek in eastern sector of Ministers North

The incised and heavily vegetated portion of Yandicoogina Creek (Photos 1 and 2) was visited by Water Planning hydrogeologists on 15 March 2018, primarily to determine whether there was any evidence of groundwater emergence in the streambed. This area, in the eastern sector of Ministers North (Figure 3), was the subject of vegetation surveys in September 2016 and May – July 2017 (Biota Environmental Sciences, 2017).

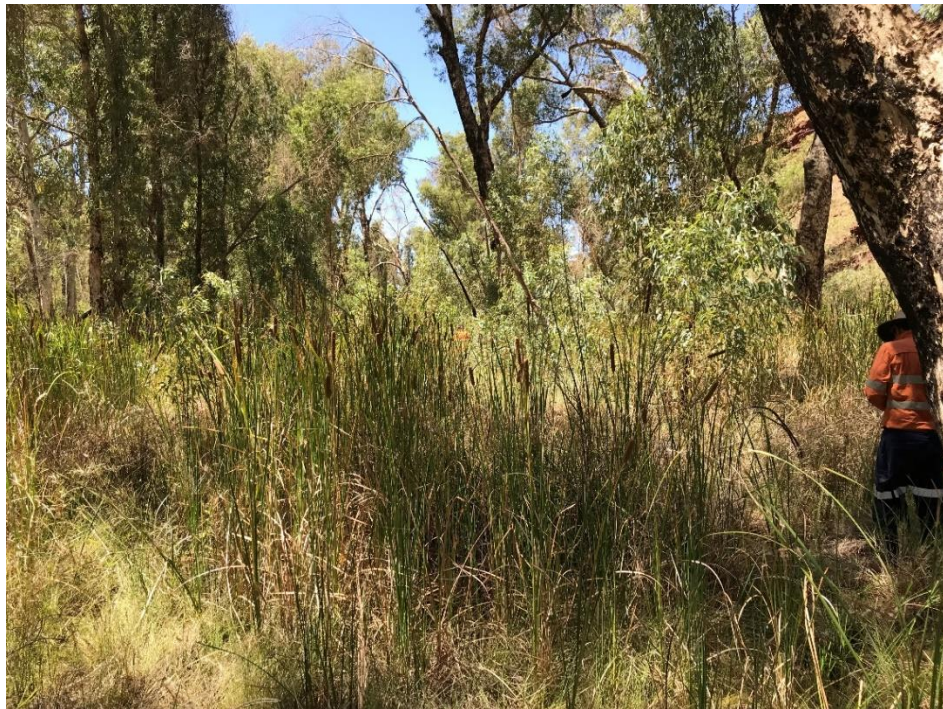
Photo 2: Healthy vegetation, including rushes and paperbarks in Yandicoogina Creek

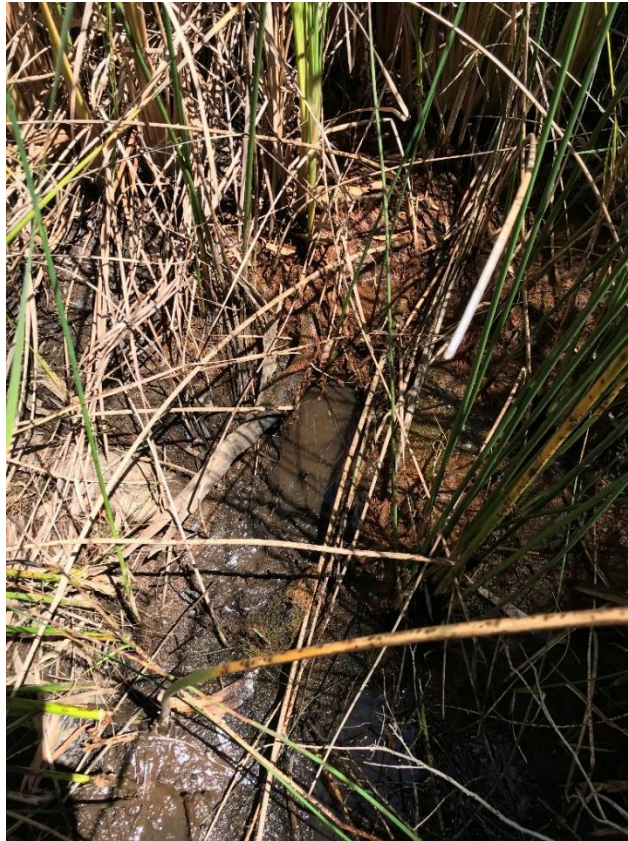
Photo 3: Excavated shallow water at base of rushes (tested using handheld meter)

- Water quality from shallow water under rushes (GR MGA Zone 50: 720088 – 7473809, Photo 3) is consistent with typical groundwater in these areas (e.g. from the rail test pumping program) rather than recent rainfall. One sample from a small excavated hole under the rushes was tested using a handheld meter. The results were:

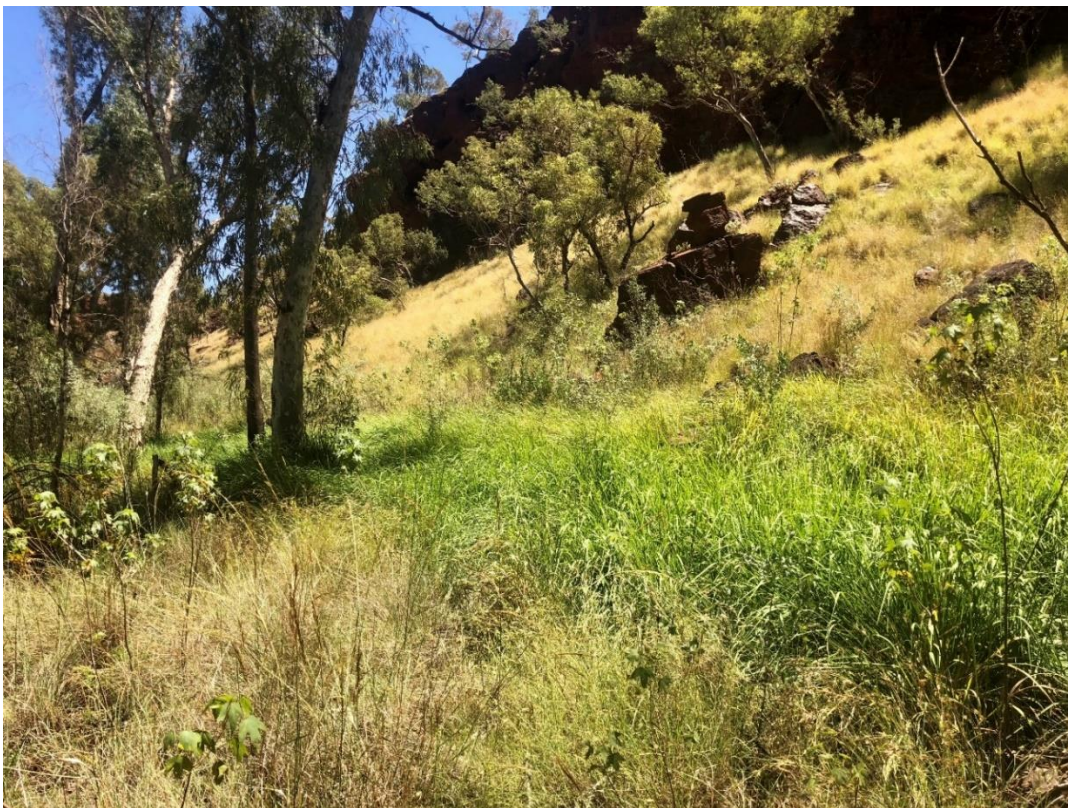
Photo 4: Seepage (“Sanders Seep”) at the base of the valley wall indicated by healthy sedge grasses

- Electrical conductivity 696 μ S/cm at 31°
 - pH 6.7
- Seepage at the base of the valley wall (at and above valley floor), indicated by sedge grasses and moist soil (GR MGA Zone 50: 720125-7473915, Photo 4). This moist zone contrasted with dry soil over most of the valley with no visible surface water despite this being after recent rains. It is likely that evapotranspiration rates are lowering the water levels to below the ground surface over much of the area.

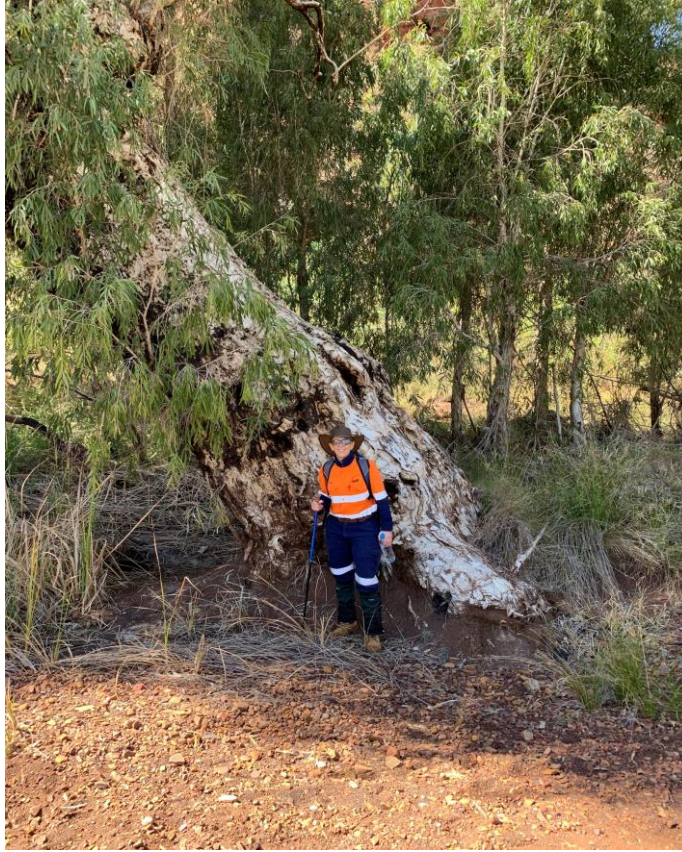
Photo 5: Large paperbark at upstream end of Yandicoogina Creek discharge zone (MGA94-50)

- GDV and persistent pools occur downstream of the point where the RL of the Yandicoogina Creek bed is about 562.9mRL (similar to nearby groundwater levels as observed at MN0117R and MN1499R). This area is denoted by a large *Melaleuca argentea* (paperbark) (Photo 5). Details and locations of the pools downstream of this point are summarised in Figure 10 and Table 4.

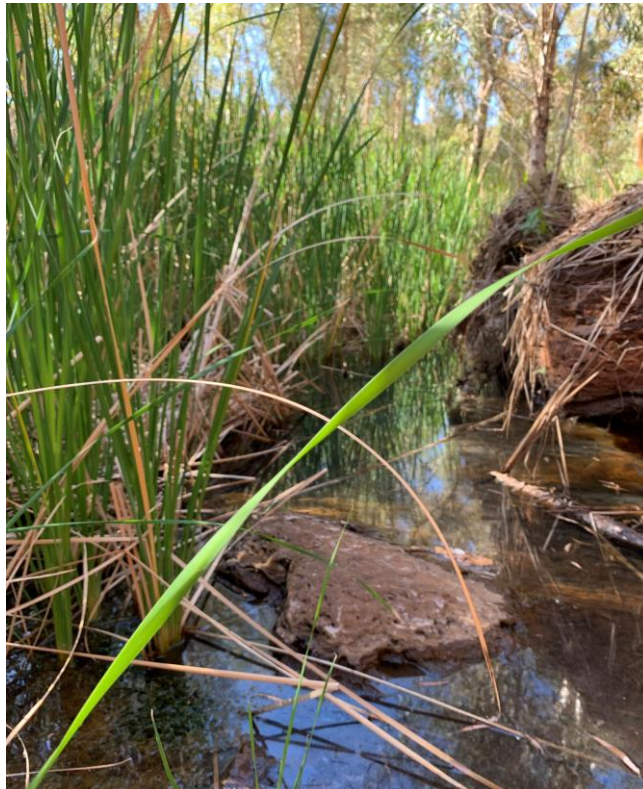
Photo 6: Standing water among sedges (EC 715 $\mu\text{S/cm}$, pH 7.16). GR 720640 – 7473900.

- The water bodies in the discharge zone range from seepages (often under sedge) to large pools (e.g. Delaneys Pool (Photos 6 – 8). Electrical conductivities (EC) of the pools vary between 528 and 798 $\mu\text{S}/\text{cm}$, which are consistent with groundwater values in the area, although it can be expected that these values have been influenced by rain-sourced stream flow and subsequent evaporation. Measured pH values vary between 7.16 and 8.3. The vegetation (particularly large old paperbarks) and the presence of fish in some pools is indicative of permanence of water in the area.

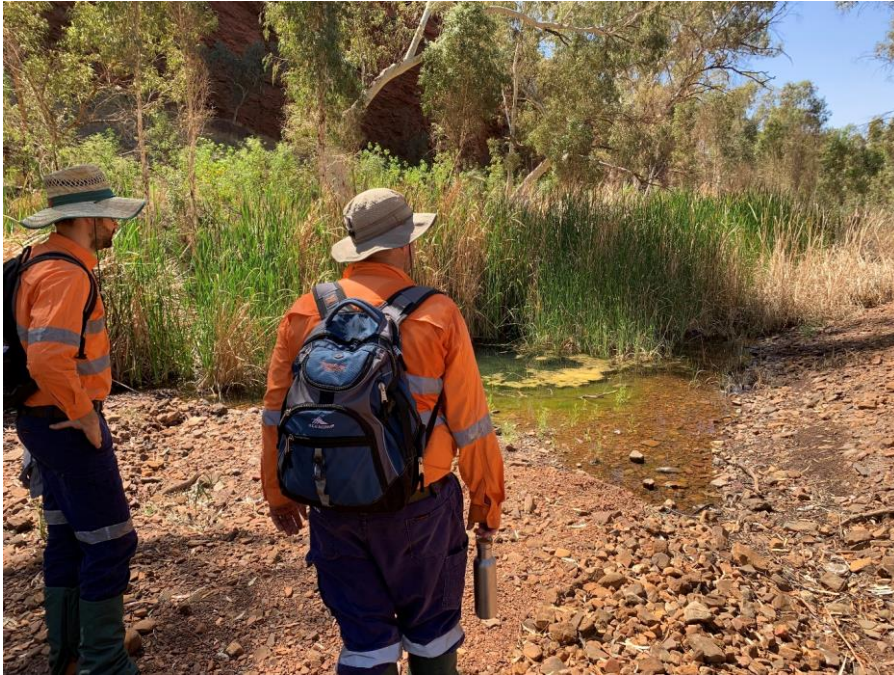
Photo 7: Pool with sedges and rainbow fish (indicating permanence). EC 621 $\mu\text{S}/\text{cm}$. GR 720991 – 7474102.

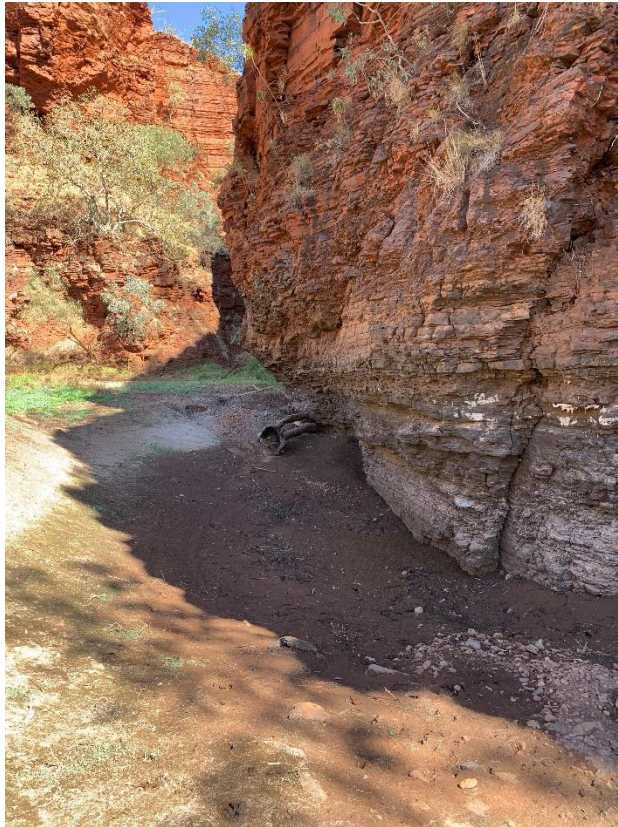
Photo 9: Remnant pool site (observed as wet in May 2019) upstream of discharge zone. Readings from water in hole excavated at lowest point of pool were EC 407 μ S/cm, pH 6.97. GR 718226 – 7472340.

- A small water sample was taken at a site where a pool (Photo 9) was observed by Biodiversity on 1 May (obtained by excavating in the bottom of the dry pool). The EC (407 $\mu\text{S}/\text{cm}$) and pH (6.97) are consistent with surface water that has been subjected to evaporation and is lower than the groundwater values measured elsewhere.

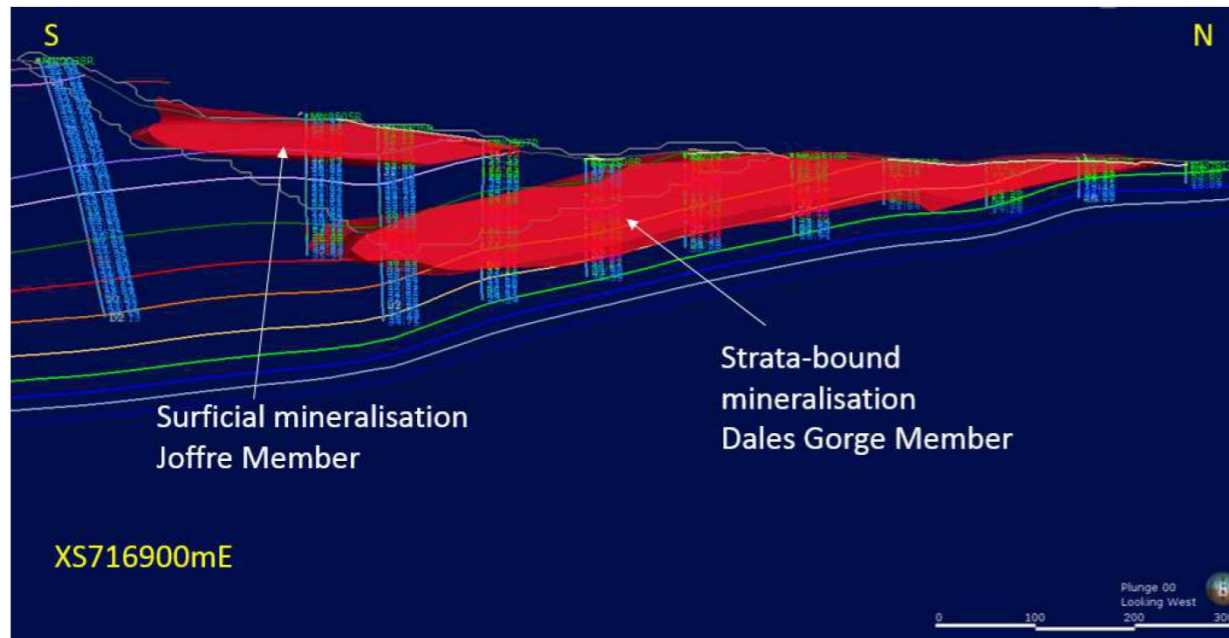
Figure 7: Mineralisation styles on the southern limb of Wirriba Anticline.

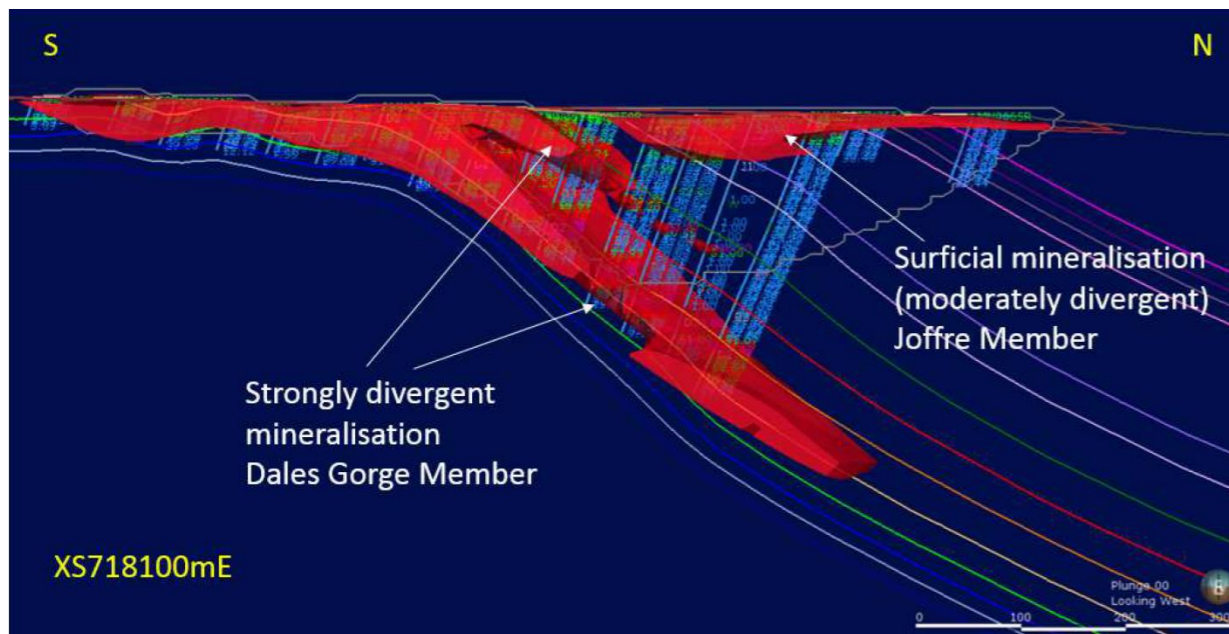
Figure 9: Mineralisation styles on the northern limb of Wirriba Anticline.

Mineralisation on the southern limb occurs primarily in the Dales Gorge Member; within the strata-bound D4/D3 mineralisation in the west, and D2 mineralisation moving east as shown in Figure 8 (BHP Billiton, 2017) and Table 2. Similarly within the northern limb mineralisation primarily occurs within the strata-bound Dales Gorge Member and it not unusual for the entire sequence to be mineralised as shown in Figure 9 (BHP Billiton, 2017)

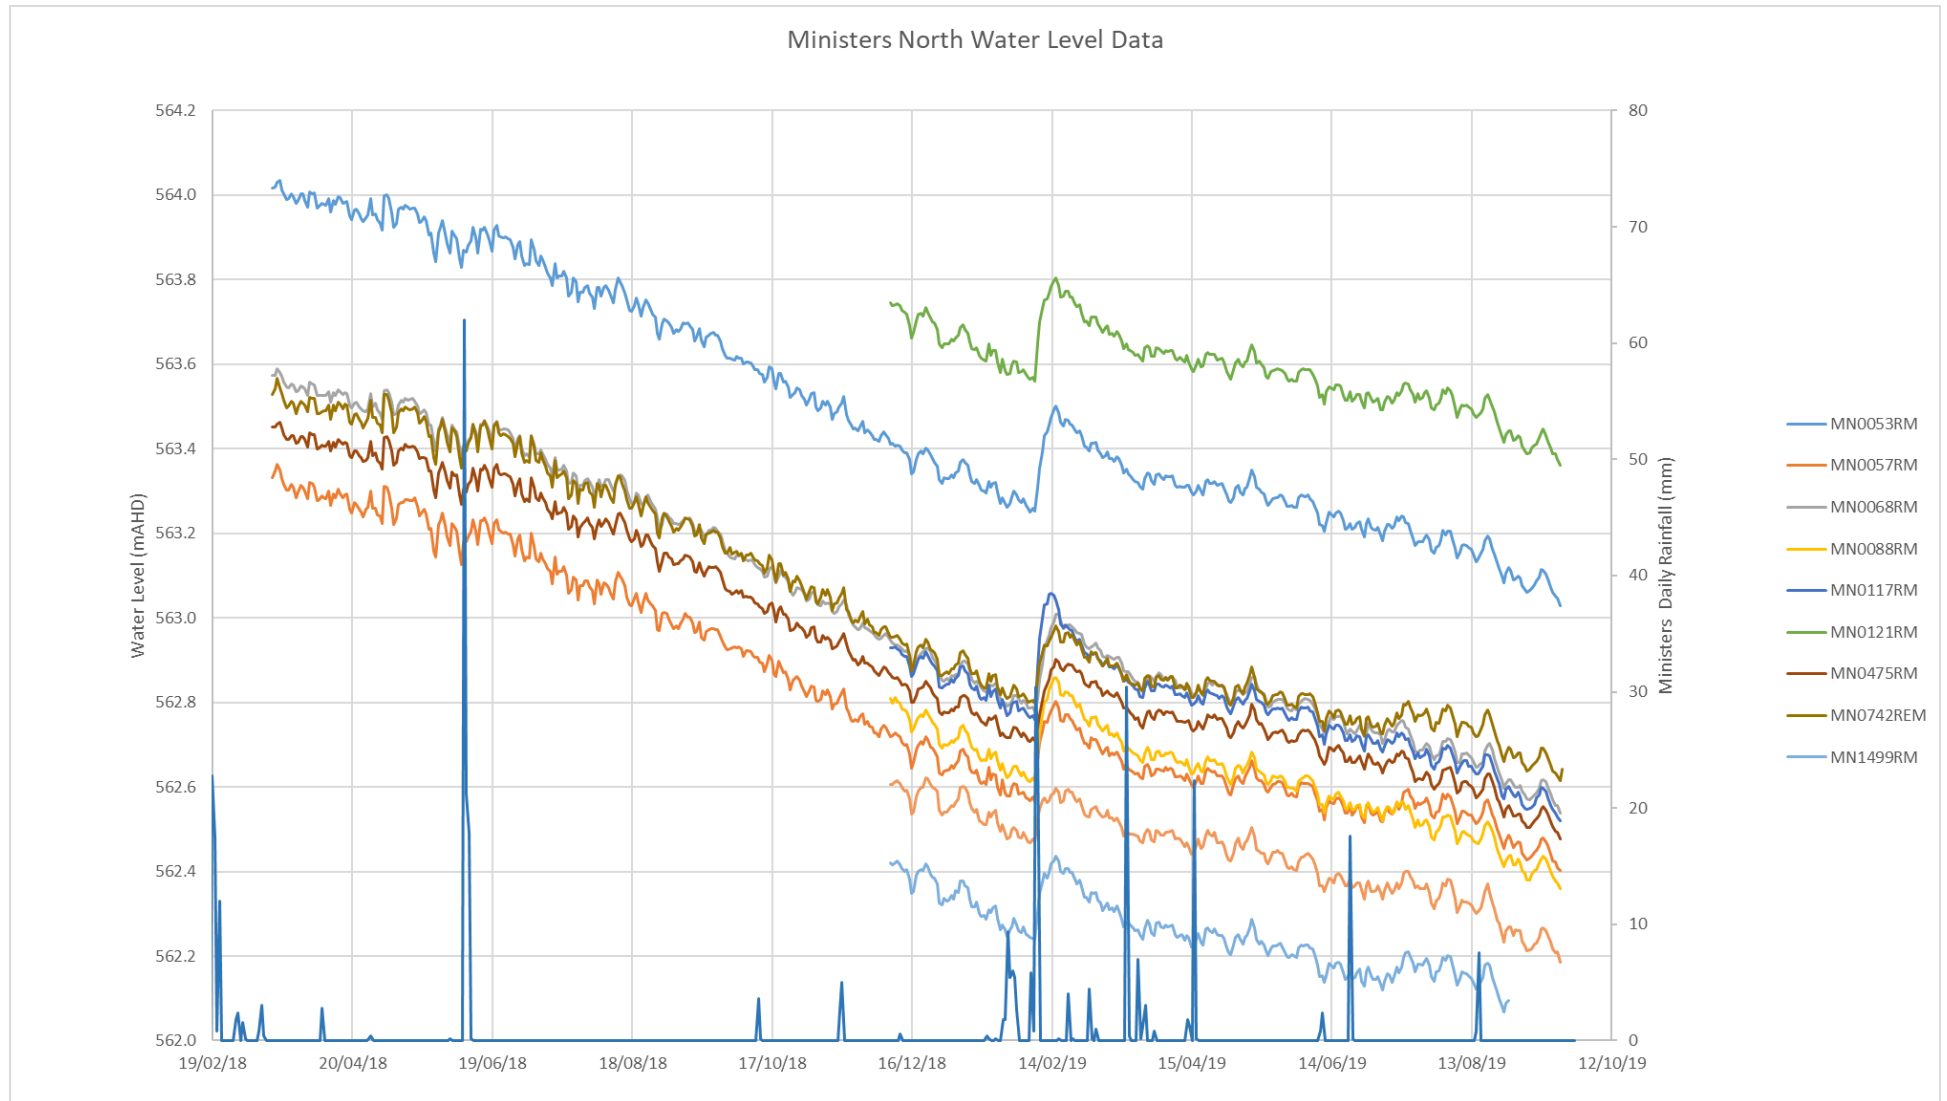
Figure C1: Logger holes showing stepped response to persistent rain in January/February 2019.

- Two types of reaction to the rainfall in early 2019 are observed:
 - A rapid rise in water level of between 0.15 and 0.25 m in 9 of the holes (Figure C1). After this rapid rise the trend returns to a similar rate of decline to that before the rainfall event. One of the affected holes, MN0068R (Figure 9a), has a water level depth of 155m and so direct recharge is unlikely. The rapid response could be interpreted as a pressure effect, potentially due to flow in Yandicoogina Creek.
