Bellevue Gold Project- Underground  
Dewatering

**Supplementary Report- M36/24 and  
M36/25 Dewatering Operation.**

May 2020. Version 1

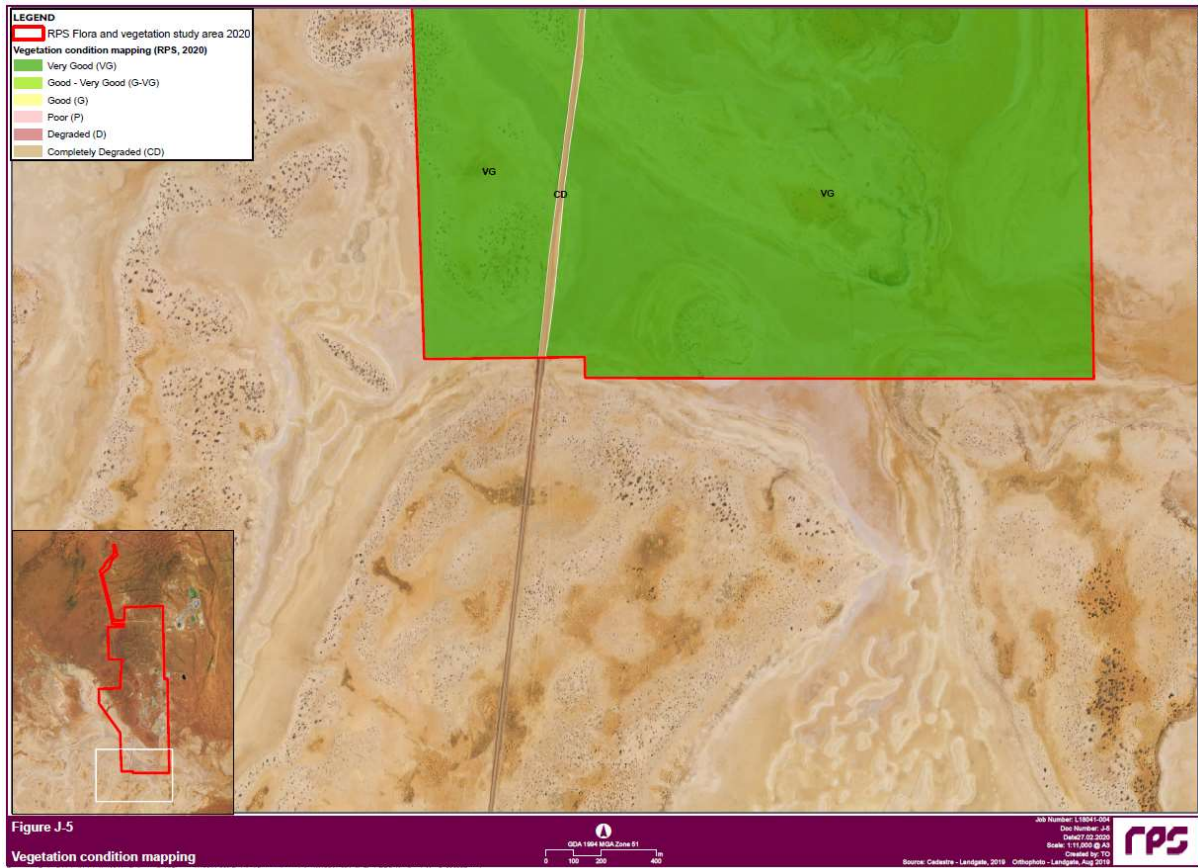
Mapping of vegetation condition has been undertaken and is presented in the figures below. From the figures it can be seen the areas associated with mining are the most degraded and the areas away from historic disturbances are most intact.

The impact of the pipeline on sheet flow dependent vegetation would appear to be very minimal. Vegetation condition mapping (Figures 6-9) show that even within proximity to the current exploration areas much of the vegetation is in good to very good condition or better. Given the pipeline has been in place for a period of almost 20 years, if significant enough sheet flow interruption was occurring to affect plant health, this would be more observable. The project does accept that in areas away from mining and mine infrastructure the vegetation condition is better, described as at least very good, but considers this to be more influenced by mining and exploration activities, rather than from interruptions to surface water flow regimes.

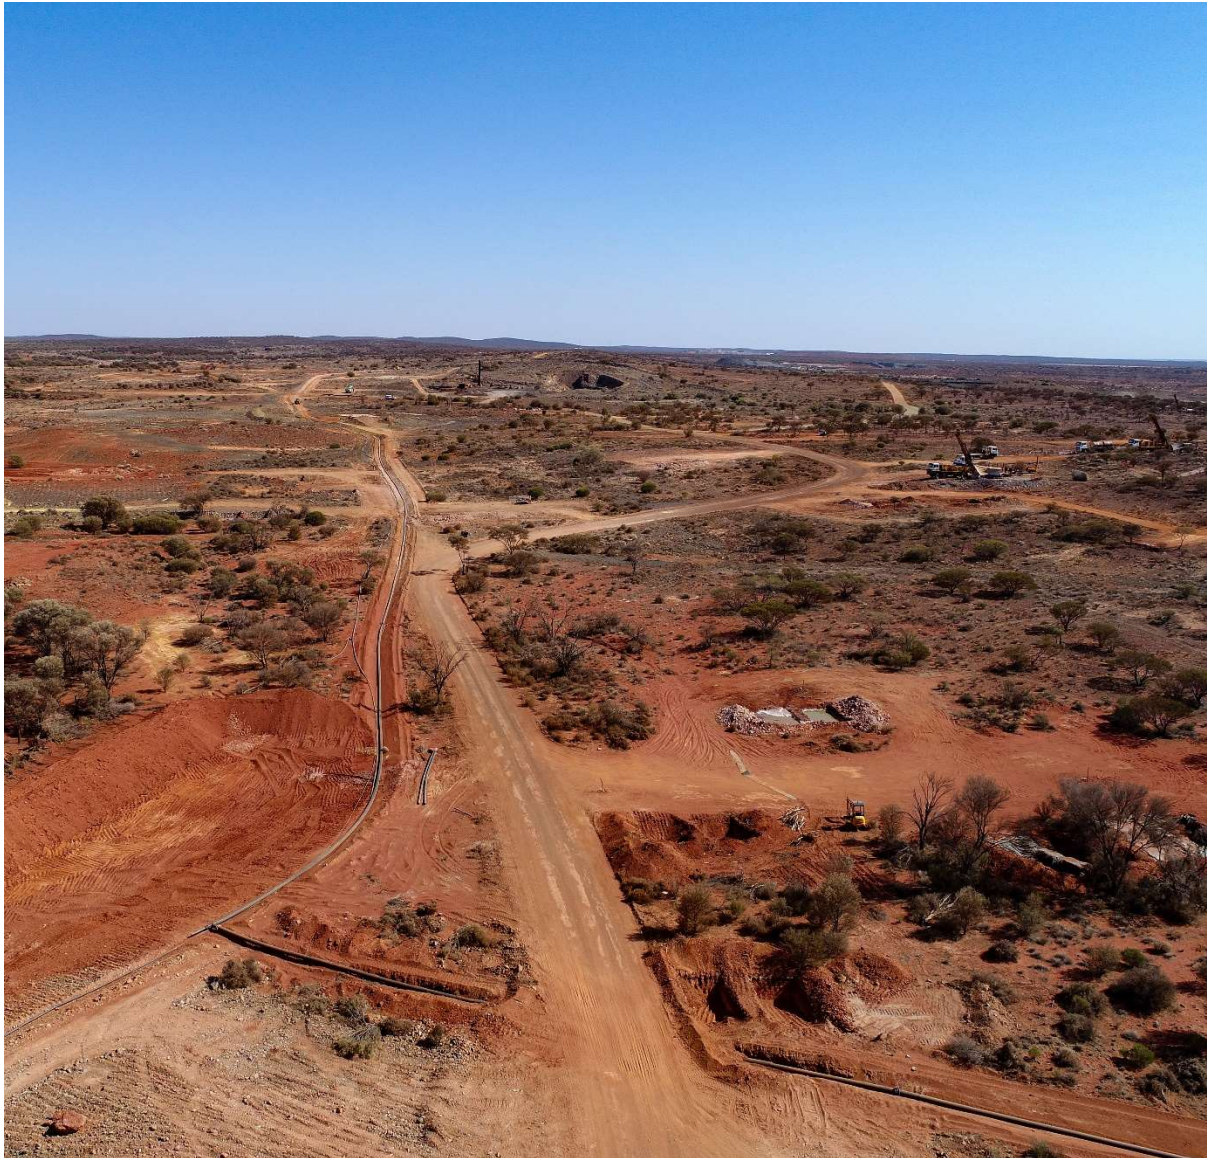
*Figure 13 Pipeline Construction*

Figure 13 shows the construction and upgrade of the dewatering pipeline. The line running east west on the bottom of the picture is the new line connecting the dewatering line to the southern vent rise, while the north south line is the historic pipeline constructed for the previous dewatering. The V drains have been upgraded to capture spills and leaks. The picture shows that the general topography of the land dips to the south and highlights the heavily disturbed nature of the general project area.
