ELECTRIC FRICTION-CONE PENETROMETER

CLIENT: Acciona Construction Australia

PROJECT: CELN Double Circuit

LOCATION: PER2025-0250

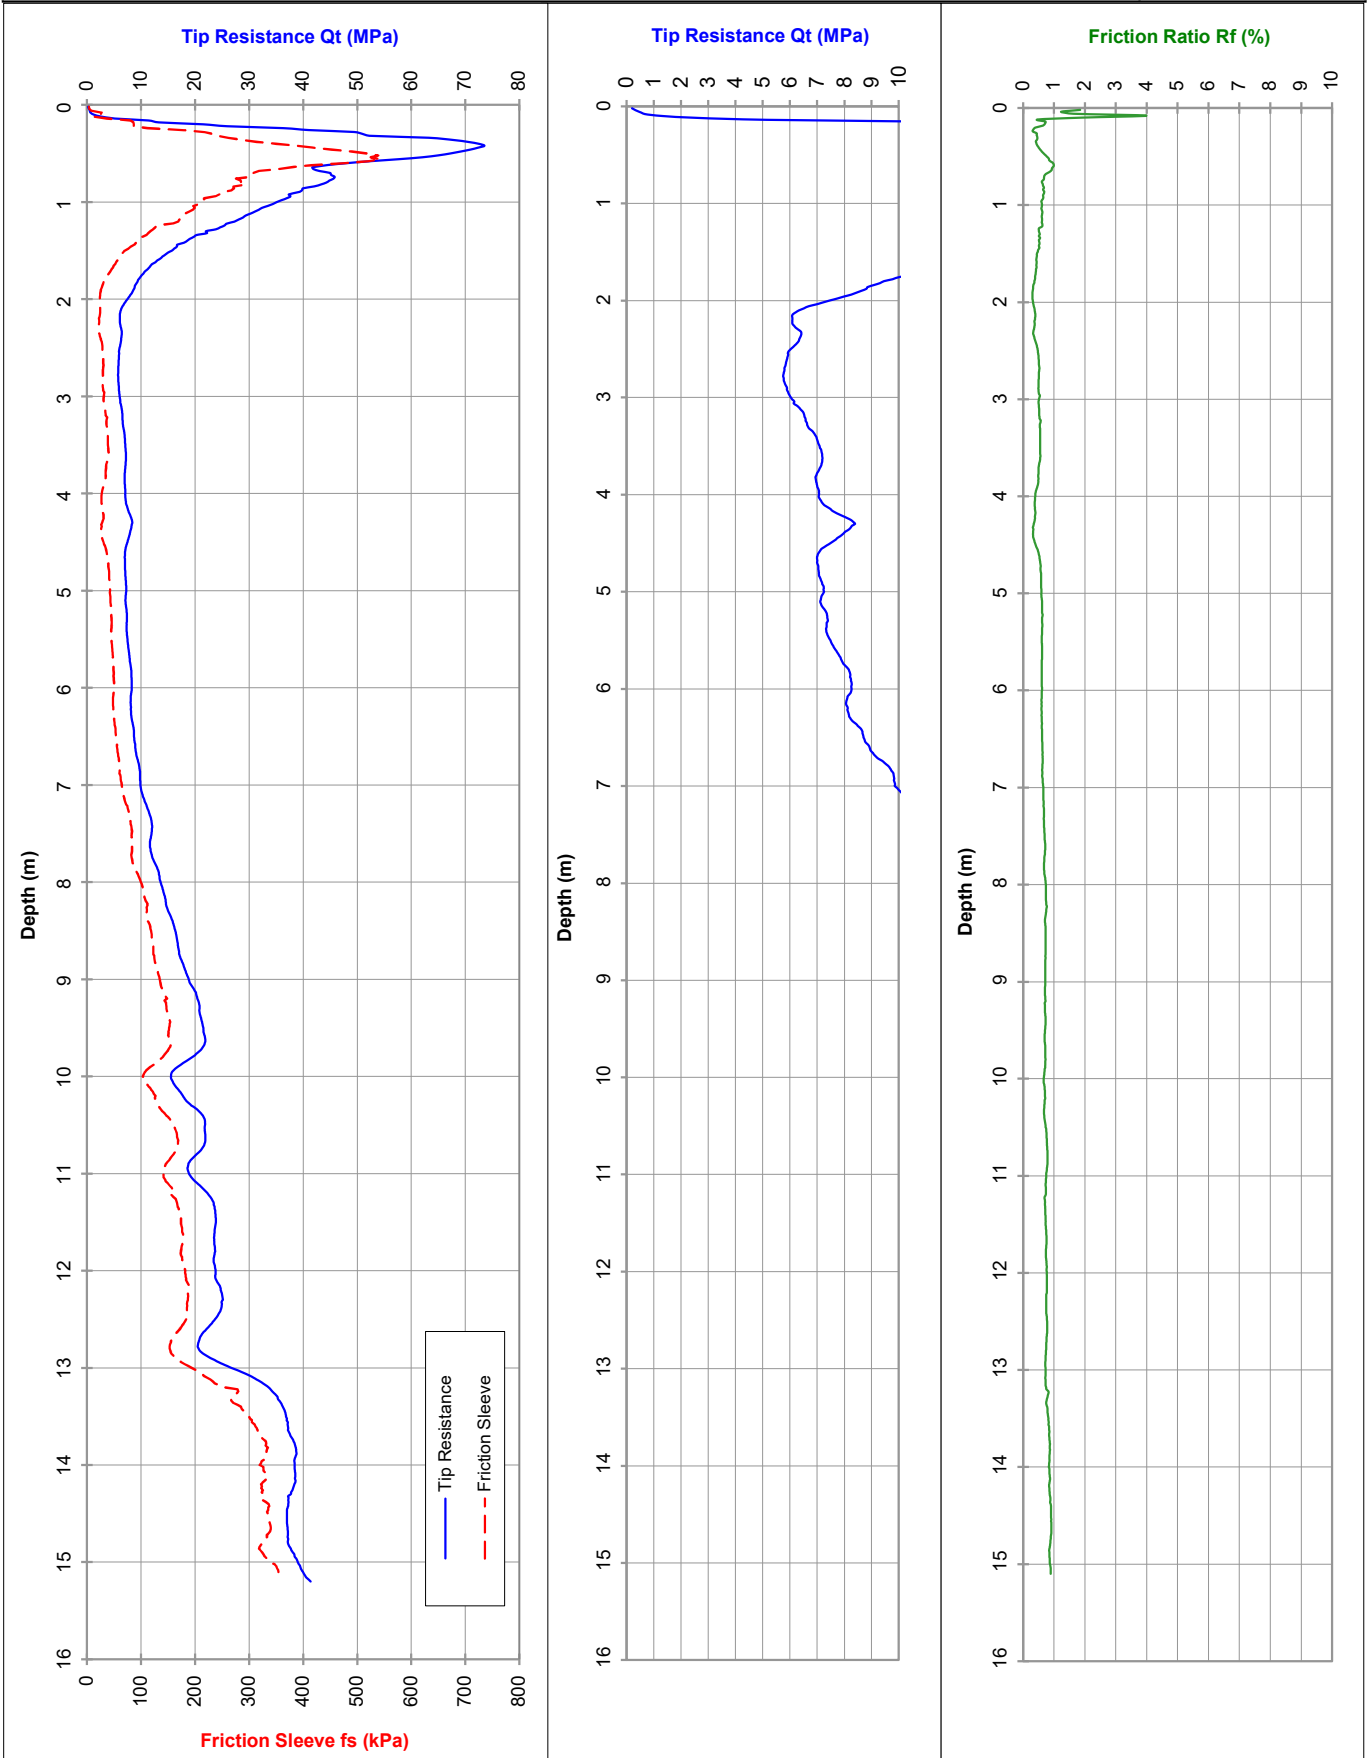
CPTU 147

Tested in accordance with AS 1289.6.5.1-1999 and IRTF 2001 for friction reducer

Approx. water (m): Dry to 0.0

Rig Type: 22t truck (MAN)

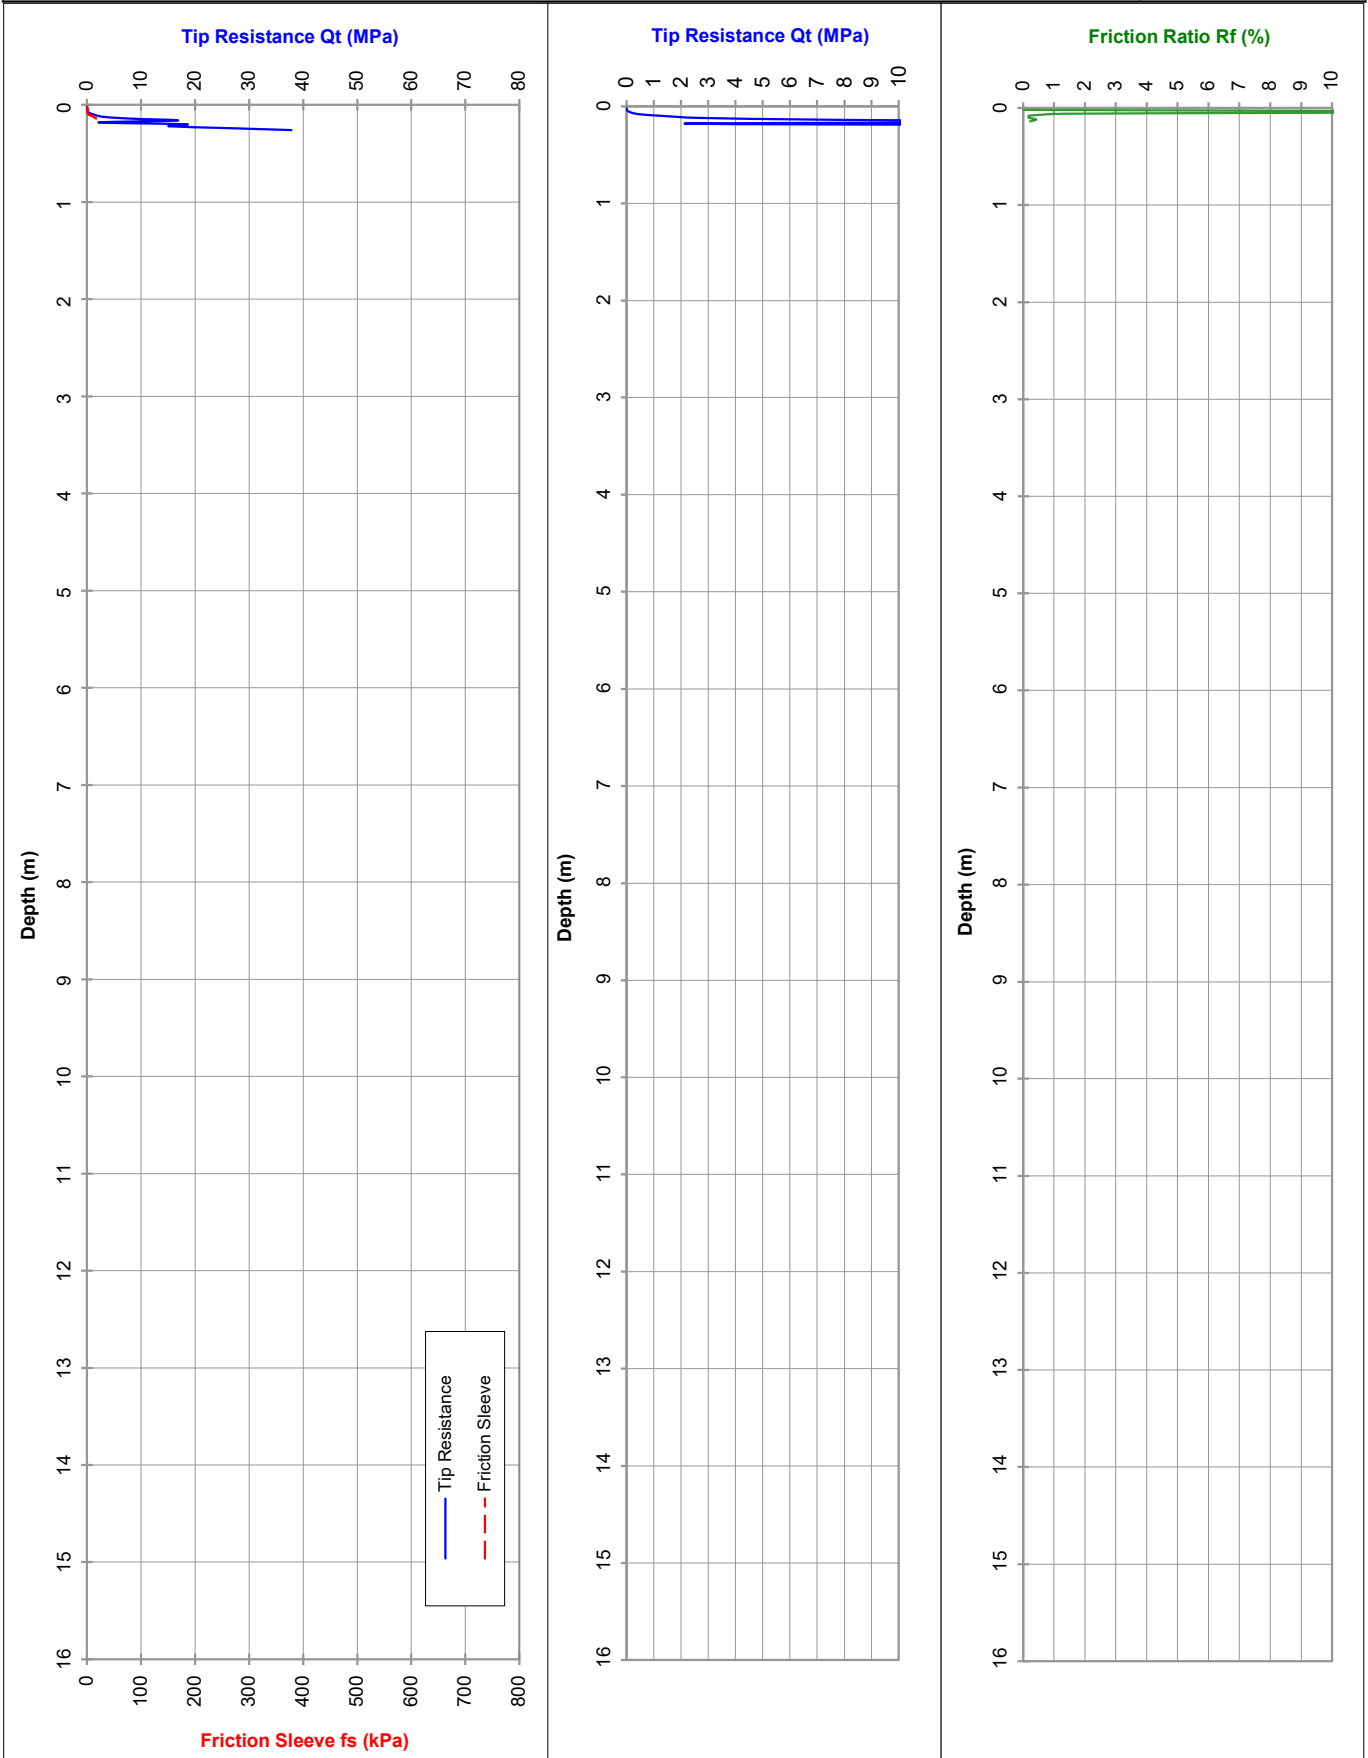
CPTU 148

Tested in accordance with AS 1289.6.5.1-1999 and IRTP 2001 for friction reducer

Approx. water (m): Dry to 0.0

Refusal: Inclination

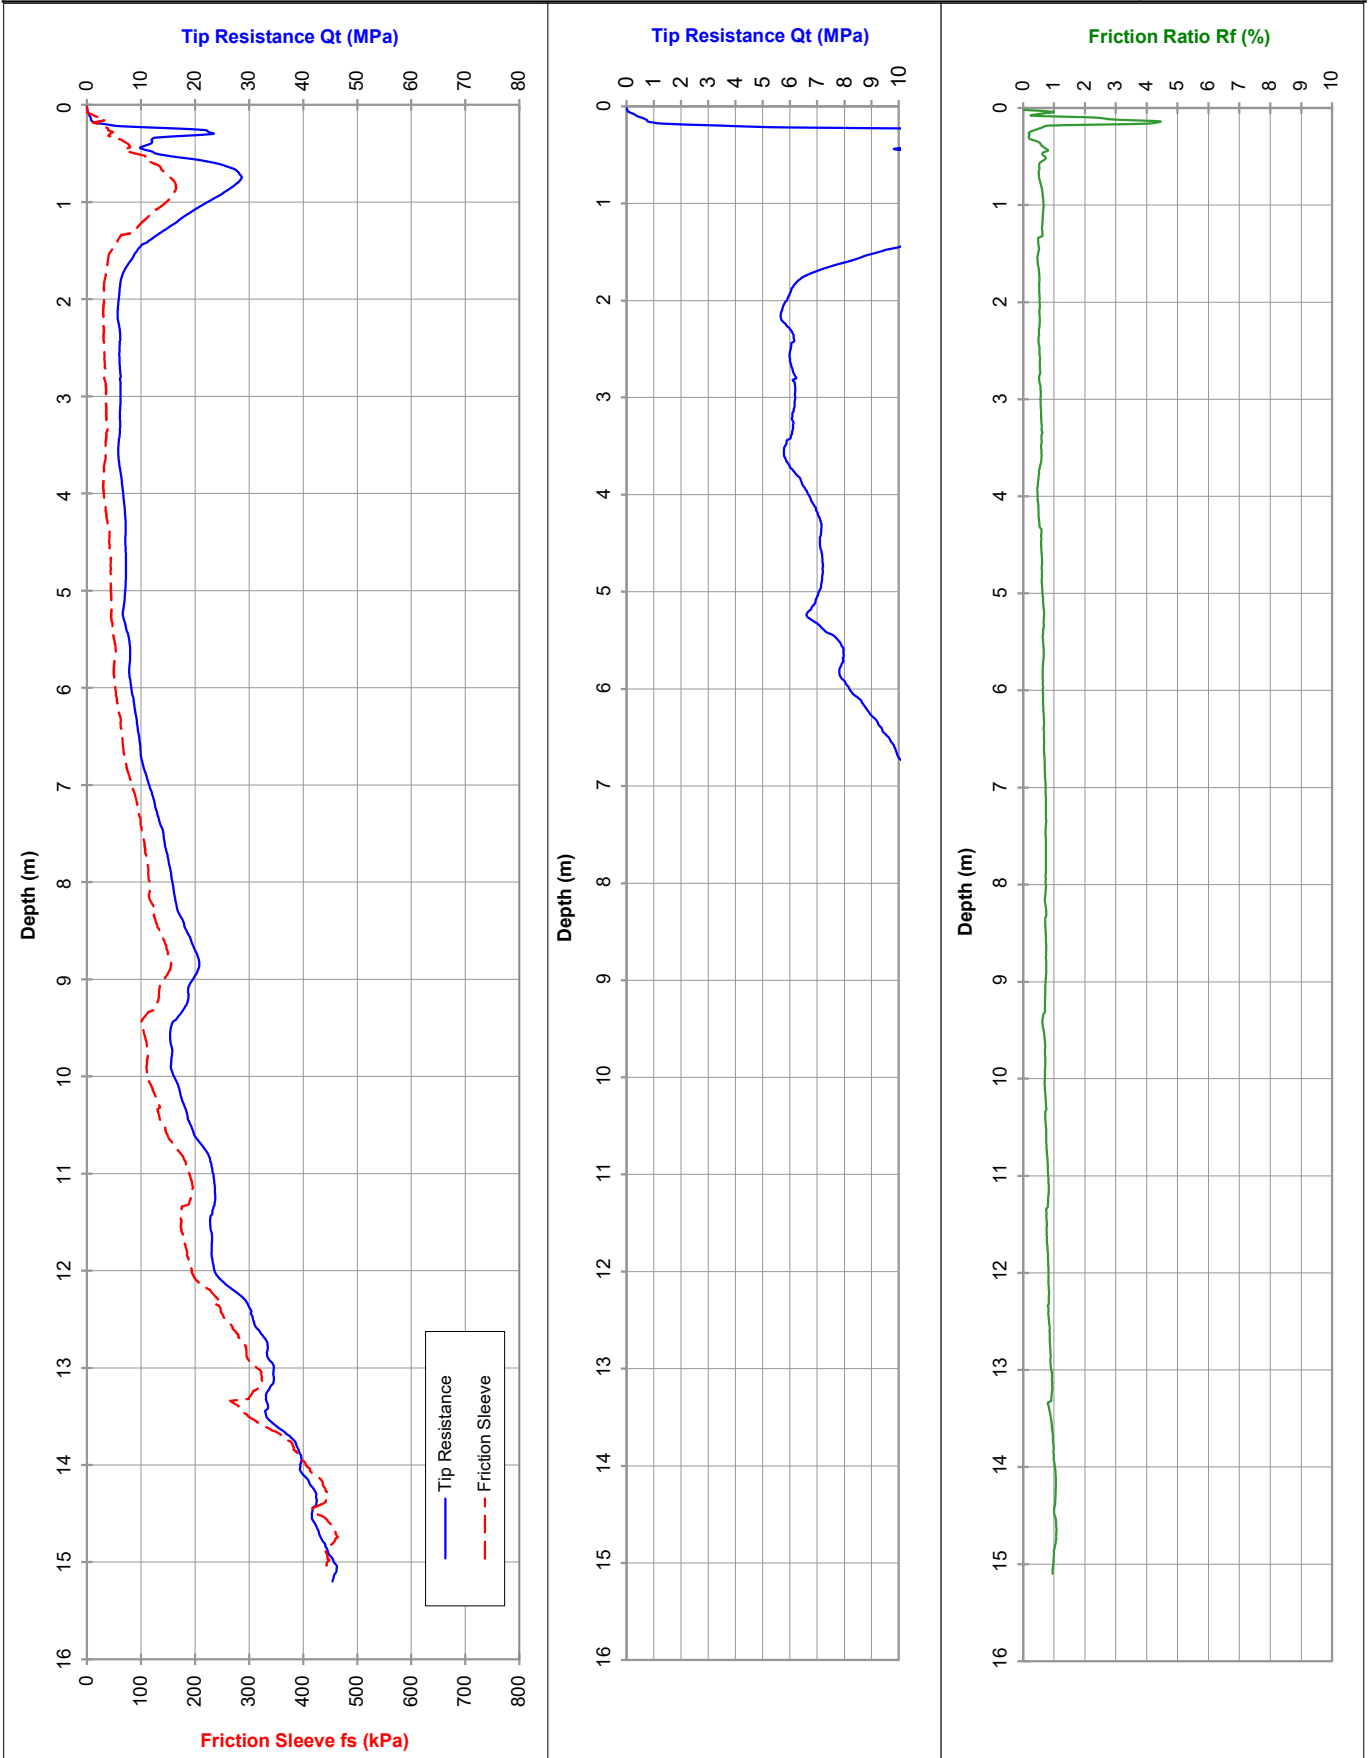
CPTU 148-B

Tested in accordance with AS 1289.6.5.1-1999 and IRTF 2001 for friction reducer

Approx. water (m): Dry to 10.3

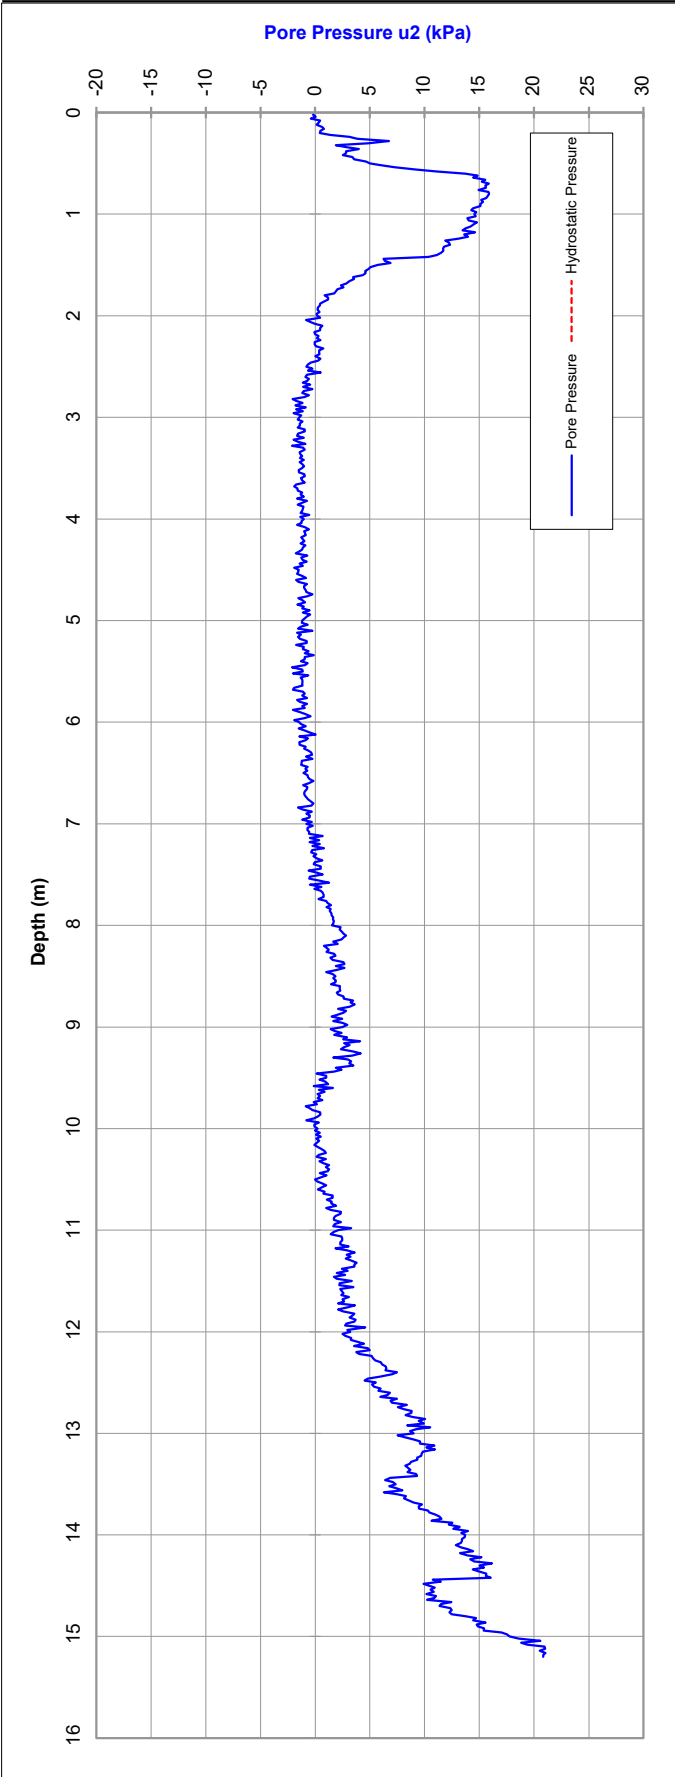
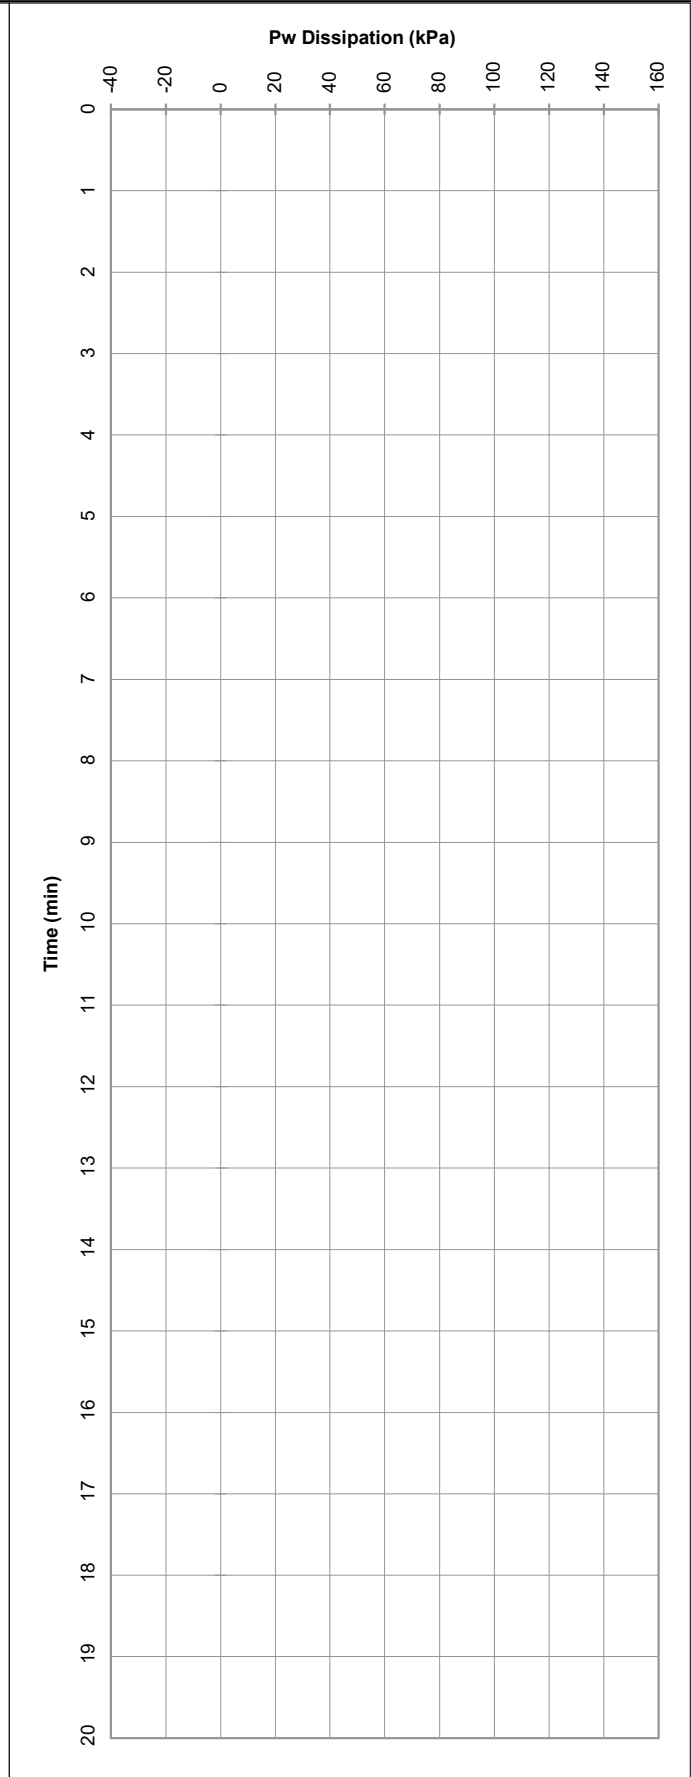
CPTU 148 B

Tested in accordance with AS 1289.6.5.1-1999 and IRTF 2001 for friction reducer

Please note: Hydrostatic Line is taken from the water level manually dipped by the CPT Operator following completion of the probe and, as such, should be used as a guide only.

Approx. Water (m): Dry to 10.3

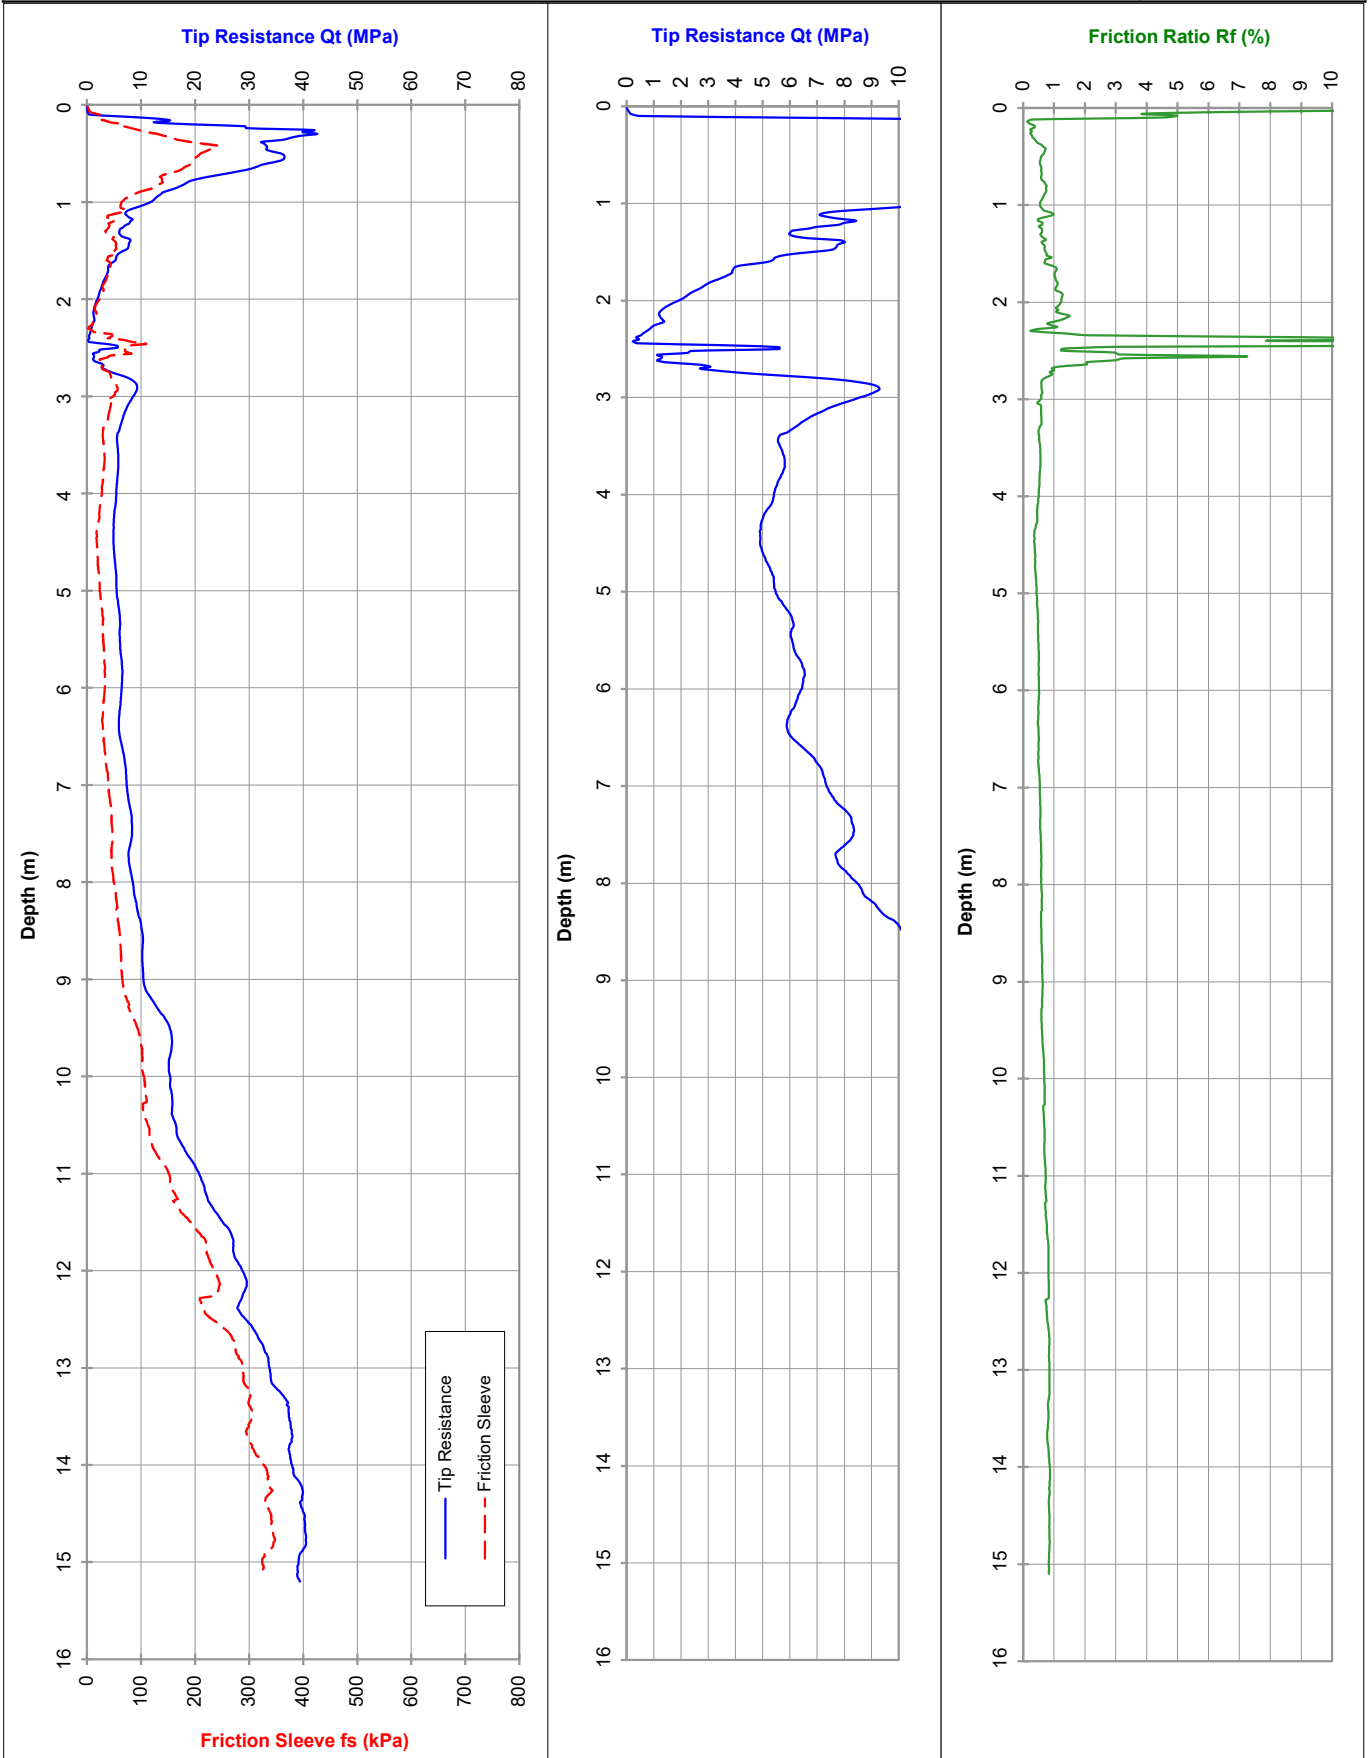
CPTU 150

Tested in accordance with AS 1289.6.5.1-1999 and IRTF 2001 for friction reducer

Approx. water (m): Dry to 0.4

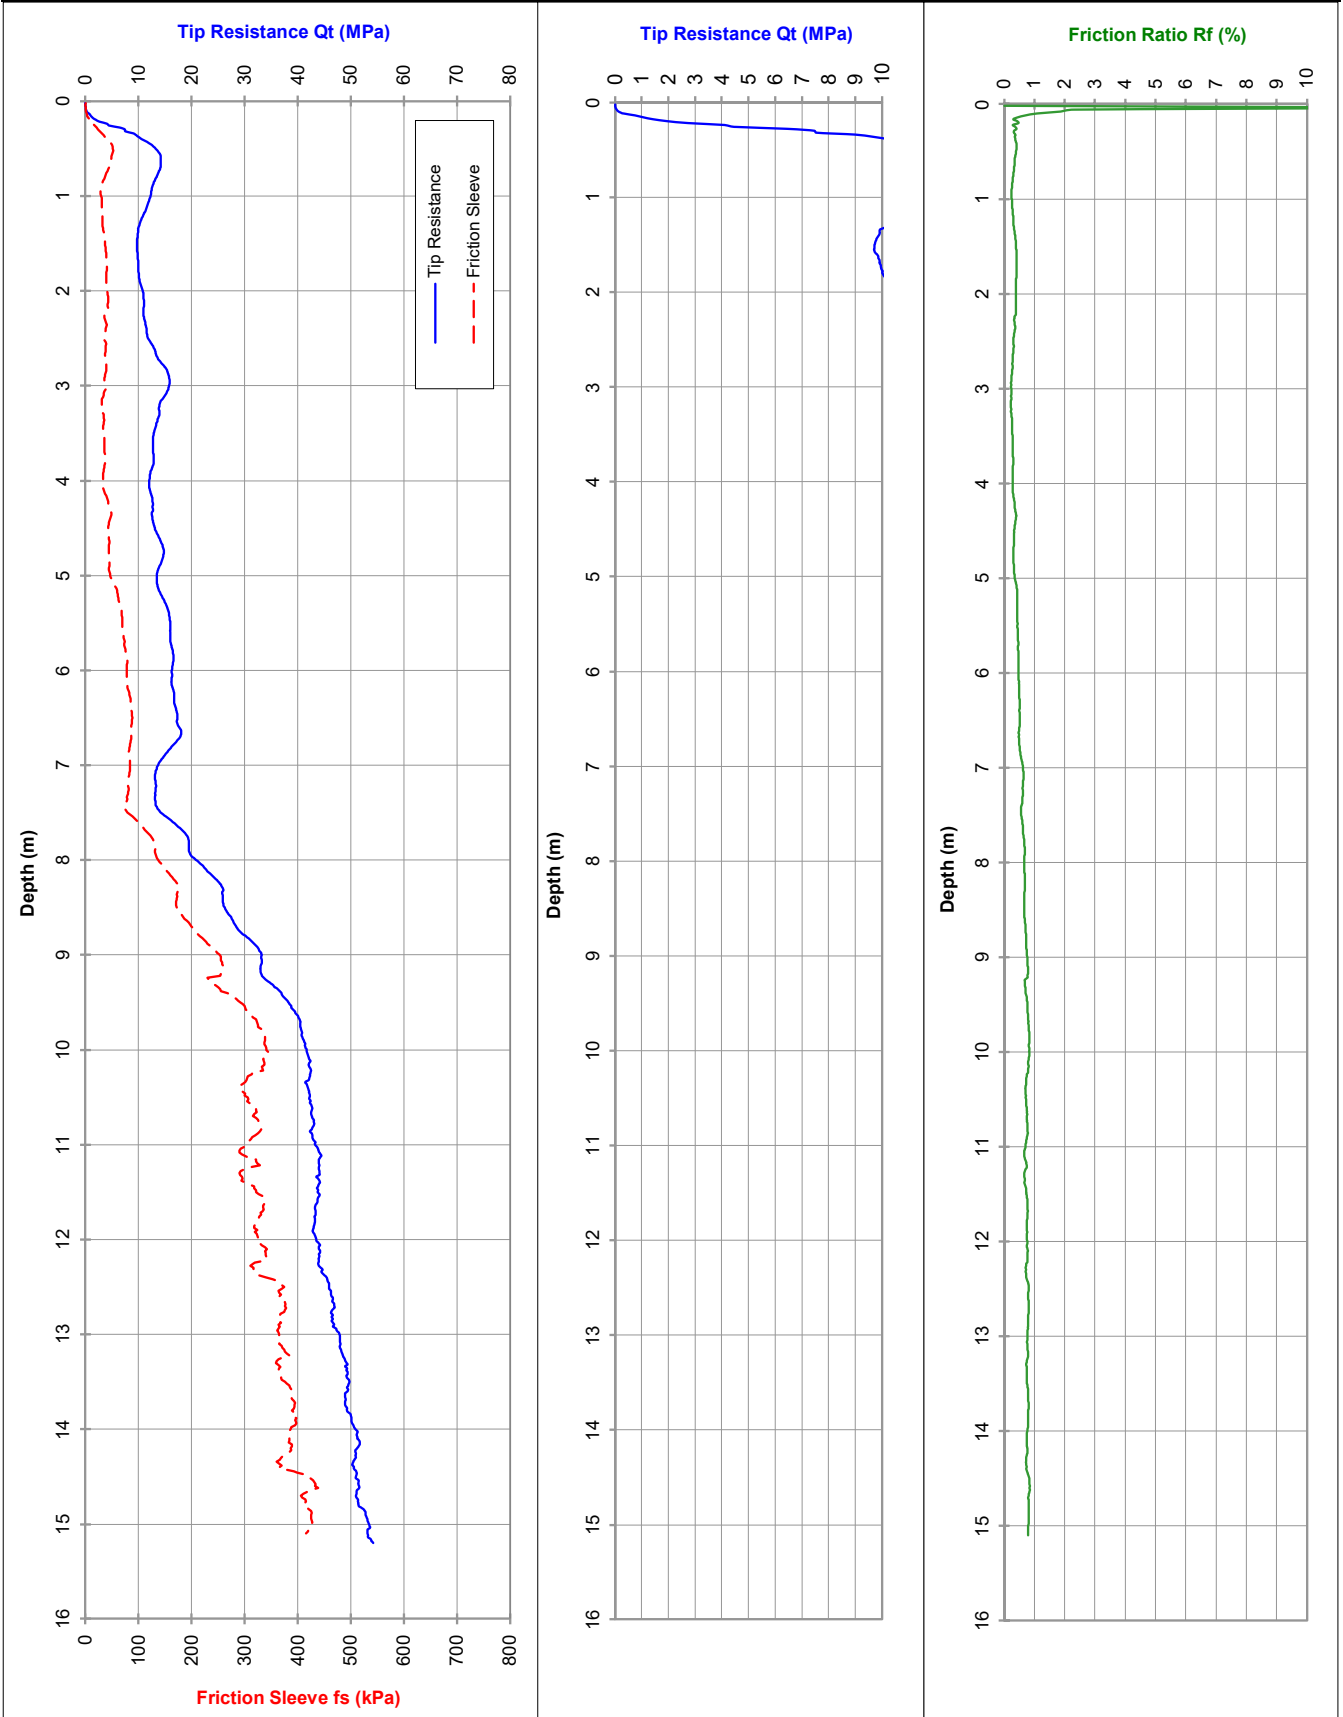
CPTU 151

Tested in accordance with AS 1289.6.5.1-1999 and IRTF 2001 for friction reducer

Approx. water (m): Dry to 2.0

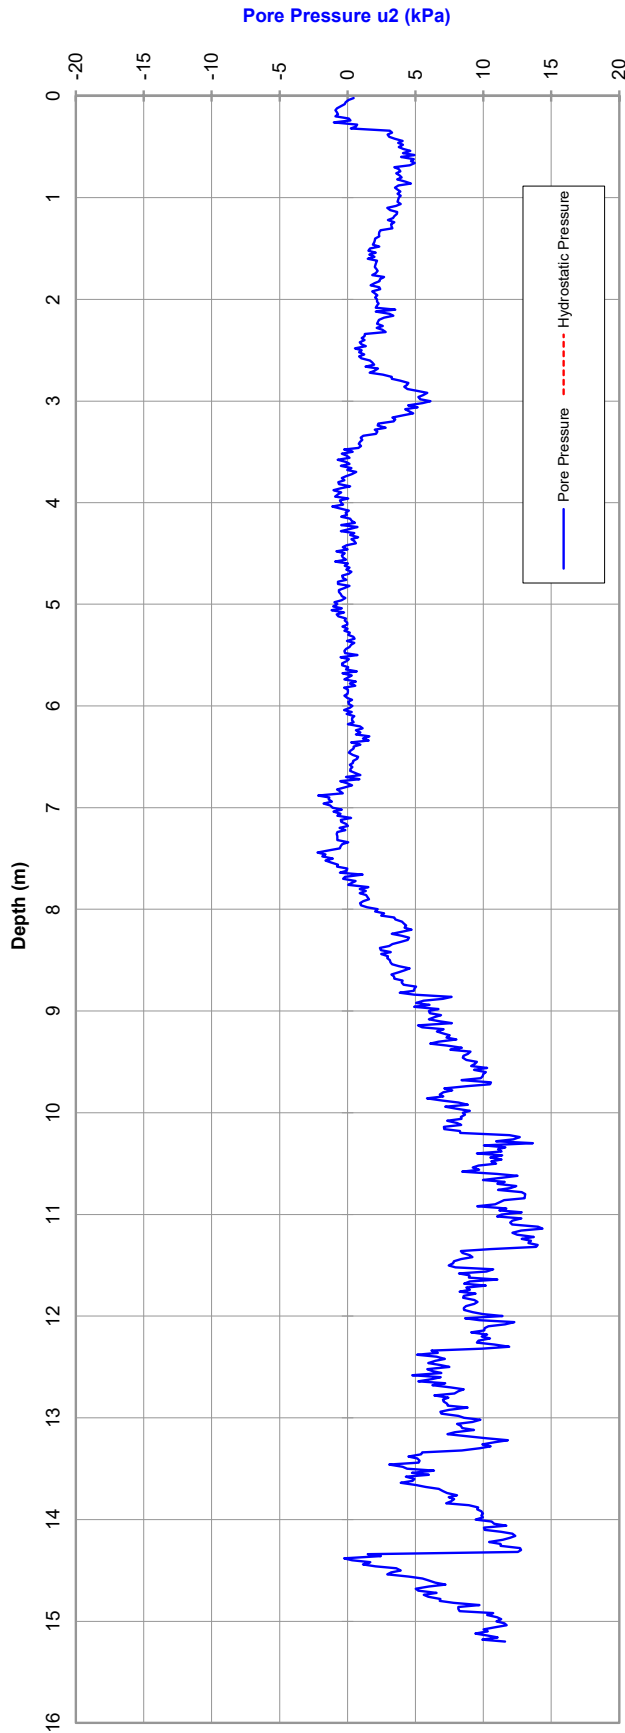
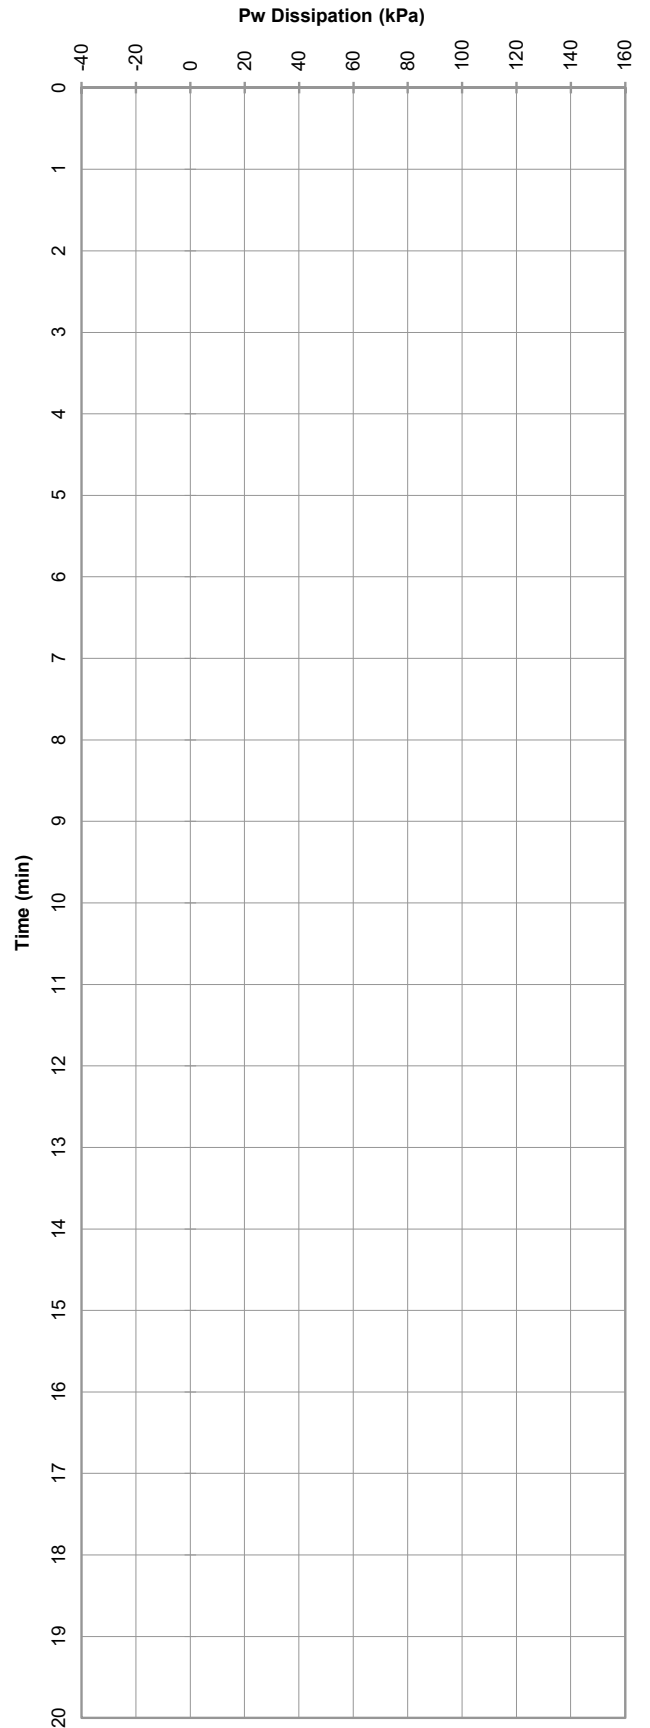
CPTU 151

Tested in accordance with AS 1289.6.5.1-1999 and IRTP 2001 for friction reducer

Please note: Hydrostatic Line is taken from the water level manually dipped by the CPT Operator following completion of the probe and, as such, should be used as a guide only.

Approx. Water (m): Dry to 2.0

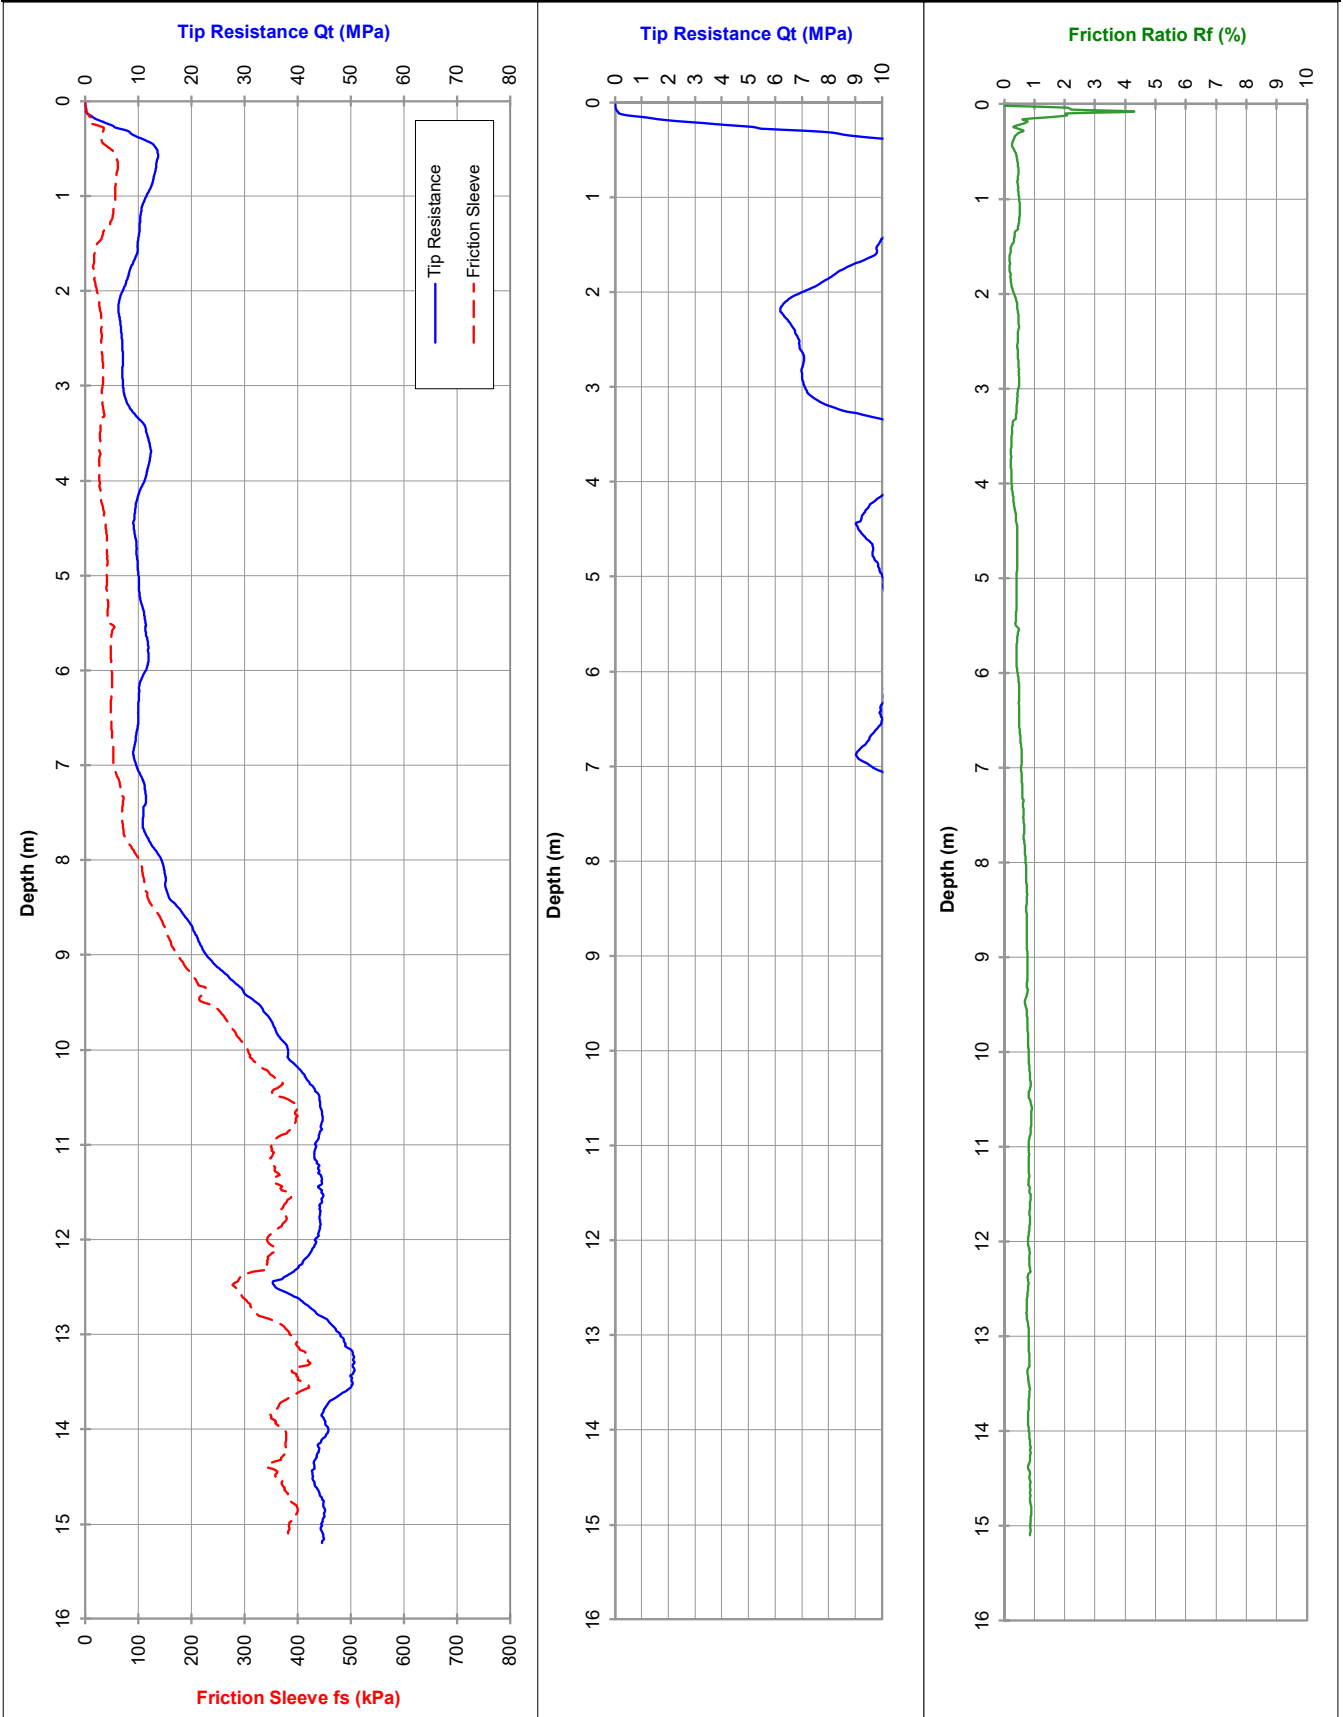
CPTU 152

Tested in accordance with AS 1289.6.5.1-1999 and IRTF 2001 for friction reducer

Approx. water (m): Dry to 1.0

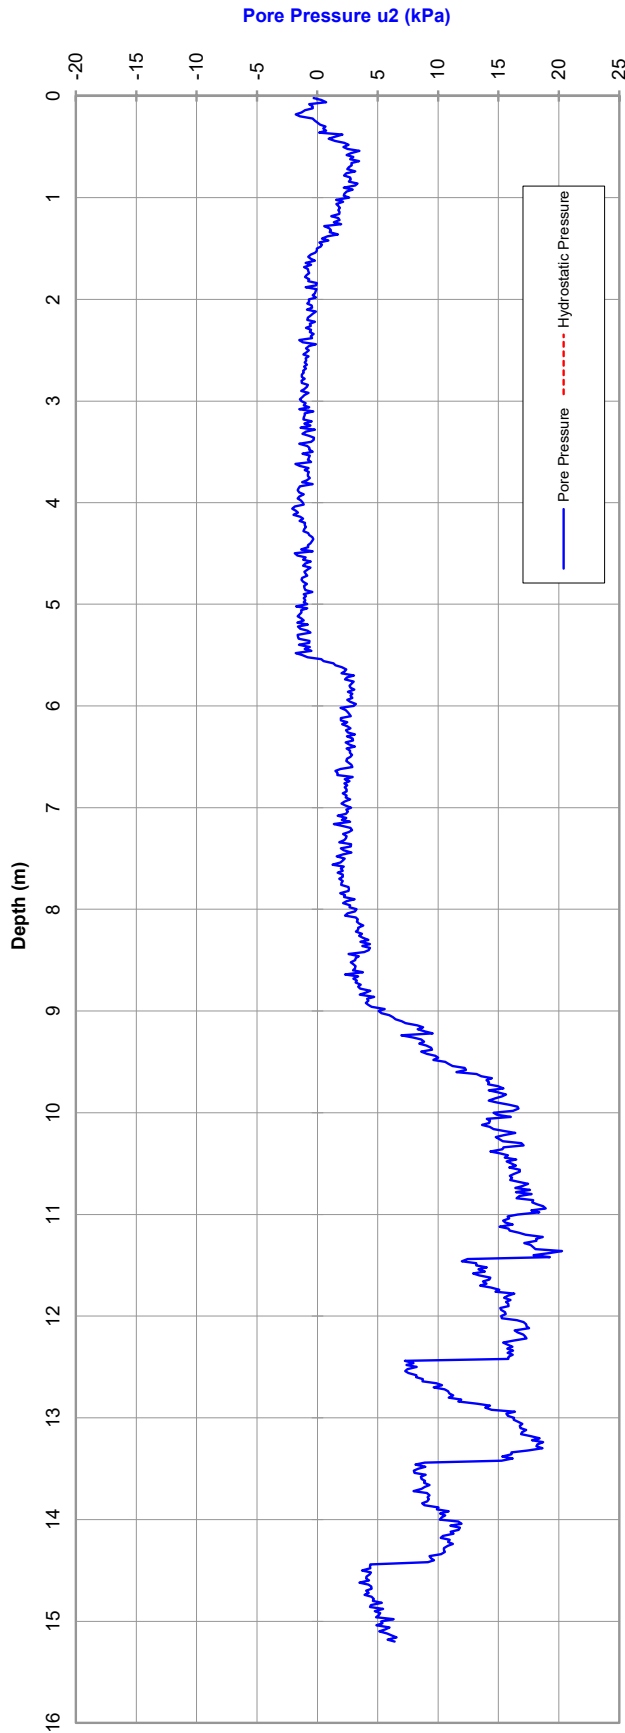
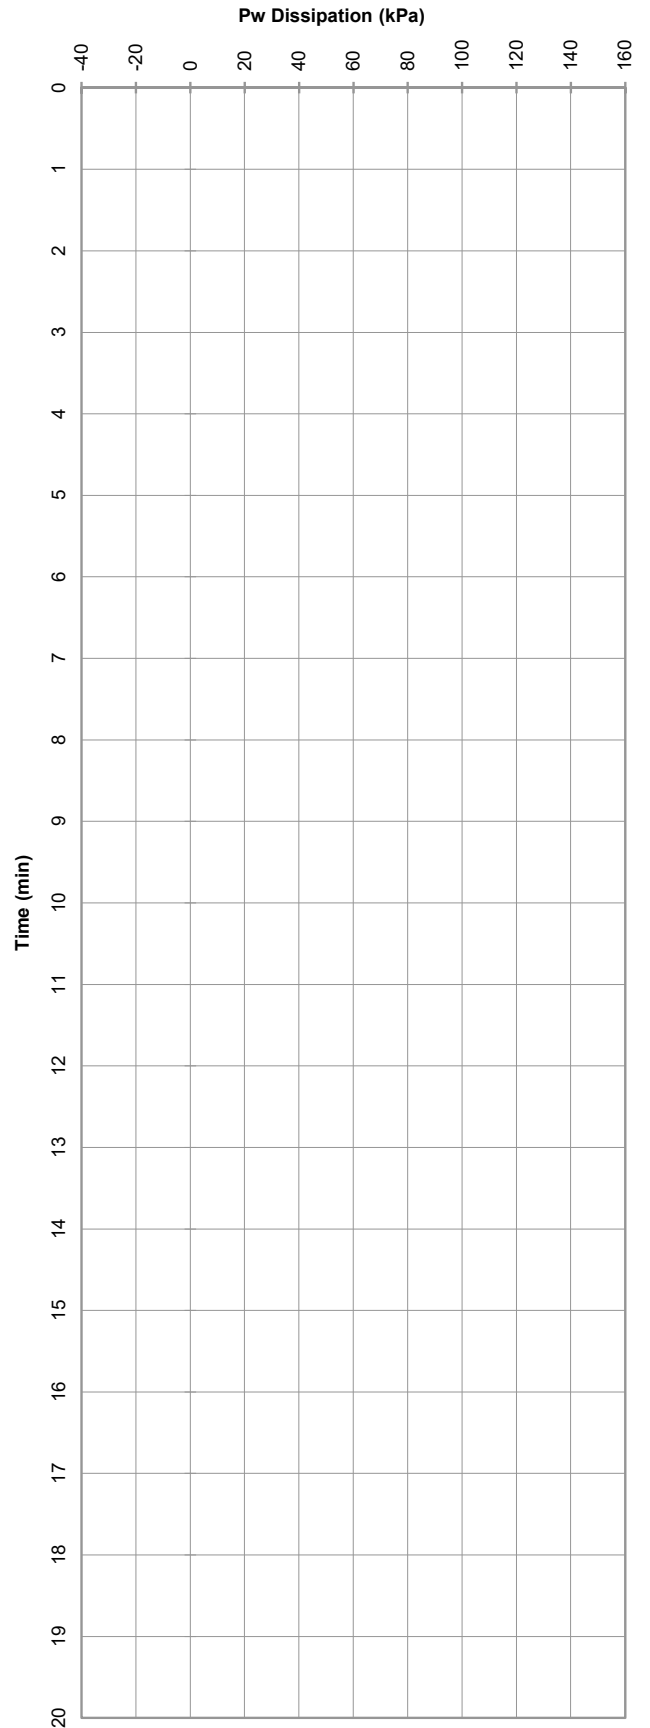
CPTU 152

Tested in accordance with AS 1289.6.5.1-1999 and IRTP 2001 for friction reducer

Please note: Hydrostatic Line is taken from the water level manually dipped by the CPT Operator following completion of the probe and, as such, should be used as a guide only.

Approx. Water (m): Dry to 1.0
