ELECTRIC FRICTION-CONE PENETROMETER

CLIENT: Acciona Construction Australia

PROJECT: CELN Double Circuit

LOCATION: PER2025-0250

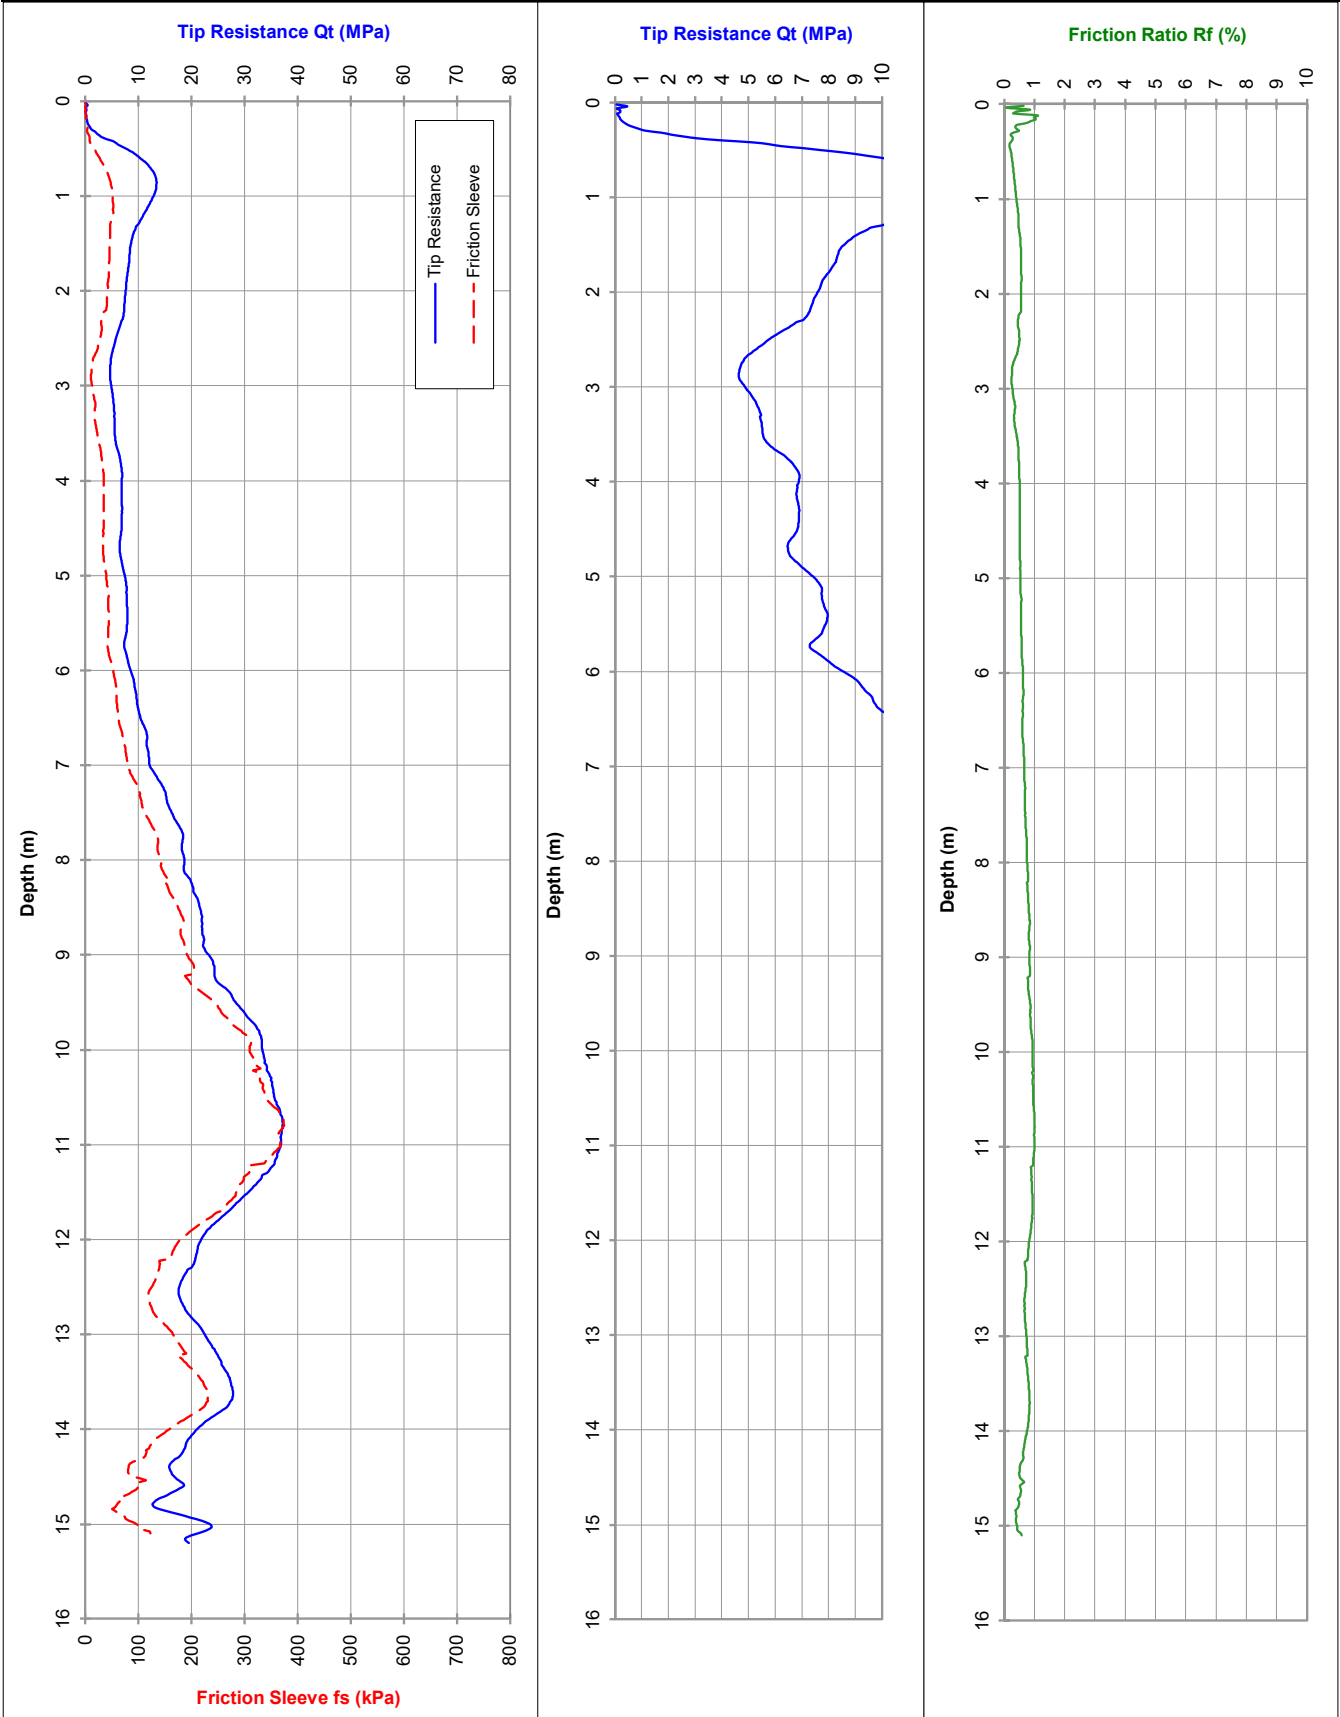
CPTU 154

Tested in accordance with AS 1289.6.5.1-1999 and IRTF 2001 for friction reducer

Approx. water (m): Dry to 1.4

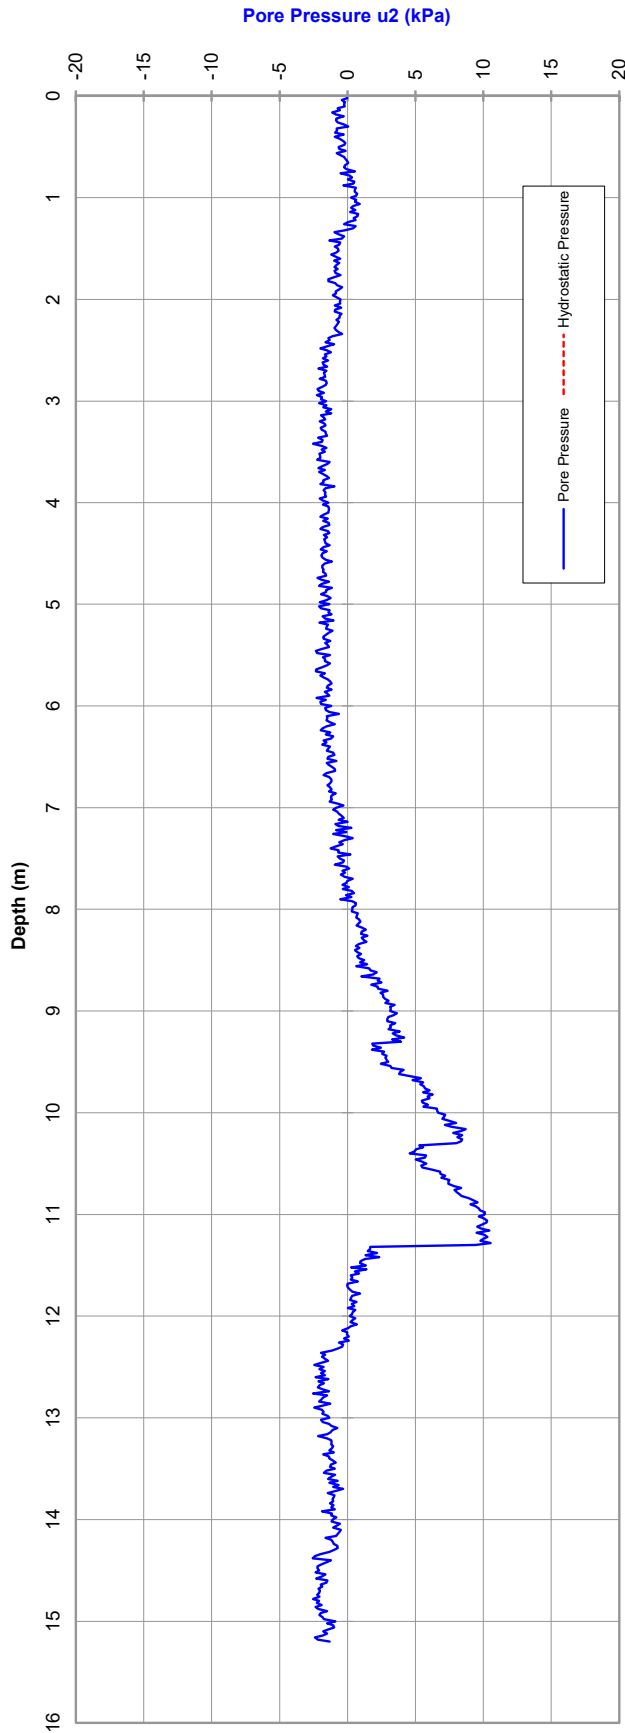
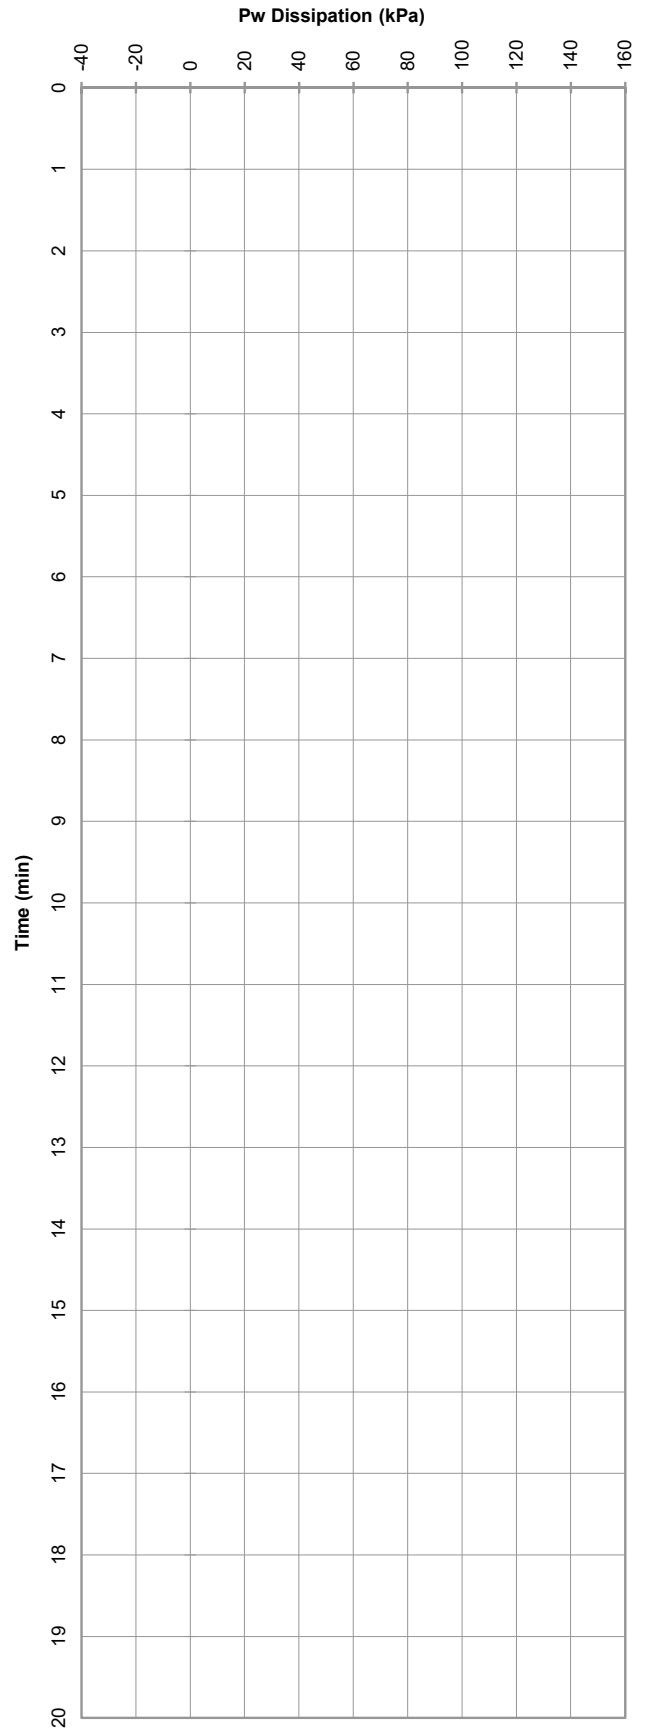
CPTU 154

Tested in accordance with AS 1289.6.5.1-1999 and IRTP 2001 for friction reducer

Please note: Hydrostatic Line is taken from the water level manually dipped by the CPT Operator following completion of the probe and, as such, should be used as a guide only.

Approx. Water (m): Dry to 1.4

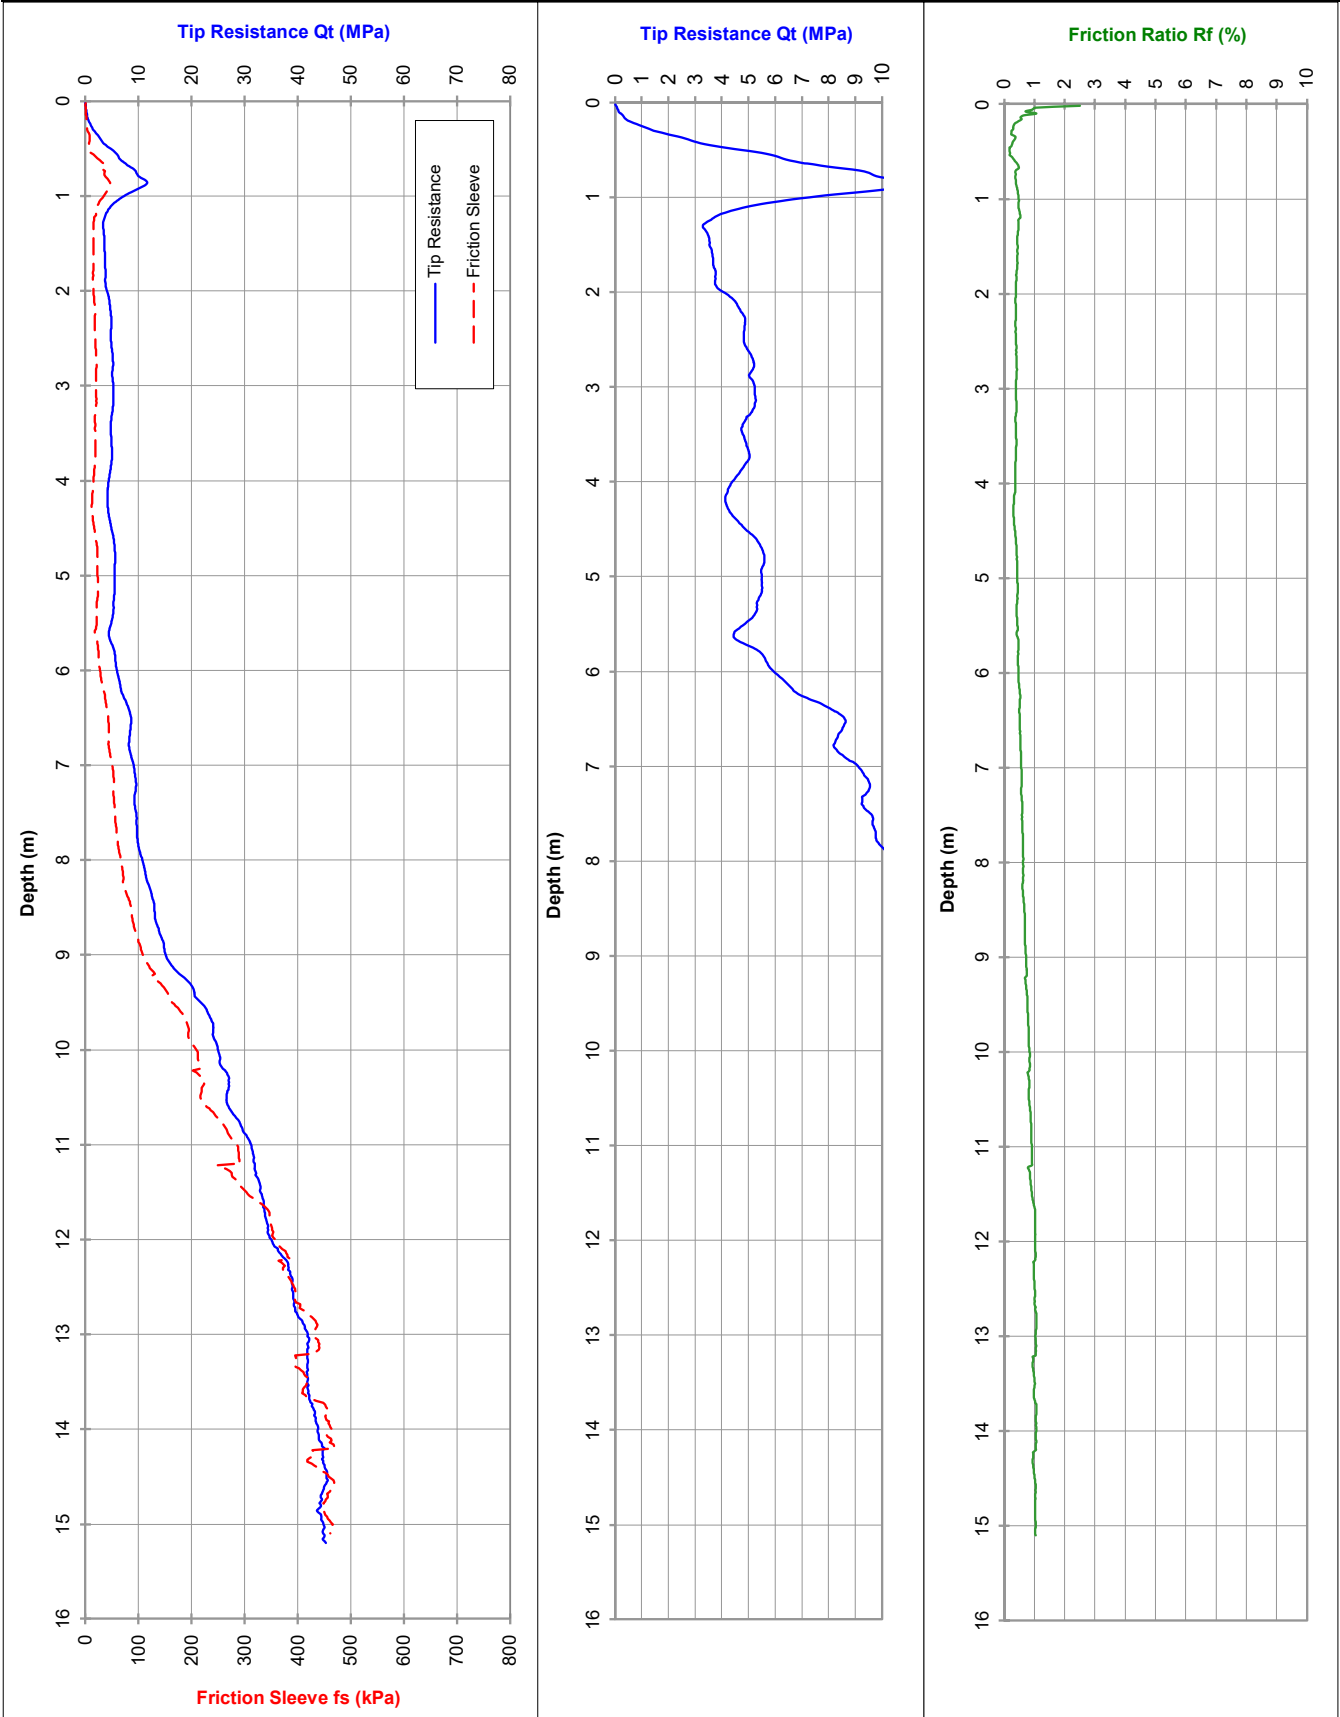
CPTU 155

Tested in accordance with AS 1289.6.5.1-1999 and IRTF 2001 for friction reducer

Approx. water (m): Dry to 0.4

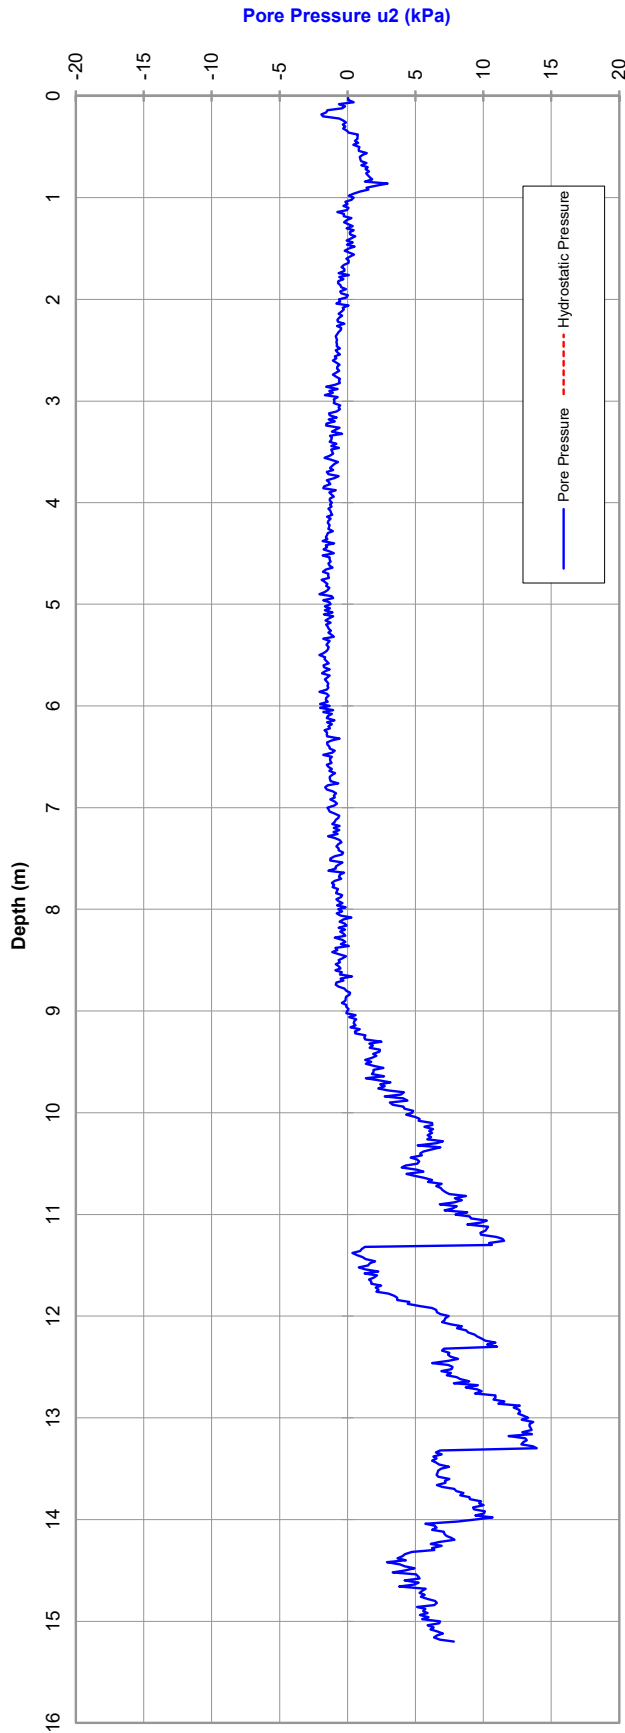
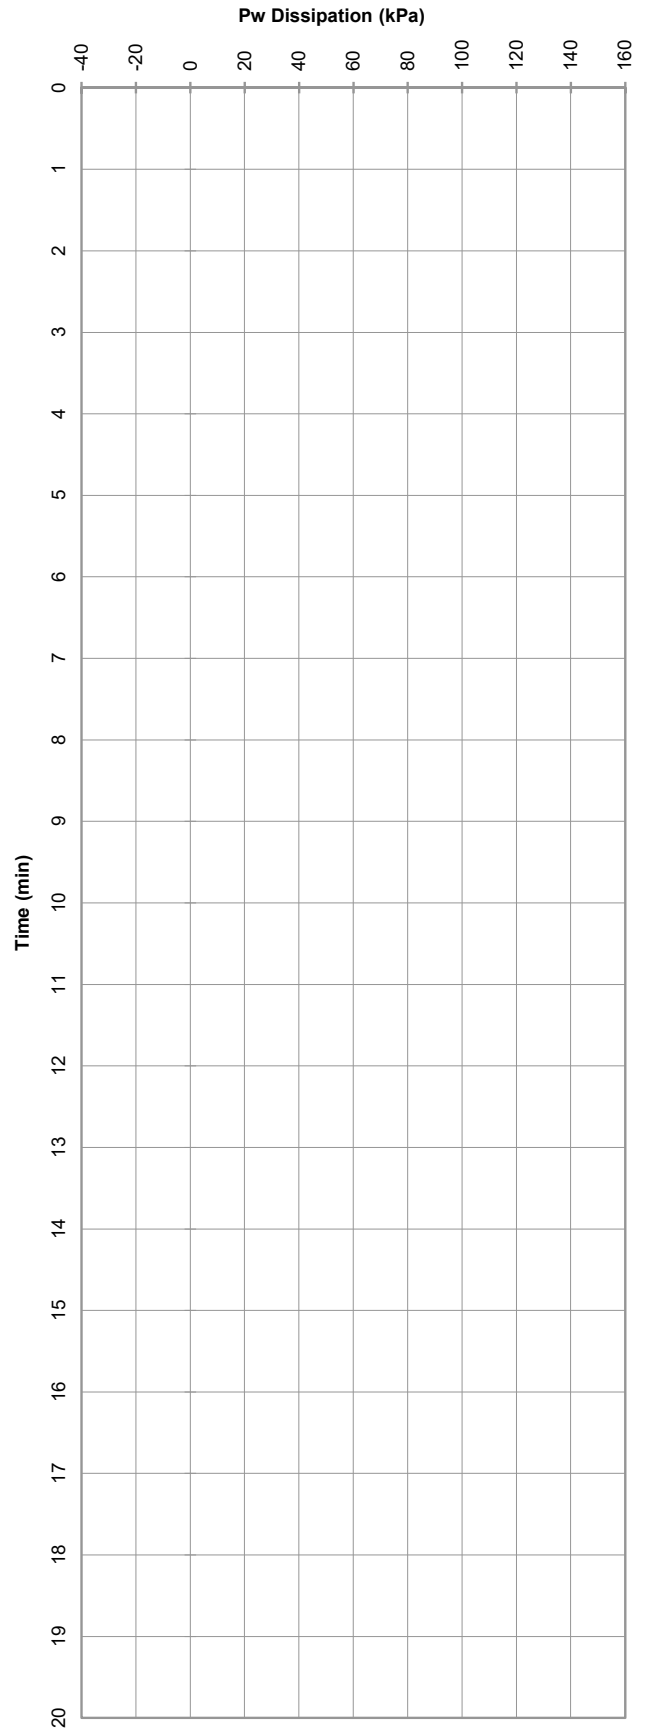
CPTU 155

Tested in accordance with AS 1289.6.5.1-1999 and IRTP 2001 for friction reducer

Please note: Hydrostatic Line is taken from the water level manually dipped by the CPT Operator following completion of the probe and, as such, should be used as a guide only.

Approx. Water (m): Dry to 0.4

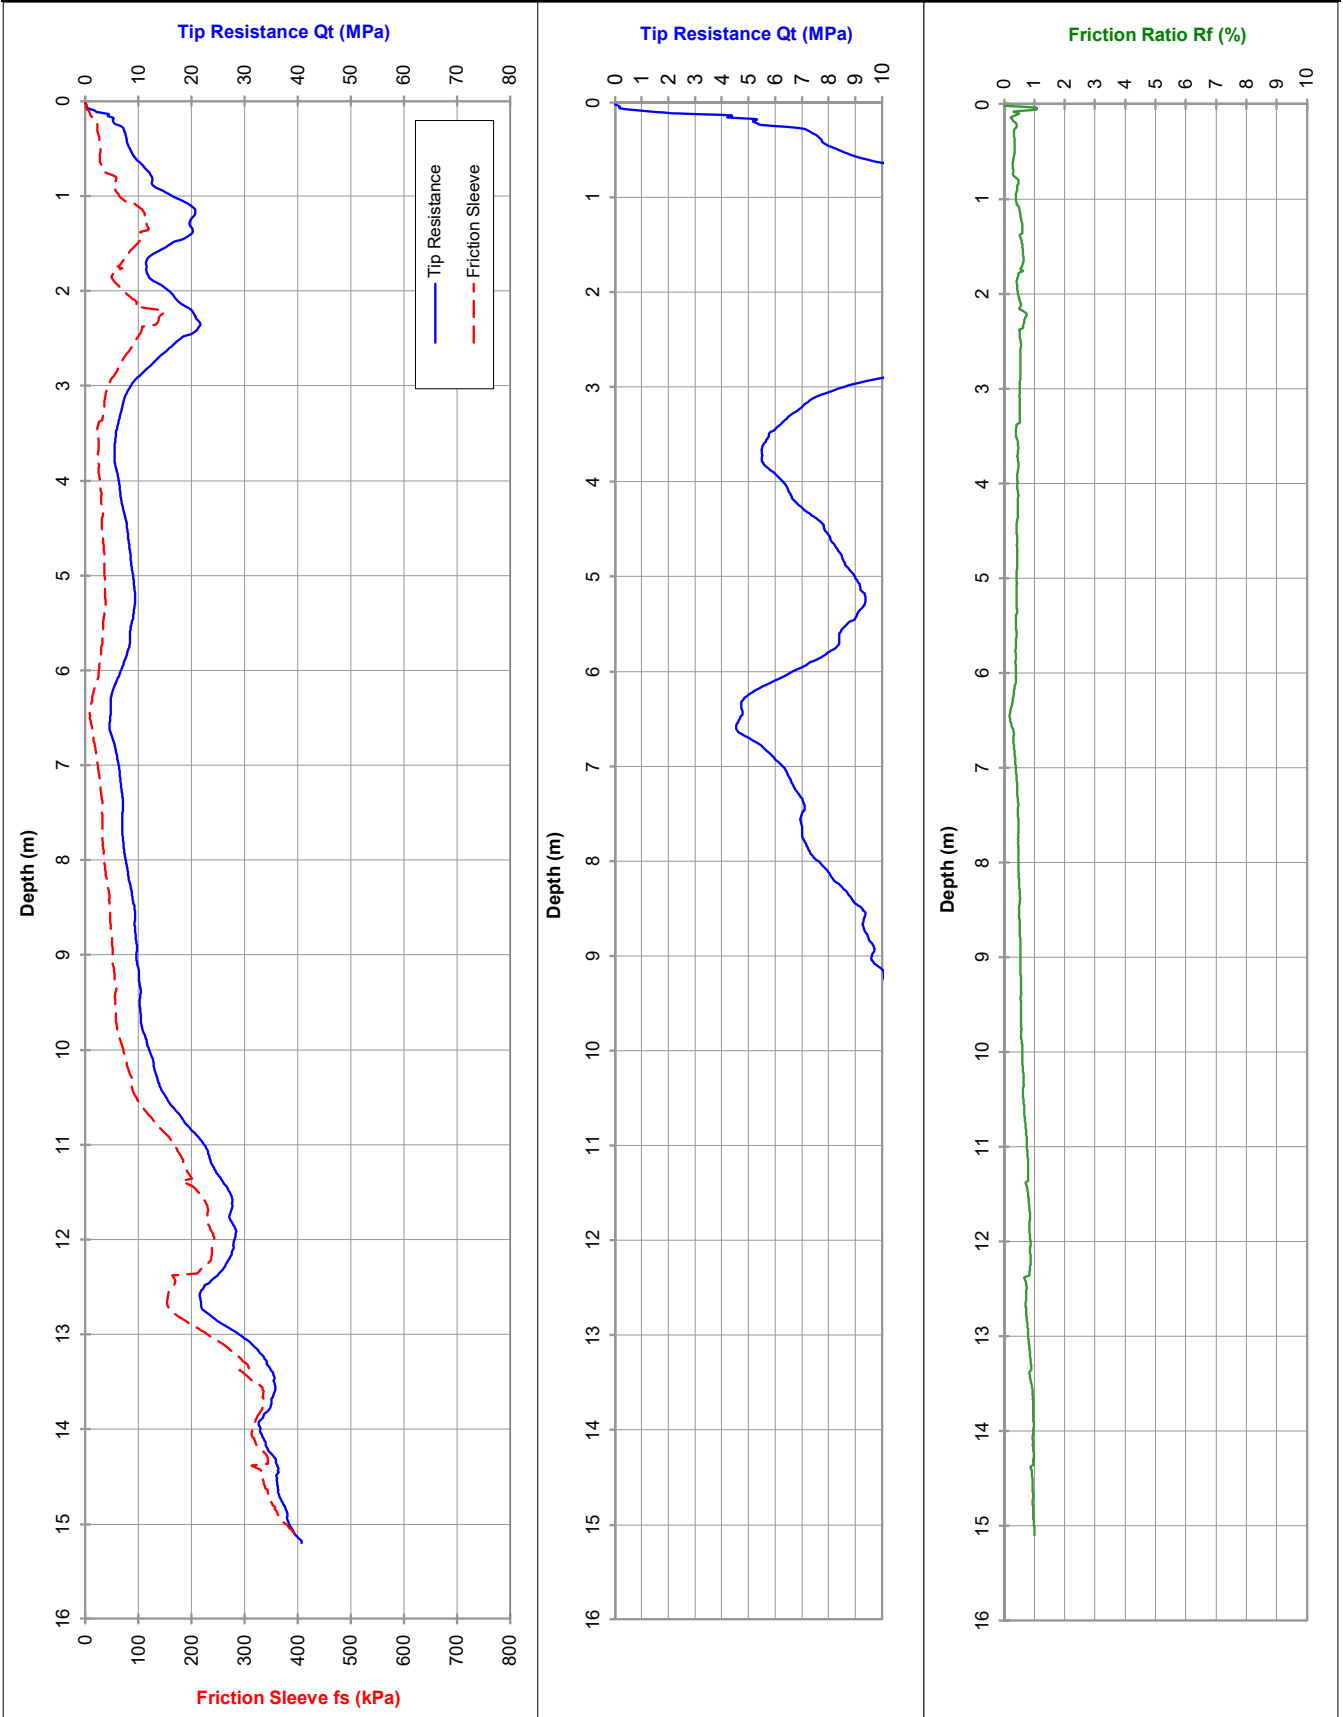
CPTU 156

Tested in accordance with AS 1289.6.5.1-1999 and IRTF 2001 for friction reducer

Approx. water (m): Dry to 0.3

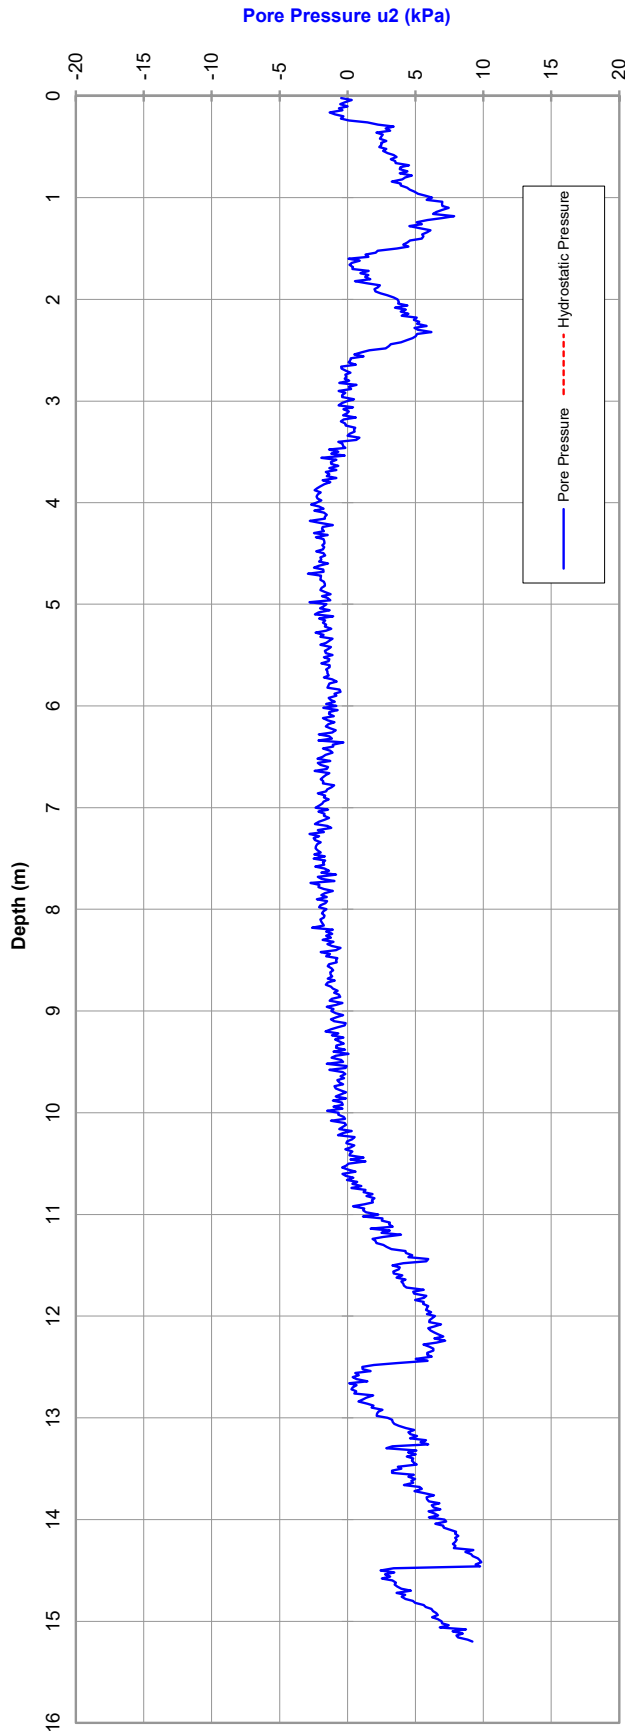
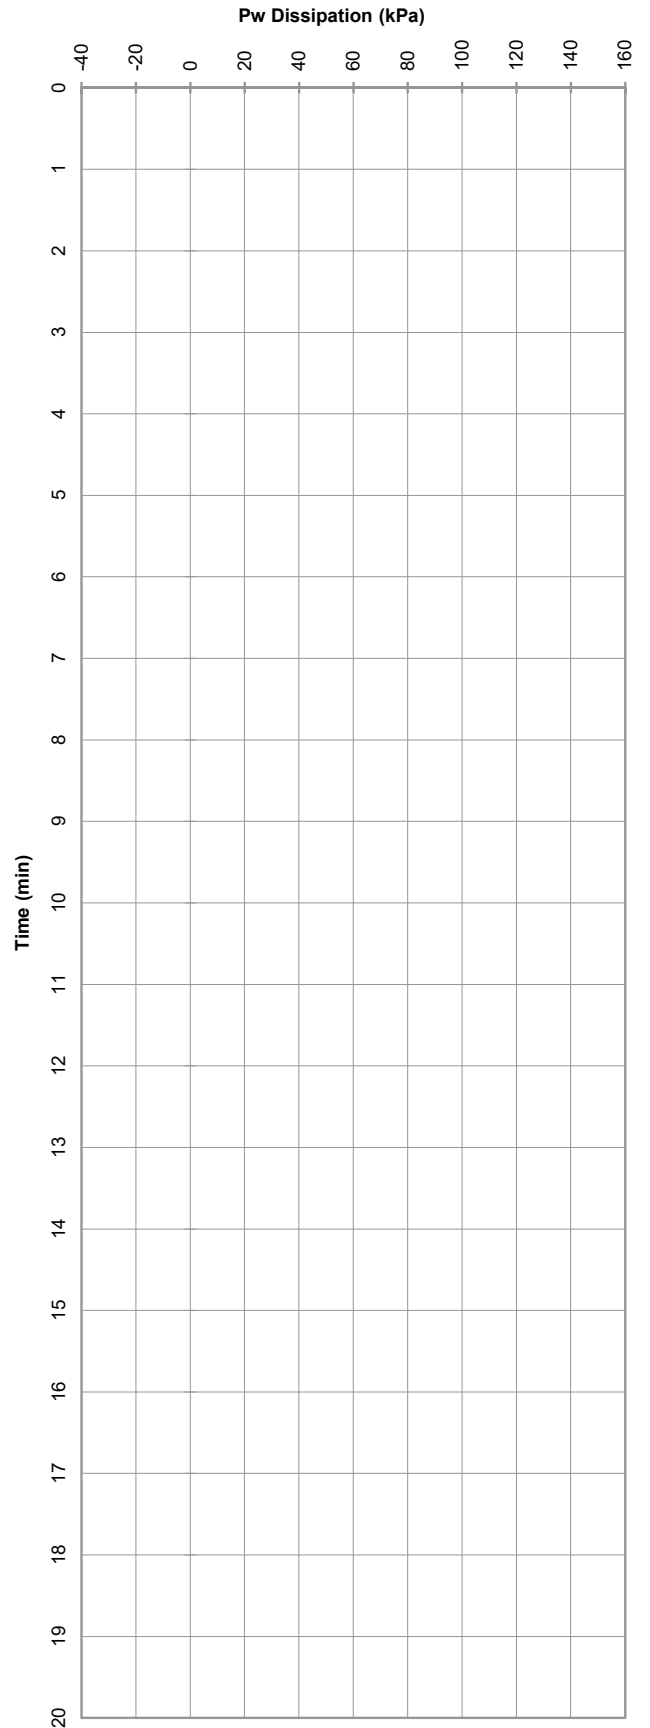
CPTU 156

Tested in accordance with AS 1289.6.5.1-1999 and IRTP 2001 for friction reducer

Please note: Hydrostatic Line is taken from the water level manually dipped by the CPT Operator following completion of the probe and, as such, should be used as a guide only.

Approx. Water (m): Dry to 0.3

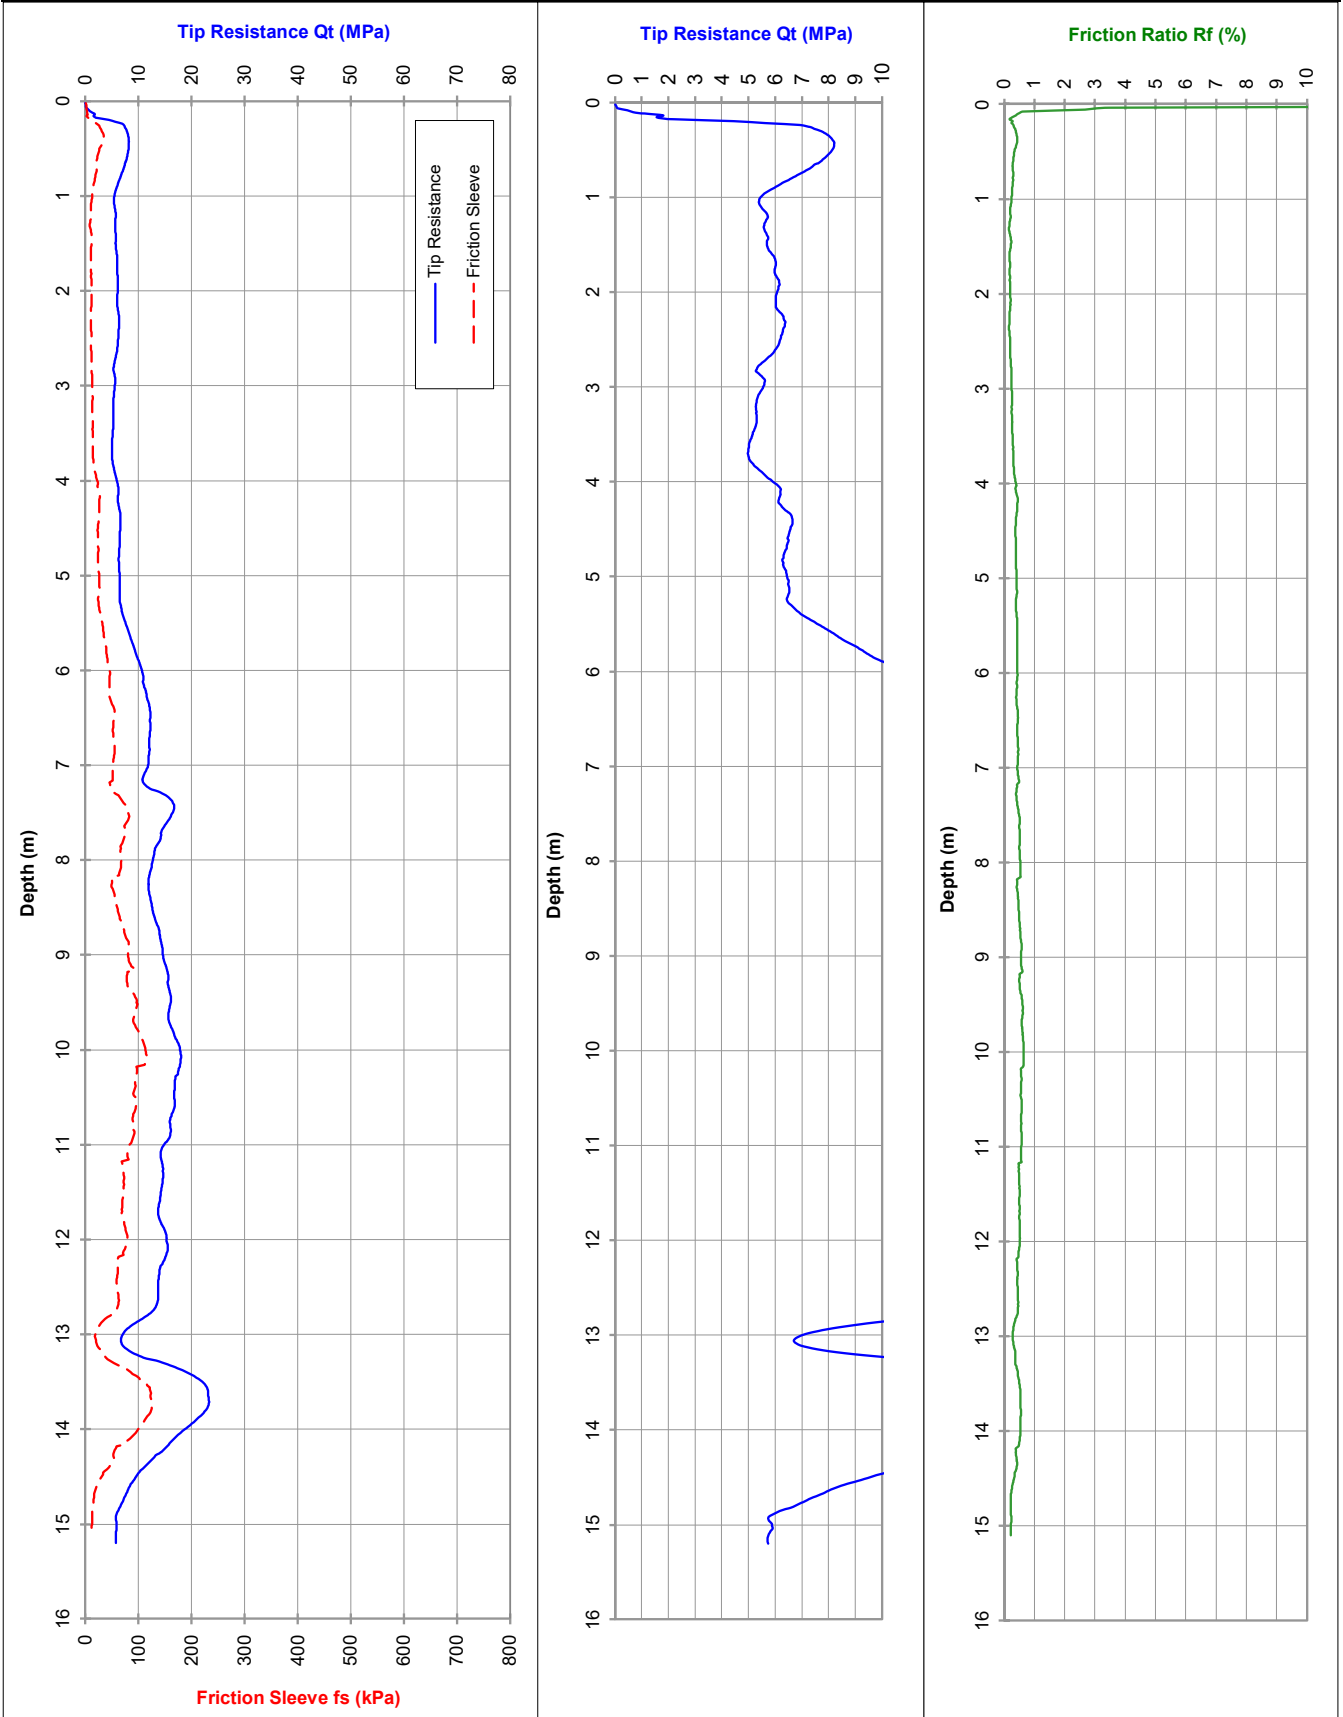
CPTU 157

Tested in accordance with AS 1289.6.5.1-1999 and IRTF 2001 for friction reducer

Approx. water (m): Dry to 12.6

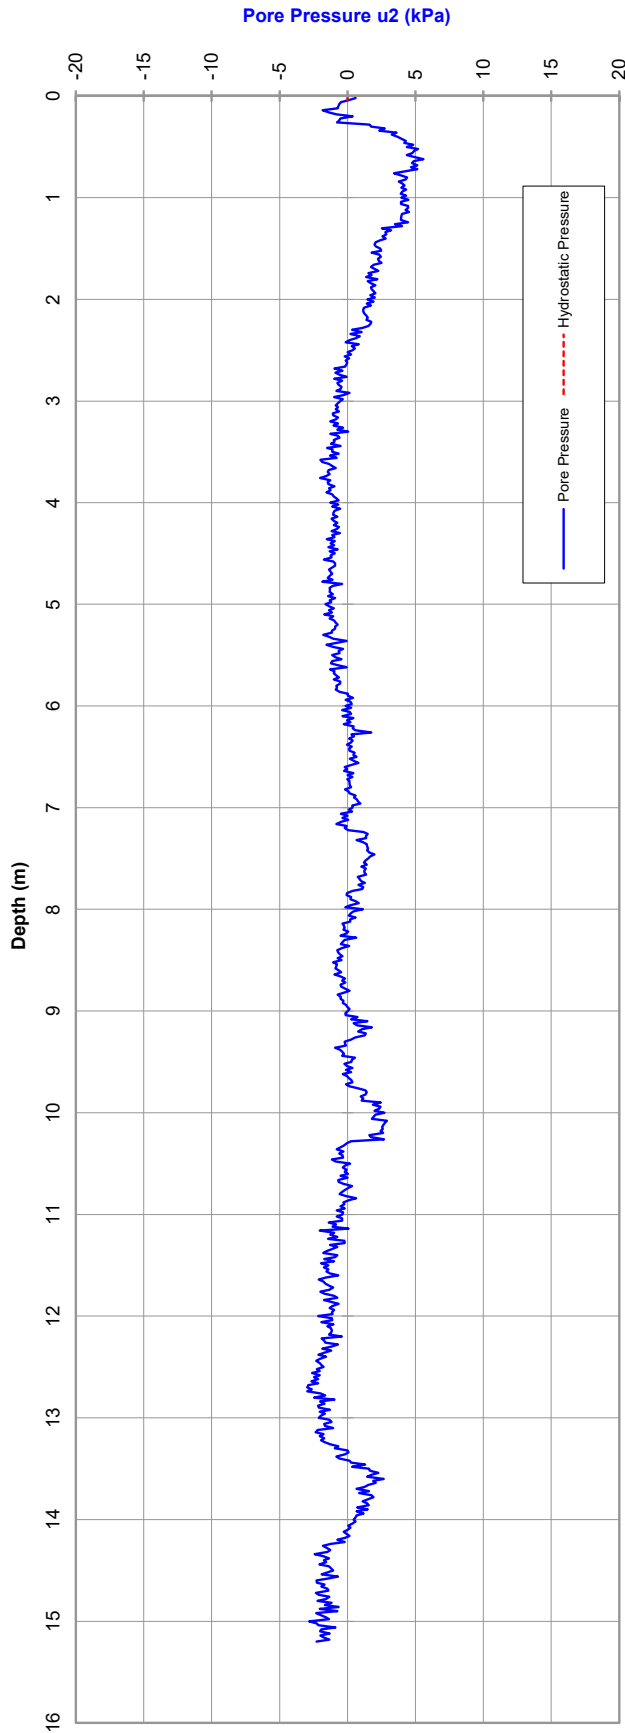
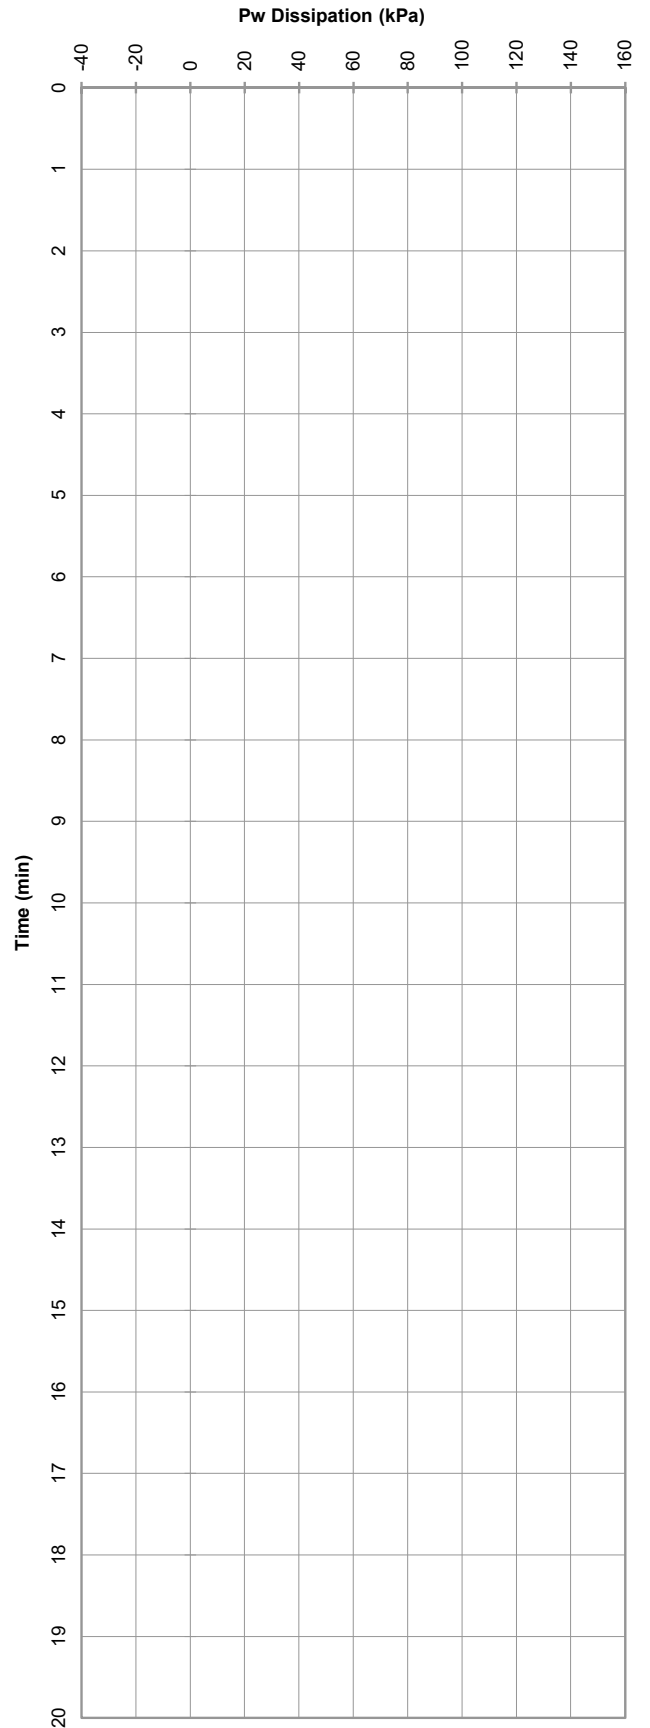
CPTU 157

Tested in accordance with AS 1289.6.5.1-1999 and IRTP 2001 for friction reducer

Please note: Hydrostatic Line is taken from the water level manually dipped by the CPT Operator following completion of the probe and, as such, should be used as a guide only.

Approx. Water (m): Dry to 12.6

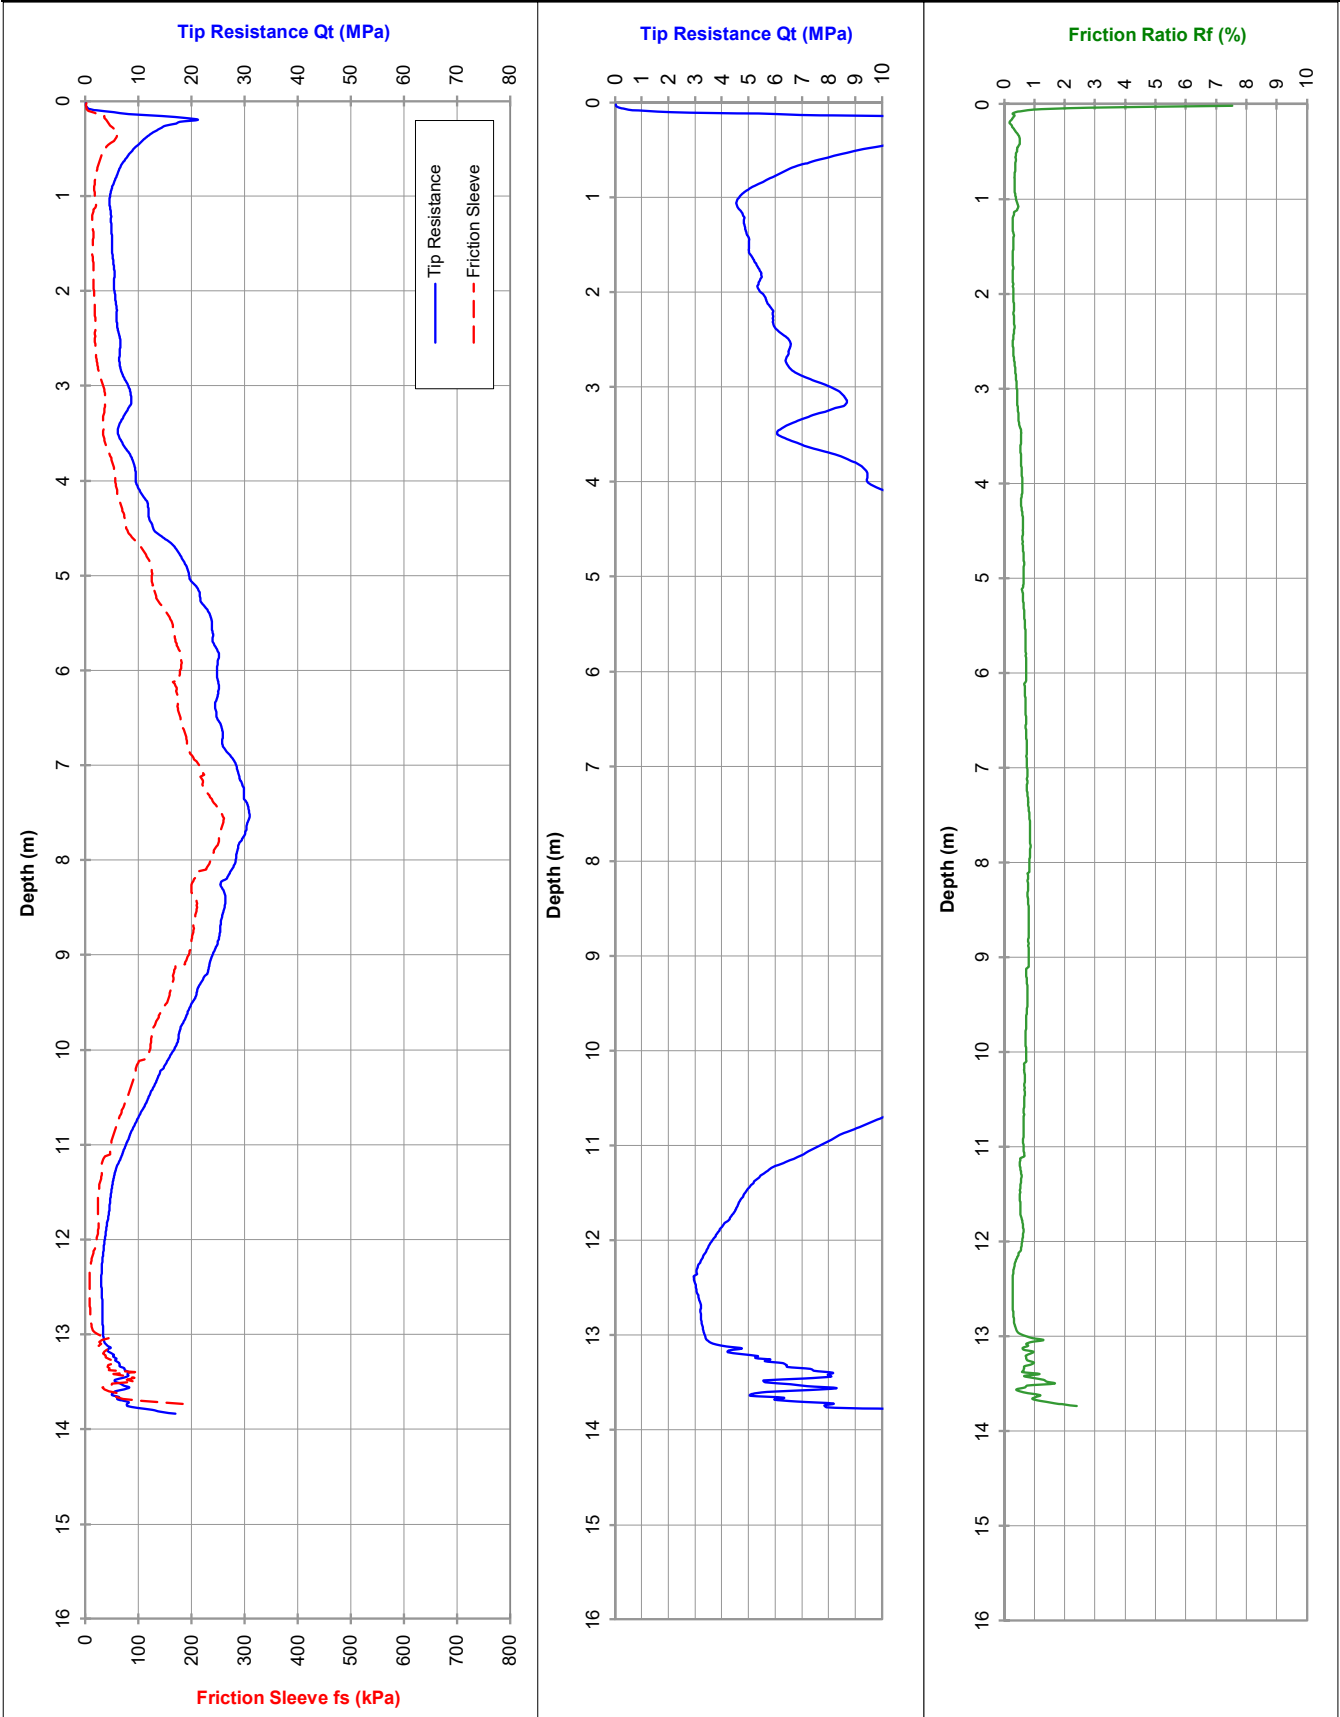
CPTU 158

Tested in accordance with AS 1289.6.5.1-1999 and IRTF 2001 for friction reducer

Approx. water (m): Dry to 1.0

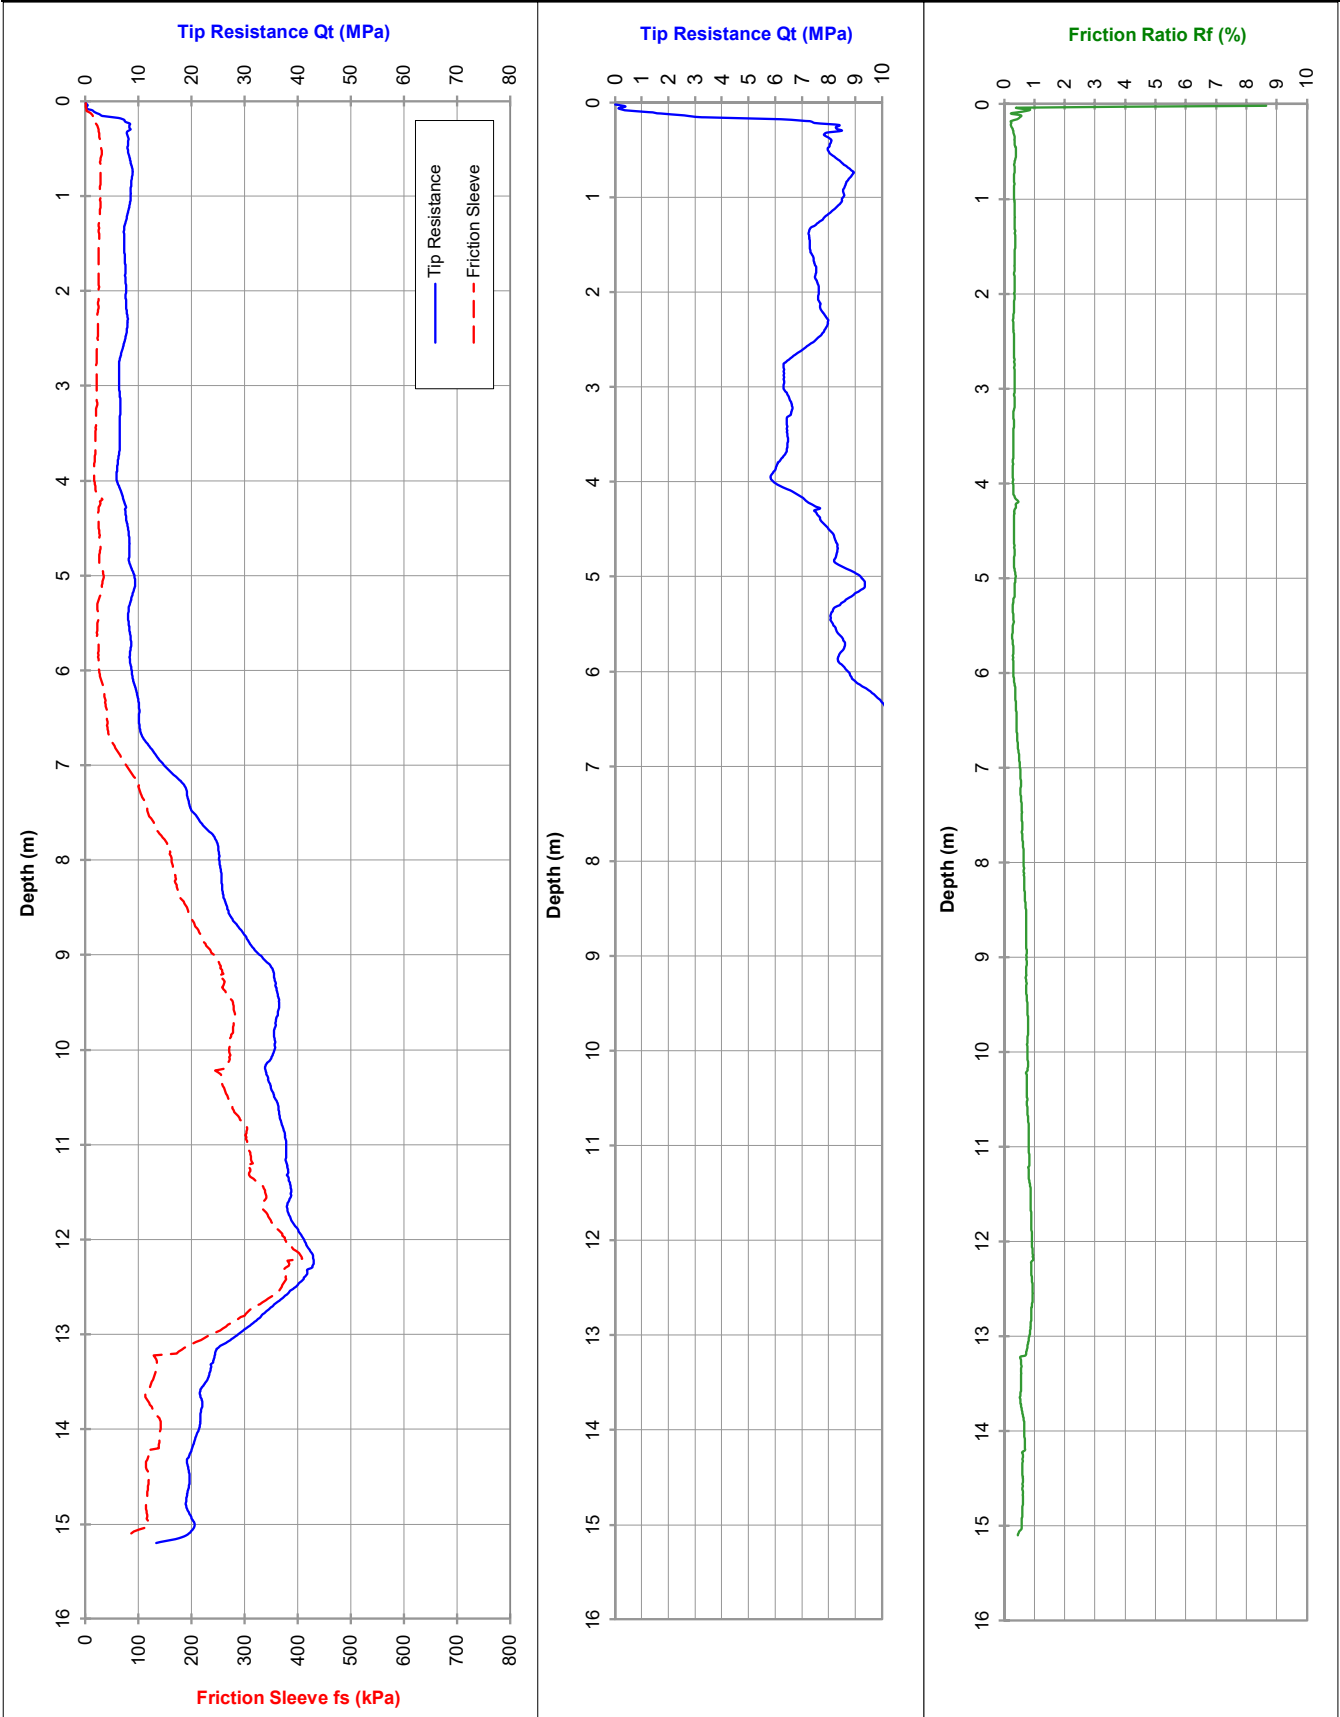
CPTU 159

Tested in accordance with AS 1289.6.5.1-1999 and IRTF 2001 for friction reducer

Approx. water (m): Dry to 13.5
