ELECTRIC FRICTION-CONE PENETROMETER

CLIENT: Acciona Construction Australia

PROJECT: CELN Double Circuit

LOCATION: PER2025-0250

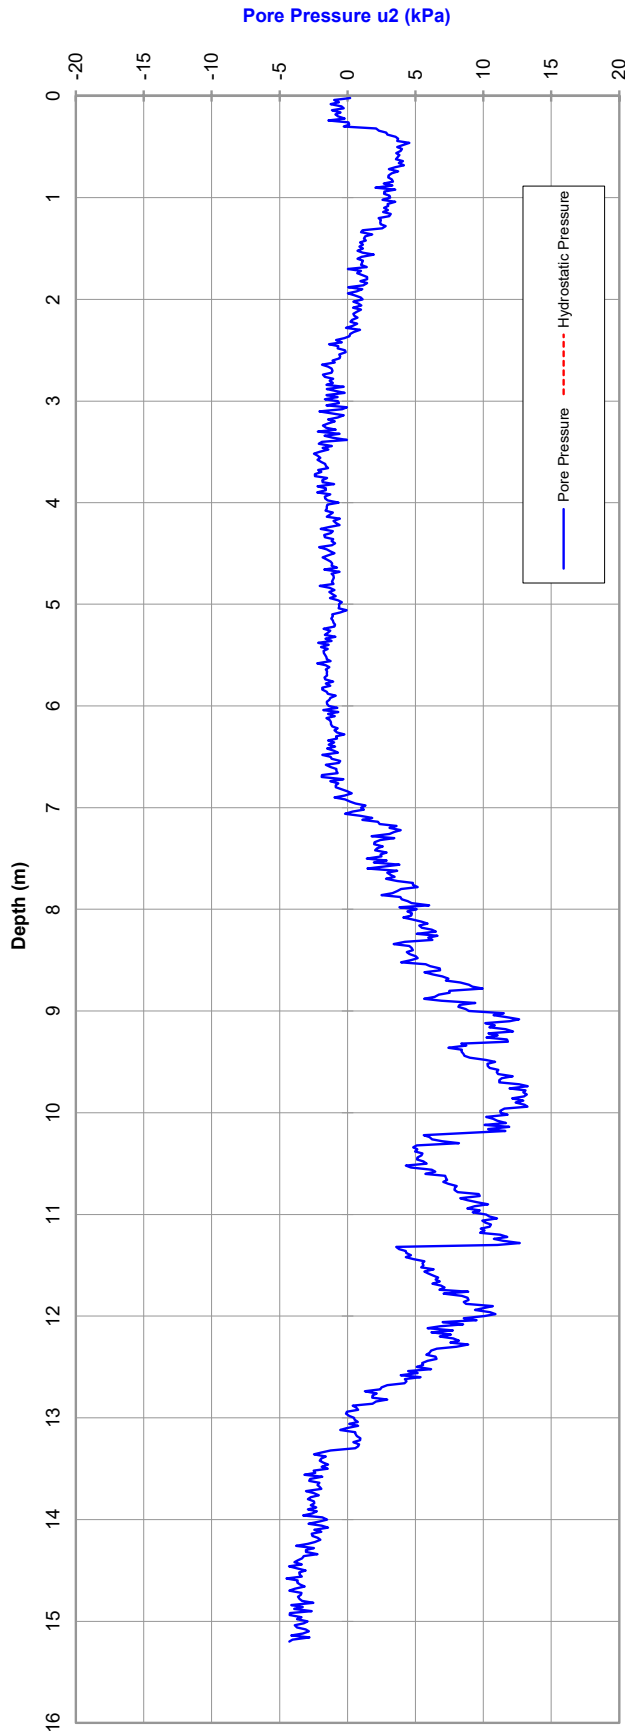
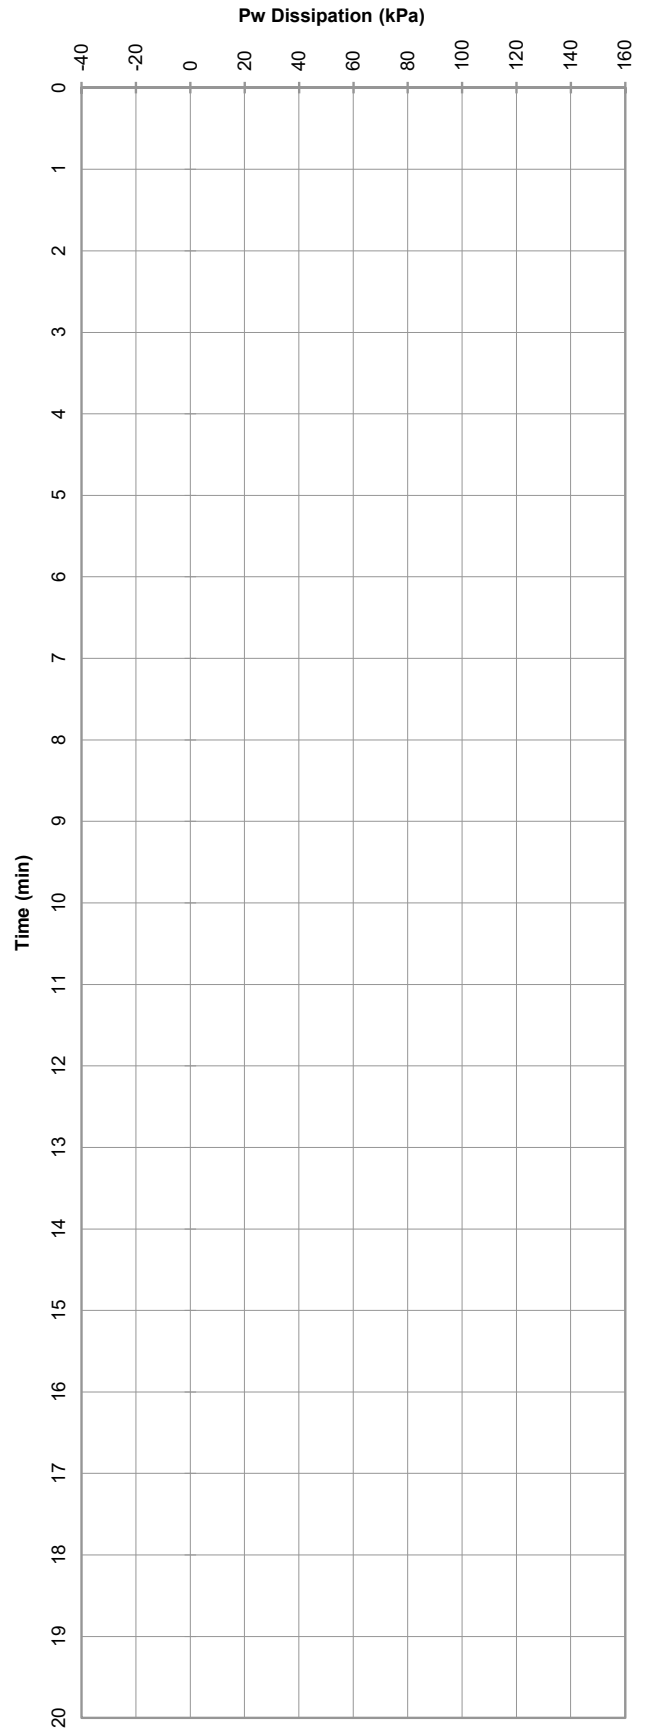
CPTU 159

Tested in accordance with AS 1289.6.5.1-1999 and IRTP 2001 for friction reducer

Please note: Hydrostatic Line is taken from the water level manually dipped by the CPT Operator following completion of the probe and, as such, should be used as a guide only.

Approx. Water (m): Dry to 13.5

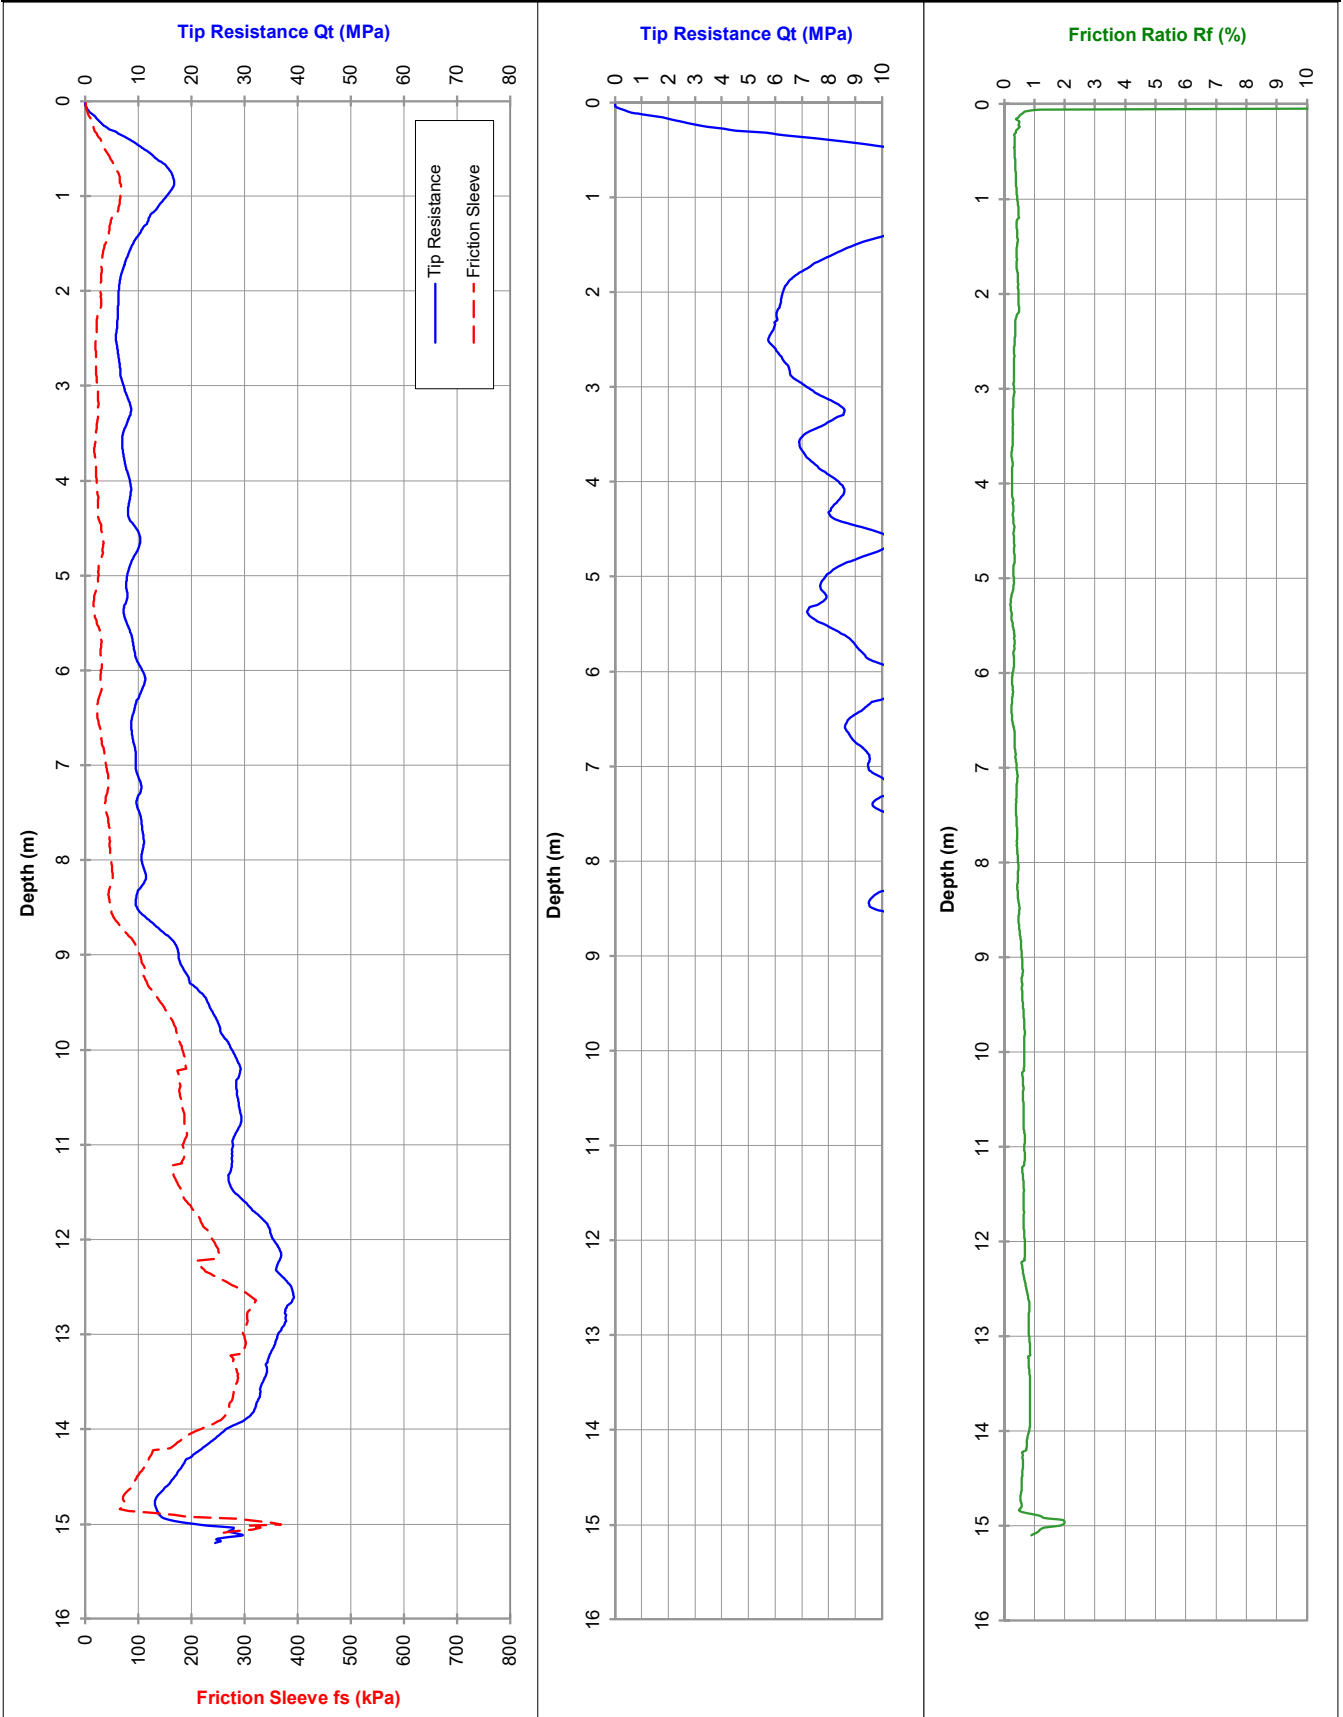
CPTU 162

Tested in accordance with AS 1289.6.5.1-1999 and IRTF 2001 for friction reducer

Approx. water (m): Dry to 13.9

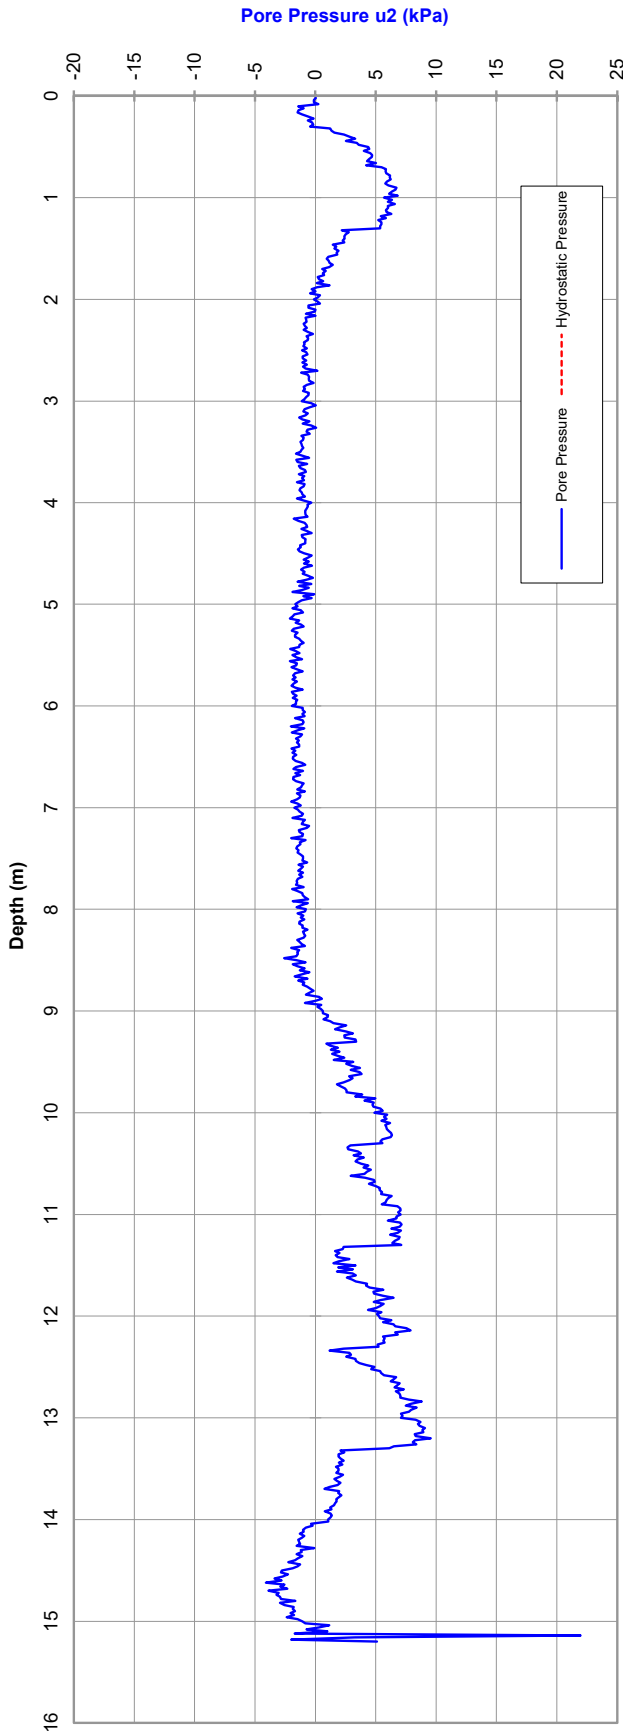
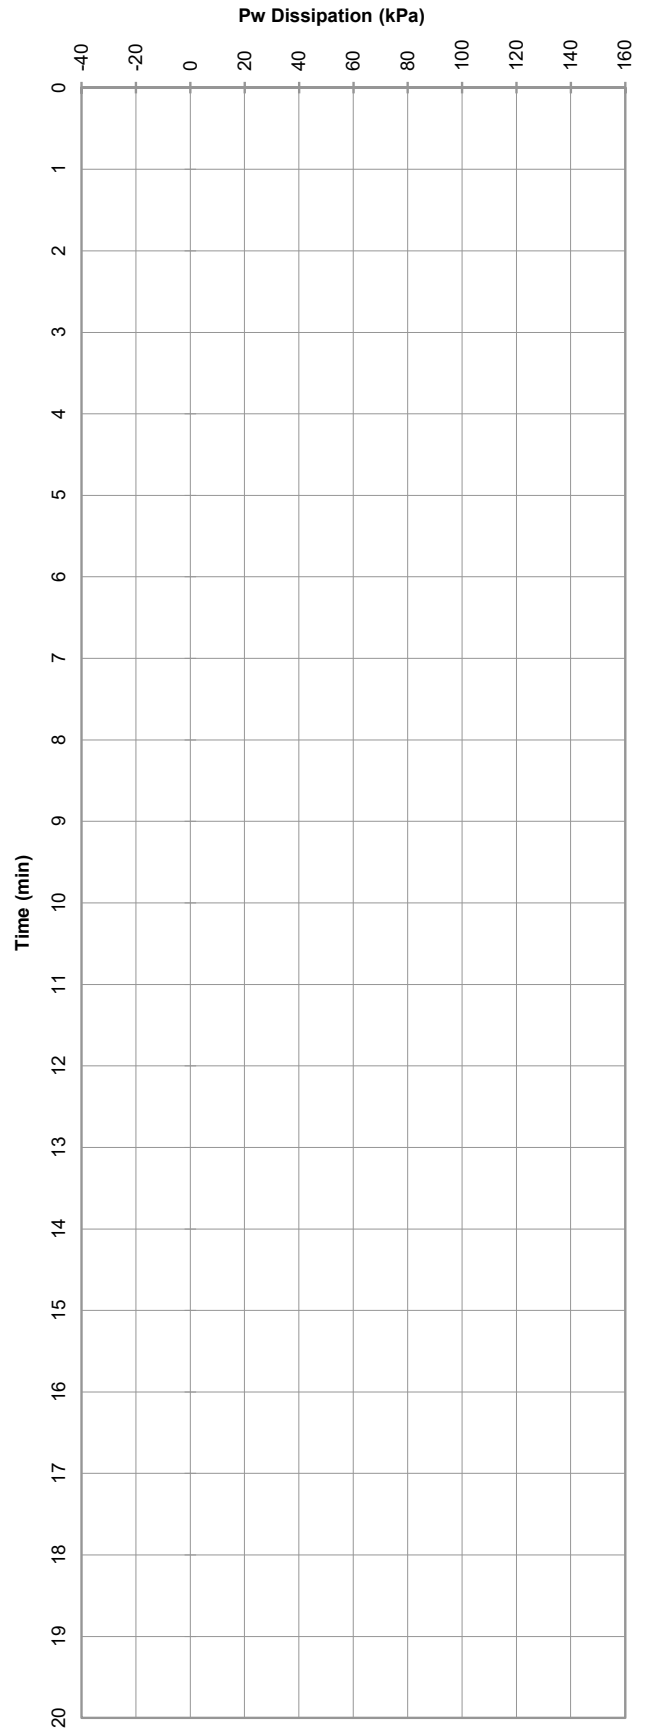
CPTU 162

Tested in accordance with AS 1289.6.5.1-1999 and IRTP 2001 for friction reducer

Please note: Hydrostatic Line is taken from the water level manually dipped by the CPT Operator following completion of the probe and, as such, should be used as a guide only.

Approx. Water (m): Dry to 13.9

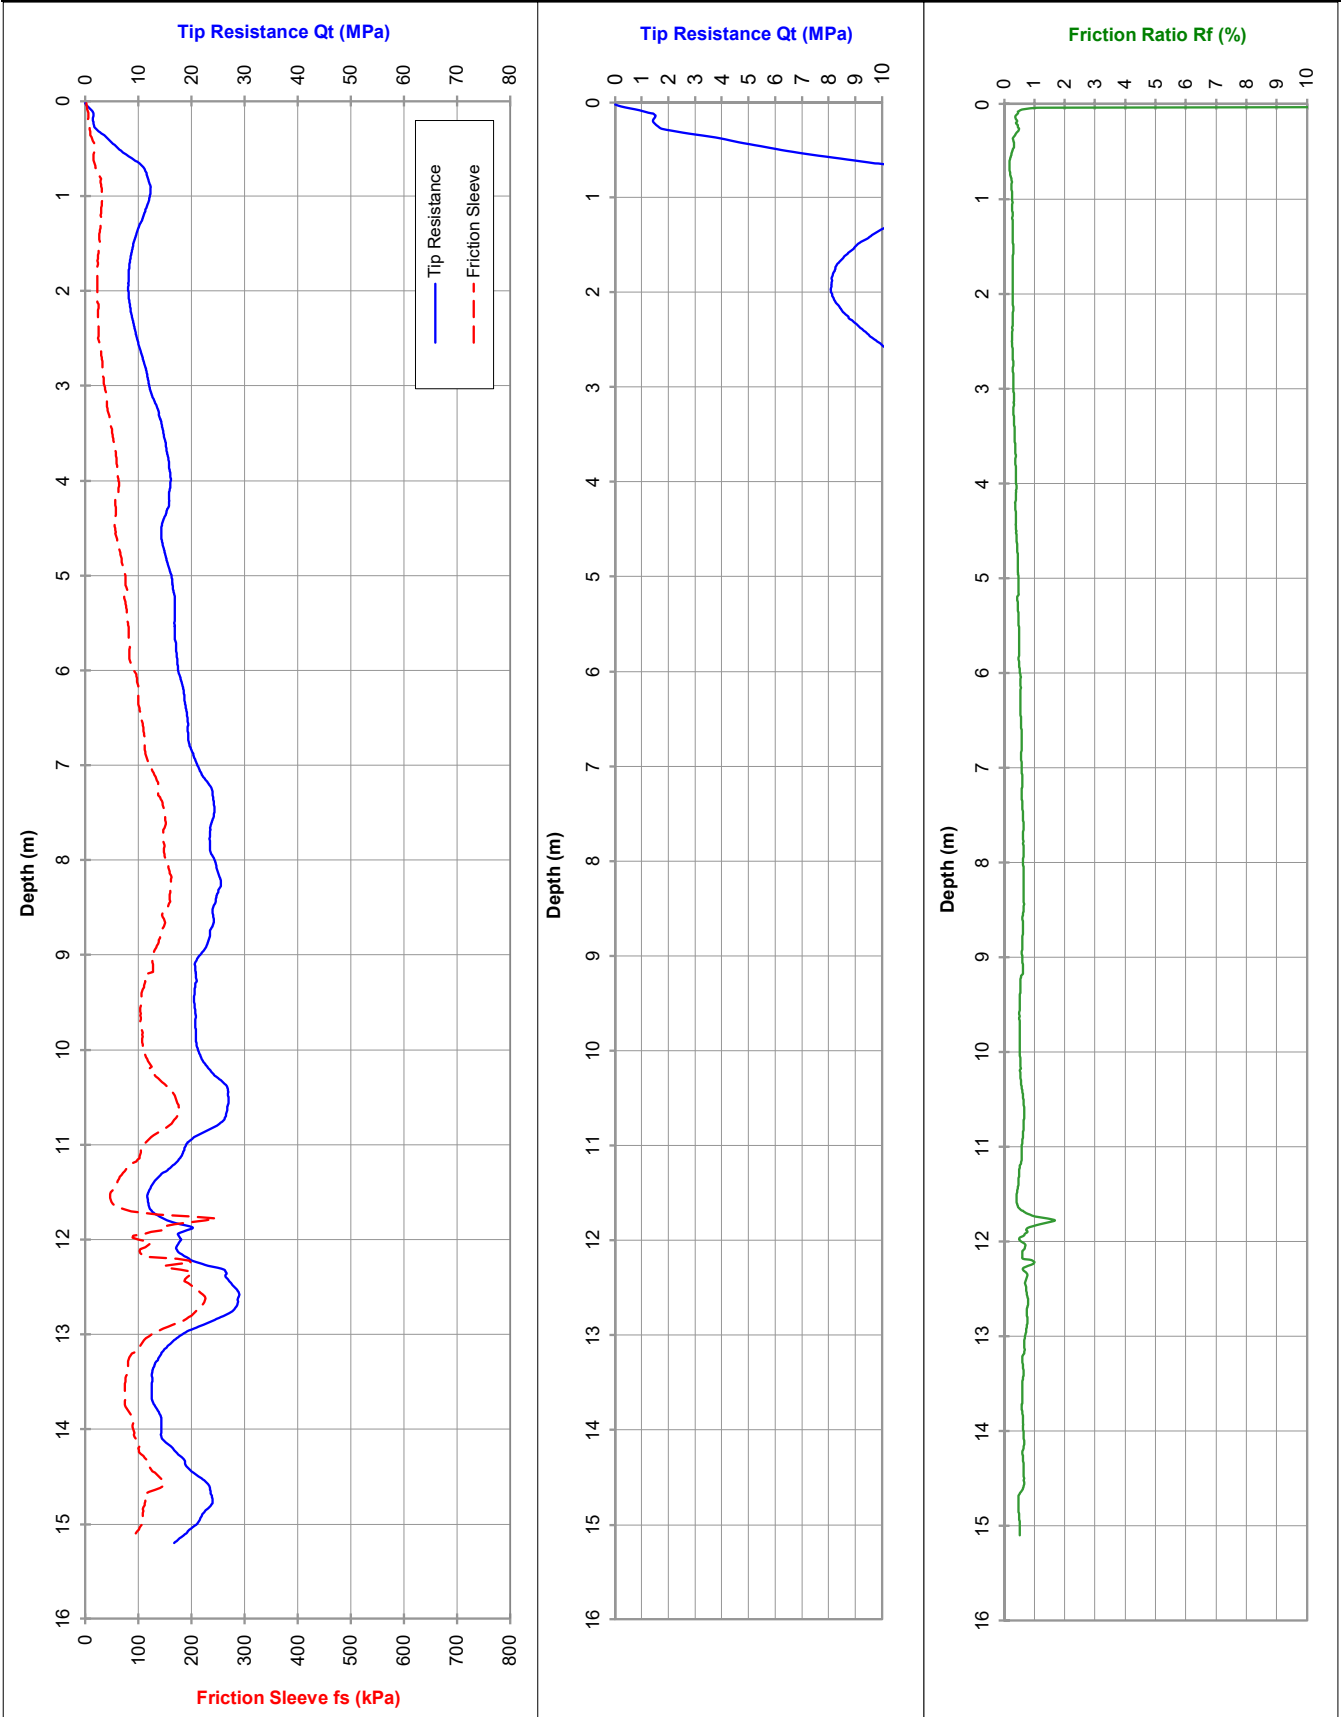
CPTU 163

Tested in accordance with AS 1289.6.5.1-1999 and IRTF 2001 for friction reducer

Approx. water (m): Dry to 14.2

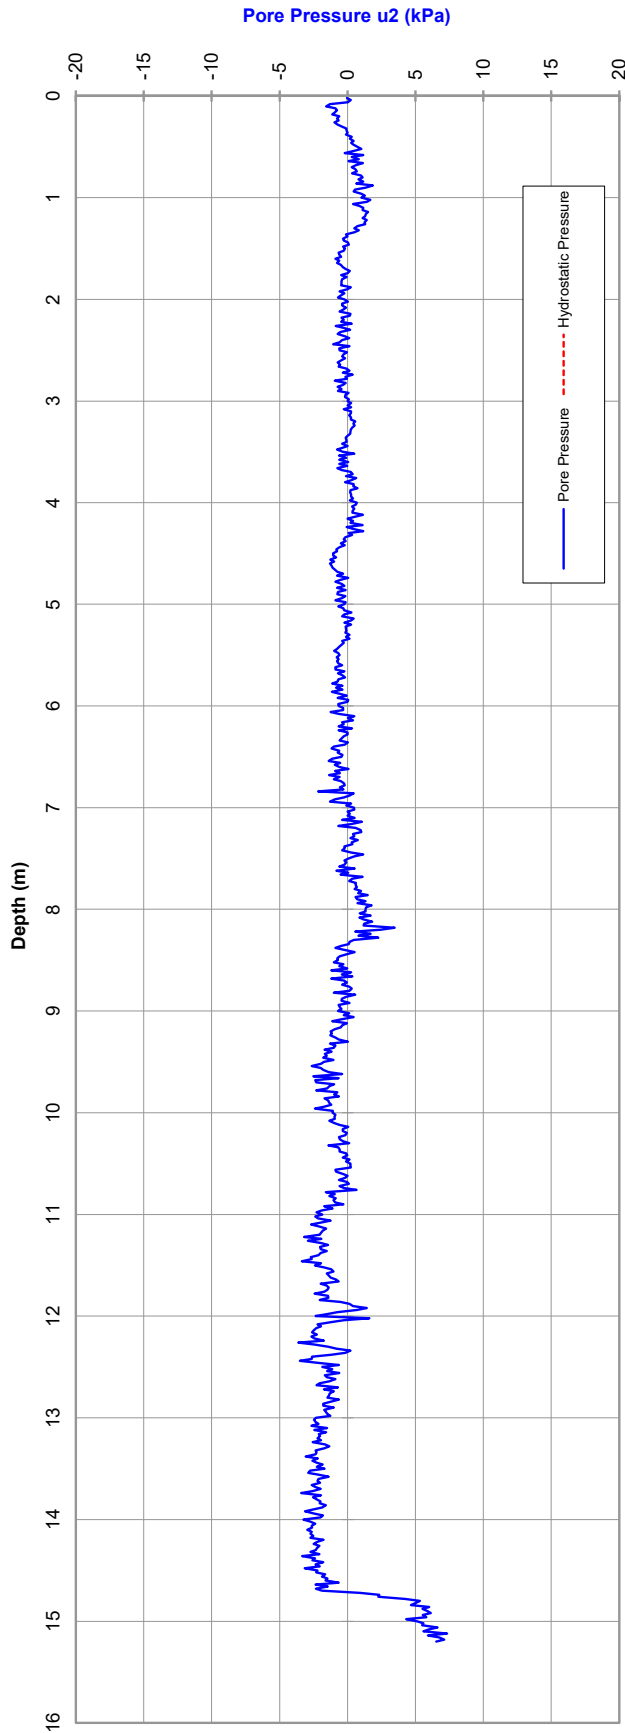
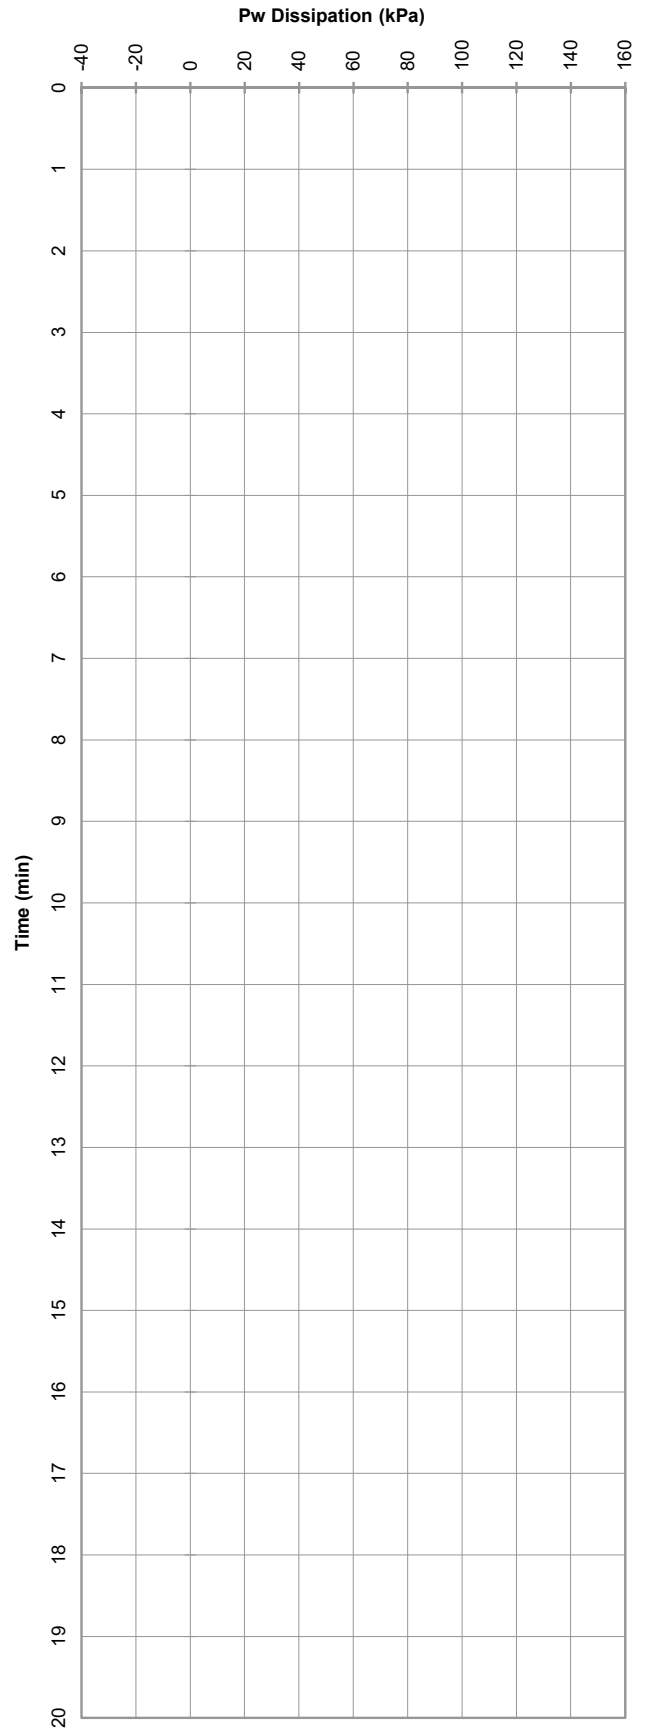
CPTU 163

Tested in accordance with AS 1289.6.5.1-1999 and IRTP 2001 for friction reducer

Please note: Hydrostatic Line is taken from the water level manually dipped by the CPT Operator following completion of the probe and, as such, should be used as a guide only.

Approx. Water (m): Dry to 14.2

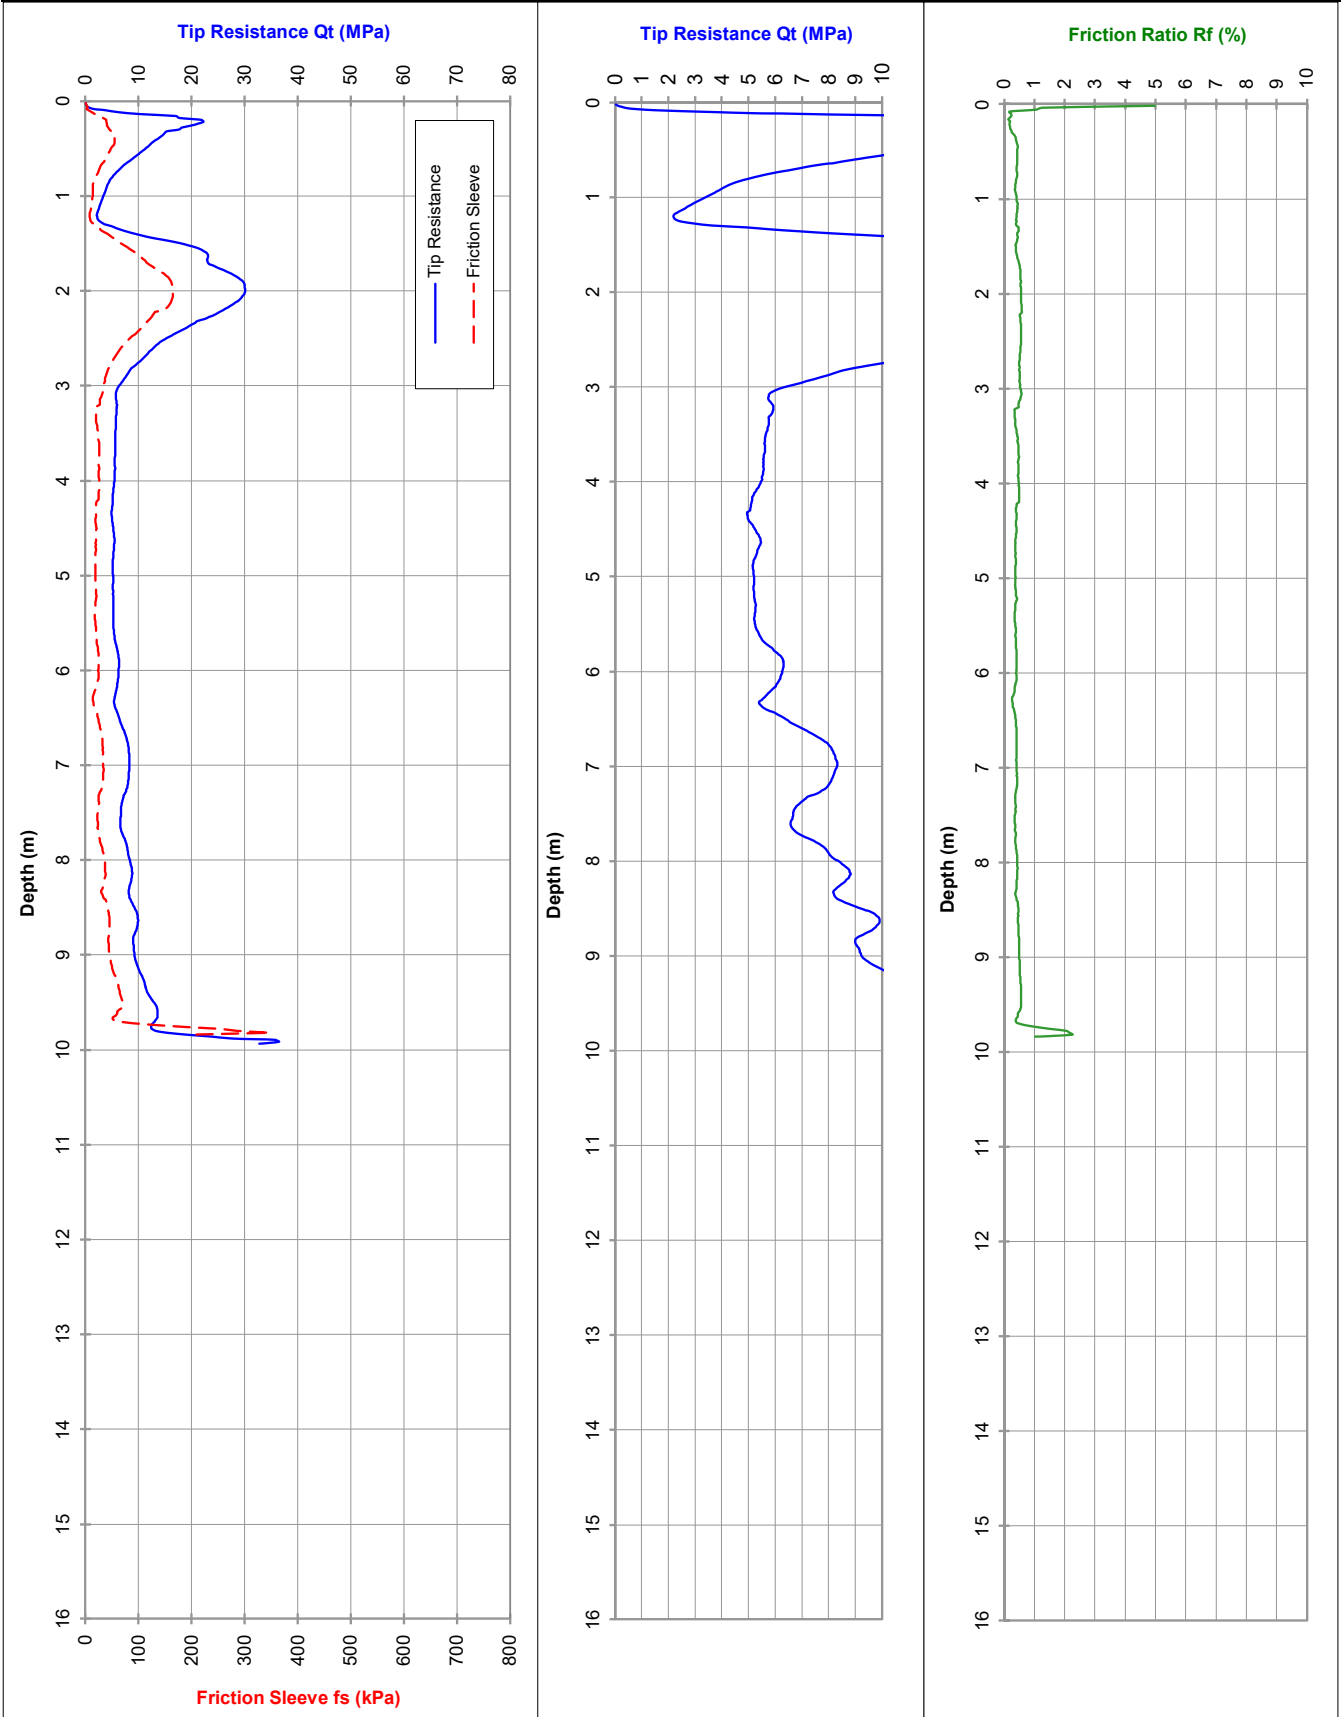
CPTU 164

Tested in accordance with AS 1289.6.5.1-1999 and IRTF 2001 for friction reducer

Approx. water (m): Dry to 7.4

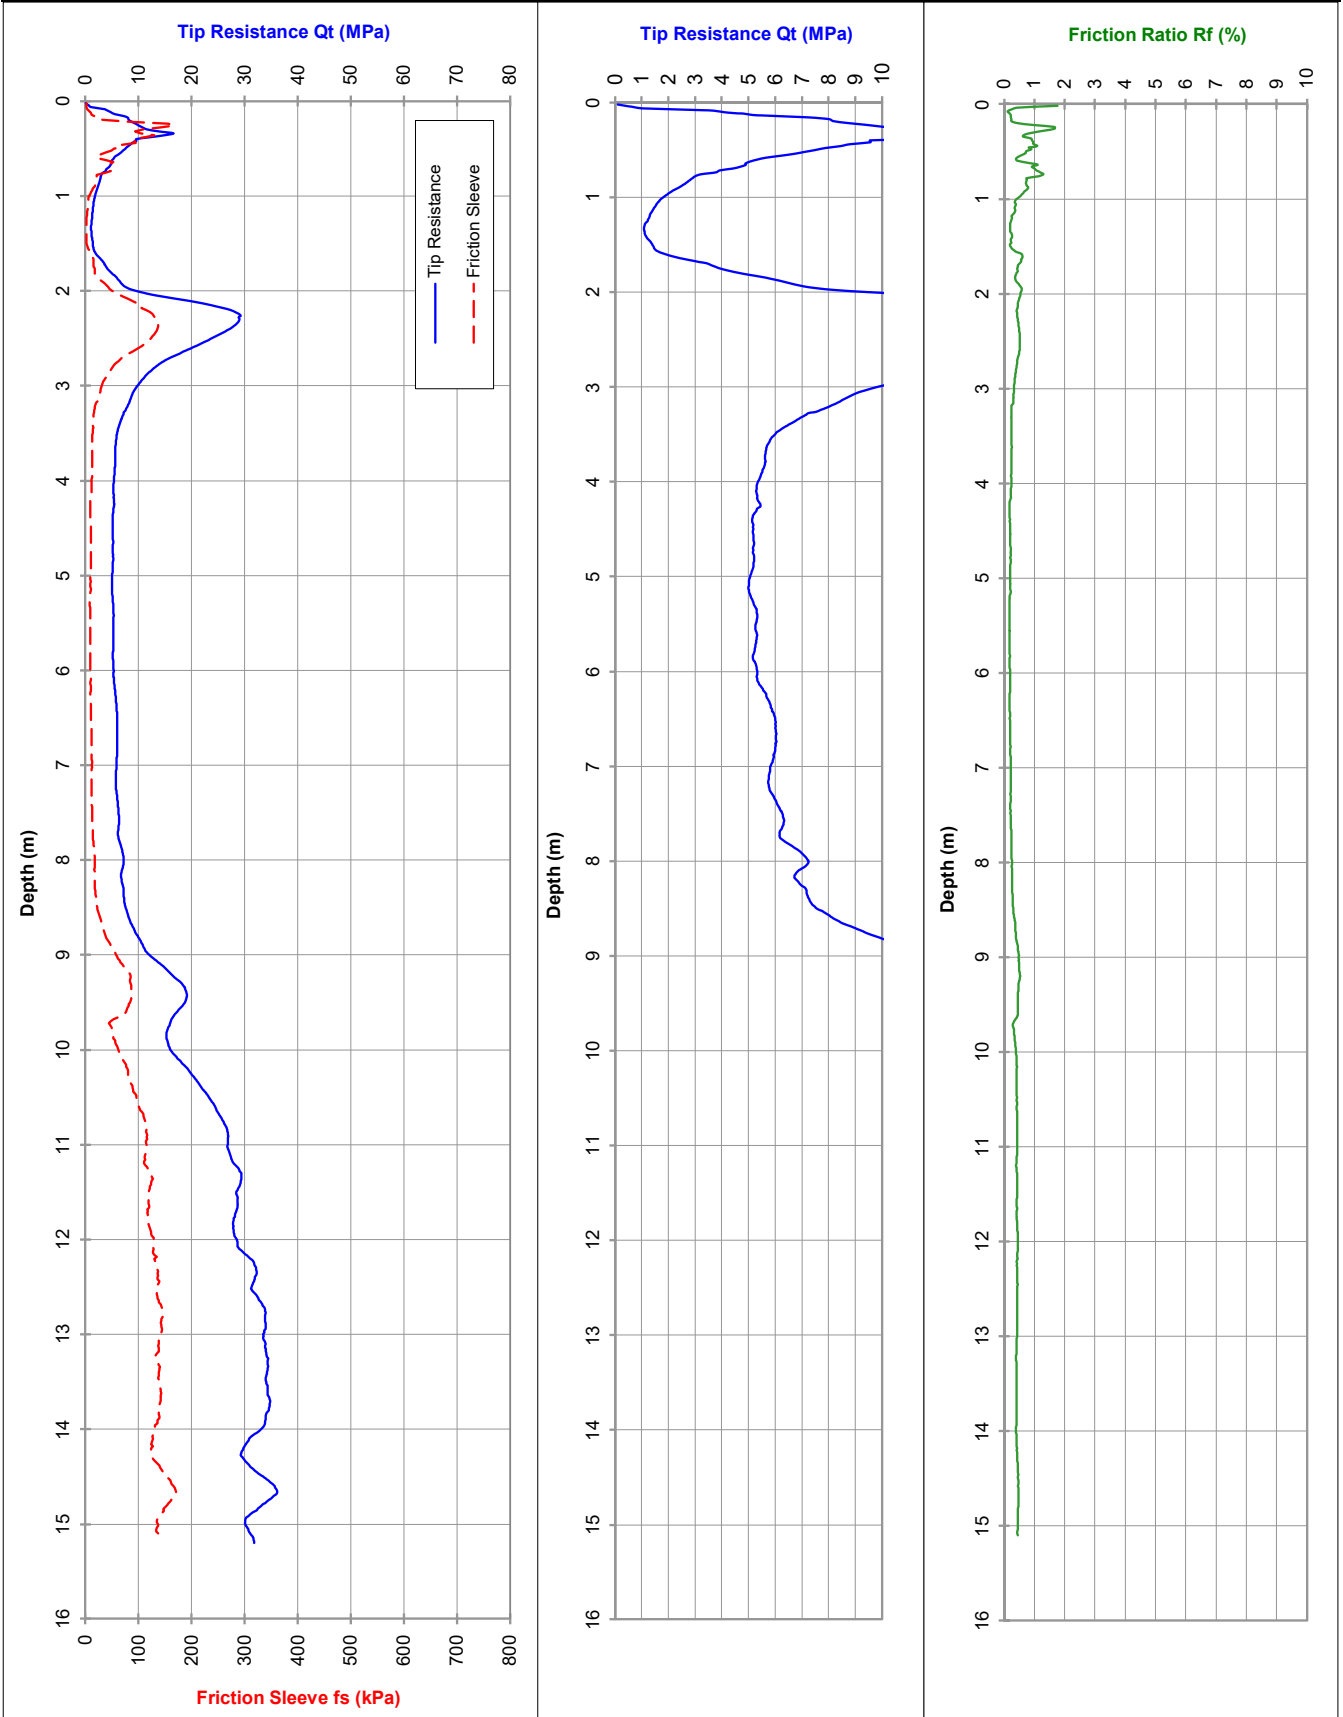
CPTU 166

Tested in accordance with AS 1289.6.5.1-1999 and IRTF 2001 for friction reducer

Approx. water (m): Dry to 0.0

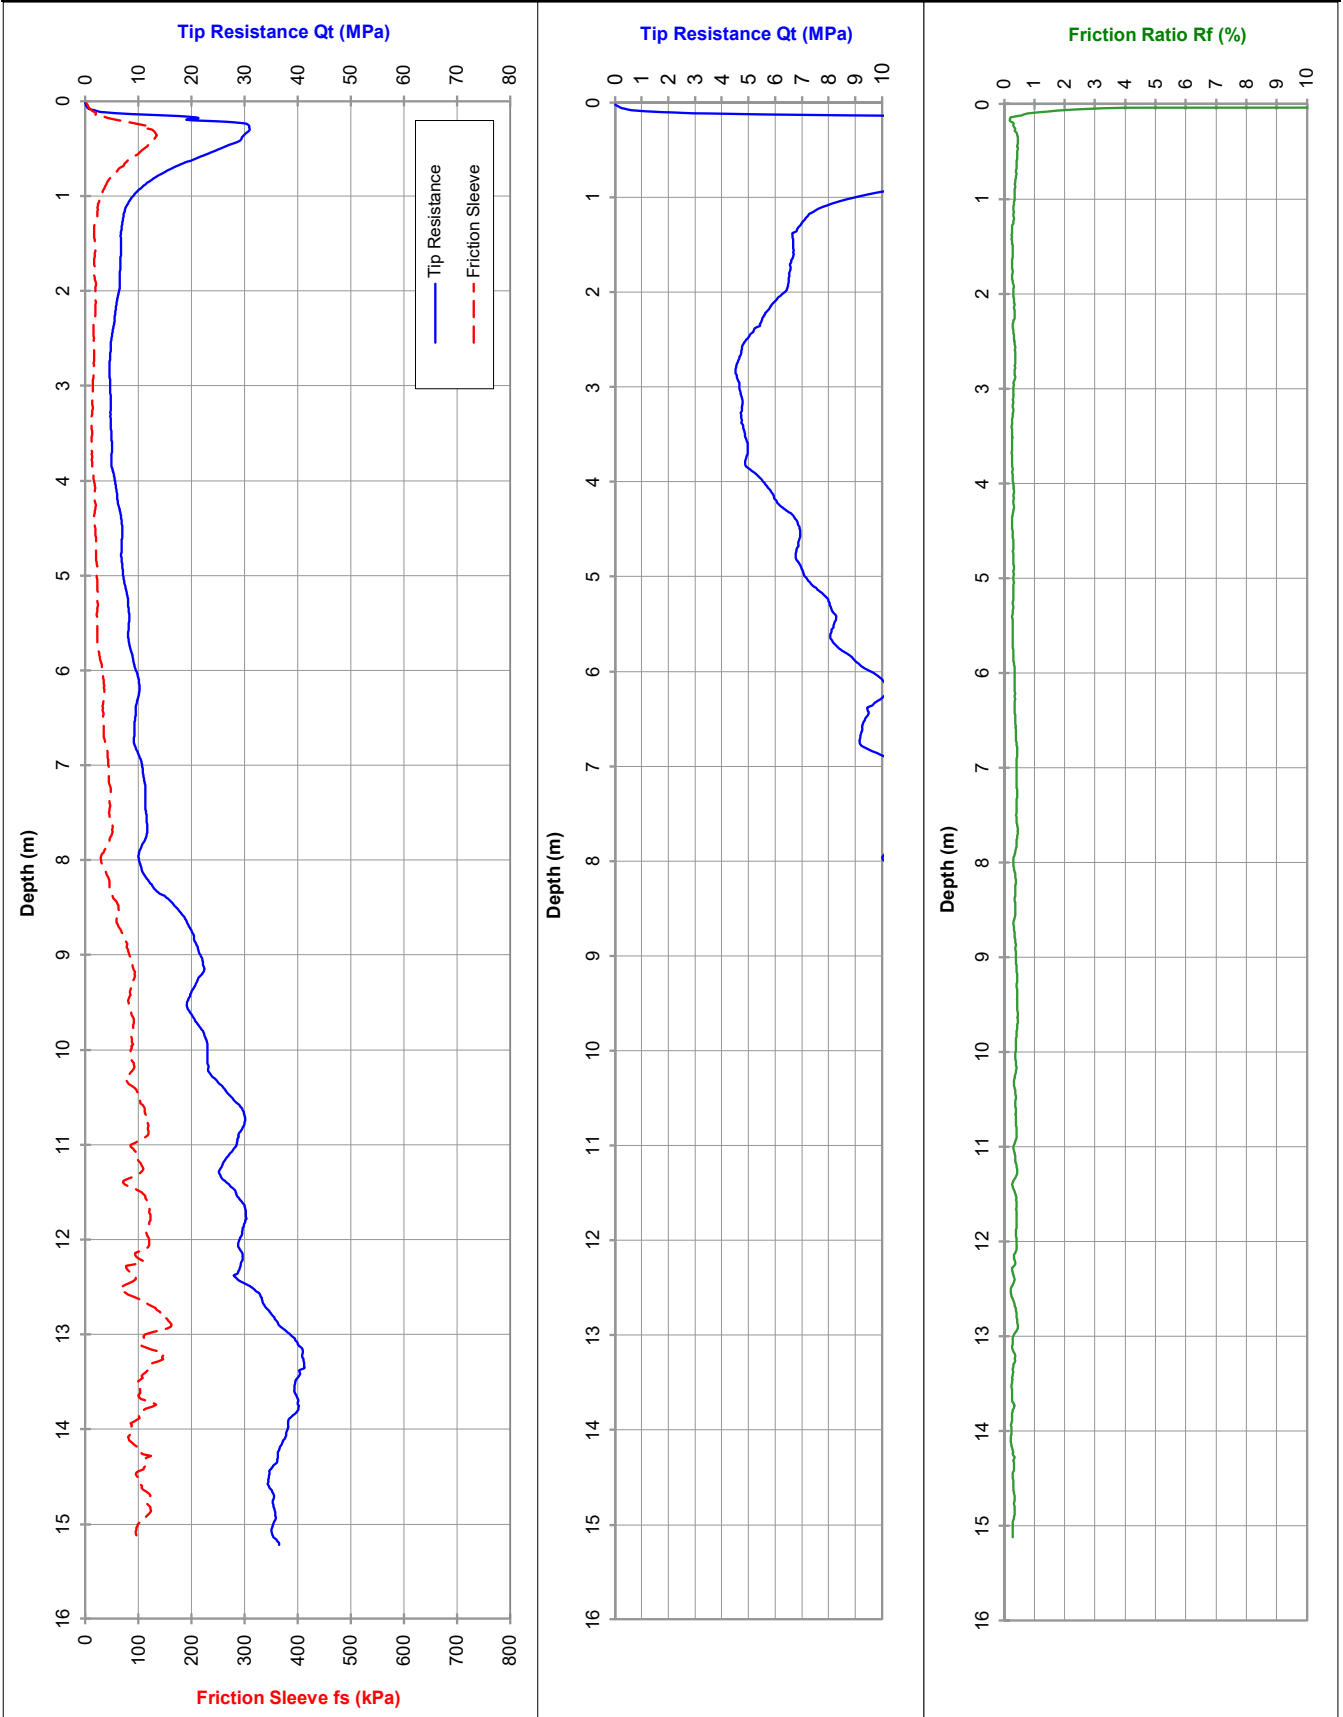
CPTU 167

Tested in accordance with AS 1289.6.5.1-1999 and IRTF 2001 for friction reducer

Approx. water (m): Dry to 7.1

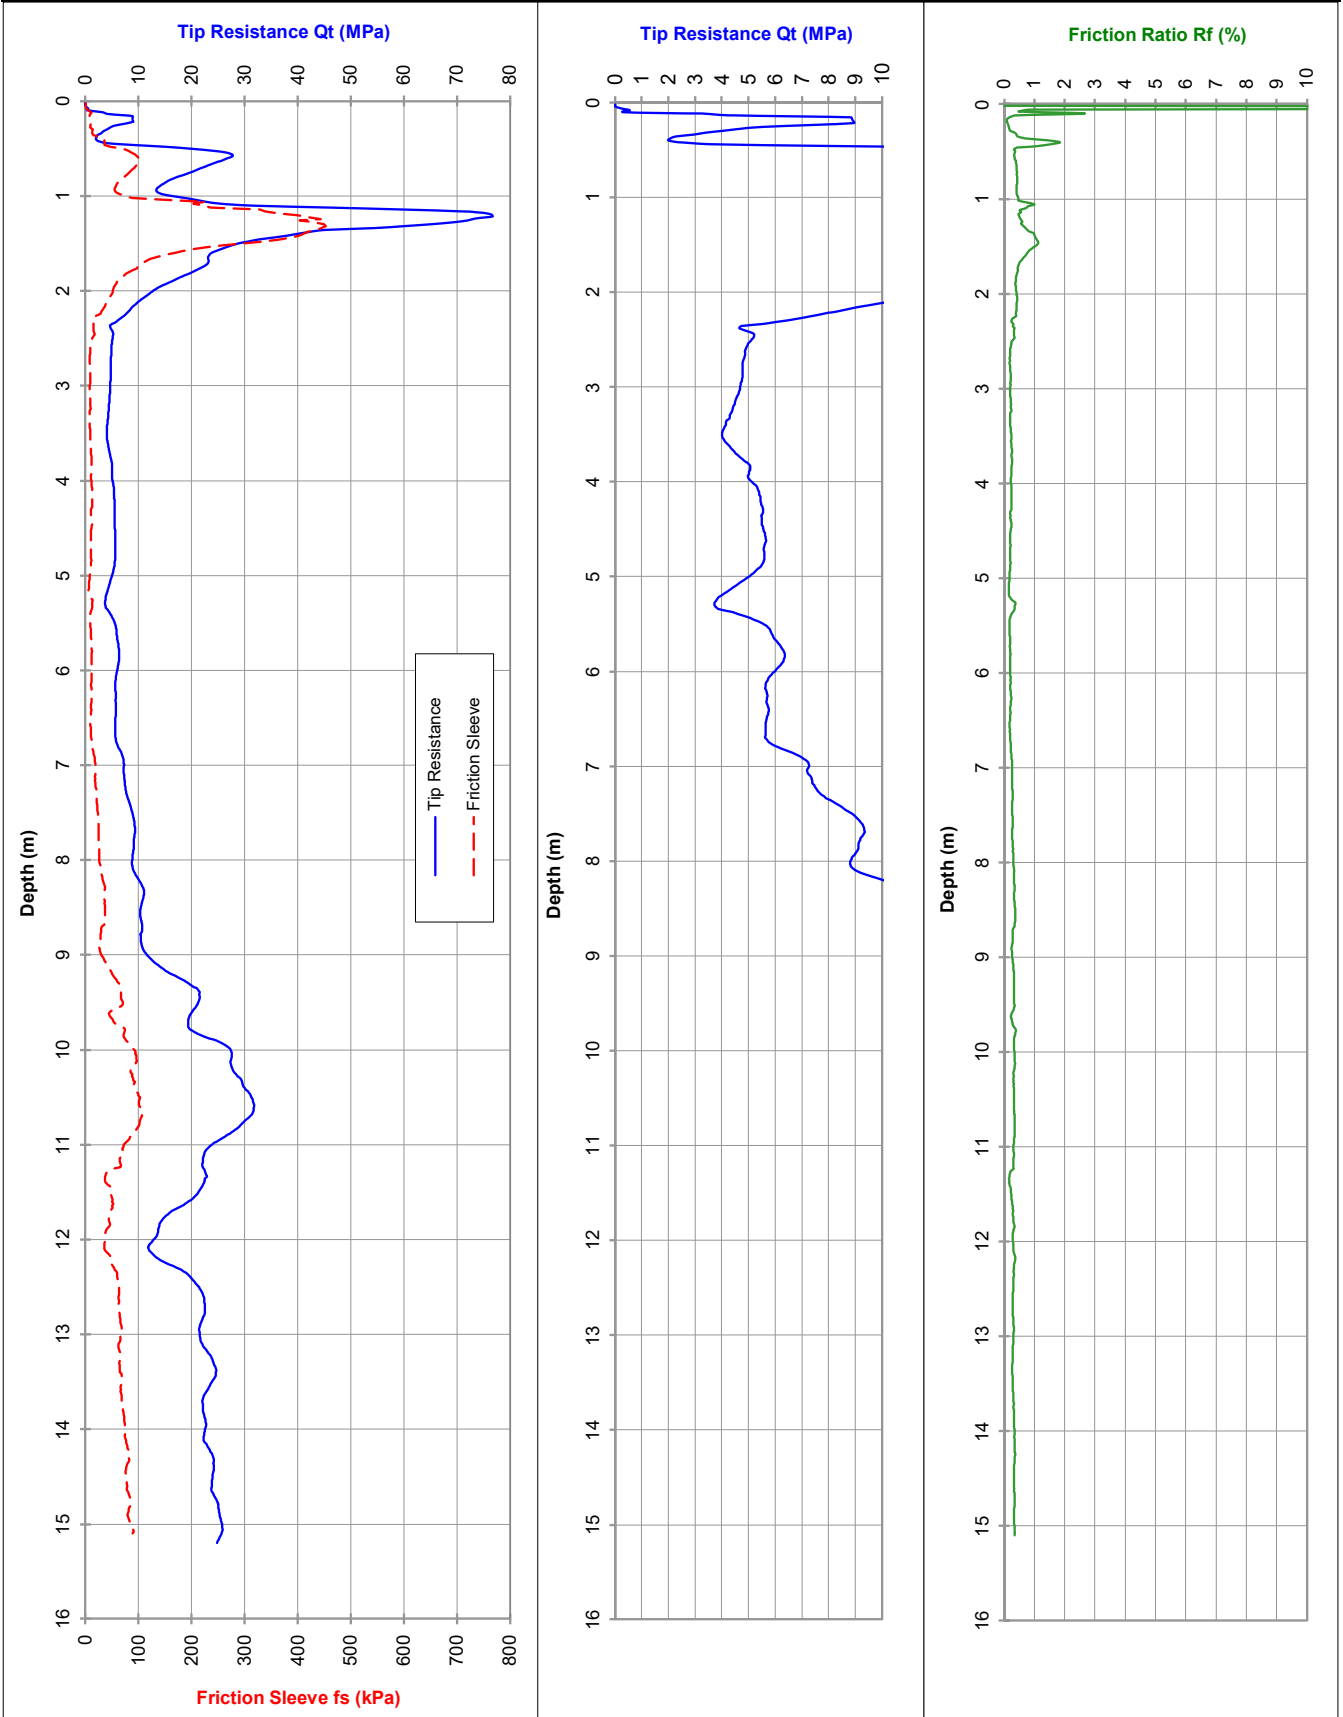
CPTU 168

Tested in accordance with AS 1289.6.5.1-1999 and IRTF 2001 for friction reducer

Approx. water (m): Dry to 7.9

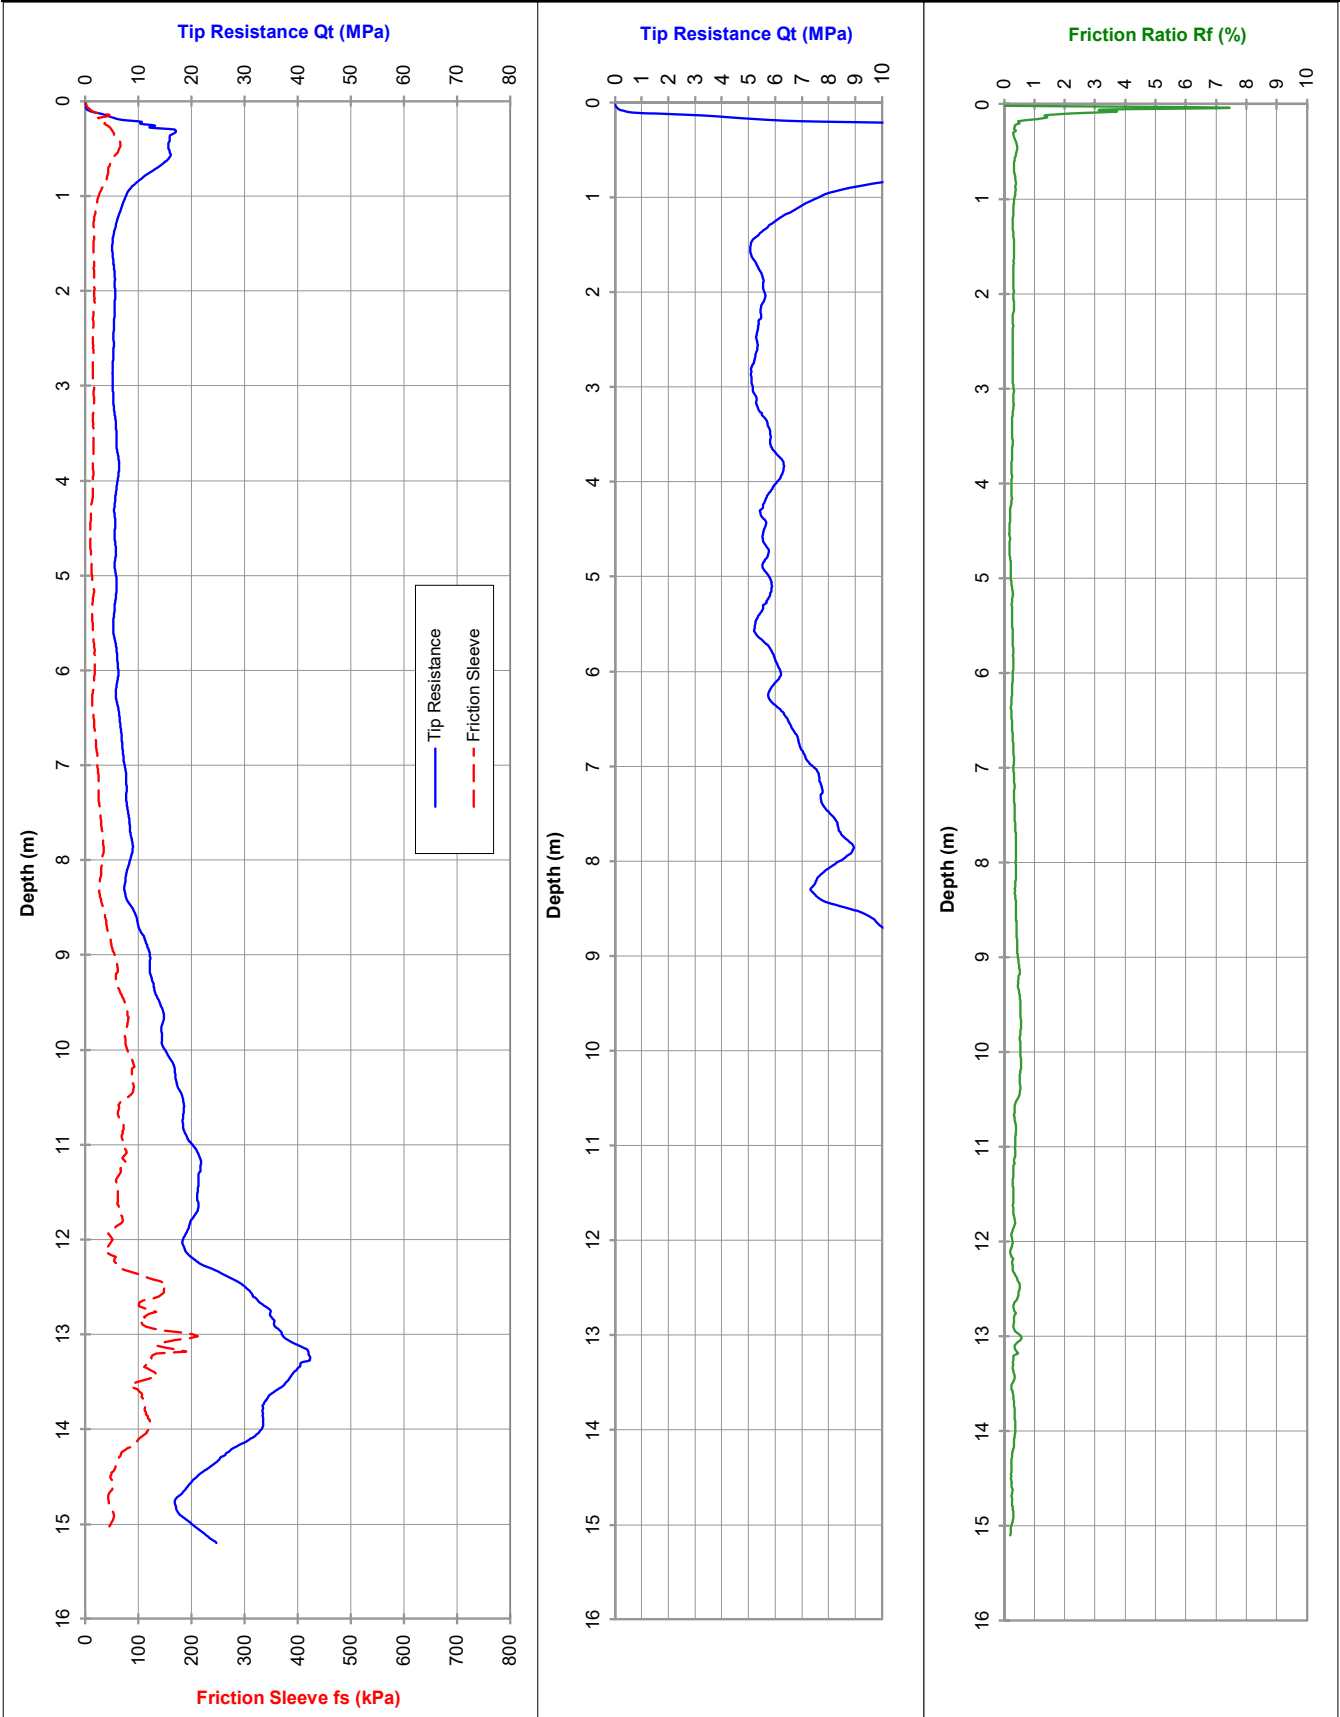
CPTU 170

Tested in accordance with AS 1289.6.5.1-1999 and IRTF 2001 for friction reducer

Approx. water (m): Dry to 9.2
