ELECTRIC FRICTION-CONE PENETROMETER

CLIENT: Acciona Construction Australia

PROJECT: CELN Double Circuit

LOCATION: PER2025-0250

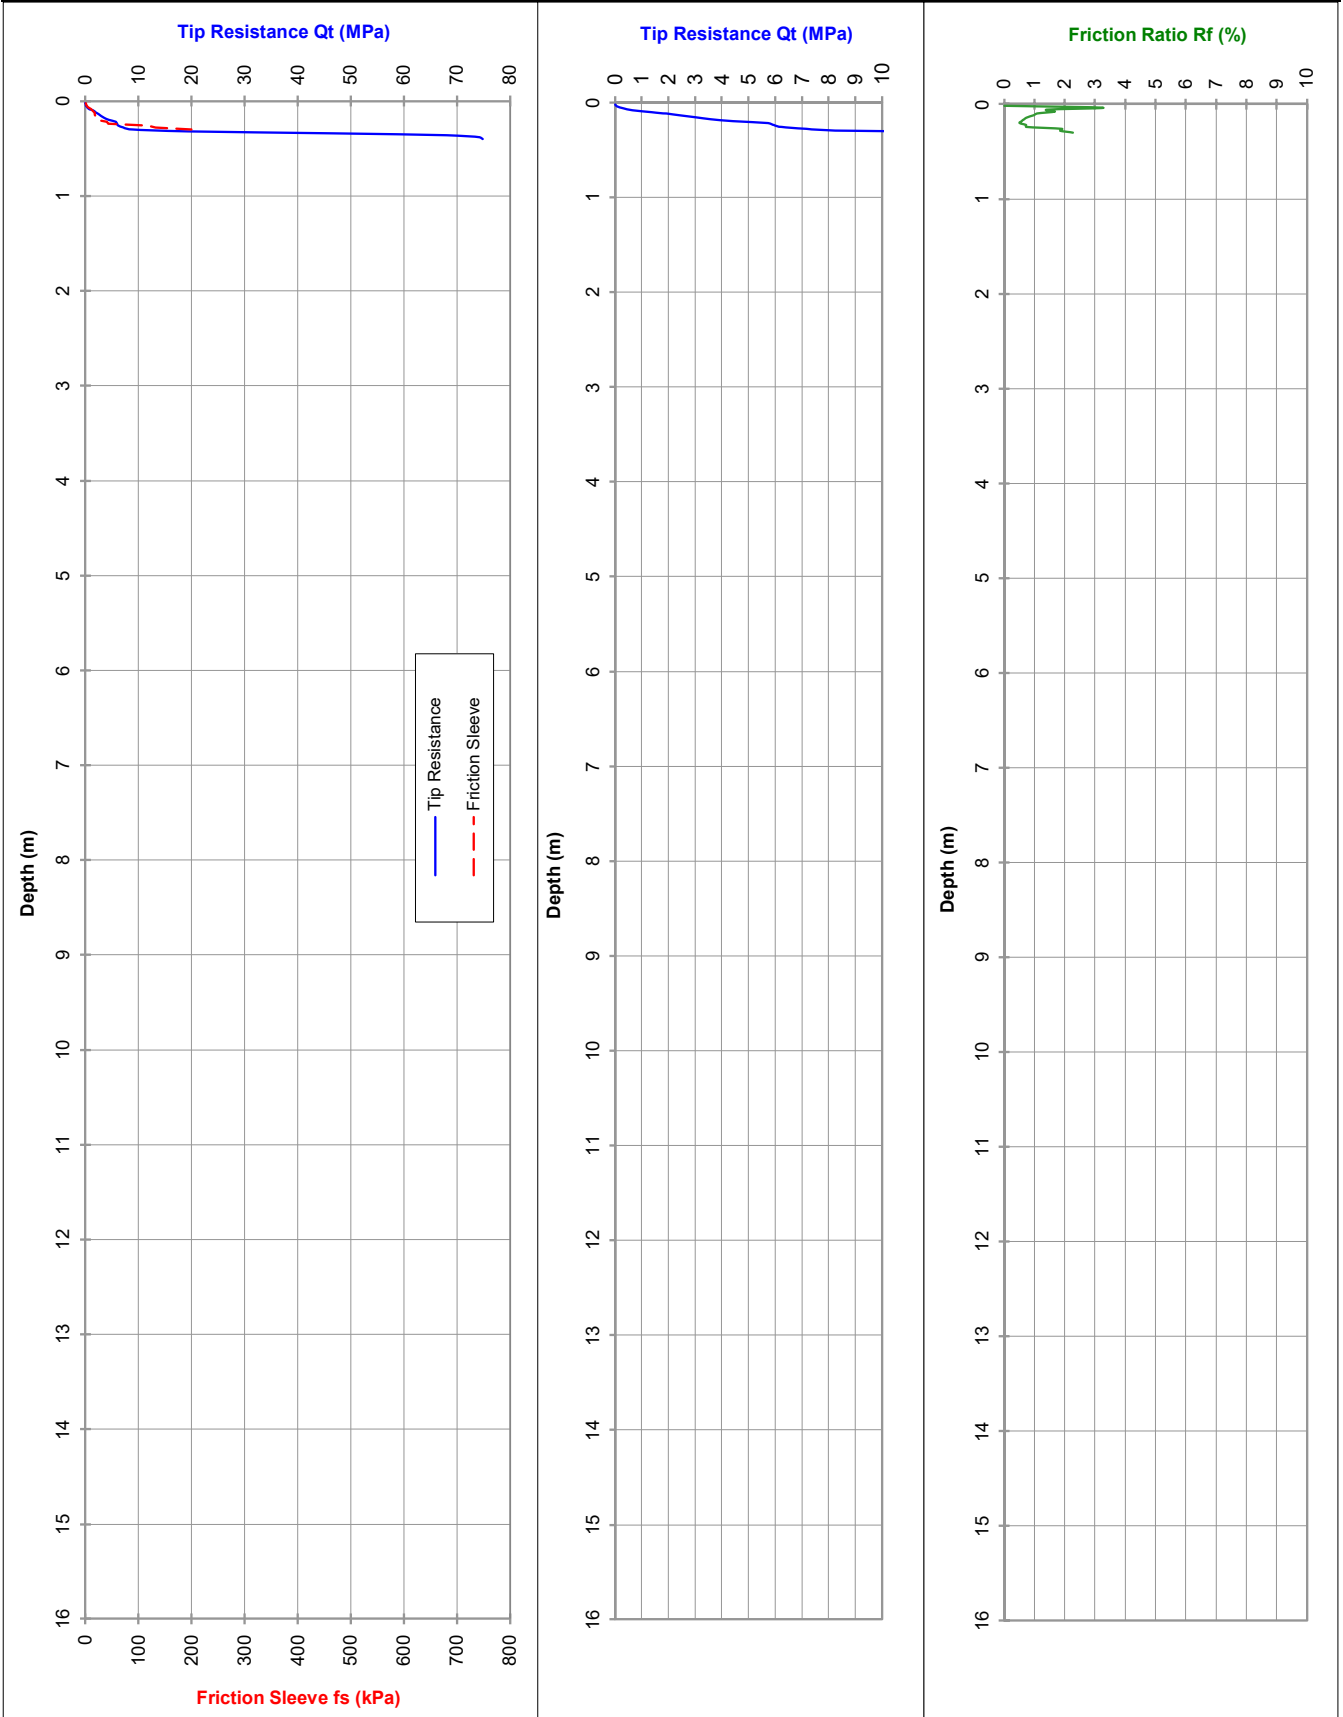
CPTU 171

Tested in accordance with AS 1289.6.5.1-1999 and IRTF 2001 for friction reducer

Approx. water (m): Dry to 0.0

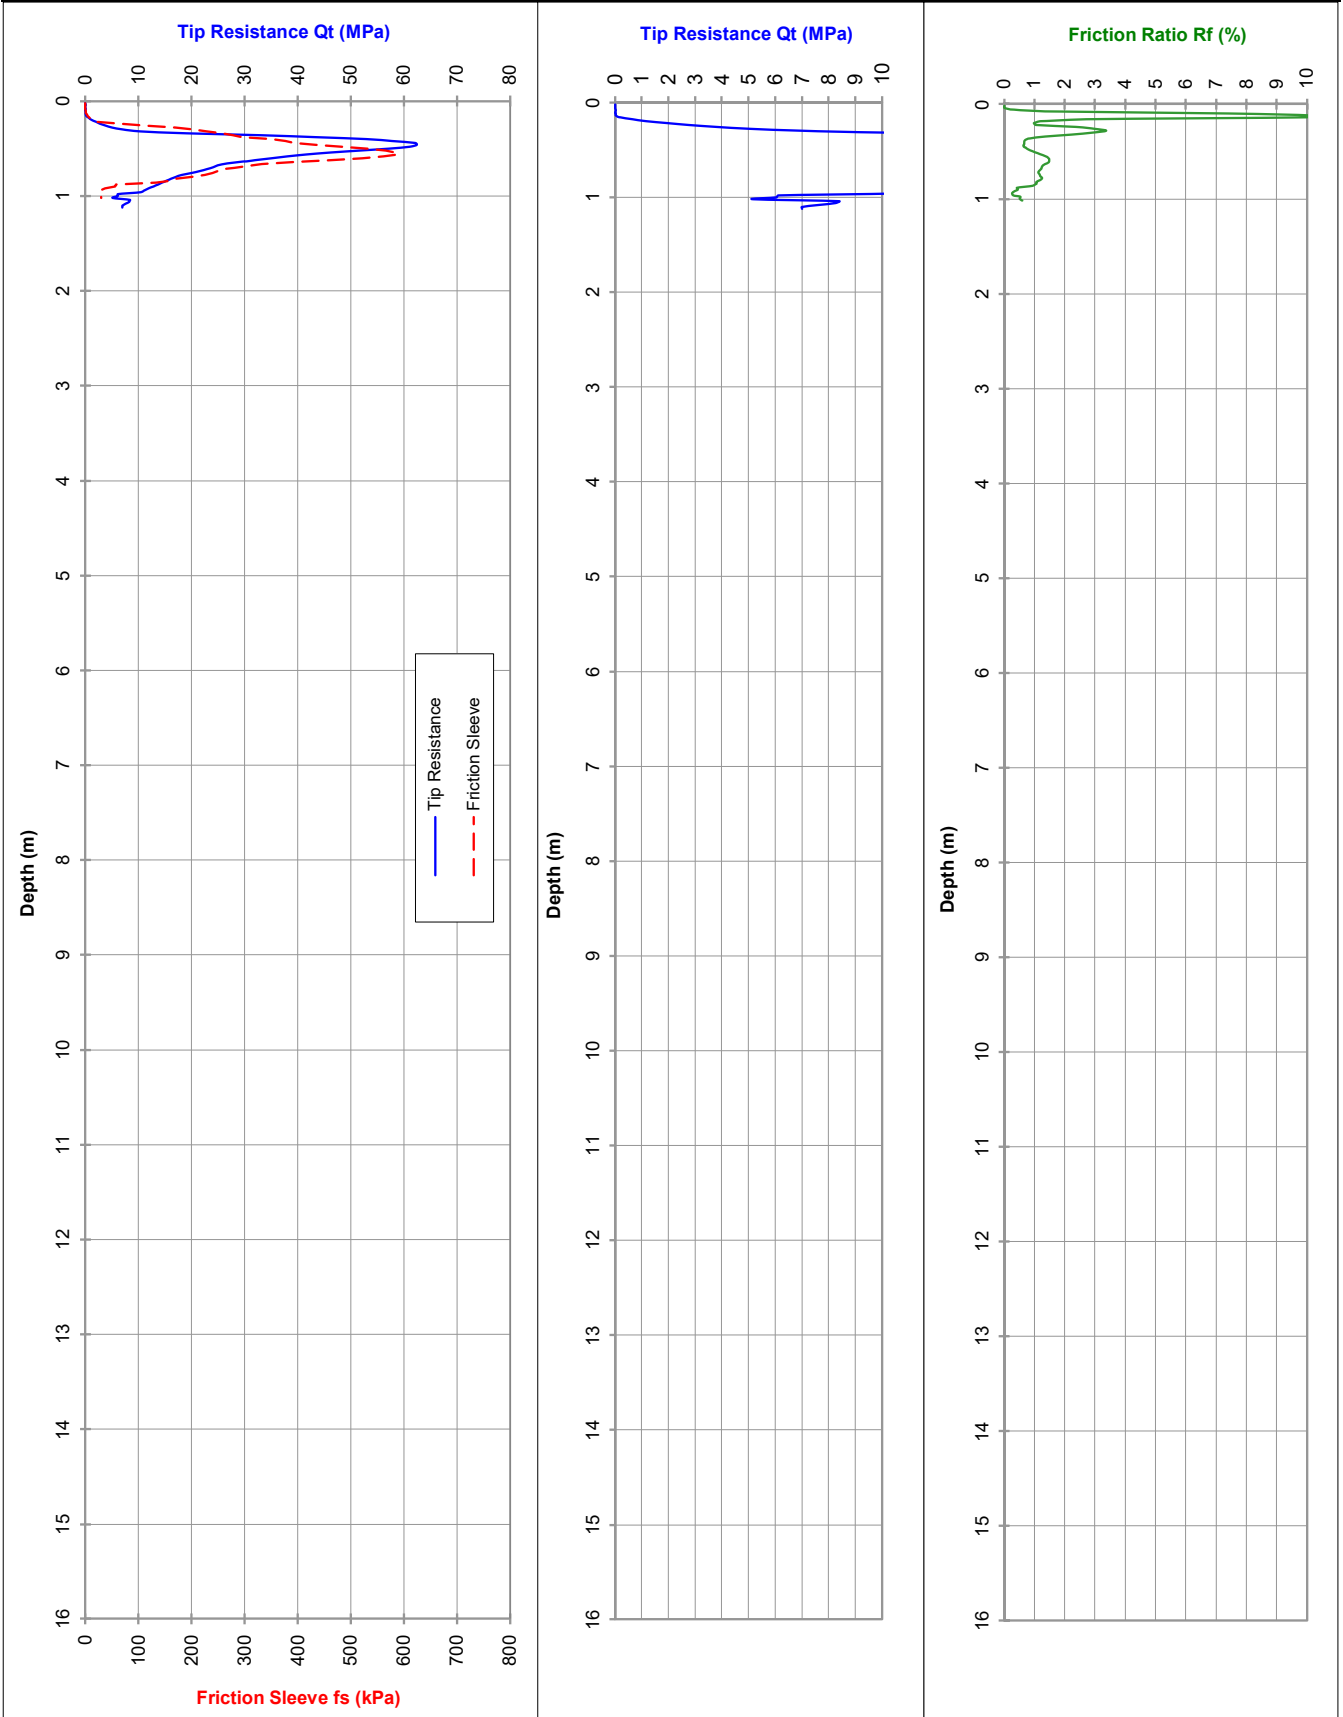
CPTU 171-A

Tested in accordance with AS 1289.6.5.1-1999 and IRTF 2001 for friction reducer

Approx. water (m): Dry to 0.0

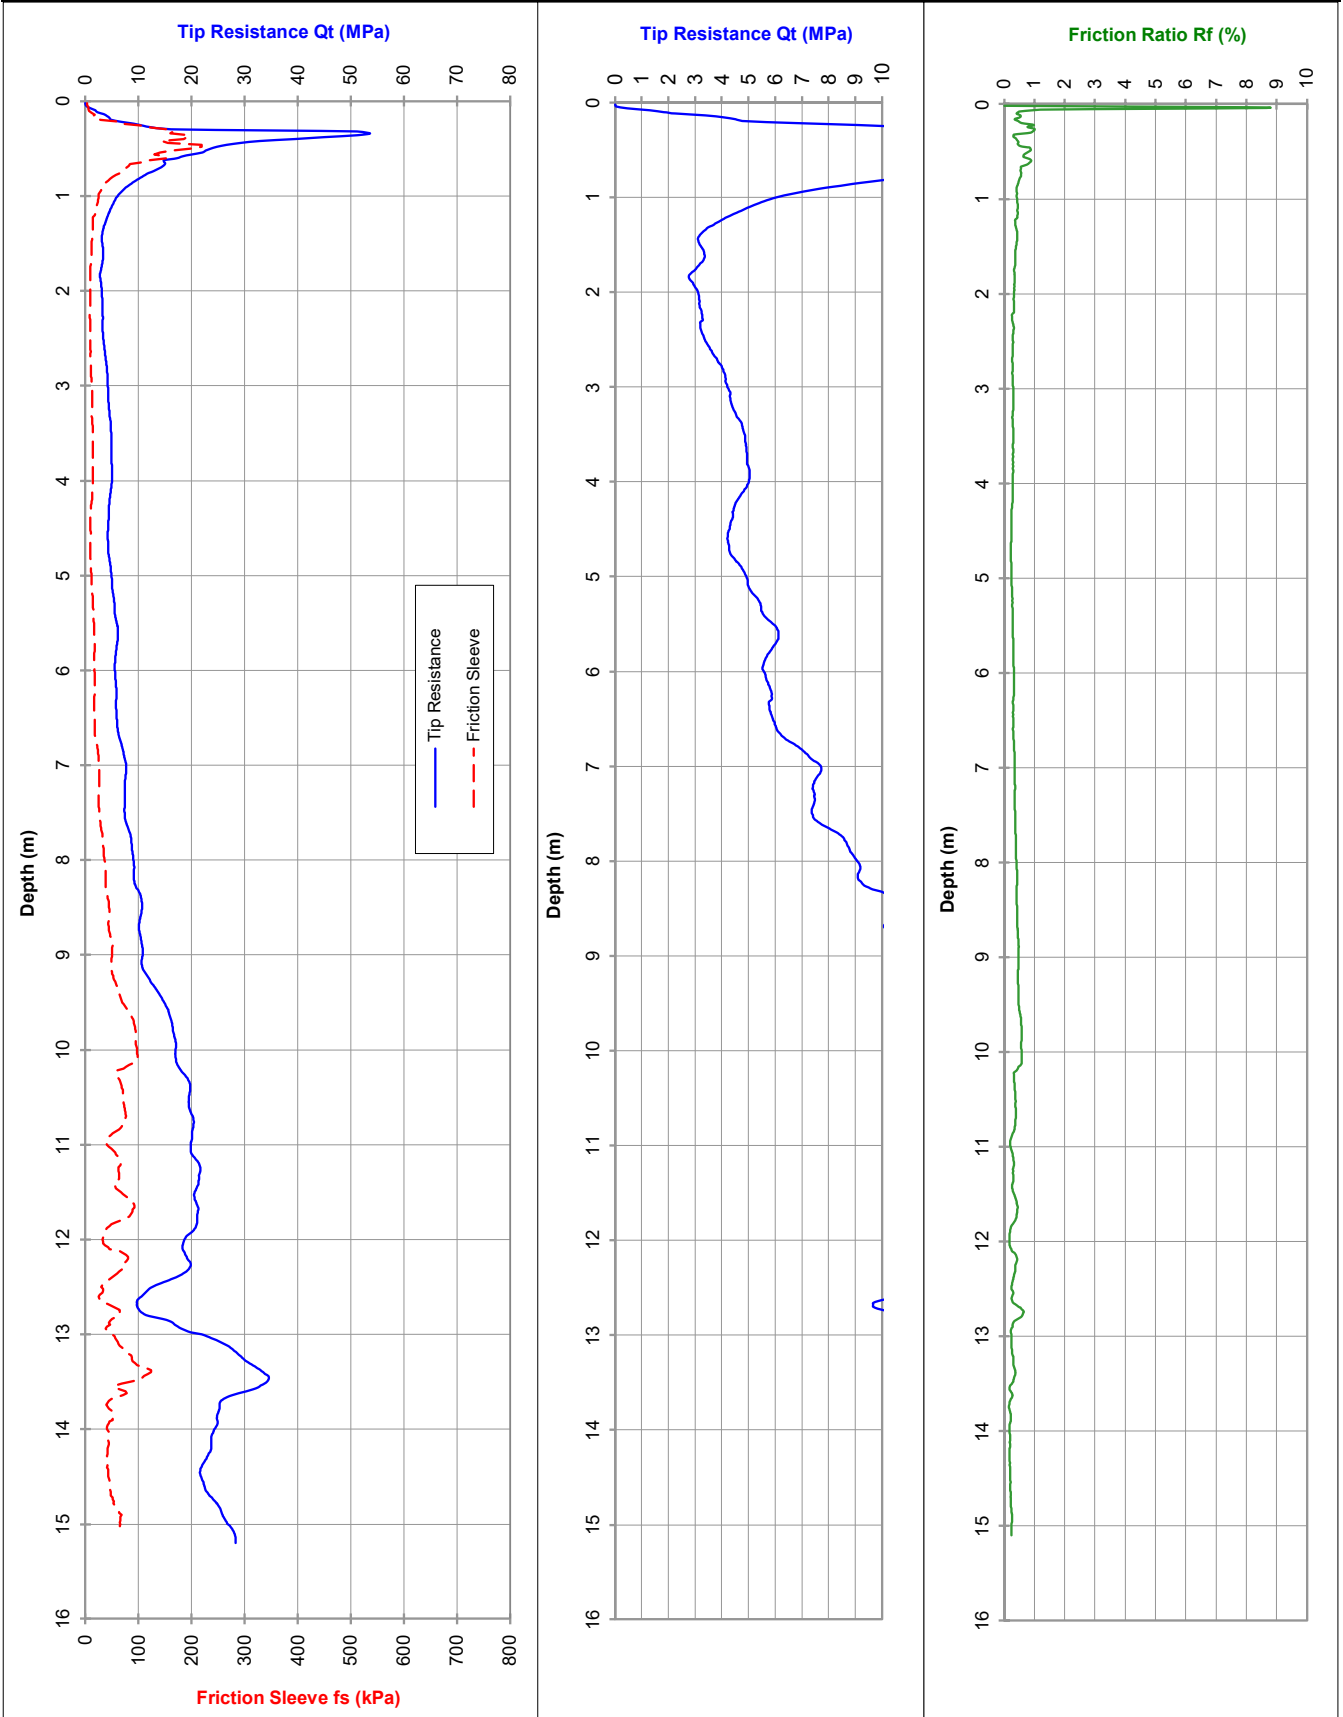
CPTU 171-B

Tested in accordance with AS 1289.6.5.1-1999 and IRTF 2001 for friction reducer

Approx. water (m): Dry to 11.6

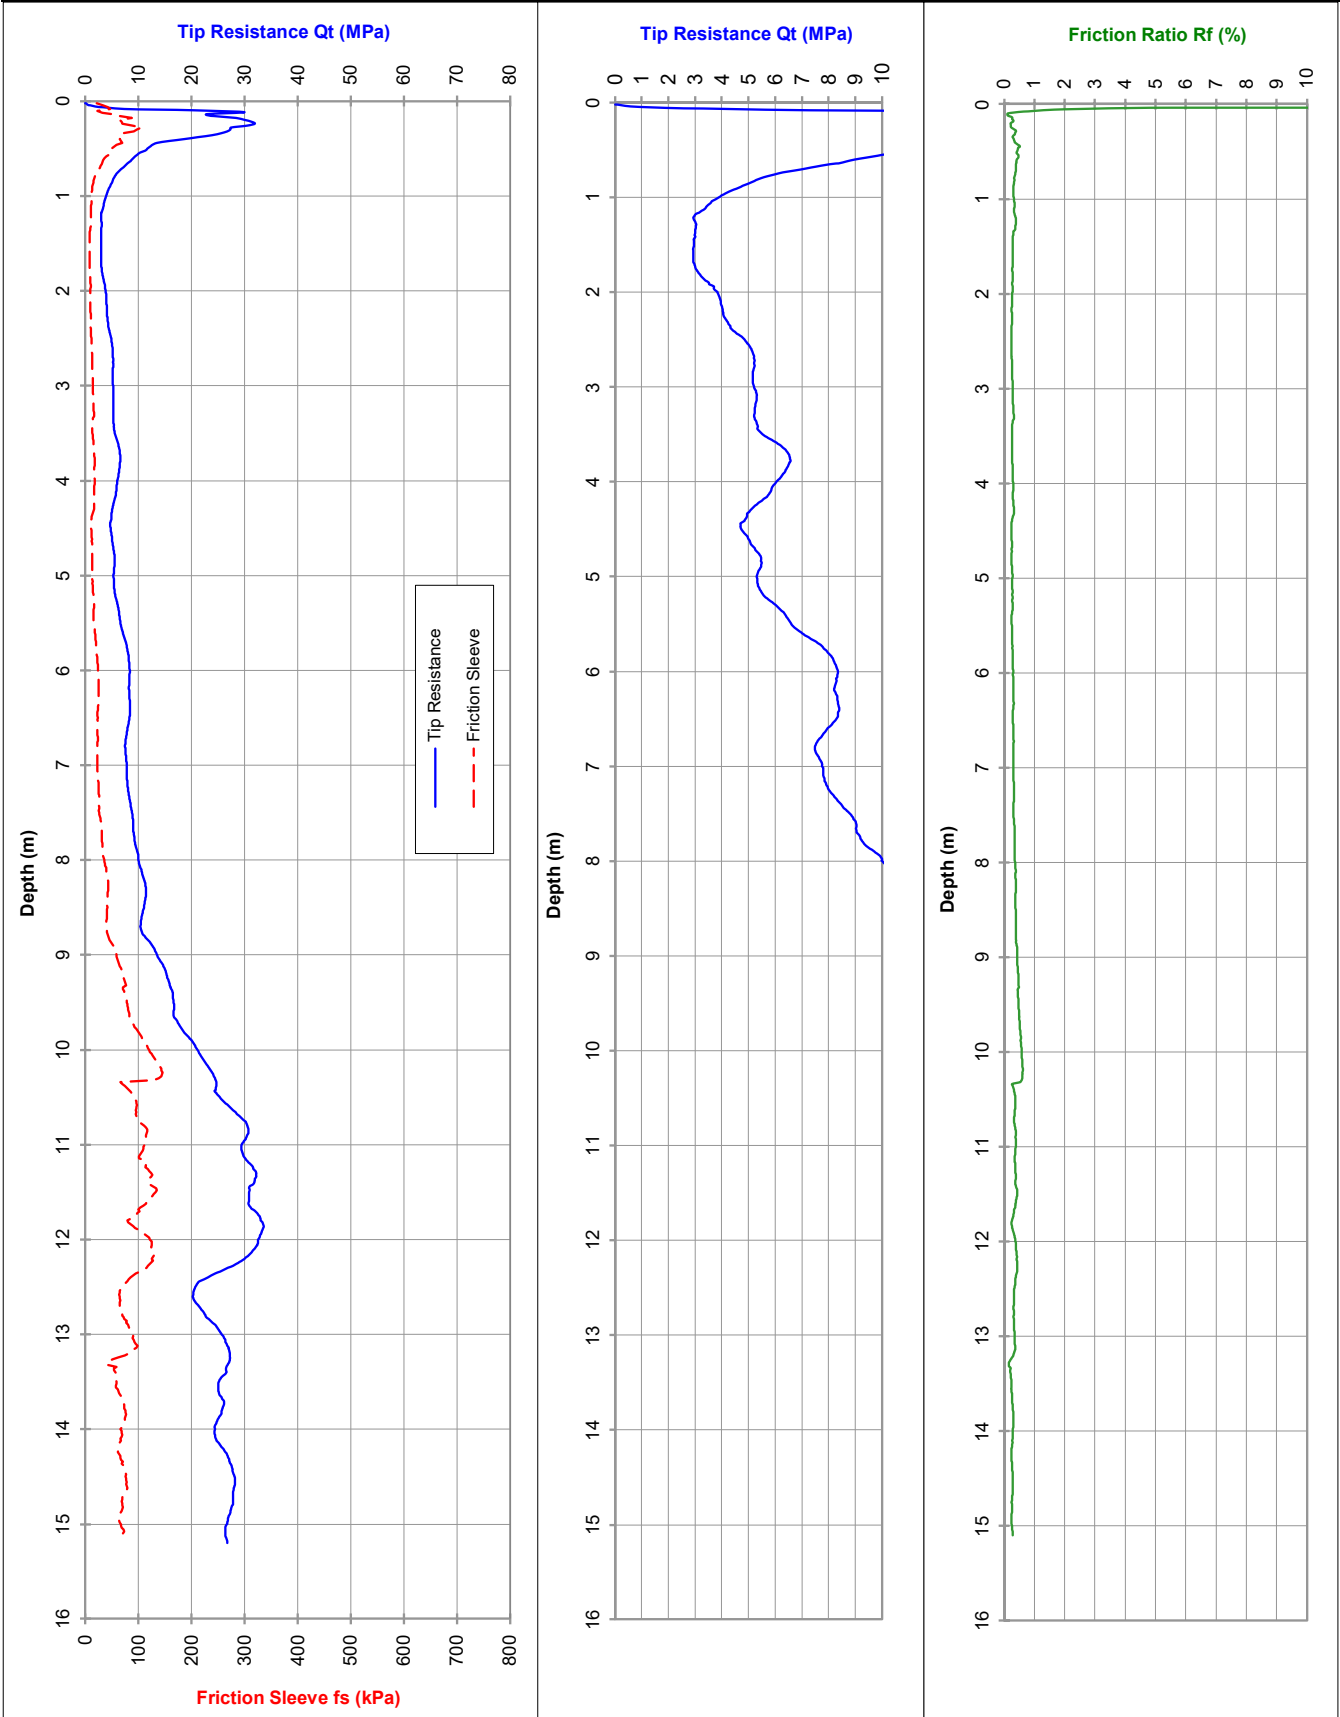
CPTU 172

Tested in accordance with AS 1289.6.5.1-1999 and IRTF 2001 for friction reducer

Approx. water (m): Dry to 10.1

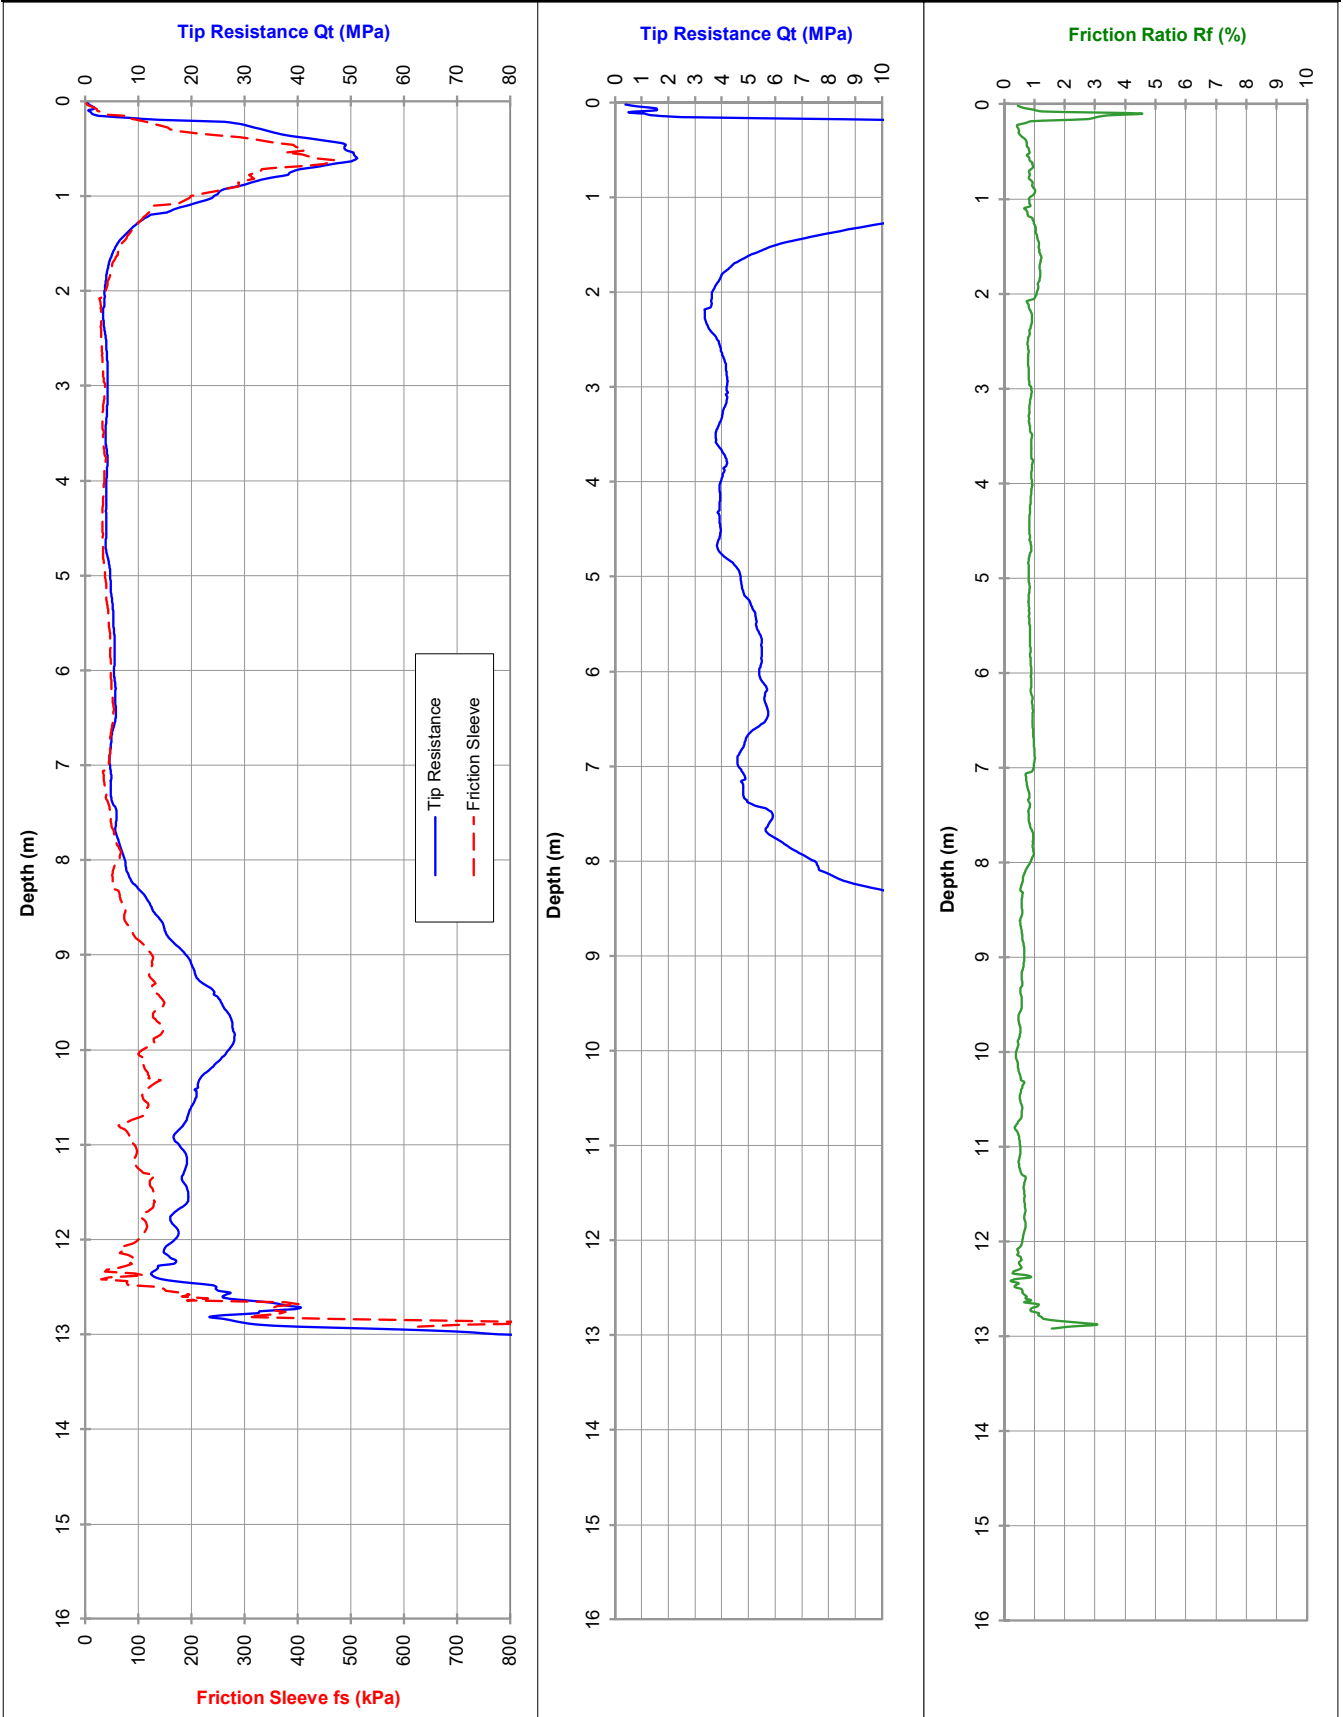
CPTU 175

Tested in accordance with AS 1289.6.5.1-1999 and IRTF 2001 for friction reducer

Approx. water (m): Dry to 11.8

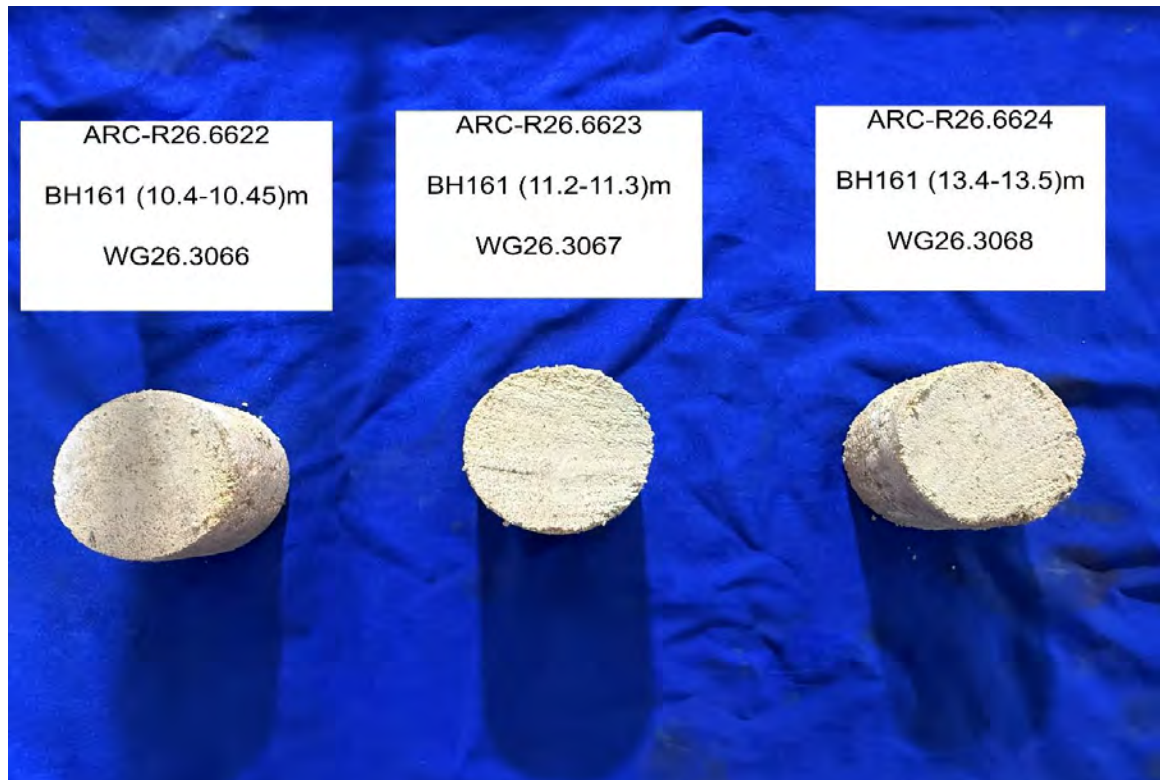
TEST PHOTOS - Pre Testing

Photo's as per client's request, photo's are not required as per AS 4133.4.1 - not covered under scope of accreditation. Job Ref: PER2025-0250.

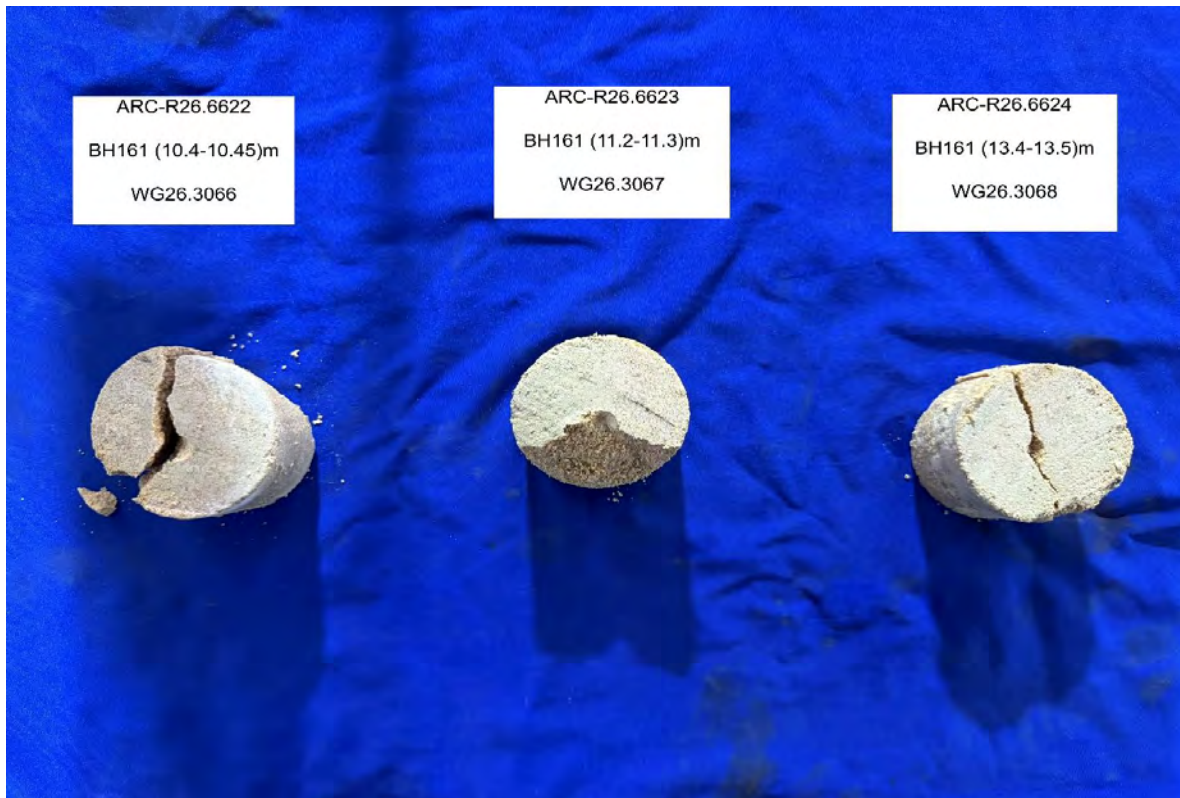
TEST PHOTOS - Post Testing

Photo's as per client's request, photo's are not required as per AS 4133.4.1 - not covered under scope of accreditation. Job Ref: PER2025-0250.
