EXCAVATION MANAGEMANT PLAN ATTACHMENTS

Proposed Hard Rock Quarry

Lot 800 Pruden Road, Whitby

OVERVIEW OF THE GEOTECHNICS AND DESIGN PROPOSED HARD ROCK QUARRY LOT 800 PRUDEN ROAD, WHITBY

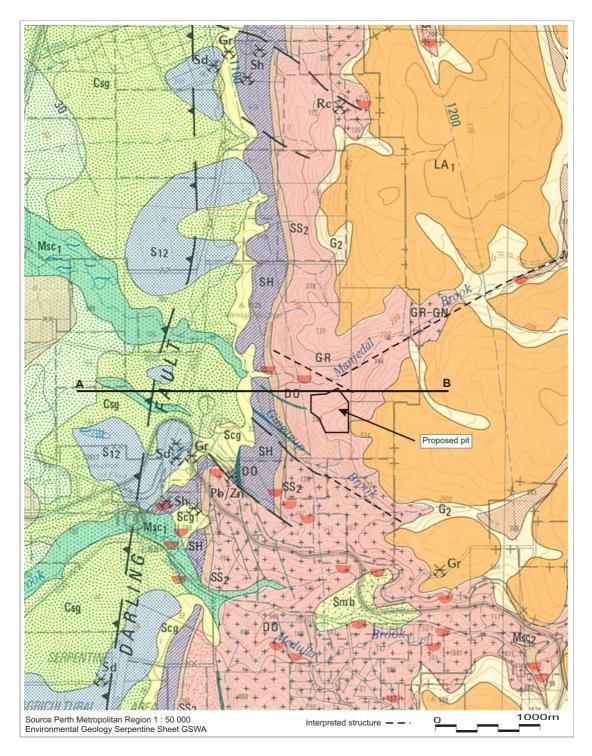
Figure 1-1 Geological map of the proposed pit

The pit is wholely located within the Gneiss Terrane. The rock in the pit is felsic to intermediate granite with some gneissic materials and lineations, which have been intruded by some minor quartz and pegmatite veins and granites with minor diorite/dolerite dykes.

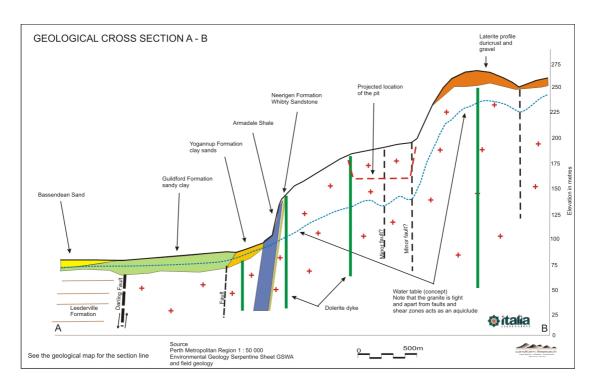
Figure 1 – 2 Geological cross section

The grainsize is relatively even coarse grained granitic rocks consisting of mixtures of granite adamellite and granodiorite that have been slightly stressed and gneissic in places.

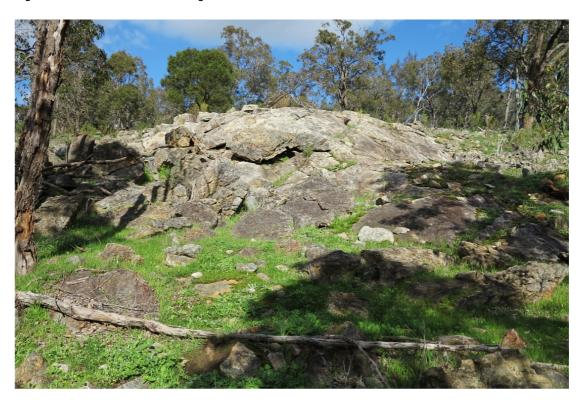
Figure 1 – 4 Granite outcrop showing the even nature of the rock and wide jointing

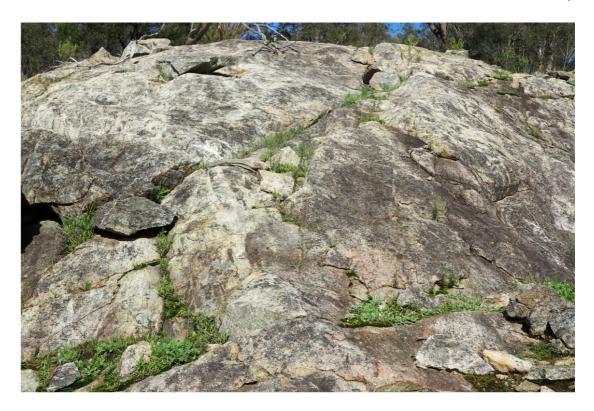
Figure 1-5 Granitic mixed rock with gneiss and granite intermixing

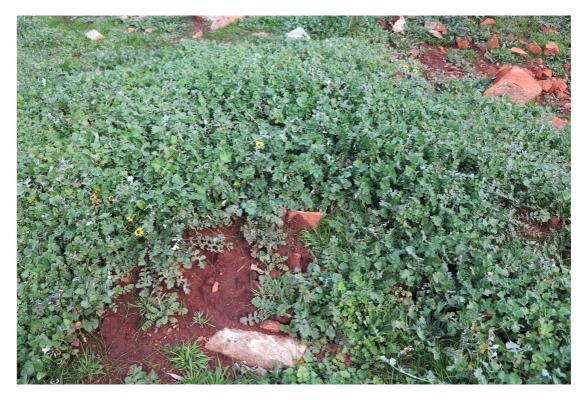
Figure 1 – 6 Dolerite dyke that is weathered

Another fracture or structure intruded by a dolerite dyke appears to run north along the western side of the proposed pit, where the rock appears softer and more weathered. This rock is proposed to be cut out to form the flat processing area and bunding, providing for an easier commencement.

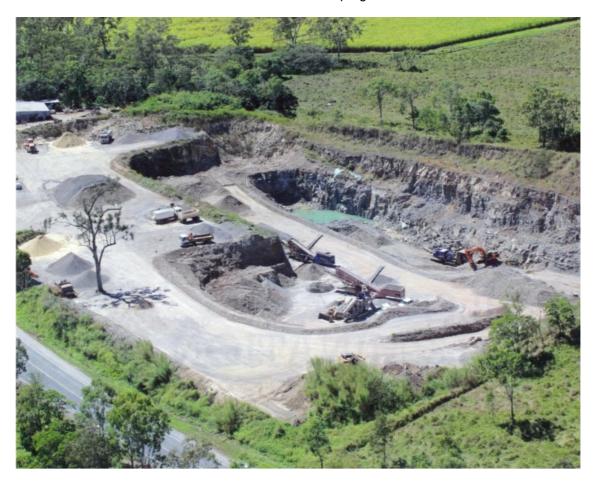
Figure 1-7 Typical smaller quarry with similar operational plant to that proposed

- Track mounted percussion drill and compressor.
- 20 tonne excavator or similar.
- Rubber tyred loader
- 35 50 tonne off-road dump truck for internal transport of rock from the pit to the crusher.
- 20 tonne water truck or similar for dust suppression.
- Self contained maintenance vehicle to attend site as required.
- Mobile primary, secondary and tertiary crushers with related screens and conveyor belts.
 These will be moved across the site as excavation progresses.

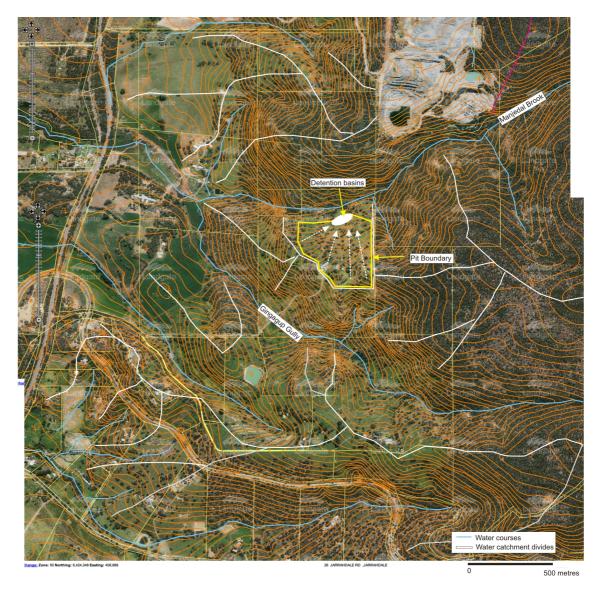
Figure 2 - 2 Water catchment boundary and quarry site

Surface water from up slope will be cut off by cut off drains and bunding to prevent surface inflow to the pit.

There are no water courses that will be impacted on by the pit or proposed processing area.

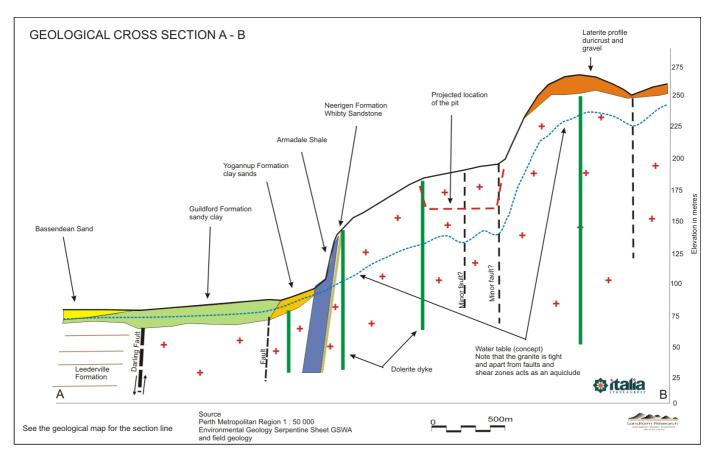
Figure 2 – 3 Geological cross section

Hard rock is tight and has some fractures. The elevation of the proposed pit is well above creek elevation so the water table will not be intersected. There may be some minor perched or trapped water occurring in fractures of the hard rock. See Figure 6 (attached).

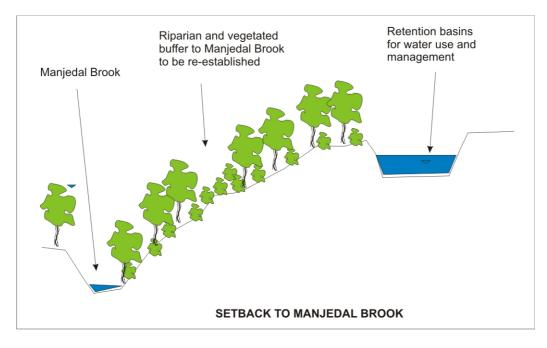
Figure 2 – 5 Sketch section to Manjedal Brook

The 50 metre buffer to Manjedal Brook will be maintained and replanted to local creek line and riparian vegetation with species matched to the location of the planting in relation to the geomorphology.

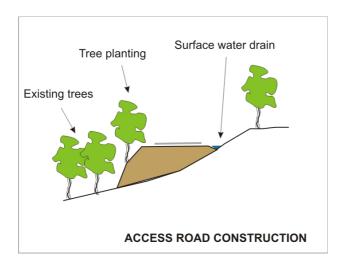
Figure 2 – 6 Sketch section showing the concept section of the access road

The access road will have edge gutters of the access road that are stable, vegetated and working. That water will flow across pasture prior to entering the creeks and therefore will not impact on them.

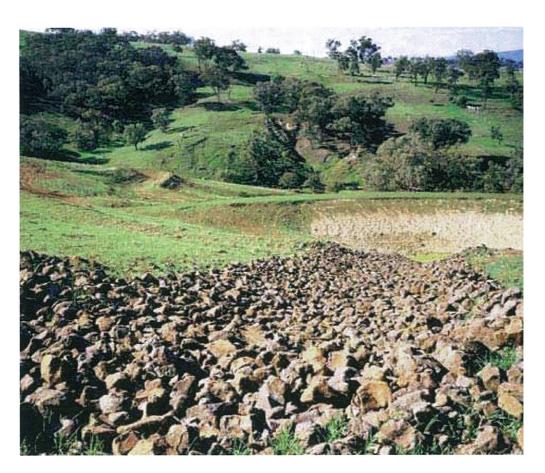
Figure 2 - 7 Examples of rip rap and stone pitching to mange water on slopes, slow the water flows. All detention basins will be provided with rock pitching to protect the outlets

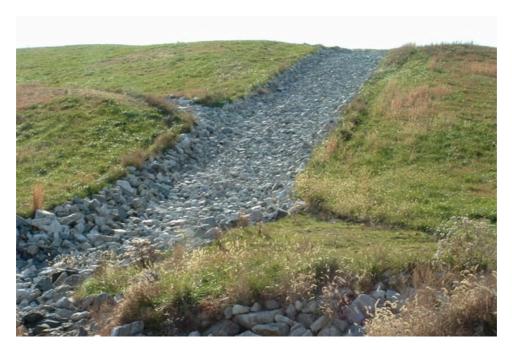
Figure 2 - 8 Examples of rip rap and stone pitching to mange water on slopes, slow the water flows. All detention basins will be provided with rock pitching to protect the outlets

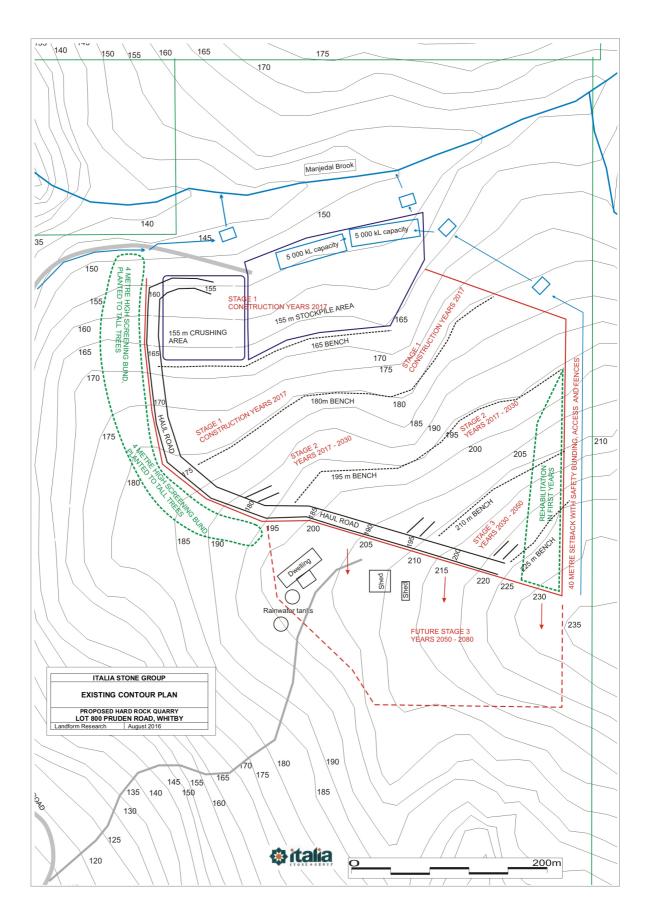
Figure 2 - 9 Proposed pit design and water management

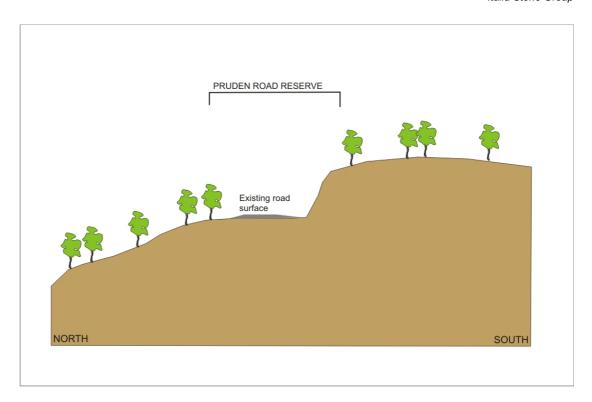
Figure 4 – 9 Existing sketch section across the ridge on Pruden Road

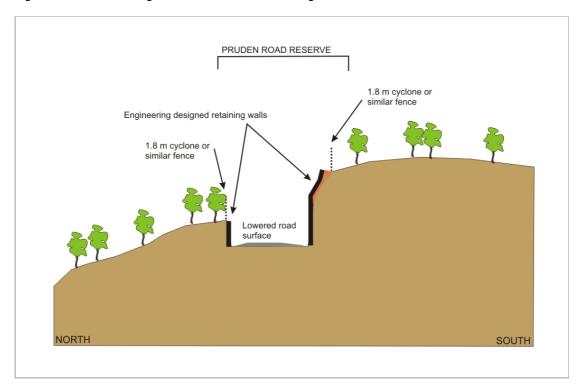
Figure 4-9 Existing sketch section across the ridge on Pruden Road showing the concept lowering

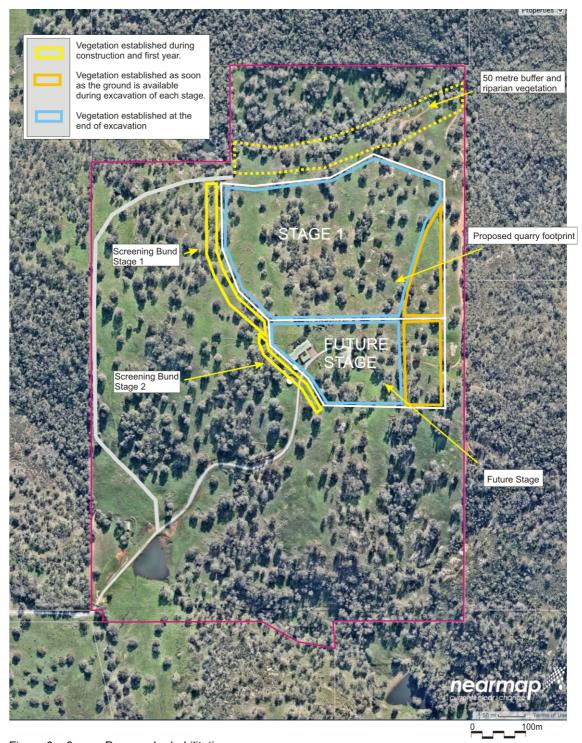
Figure 6 – 8 Proposed rehabilitation
